Laxá Hydropower Scheme, Iceland

Review of Sediment and Ice Challenges

LV report no: LV-2013-112 **Date:** 02.10.2013

Field Report

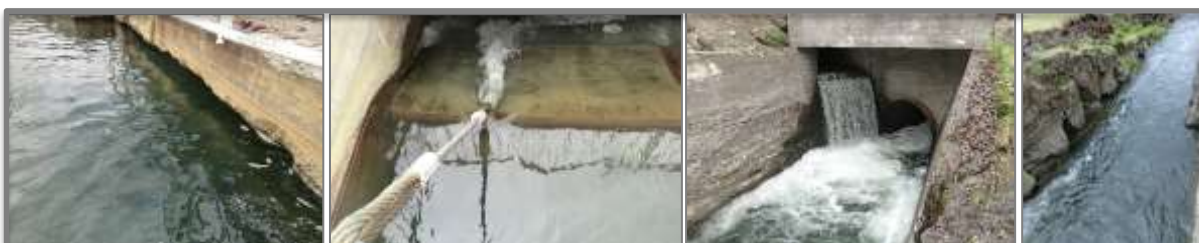
Figure 9: Overflow gate for passage of ice at the old intake location to Laxá 1 HEP

The overflow gate hoisting arrangement, with a hydraulic cylinder located under the gate as shown in drawings, was not in place. The gate is kept in position by use of two steel wires as shown in Figure 9.

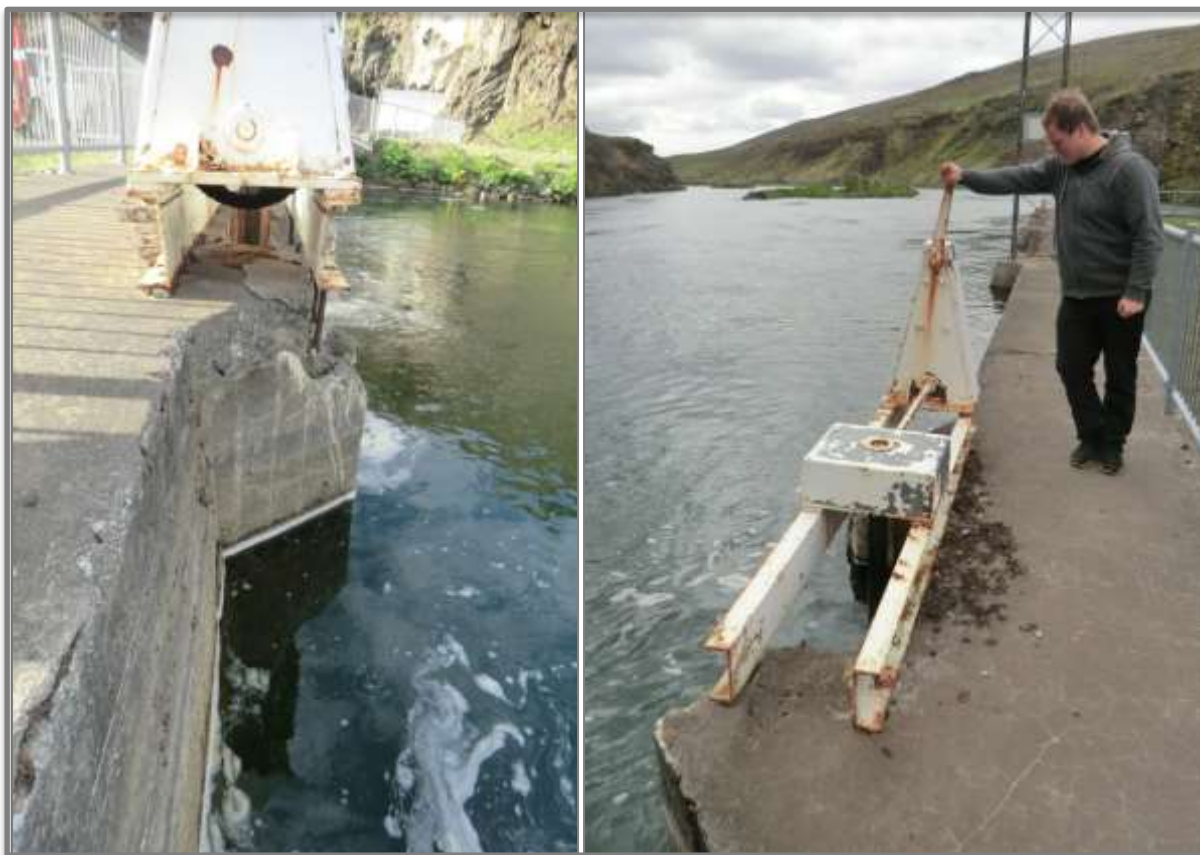
The bottom outlet gate (width: 1.25 m, height: 2.00 m) just upstream of the overflow gate at the original intake site is shown in the drawing in Figure 5, but not on Figure 6. The hoisting mechanism was damaged as seen in Figure 10, and it was not clear if the gate could be operated again. The

downstream side was closed by an embankment. It is not clear whether it is possible to reactivate this gate and use it for sediment flushing, see also Figure 30.

Figure 10: Hoisting arrangement for the bottom outlet gate, possible sediment flushing gate?

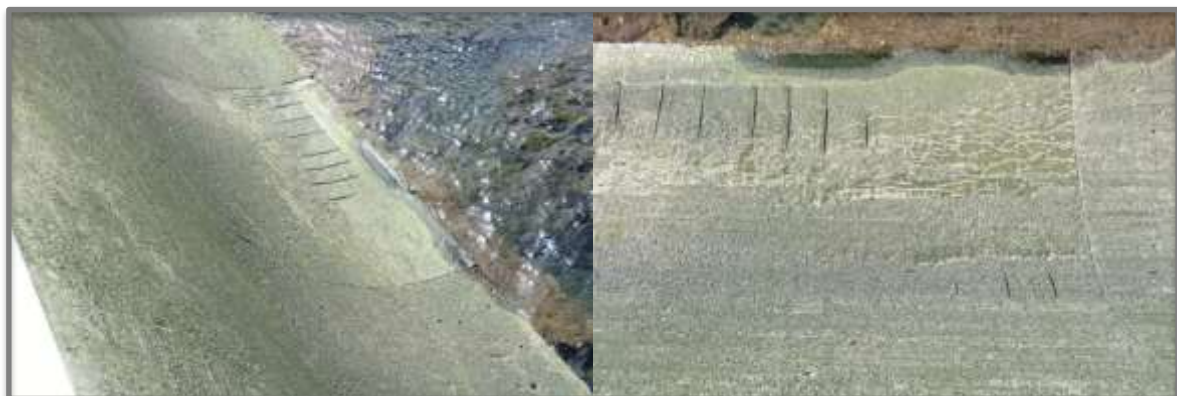
The flip bucket of the spillway on the dam has damages as it can be observed in Figure 16. This is most likely caused by freezing action and not by cavitation or sediment wear. It seems that it is concentrated on one section of the dam which may have had poorer concrete quality than the other sections initially.

Figure 16: Damages at the flip bucket of spillway at Laxá II dam

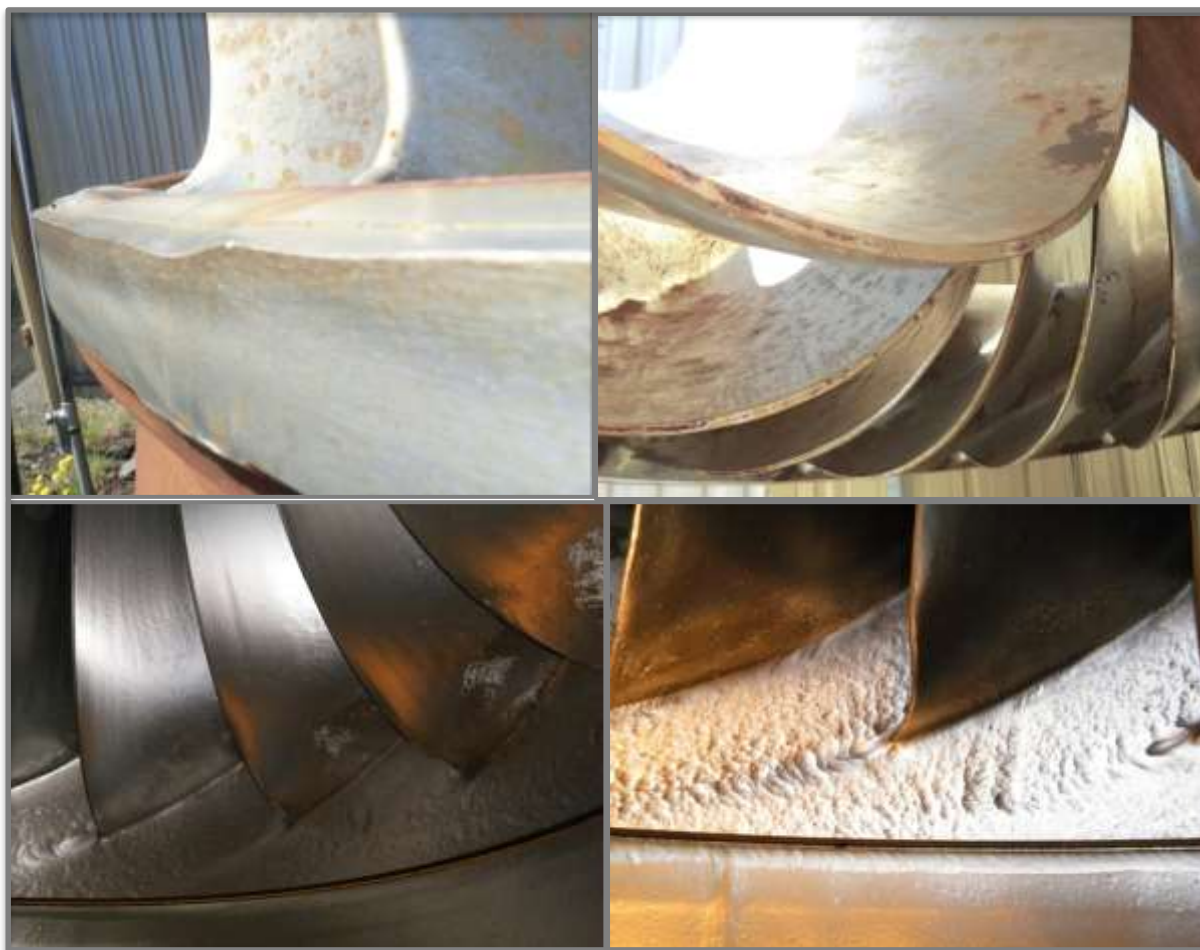
The sediment related problems at Laxá Hydropower Scheme are addressed by (Gunnarsson, 2012) reference is made to Chapter 2 in Appendix 2 where the findings prior to the field visit are summarized. The bulk of the sediment load which is transported by the river into the head-pond of the Laxá III dam is passing through the intake, the headrace tunnel and the turbine as there is no efficient and “easy to operate facility” for bypassing the sediment load of the river. Sediment-induced erosion has been observed in both Laxá 3 and Laxá 2 turbines as shown in Figure 17.

Figure 17: Upper: replaced runner from Laxá 2 with signs of sediment-induced wear. Lower: the runner of Laxá 3 from an inspection of the turbine on 5th April 2011 (Ref. 3).

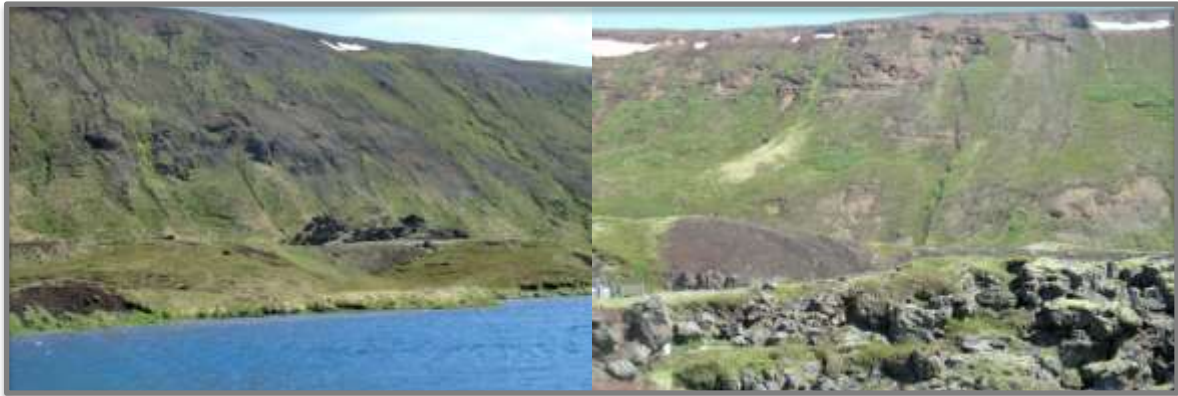
It is believed that the main sediment source is the steep slopes along the Laxá valley. The erosion is believed to take place during heavy rains and snow melt. Snow avalanches as well as mass wasting (slow land-slides) may also play an important role with respect to feeding the river with sediment from the valley slopes. The slopes shown in Figure 18 and 19 are very subjective to erosion and an unlimited sediment source to Laxá.

Figure 18: Valley slopes on the eastern side of the Laxá valley upstream of the Laxá III dam

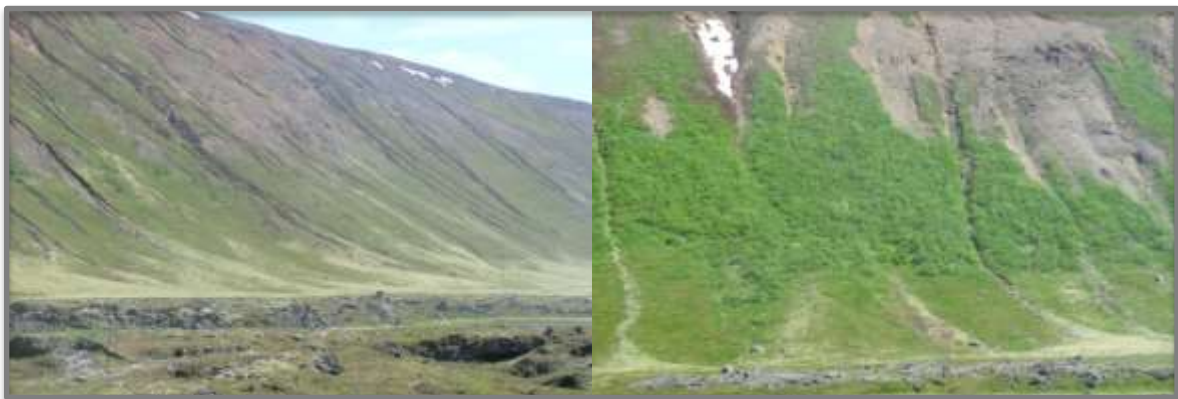
Figure 19: More sediment yielding valley slopes in the Laxá valley upstream of the Laxá III dam

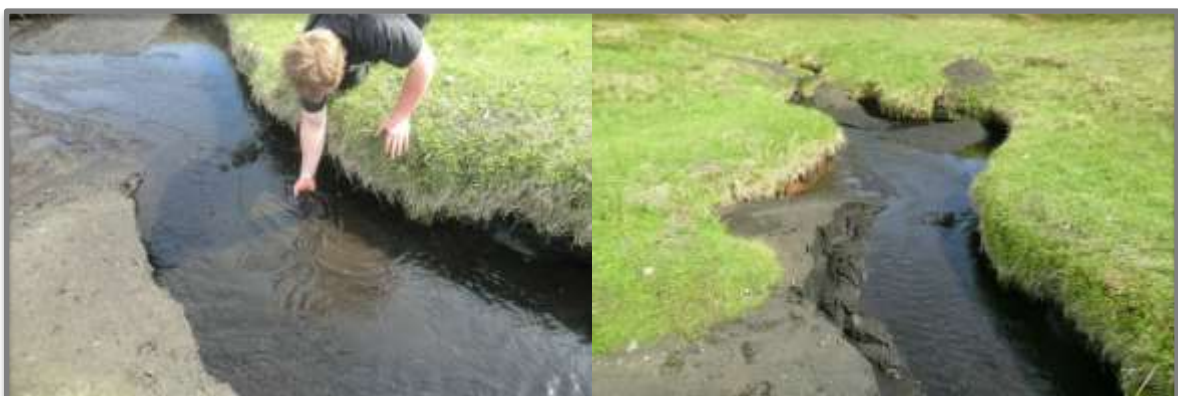
Figure 20: Sediment deposits in a small right bank tributary to Laxá River close to the dam

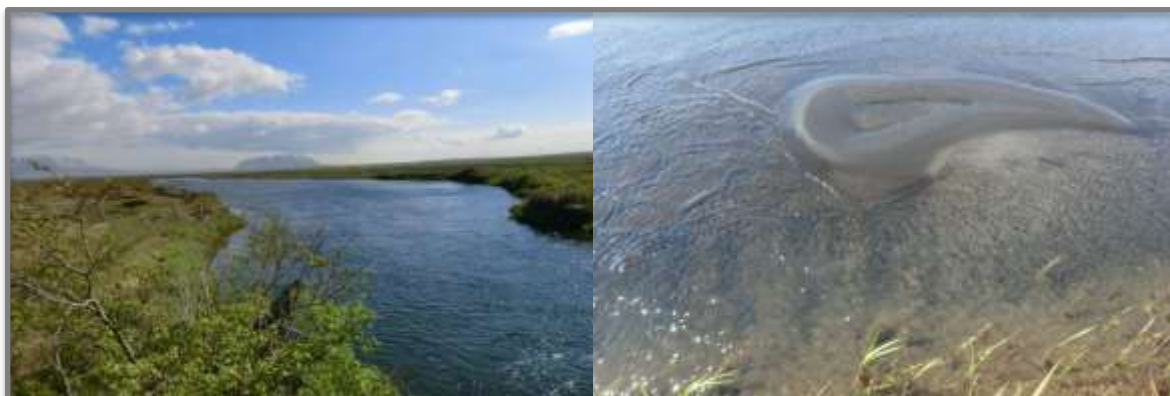
Figure 21: Sediment deposits along the bank of Kráká River upstream of Mývatn

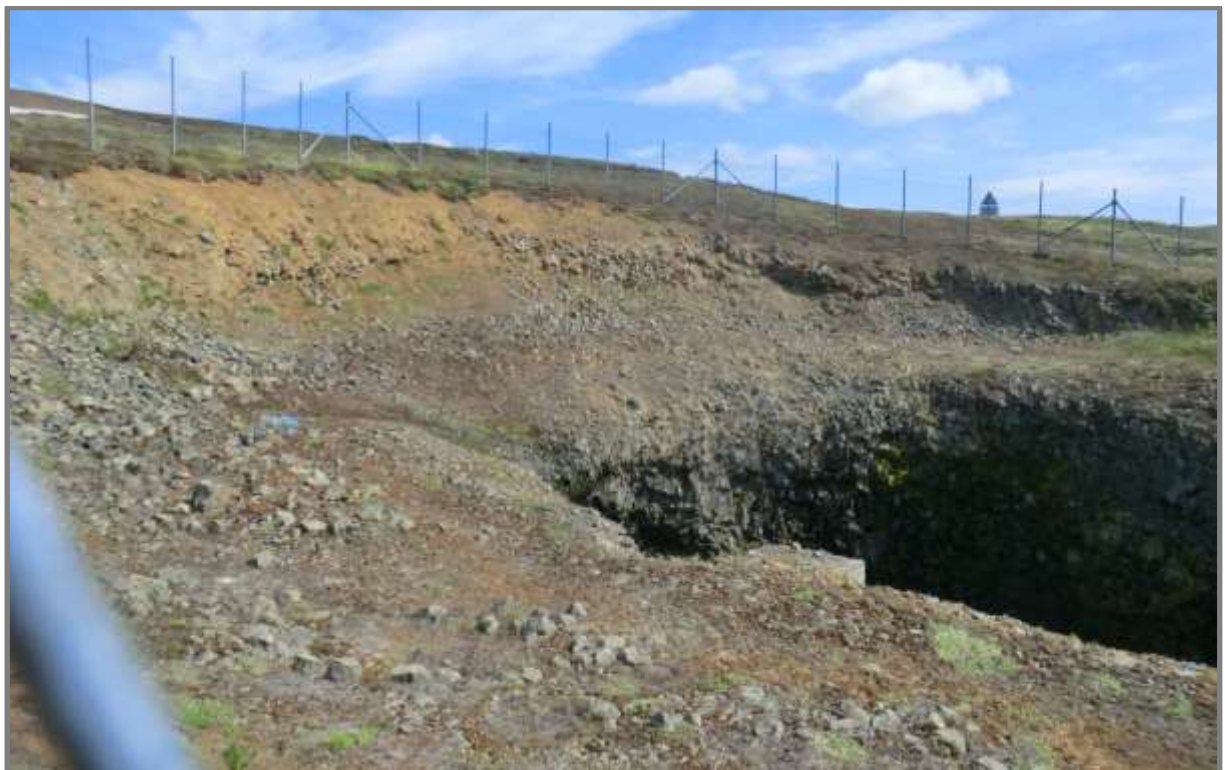
Figure 25: Surge shaft opening as it is today

Some of this ice may settle sideways and upwards into the surge chamber and give momentum to the formation of an ice cover in the chamber. This ice cover will bind itself to the rock surface in the chamber and break down the rock as the water in the cracks in the rock will expand and slowly cause fragmentation of the rock. Large forces will occur when the ice surface starts to move up and down due to surges in the water ways when the load changes. Pieces of rock will break off and sooner or later be transported into the tunnel and the turbine due to surges or together with ice blocks.

When the surge chamber is inspected, arrangements for removal of stones and gravel which may be found on the platform where the diameter of the surge chamber changes from 13 m to 4-6 m as well as in the tunnel system connecting the surge chamber with the headrace tunnel should be made. The geometry of the connection between the surge chamber and the headrace tunnel shall also be documented as this is important for how ice and air moves in the tunnel system. Each stone which may end up in the turbine is a potential risk for the turbines safety and efficiency as such, but also a possible generation loss risk which may lead to an emergency closedown of the plant.

We recommend Landsvirkjun to start the work as soon as possible on safeguarding the surge chamber and thus prevent intrusion of snow, ice and sediment into the chamber and the waterway of the plant which may cause an emergency shutdown of Laxá 3 hydropower plant.

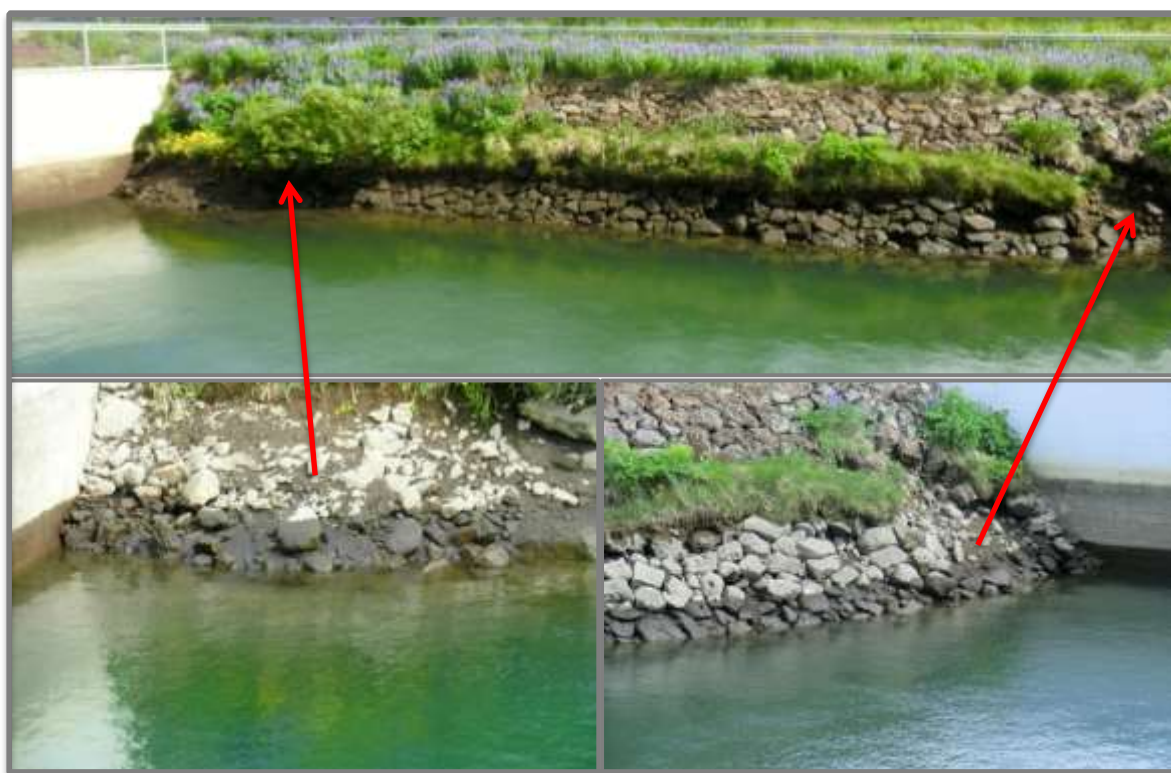
These large particles are most likely transported by ice. They may come from the river upstream, but it is more likely that they are eroded from the banks of the forebay and the head-pond. Figure 24 shows that the stone masonry lining of the bank of the forebay is damaged and many stones have been removed also from the stone-lined right bank of the head-pond as shown in Figure 25 as well as Figure 13.

Figure 26: Damages of the stone masonry lining along the right bank of the forebay

We do also recommend Landsvirkjun to carry out works to protect the banks of the Laxá II pond from further erosion and degradation. This is most important for the eastern slope inside the forebay, but also for the slope along the road further upstream on the eastern side of the pond.

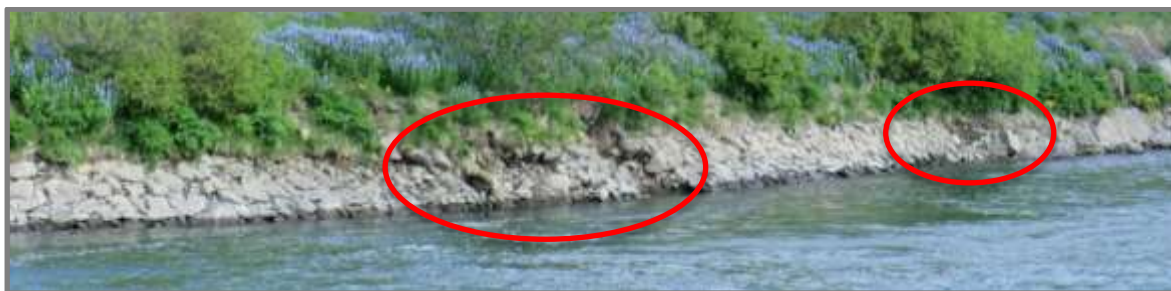
Figure 27: Damages of the stone masonry lining along the right bank of the head-pond

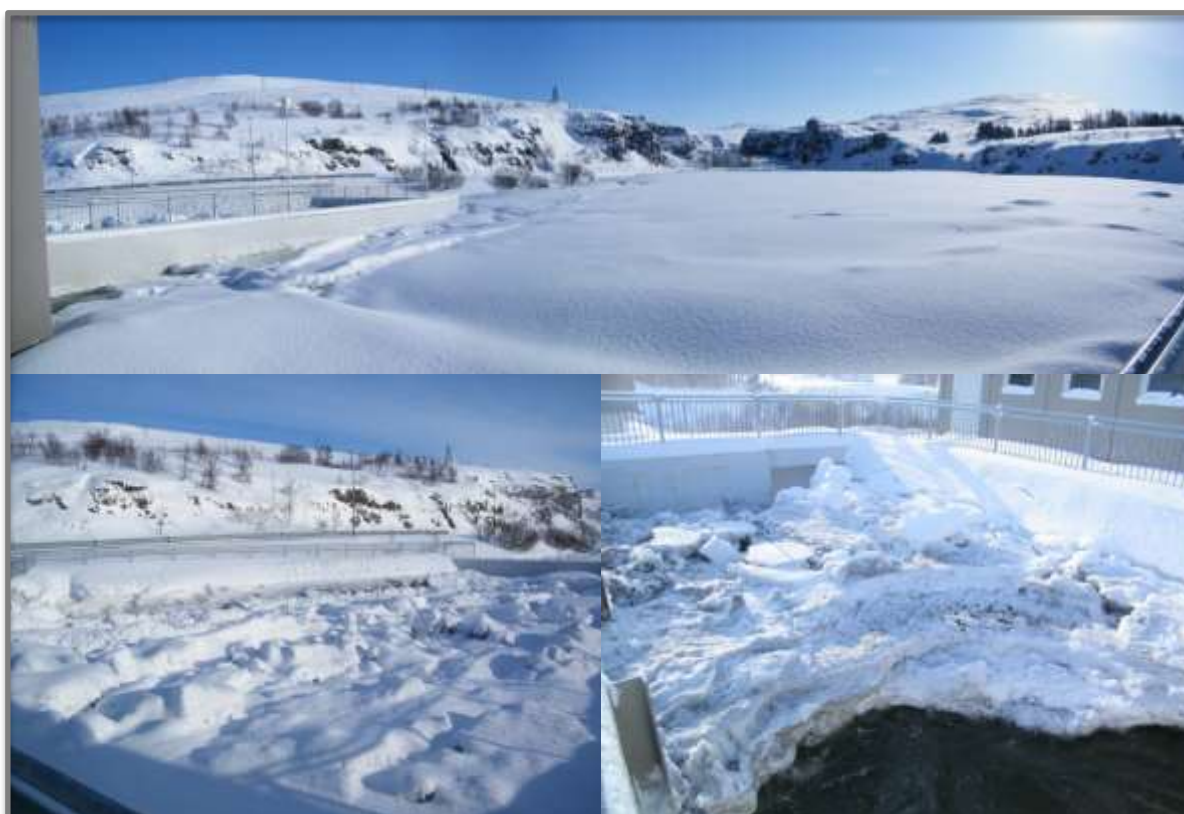
Ice in action in the head-pond and the forebay of Laxá II dam is shown in Figure 28. This is the most likely mechanism to transport stones and gravel from the banks of the head-pond to the intake trash rack.

Figure 28: Ice action in the head-pond and the forebay of Laxá II dam (Ref. 3)

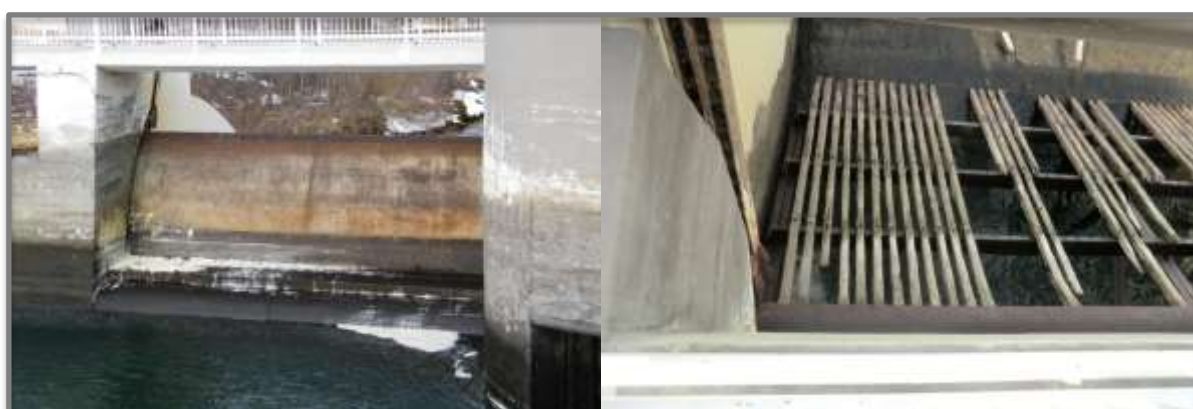
Figure 29: The flood-sluice-gate with damaged downstream apron made of wood-staves

As seen in Figure 29, the gate is in a poor condition. The steel frame supporting the downstream apron is damaged and many wood-staves are removed. If water is running over this gate for passage of ice when the air temperature is well below zero and the water temperature is close to zero, the temperature of the structures and the gate itself will also be below the freezing point. Water will therefore freeze as it hits the steel and concrete structures. Ice blocks will jam the wood staves and the hoisting mechanism of the gate. The cracks in the steel structure under the wood staves indicate that large forces have occurred from ice directly or as a result of an attempt to manoeuvre the gate in a frozen condition. As it is today, the flood-sluice-gate is therefore not an appropriate tool for passage of ice.
