## MILOS GEOTHERMAL DEVELOPMENT

Consultant's Field Report

**Report NO: OS-89008**

**March 1989**

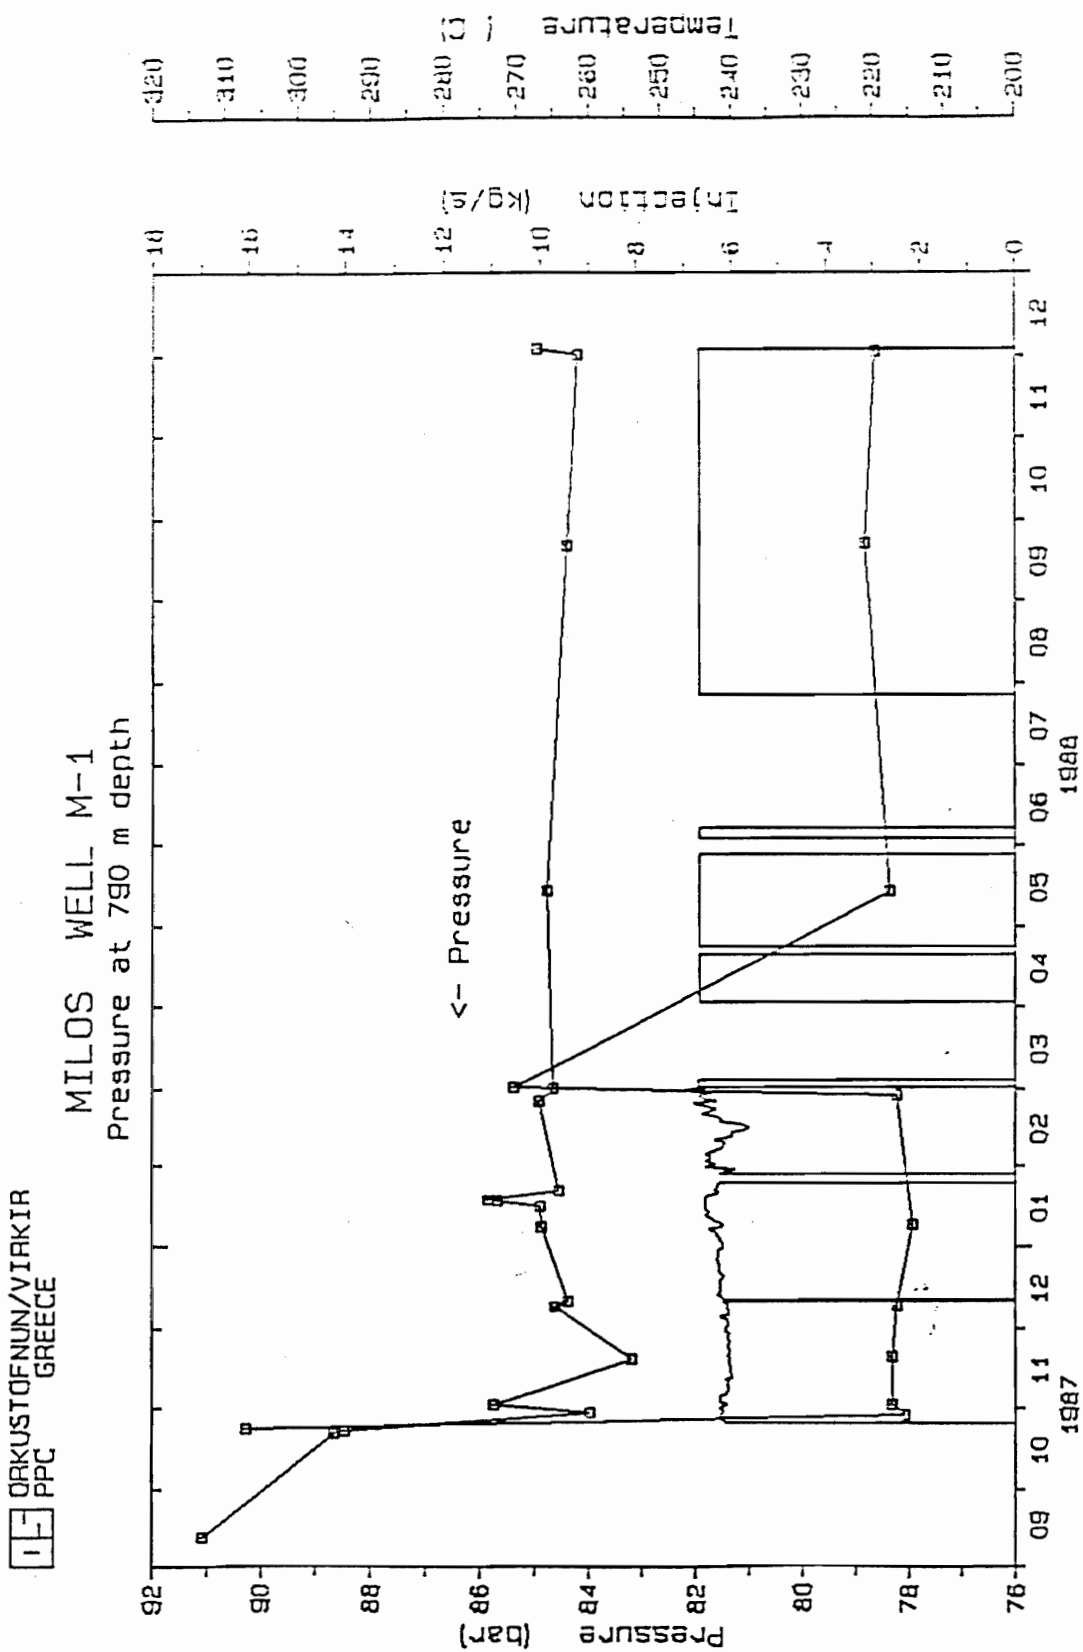
Fig. 1. Pressure at 790 m depth

The analytical model was nevertheless checked against the additional data using the same parameters as earlier. An adequate match is obtained between measured (smoothed) and calculated pressure values until June 1988. At that date, the reinjection was interrupted for nearly two months. After injection was restarted in late July, the model predicts higher pressure increase in well M-1 than is actually measured. Possible reasons could be, that the model fails as stated earlier, the reinjection rate is less after July than it was before, or the injectivity of well M-1 has improved from earlier conditions during this last period. Further data and possibly numerical simulation is required to distinguish between these possibilities.
