ORKUSTOFNUN
NATIONAL ENERGY AUTHORITY
DEPARTMENT OF WATER POWER

THE III INTERNATIONAL CONGRESS OF
ENGINEERING GEOLOGY

EFFECTIVE SEALING BY SEDIMENT LOAD

DAMAGE TO EARTH DAMS AND OTHER MAN-MADE STRUCTURES CAUSED BY
RIFTING ACTIVITY IN NORTH ICELAND 1975-1977

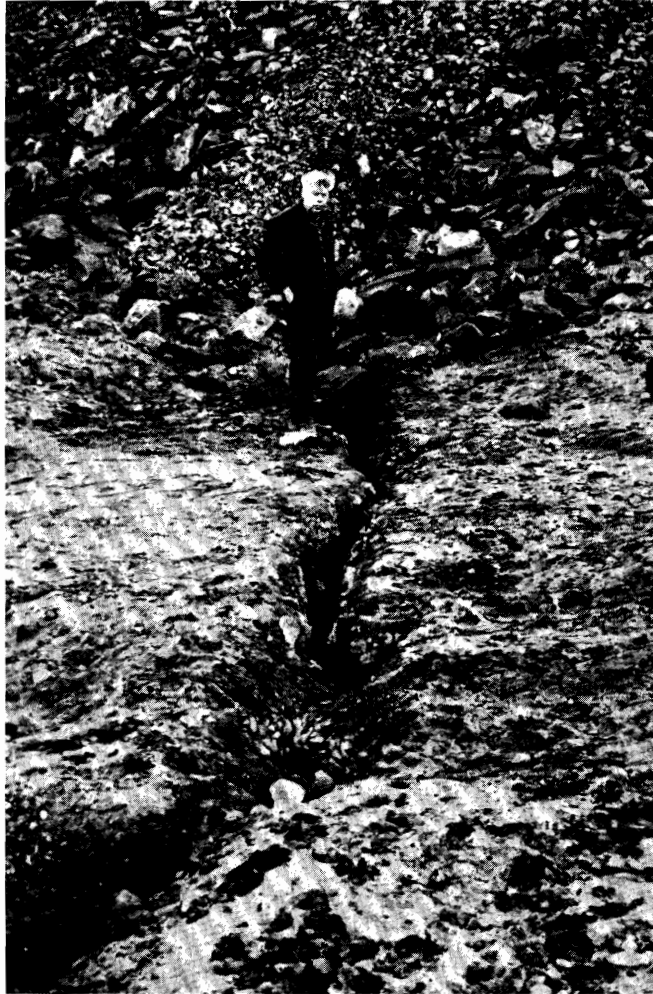
Fig. 3

Fracture 1 where it
disappears under the
upstream toe of the
dam.

The fractures were repaired by various methods but the one running under the dam was sealed by pumping in a mixture of sand and bentonite. At the latest stage a cement bentonite mixture was used until the fracture had been filled. Shortly after reimpounding of the lake at about 4 m water depth minor leakage was observed at the fracture downstream of the dam. The lake was emptied again and the water disappeared in 3 days. It was then seen that a part of the fracture system had reopened. The glass plates indicated compression amounting to a millimeter or slightly more. This fracture was again repaired and since then no water has appeared at surface downstream of the dam.

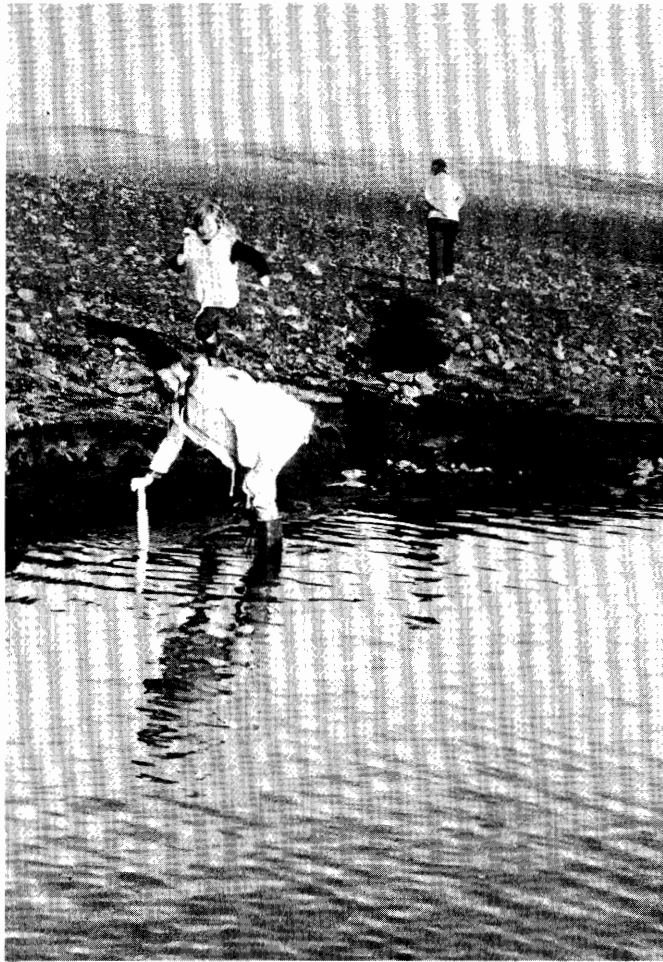
Fig. 7

Several other faults formed in the Langalda lake bottom. The biggest one, no. 2 on the map figure 6, opened up in September 1972. It extended about 100 m up on dry land making visual observation possible. Sudden increase in leakage recorded in continuous stage recorders on lake and inflow indicates that it was found 1 or 2 days after it opened up. These later faults were formed both in moberg and postglacial lava. They are probably new in the postglacial lavas as old fracture fillings were not observed there. But in the moberg underneath these are certainly old faults in most cases. Faults no. 3, 4 and 5 were found when lake level was lowered in 1972 for repairing swallow holes and fault no. 2. At this time it was obvious that fault no. 1 was practically tight as the level did not fall much below the lowest point of fracture no. 2 although no inflow was allowed for several days. Figure 7 shows fault no. 2.

Fracture 2 which opened up
in September 1972.

Photograph taken where it
extends up to dry land.

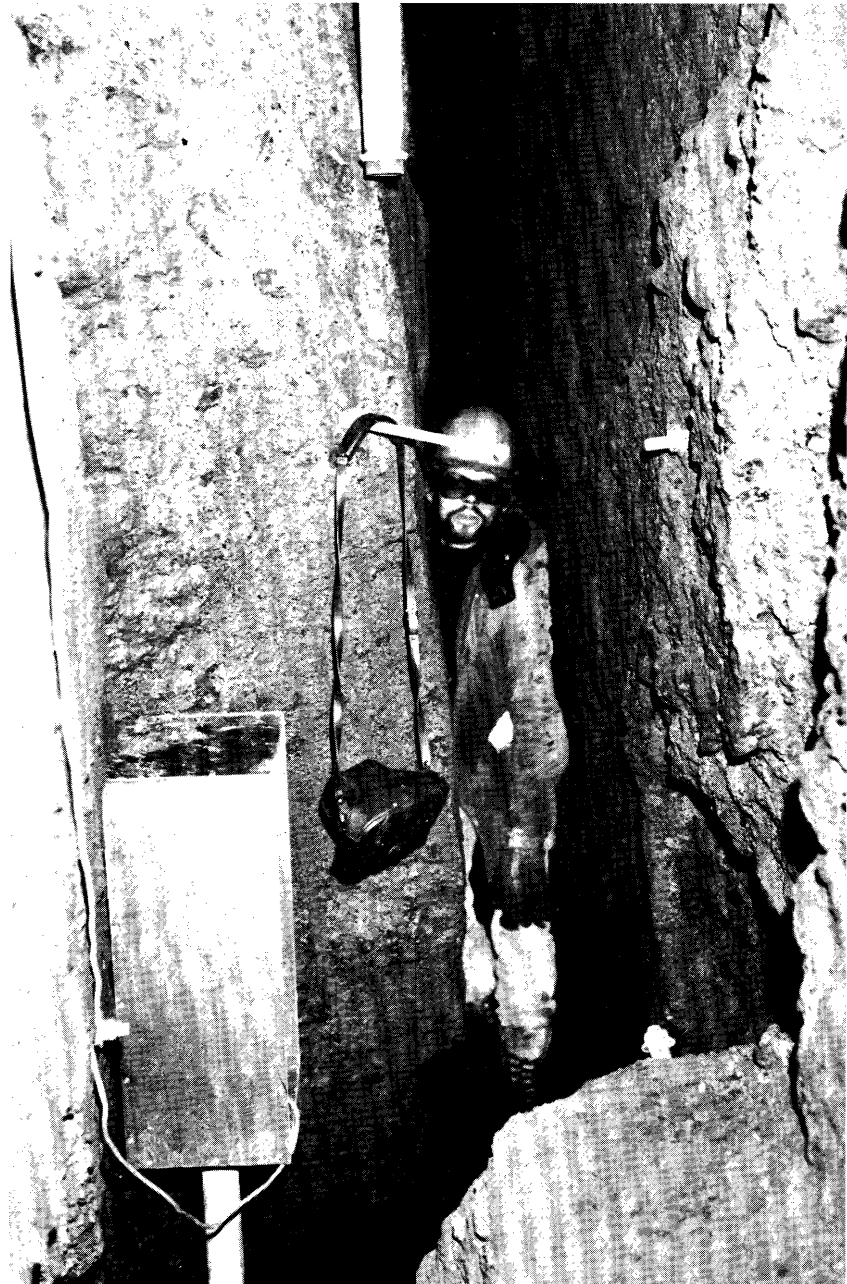
Fig. 8

Fracture 6 was never observed as a continuous rupture. It was first detected in August 1975 as a line of swallow holes in the lava. In spring 1976 a trench was excavated in the moberg hill south of the lake in a continuation of this line to try to find the fracture there and it was certainly found, a large open fracture as seen on figure 8. This fracture was bridged by moraine and loessy soil and had not been opened at this place for at least several thousand years. Fractures no. 1, 2 and 6 have been instrumented with strain meters and all show the same tendency in reaction to the groundwater level, the higher the groundwater level the wider the fractures.

In fracture no. 6 where it
was opened up by a bulldozer
trench.

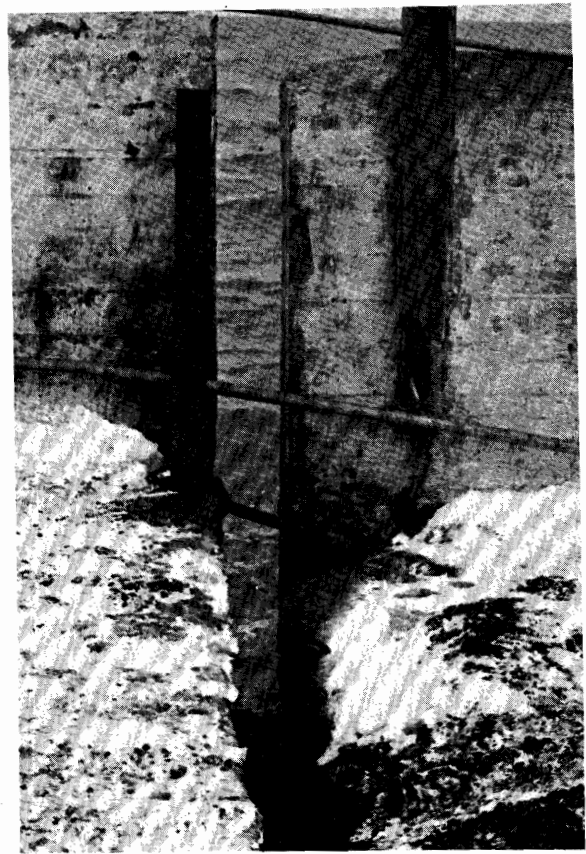
Fig. 3: The concrete box caissons in the Kópasker pier moved about 0.5 m apart and tilted in the 6.3 M Kópasker earthquake of Jan. 13 1976.

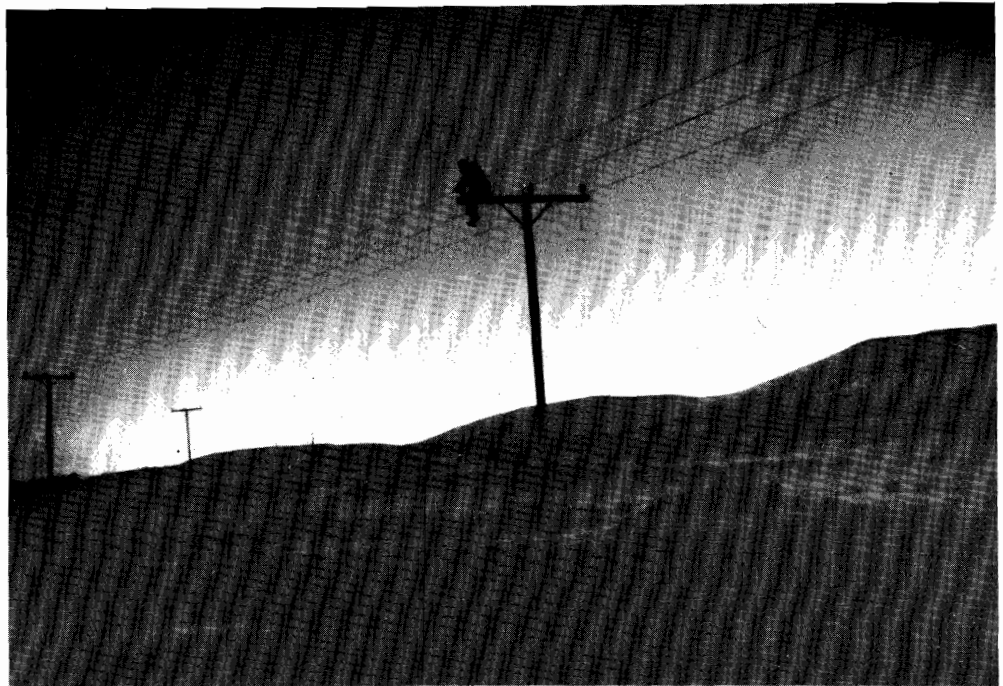
Fig. 4: Electric transmission lines across the rifting zone in Bjarnarflag, south of Krafla. The wires are strained almost to breaking point. The photograph shows a man lengthening the wires in the evening of April 29, during rifting.

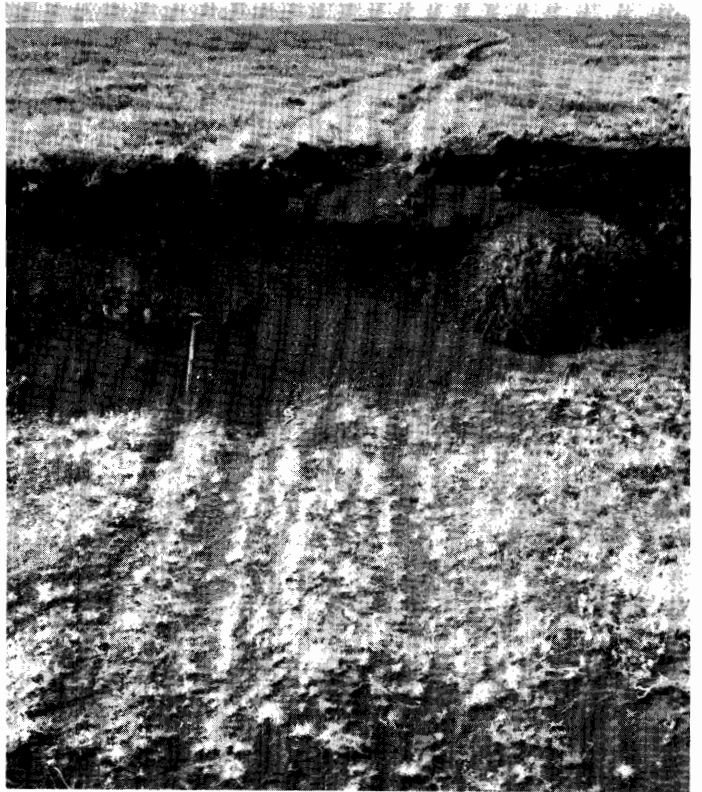
Fig. 5: On the outwash plain south of Axarfjörður bay, escarpments over 2 m high were formed during the rifting and subsidence in the Winter of 1975-76. On the photograph a rough car track has been displaced. Length of shovel is 1 m.

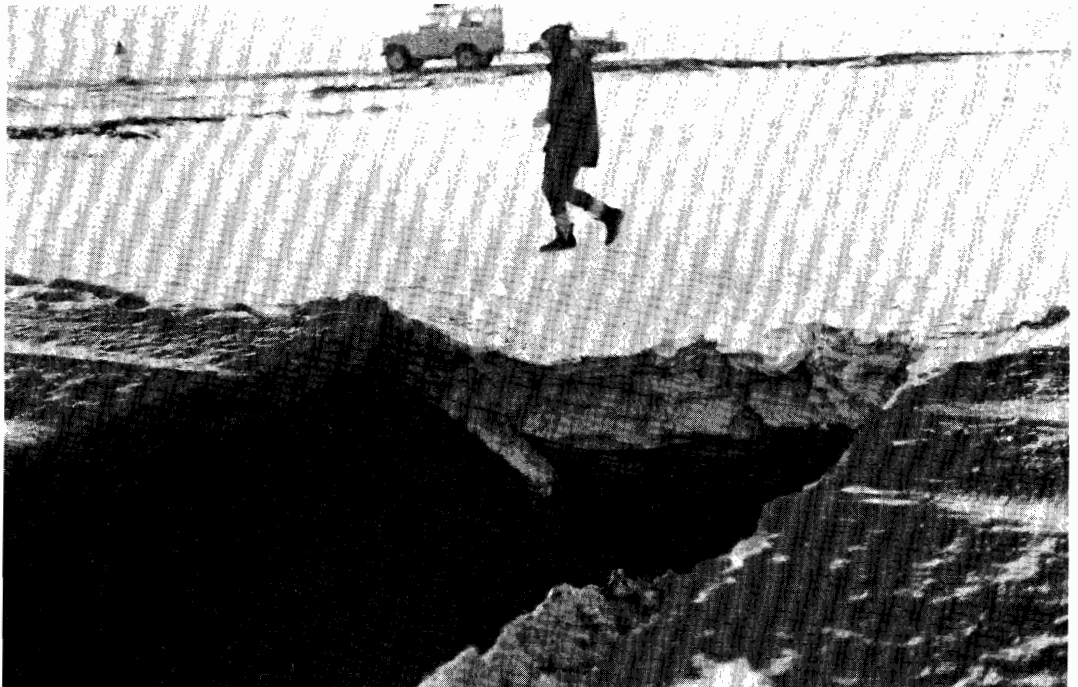
Fig. 6: One of the trenches formed in the Axarfjörður main road. The hardened snow forms a bridge across the trench. See text for explanations.

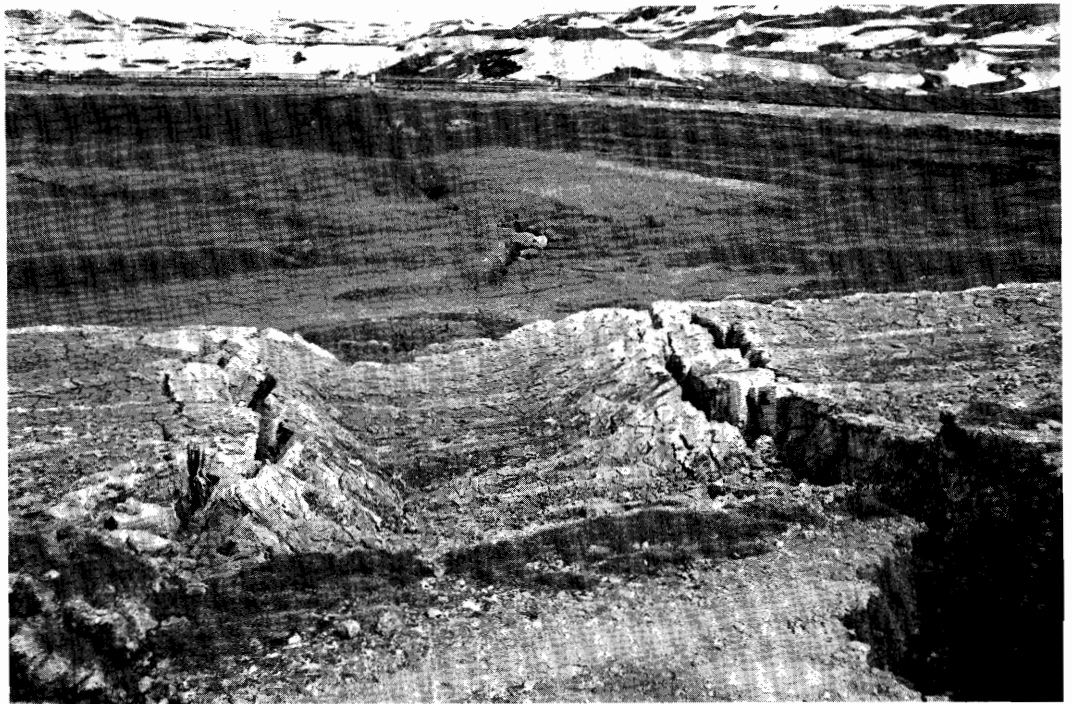
Fig. 7: One of the empty diatomite reservoirs at Bjarnarflag. This one was emptied through the fissure seen on the bottom of the reservoir.

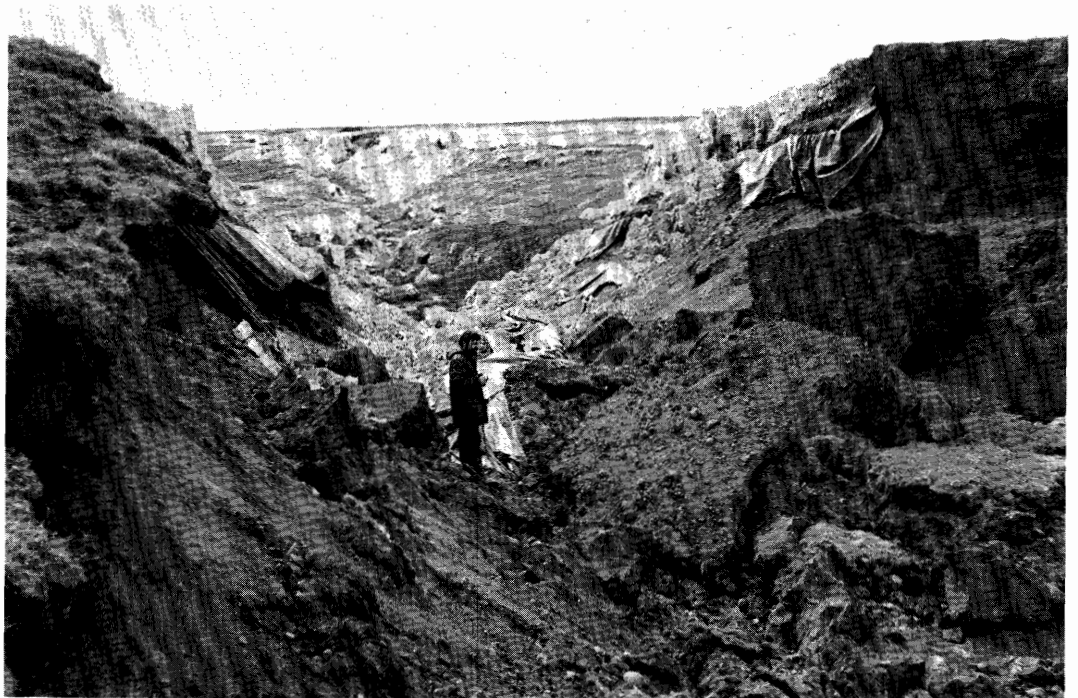
Fig. 8: Another diatomite reservoir was emptied through this breach in the earth dam caused by a fissure that can be seen in the background running through the reservoir bottom. The polythene sheet can be seen on both sides of the breach.
