ORKUSTOFNUN
Raforkudeild

Seepage at Þórisós and Kaldakvísl dams

Haukur Tómasson and
Hrefna Kristmannsdóttir

Reykjavík nov. '72

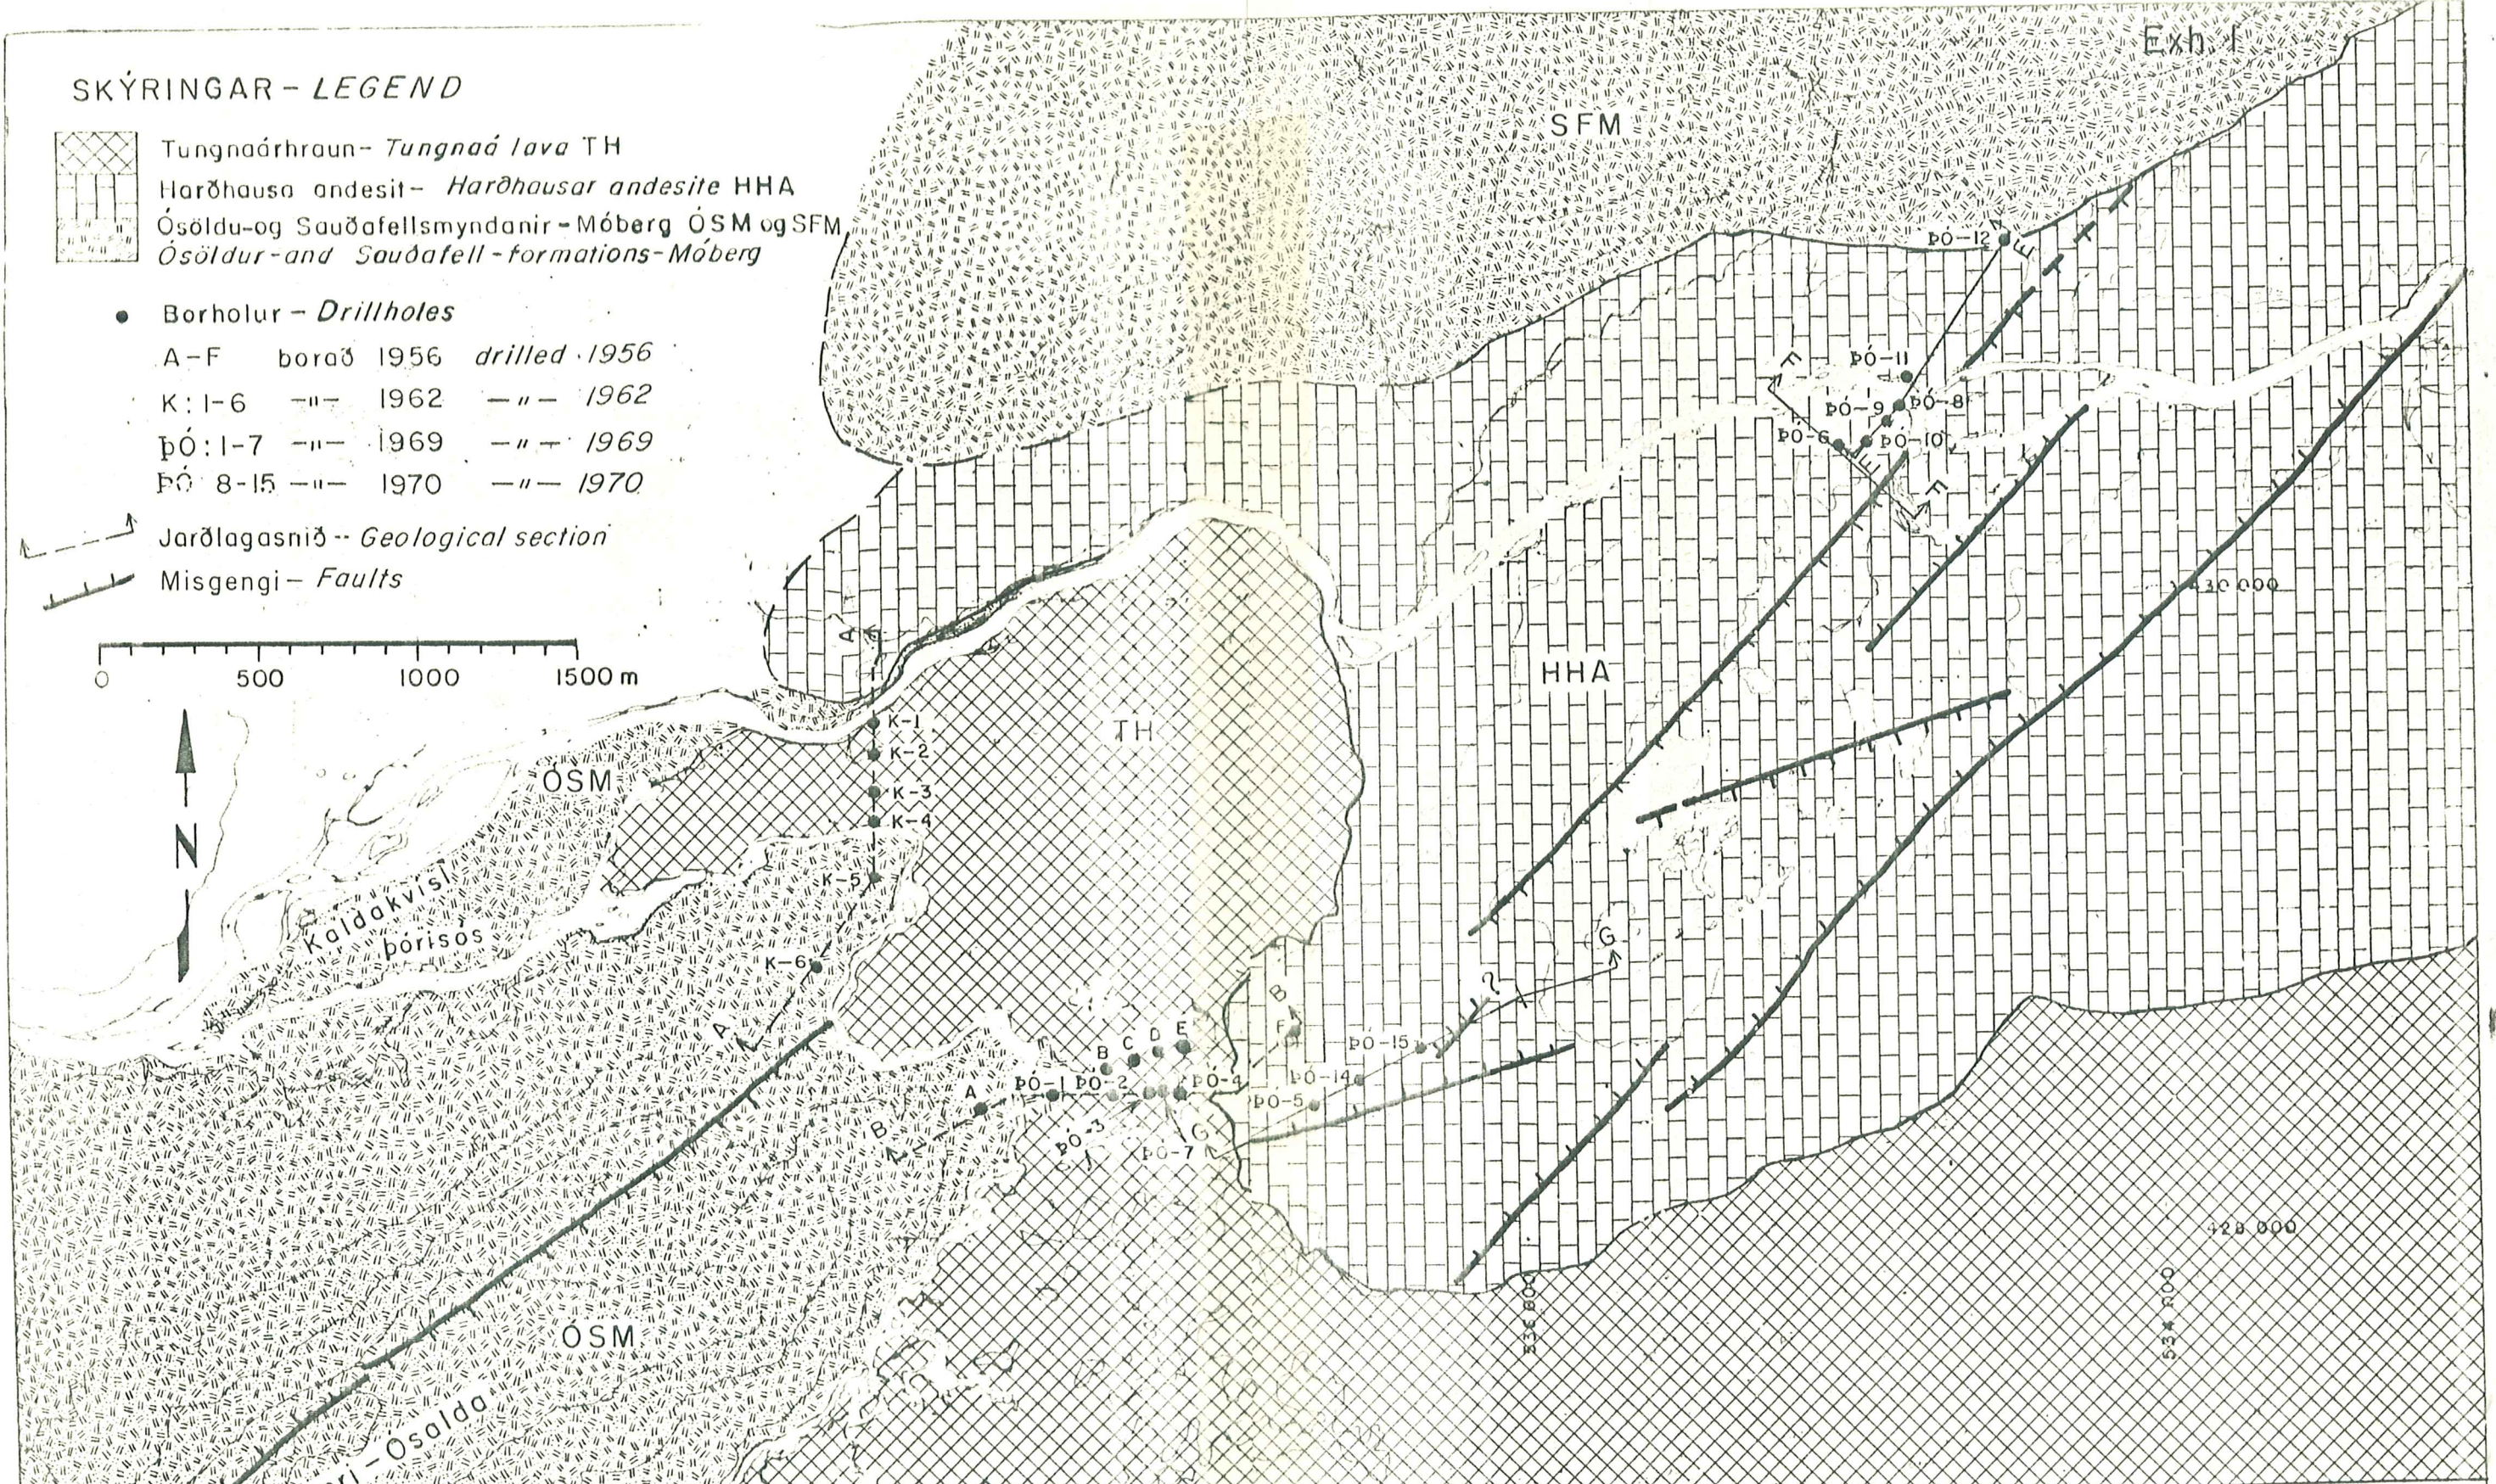
Þórisvæn - Þórisós
Jarðfræðikort *Geological map*

This report is intended to describe the conditions at Þórisós and Kaldakvísl dams before, during and after their construction. In figure 1 is a map showing roughly the geological circumstances at the two damsites

Two móberg formations, both permeable constitute the oldest rock unit. In a depression between the móberg formations is a pile of andesitic lava flows, on the whole rather impermeable in vertical direction, but can be a good aquifer along contacts. Both those units are covered with moraine and tillite, both generally poor aquifers. At a few places gravel deposits are found on top of the moraine by nature a fairly good aquifer. Yet the main ground water aquifer is the postglacial lava flow at Þórisós wherefrom numerous large springs were issuing both upstream and downstream of the dam prior to its construction and at the lava front at Kaldakvísl. The main concern of the foundation treatment at Þórisós dam was the cut off through this lava flow, which was done by a slurry trench.

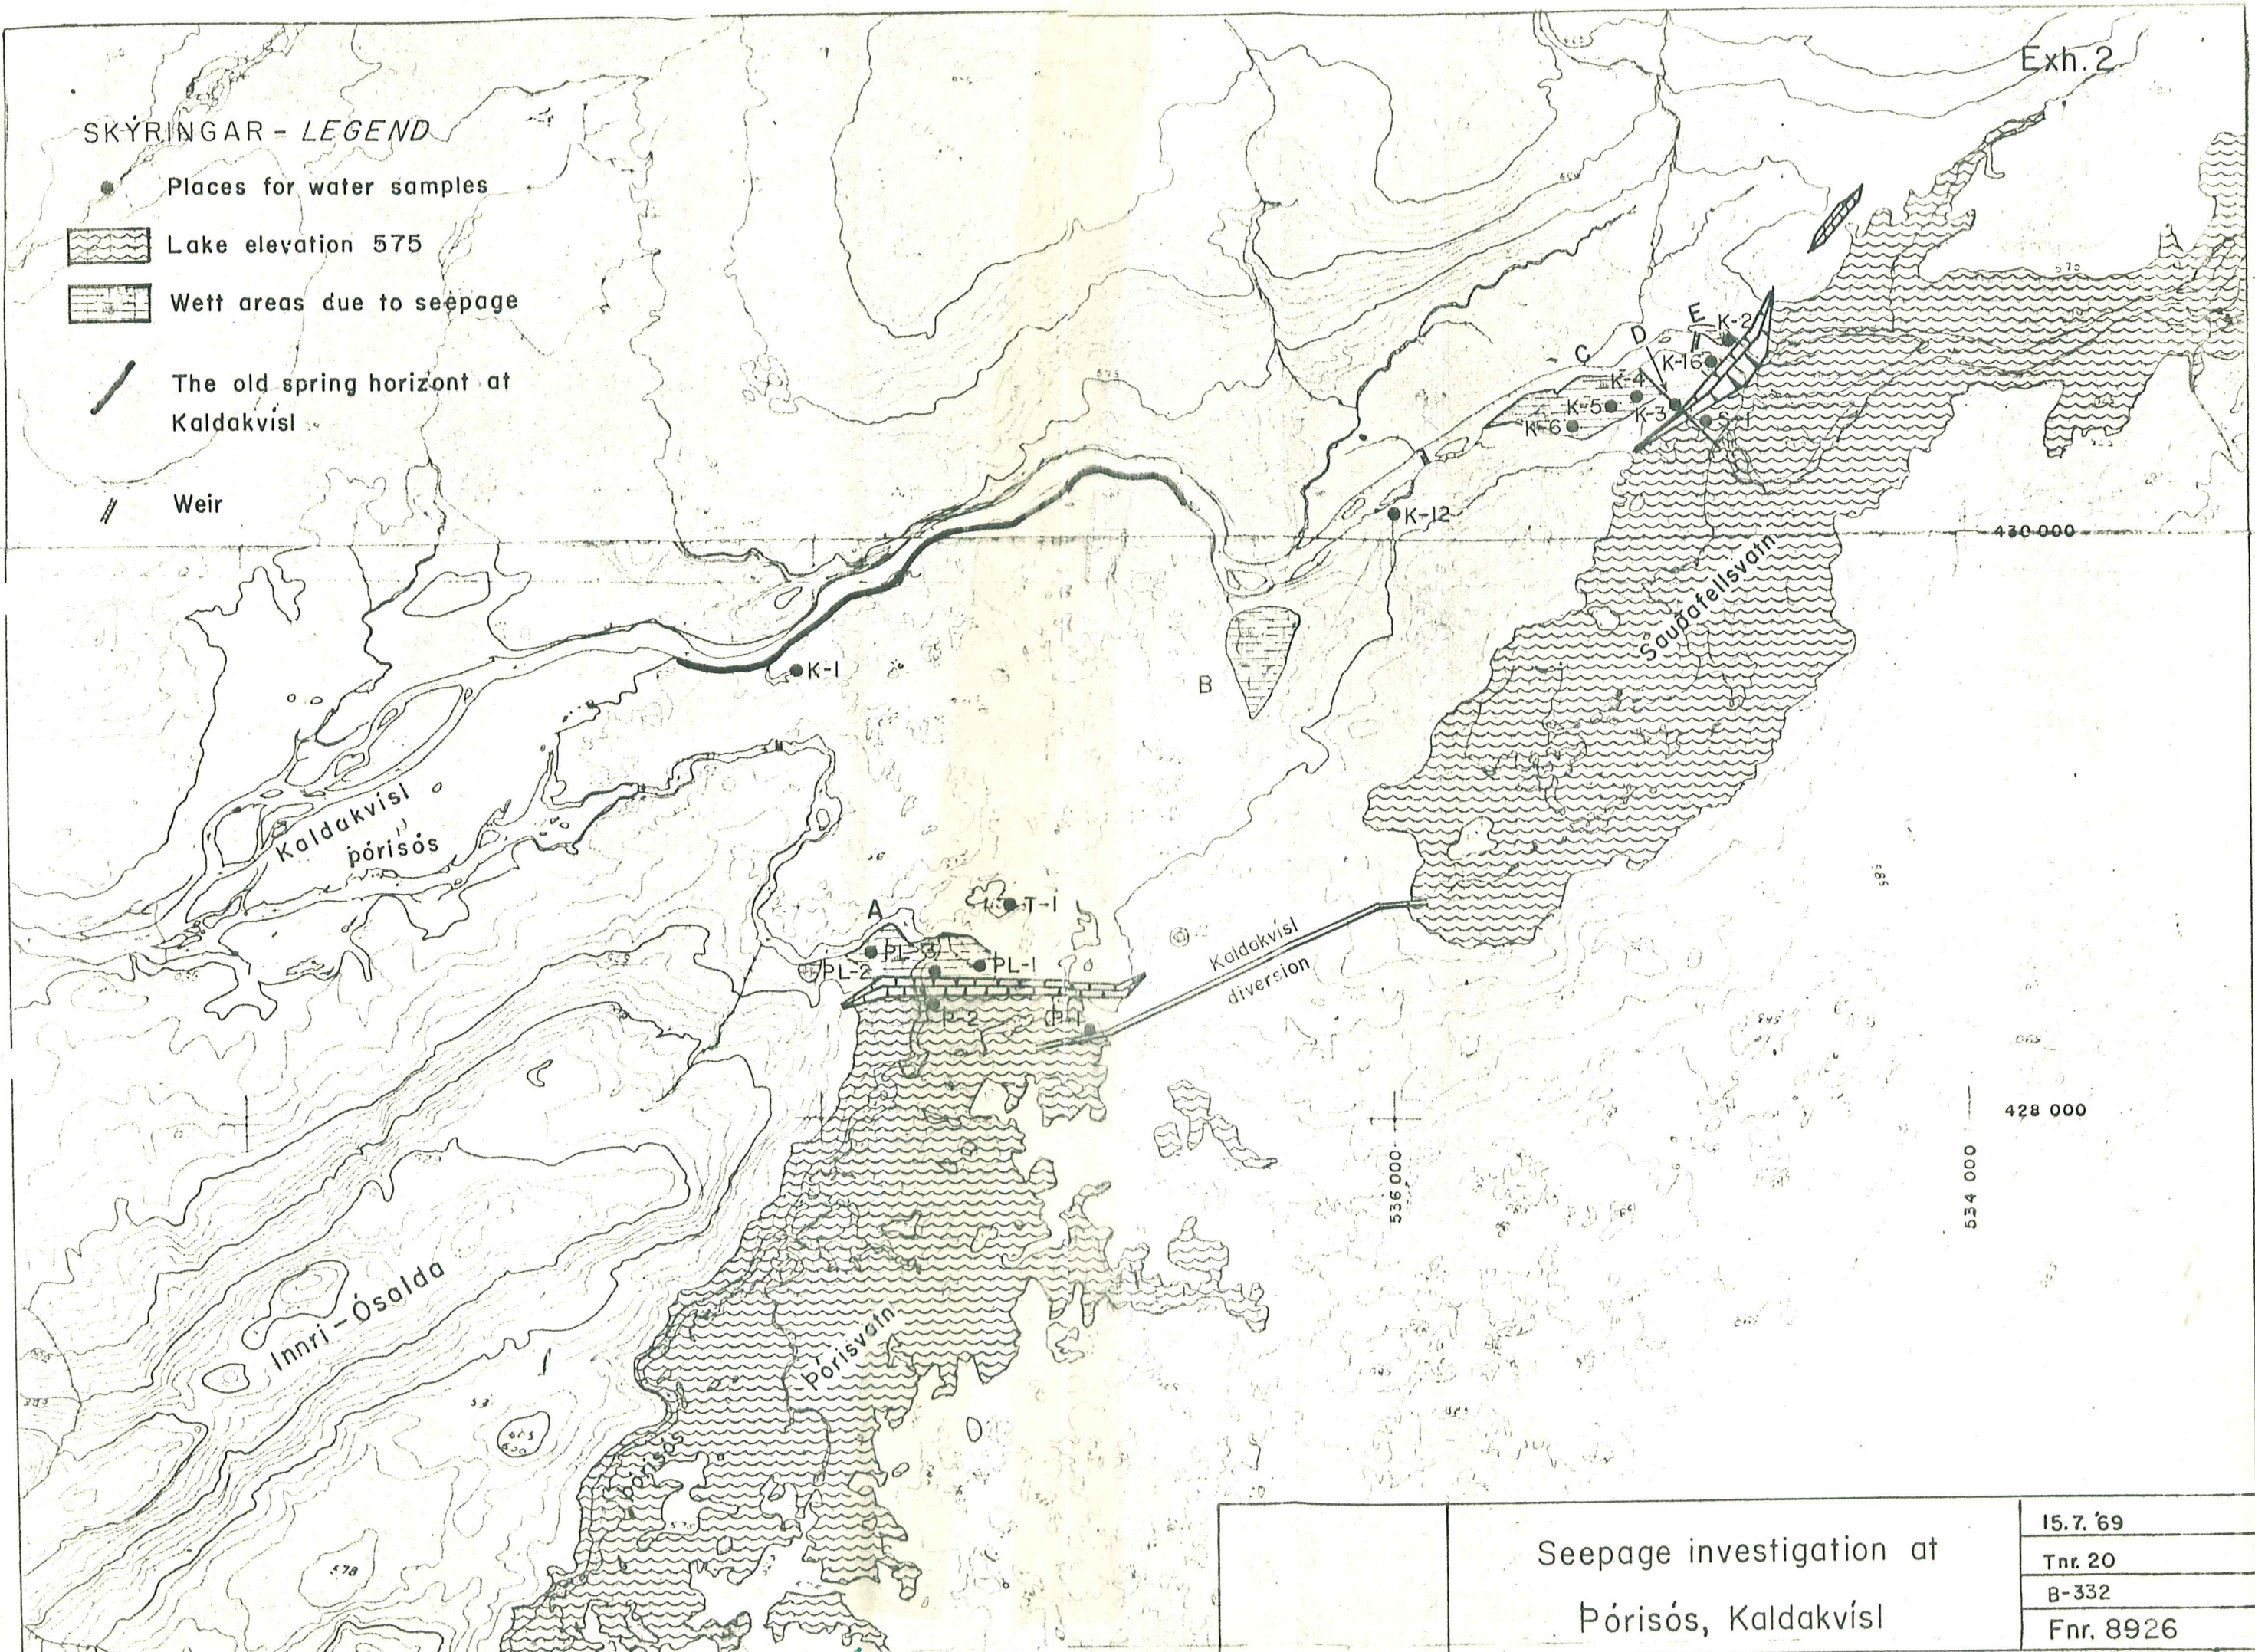
Seepage investigation at Pórisós, Kaldakvísl	15.7. '69
	Tnr. 20
	B-332
	Fnr. 8926

On August 11th the Þórisós dam was closed and the lake level began to rise behind that dam. On August 15th Kaldakvísl dam was closed and a lake started to form upstream of that dam. Immediately, the trend in groundwater and springs was reversed and gradually old springs were reactivated and new ones formed. On Exhibit 2 are shown spring areas. Most of these areas had springs, ^{prior to diversion} but the level of the springs is much higher now and the discharge also much greater. Yet the spring horizon at Kaldakvísl is still much smaller than before.

Nothing is more logical than suspending of ground downstream of a dam, but the water in these springs was not clear possibly indicating piping. ~~XXXXX~~ Piping could have especially serious consequences at the Þórisós dam where the cut off slurry trench is in some parts of the foundation not going through the gravelly deposits on top of the moraine. Just downstream of these are the largest springs.

In order to investigate this a sampling program has been undertaken and samples have been collected in Sauðafellsvatn and Þórisvatn at the dams and in several of the springs. The sampling places are shown on Exh. 2, and each is marked with the number of the first sample taken there. Up to 3 samples has now been taken at many of the places. The purpose of the sampling was to measure the amount of solids by using photoadsorptions. Keys for photo adsorption versus sediment load has been worked out for some localities at Búrfell power plant and one of that keys are used in this connection.

Under the present circumstances the only thing to do is to wait and see and go on with the investigation program during at least the next year.
