CORROSION IN
SELFOSS DISTRICT HEATING SYSTEM

R. #10,338
PC #3202

8/12/53

CORROSION IN SELFOSS DISTRICT HEATING SYSTEM

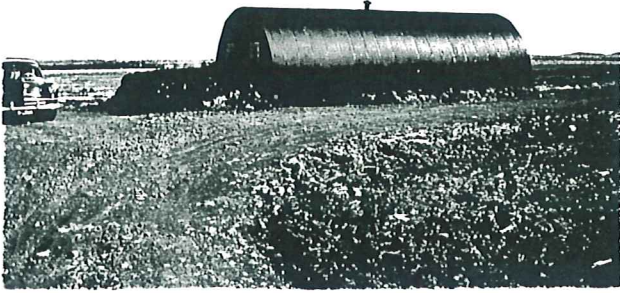
Figure 1

The natural hot water flowing from the wells passes to a collecting tank. The collecting tank is partially buried in the ground, has a capacity of approximately 8 cubic meters and was reported to be a steel tank set on a concrete bed and insulated with pumice or volcanic ash approximately 1/2 meter thick. The portion above ground is covered over with soil. There were five inlets in the collecting tank but only four were delivering hot water. The inlets seemed to be near the middle of the tank. The collecting tank is not equipped with a flow control. There is a level glass inside of the pump house to indicate the level of the water in the collecting tank. Next to this collecting tank is a corrugated iron Quonset hut housing the pumps. The collecting tank and the pump house are shown in Fig. 1.

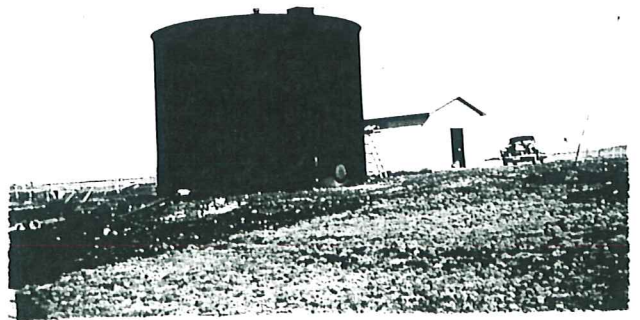
Figure 4

tank is reported to be about 4 years old and to have shown some corrosion during the first two years of service, with water from the old wells, but to have given no trouble during the past two years of service with water from the new wells.

The storage tank and the adjacent pump house is shown in Figure 4.

Although the report is that no excessive corrosion is occurring in the main storage tank as illustrated in Figure 4, there may be danger of such corrosion initiating in the future. Due to the high chloride content of the water and its accompanying low resistivity, it should be possible to apply cathodic protection to the inside of this tank by means of magnesium anodes. The tank could be equipped with approximately six magnesium anodes about three or four inches in diameter by 10 feet long hung at 60° intervals, halfway between the center and the outside of the tank and supported by connectors of high electrical conductivity to the steel roof and thus to the sides of the tank. Such magnesium anodes would require replacement occasionally but not oftener than every year or so and could be inspected at the regular shut-down and inspection period. Such magnesium anodes would introduce a slight additional amount of magnesium into the water which together with the magnesium already there and the silica content of the water would afford still better protection against corrosion in the mains in the house connections and in the house or building systems being fed from this tank.

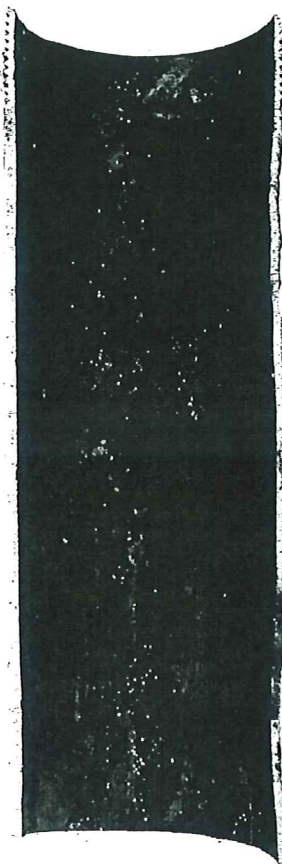
Figure 5 Plate #14925

A 2½" water main which had corroded through from external corrosion was being replaced during the time of the writer's visit. A sample of this 2½" pipe was taken as it was removed by the workmen. This sample was brought back to the laboratories of Sam Tour & Co., Inc., was sectioned longitudinally and some of the scale from the inside was removed for analysis. The sample and the scale are shown in Figure 5, Plate #14925.

When thoroughly dried the rust scale from the inside of this pipe was found to be brown to black with a considerable amount of a white or grey siliceous material in it.

<u>Element</u>	<u>Inside Scale</u>	<u>Outside Scale</u>
SiO ₂	34.1%	9.8%
Fe	39.7	57.9
MgO	9.0	Not found.
CaO	Not found	1.4
SO ₄	0.5	Not found
Chlorine	0.2	0.6
Sulphur	0.5	----

It is quite evident that the magnesium is sufficient to deposit with the silica and to cause the silica to deposit to form a protective film. Undoubtedly, the pipes are being protected somewhat by the silica-magnesia combination in the water being used at present. It is difficult for such pipes to be protected if they were previously corroded and had developed a heavy incrustation of rust. However, even under such conditions the continuing corrosion can be inhibited greatly by the silica-magnesia combination present in the water.
