TESTING OF EQUIPMENT FOR USE IN CONNECTION WITH
WORKOVERS ON FLOWING GEOTHERMAL WELLS.

SVARTSENGI, 13-18/3. '81

JEA-81/01

Maí 1981

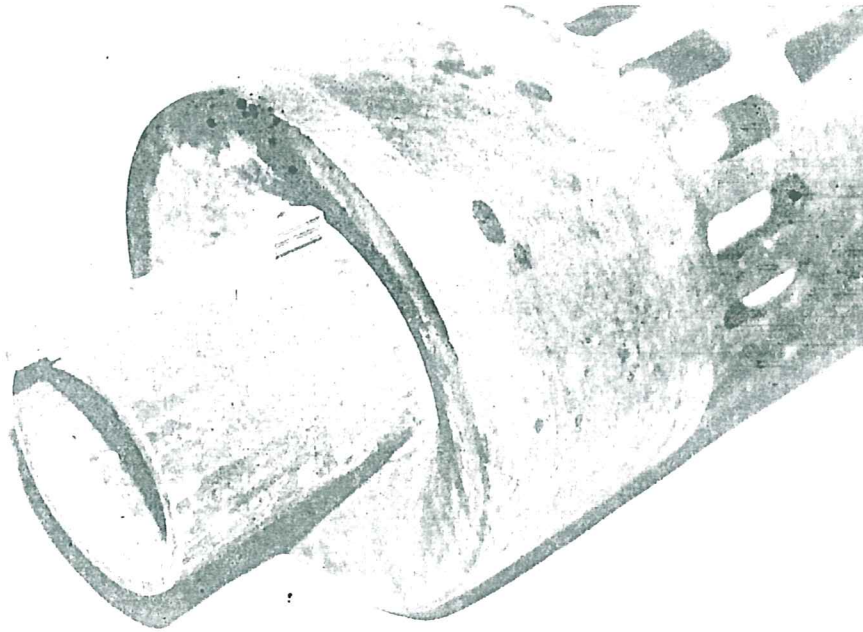
Fig 5.6

The drawings were not followed in detail when the restriction was constructed. The bottom plate had less than 50% of the desired thickness. This plate was severely deformed by the bit sub when it hit the bottom of the restriction (presumably with a force corresponding to 2 tonns) (fig 5.6a), but this did not have any effect on the function of the flow restriction. The friction between the outside of the restriction and the RDH bowl caused some wear (fig 5.6b) on the restriction.

a) The flow restriction deformed after being hit by bit sub

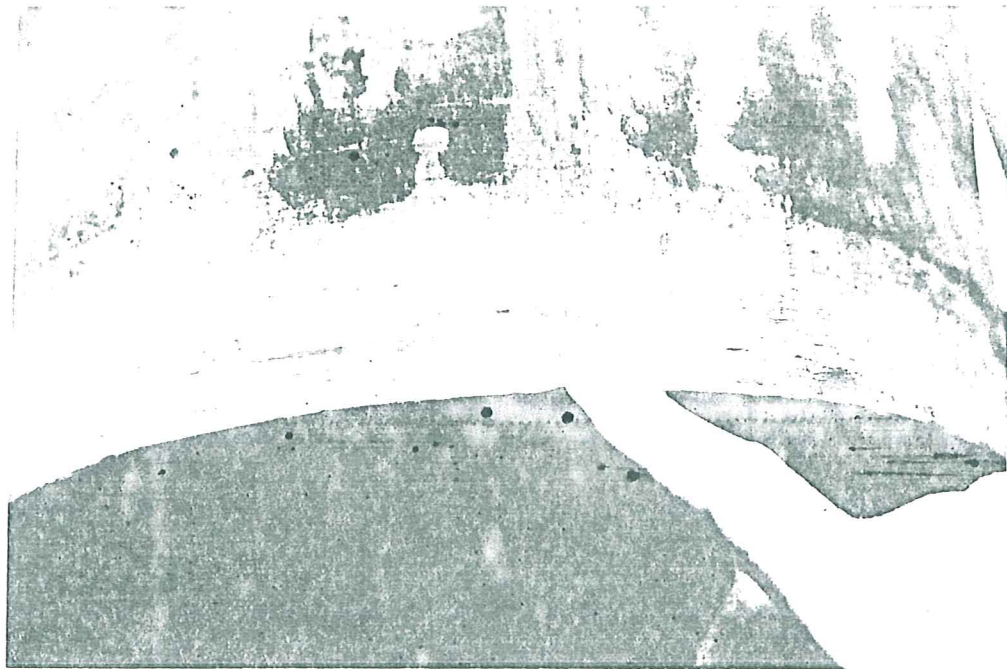
b) Wear on the flow restriction caused by friction between the restriction and the RDH bowl

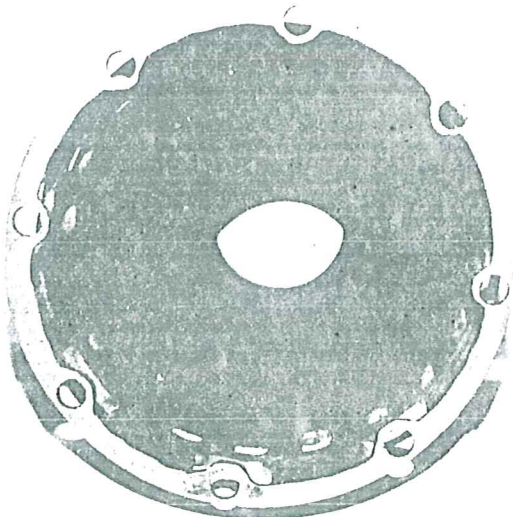
No cracks were detected in the top flange of the restriction (fig 5.6 c and d).

c) Top flange of the restriction undamaged after the testing

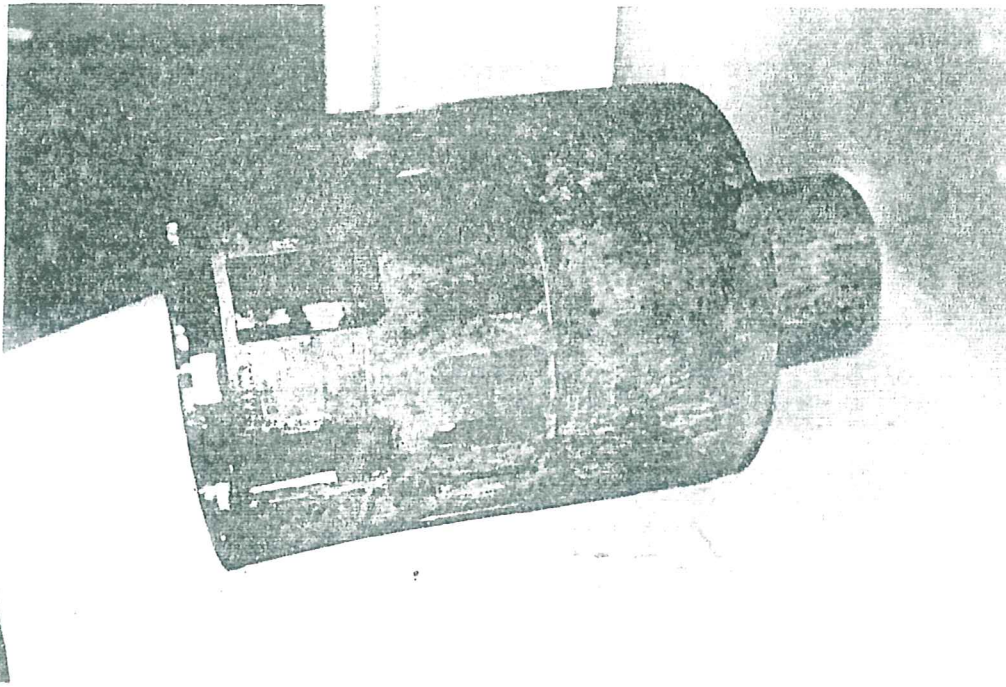
Fig. 5.6 (continued)

d). The restriction after the testing, undamaged.

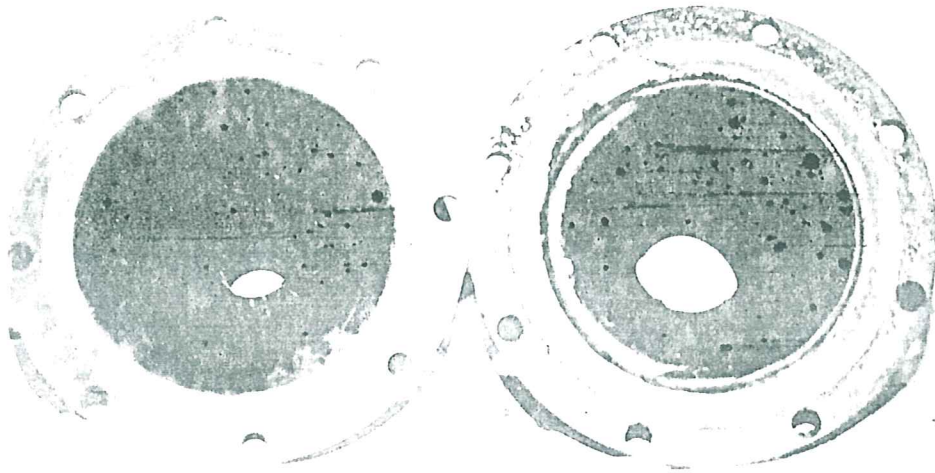
Fig. 5.7.

The rubber was severely deformed and damaged after test run no. 5. As can be seen from fig. 5.7 , when the rubber is compared with an undamaged rubber, the hole is now drastically enlarged. The hole was measured to be 4".

a) Undamaged (left) and damaged (right) stripper rubbers seen from above. Note the enlarged hole through the damaged rubber.

- The stripper rubber should be replaced after each job, as a safety precaution.

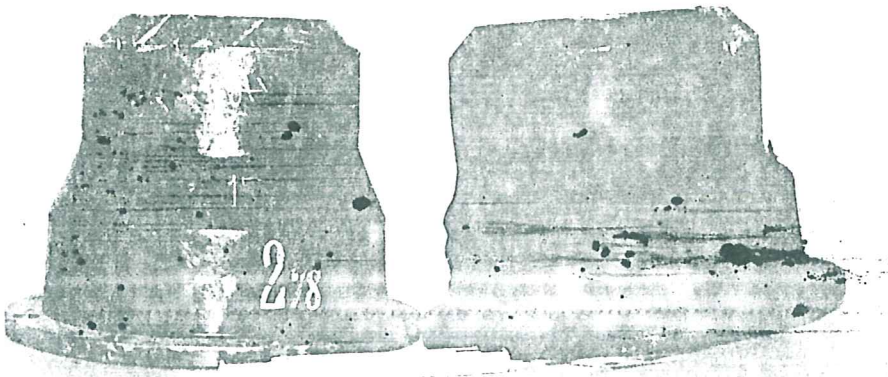
The stripper rubber is no longer symmetric, and there were cracks in the rubber (fig. 5.7.c) possibly originating from gas bubbles in the rubber. This explanation is supported by the fact that the whole surface of the stripper rubber was completely covered by tiny holes.

b) Undamaged (left) and damaged (right) stripper rubbers. Note the changes in shape.

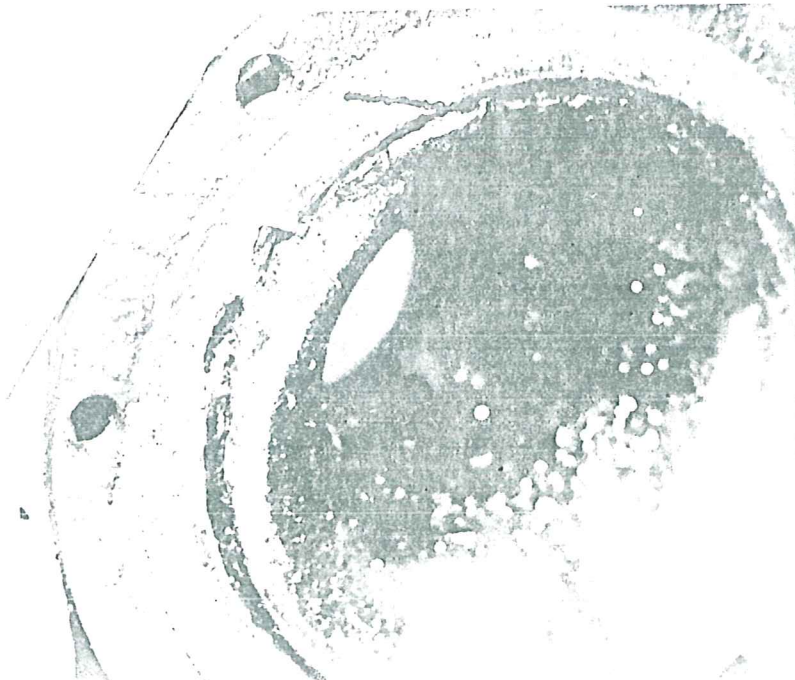
c) Crack in stripper rubber after destructive testing.

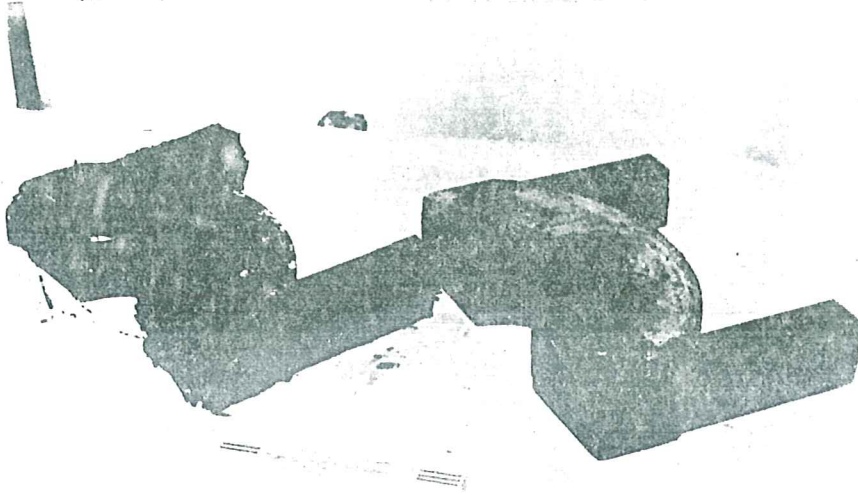
Fig. 5.8.

Inspection of the rubber seals on the rams after the test showed that they were severely damaged (fig. 5.8).

The reason why the seals still functioned wventhough they were damaged is of course the fact that they are designed to withstand 3000 psi or 200 bars. 16 bars does therefore not put any significant strain on the seals.

a) Front and side seals for Cameron QRC BOP. Damaged (left) and undamaged (right). Note the worn edges.

- The rubber seals should be replaced by metal seals. This should be possible due to the relatively low pressure.

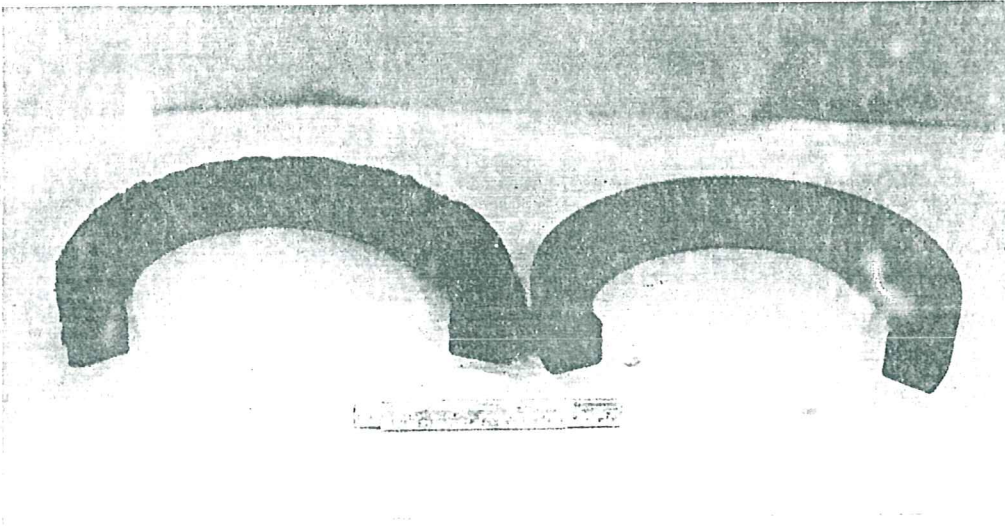
b) Rear seals for Cameron QRC BOP. Damaged (left) and undamaged (right). Note the worn edges.

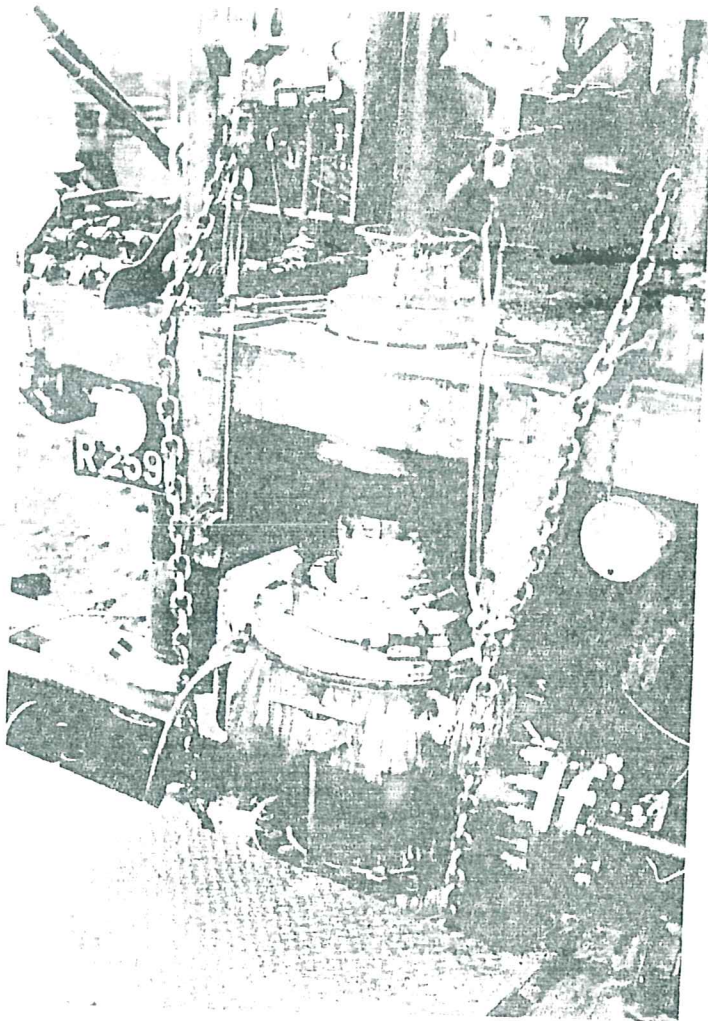
Fig. 5.9.

The distance between the top of the drive bushing on the RDH and the bottom of the rotary table was extremely small. It was necessary to burn off 5 cm of the drive bushing in order to make installation of the helly bushing bossible (fig. 5.9). The rig was jacked up to maximum hight. This problem can be solved by using a shorter BOP for instance a Schafter SL-BOP which is only half the hight, 0,45 cm vs. 0,90 m.

The rotary table doeš not enable passage of the 16" diameter drive bushing. It was therefore necessary to remove the rotary when this piece was to be taken in and out of the hole.

Rotary table and
Grant RDH.

It is not absolutely necessary to change the rotary, because the method being used during the test functioned, but it would ease the work.
