SIGALDA

Fissures in the head race canal

Haukur Tómasson, Birgir Jónsson

Client: Landsvirkjun (National Power Co.)

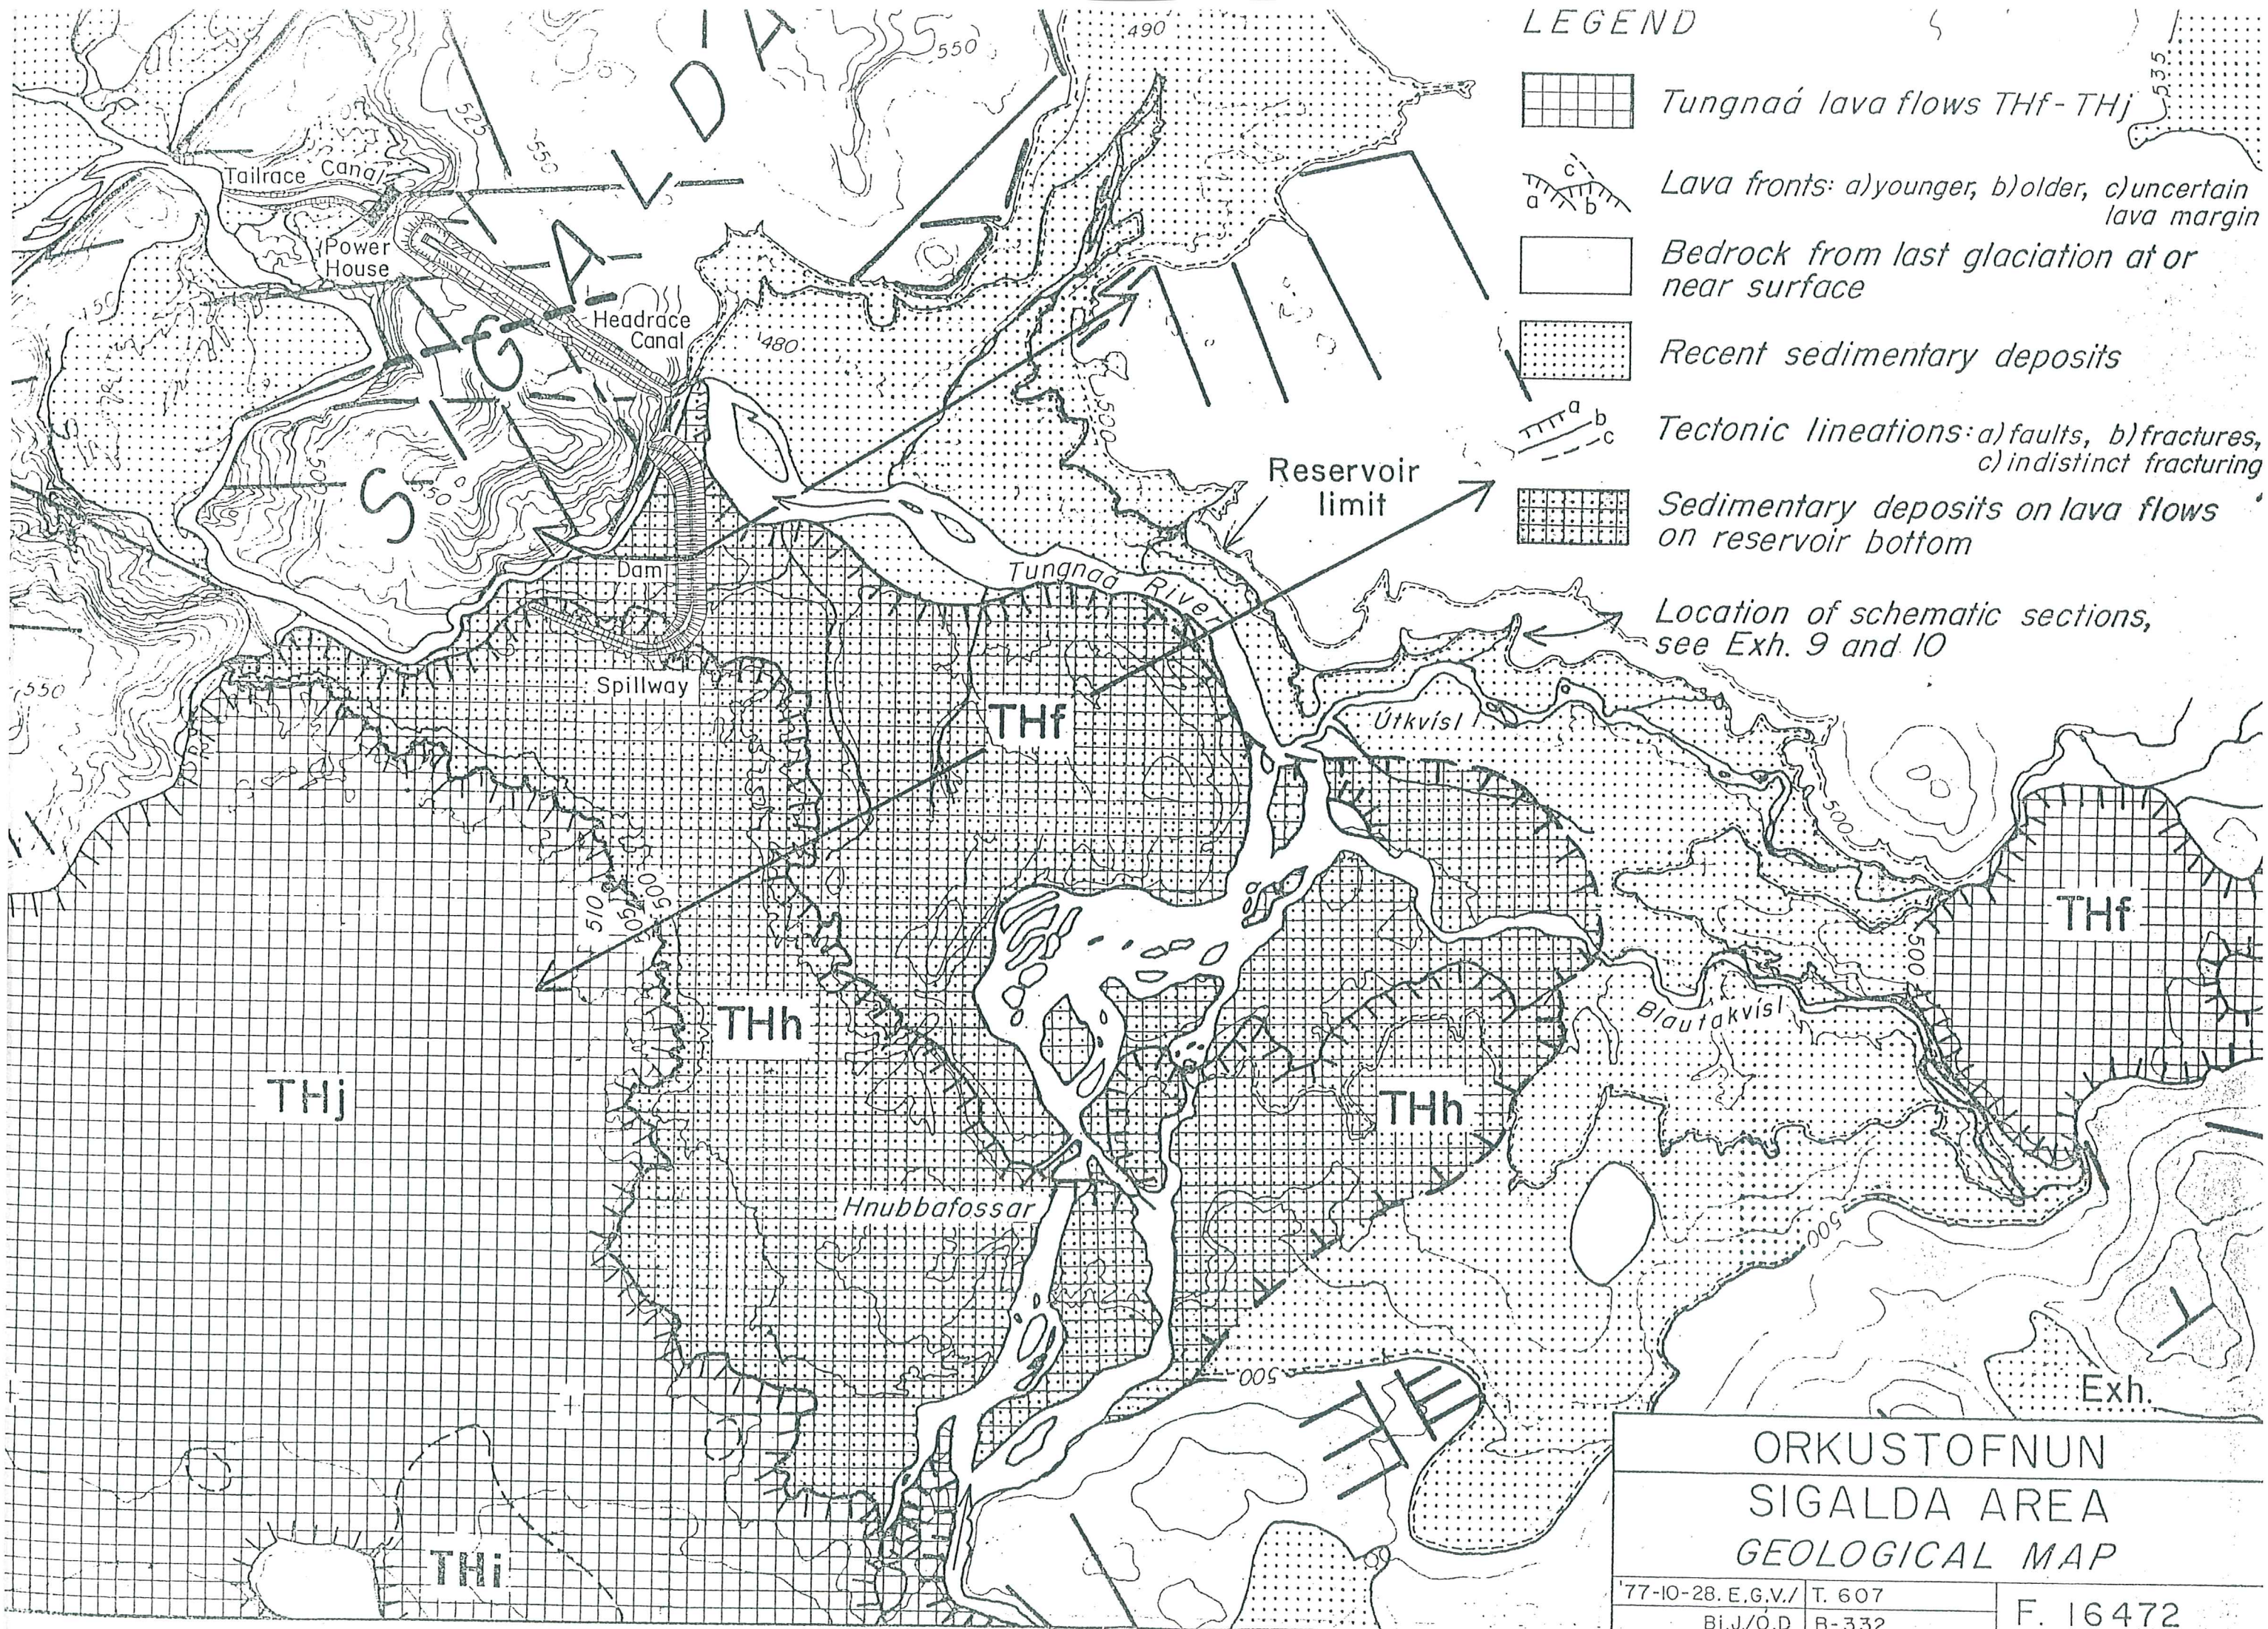
<p>ORKUSTOFNUN SIGALDA AREA GEOLOGICAL MAP</p>	
77-10-28. E.G.V./	T. 607
Bj./Ö.D	B-332
F. 16472

Two almost parallel fractures running ca. ENE can be seen in the canal. They are just downstream of the cut and cover gallery and the distance between them is ca. 30-35m at right angles. On this location the "bedrock" is a very loose volcanic breccia and a clear fracture was not seen when geological mapping of the canal walls was done during construction. However, some irregularities that might indicate the presence of faults or weakness zones were seen there. This ENE tectonic direction appears quite clearly in the Sigalda area landscape and the fracture zone that has now opened up in the canal, seems to control the course of the Tungnaá river just upstream of the Sigalda waterfall (see accompanying map). The distance from the head race canal to the Tungnaá river along the fracture zone is ca. 600 m. Piezometer PZ-10 is very close to the fracture zone and could give indications of when the present fractures opened up.

Of the two fractures the one further SE can be seen in the canal bottom, the right wall and on the right berm. The fracture is located in the shotcrete, near its edge. It has opened up by about 3-4 cm and water from the cut and cover gallery flows into it. The fracture can not be seen in the left wall or the right one above the berm, because of the presence of rip rap. The fracture further NW is easily visible on the bottom (ca. 8-10 cm opening), and on the right berm, but the rip rap covers it elsewhere. Still, there is a slight depression in the rip rap in the left wall, indicating the presence of the fracture.
