## Investigation and repair of a wellhead leak on geothermal well BO-2 at Boullante

**Greinargerð SP-2003-02**

Bouillante 08.05.2003

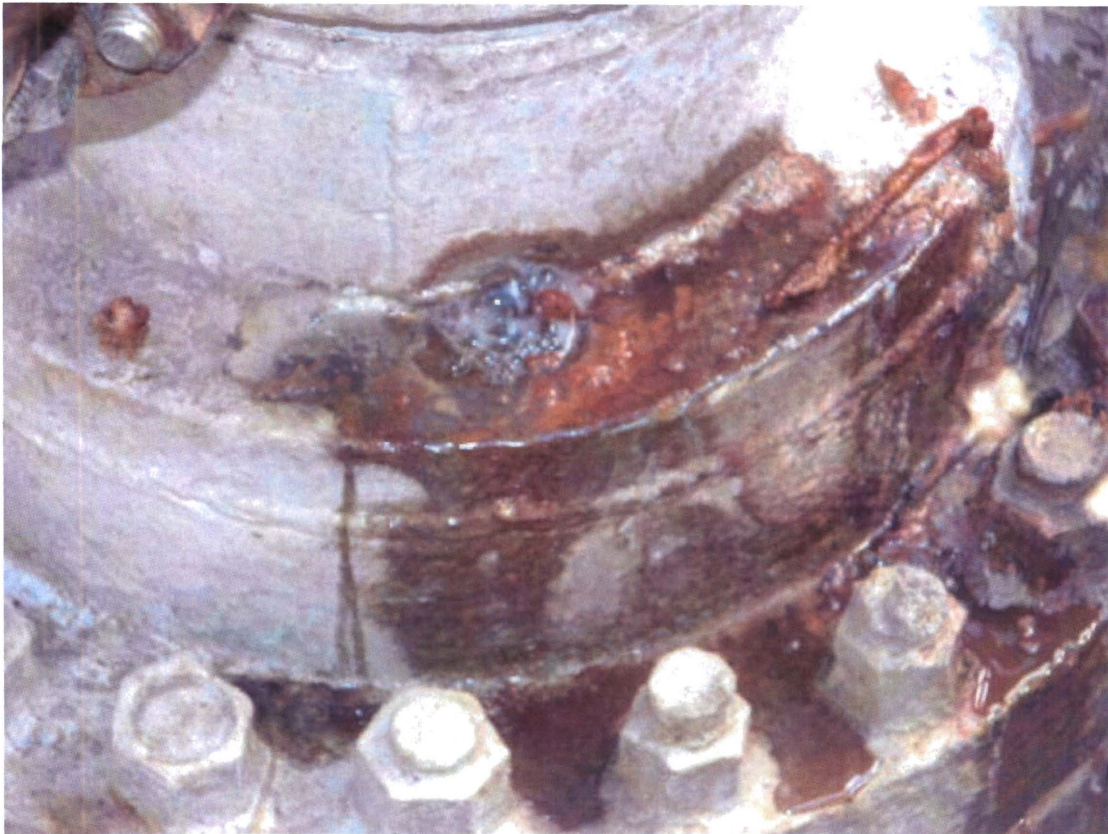
**Figure 1. Photograph of the leak on BO-2 wellhead sent to me May 1 (photo H. Correia)**

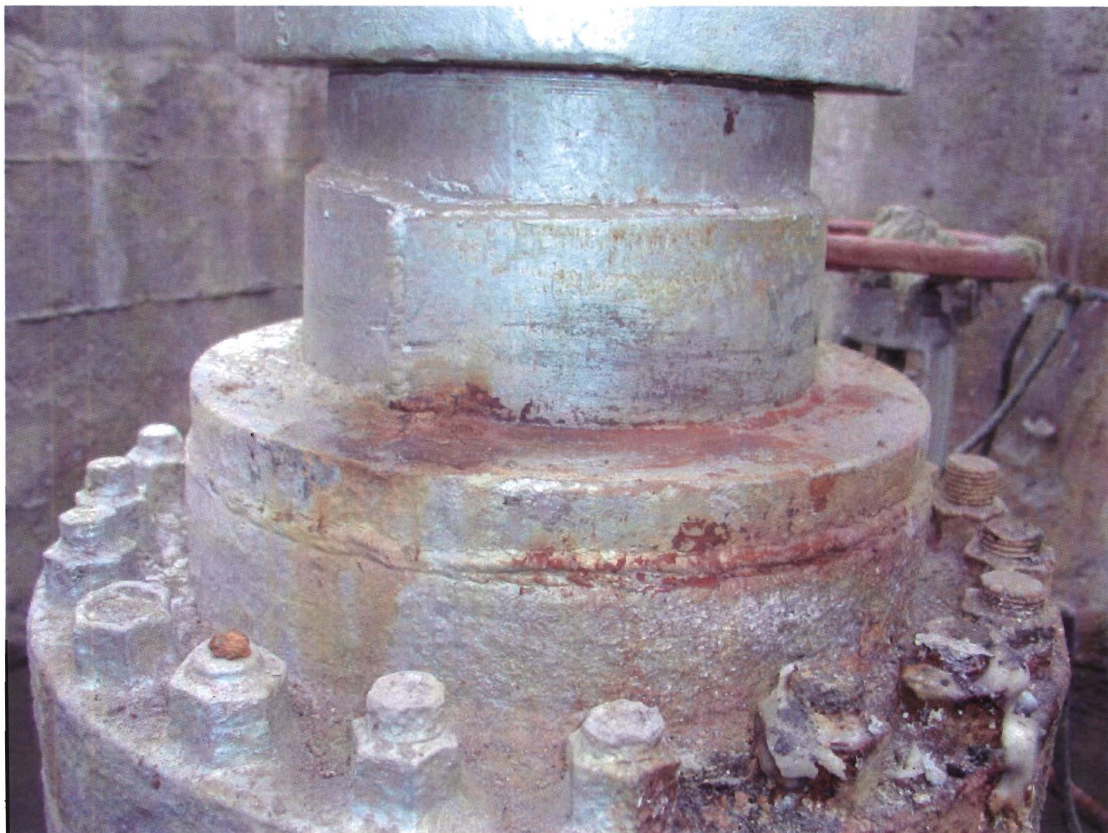
Then we went to well BO-2 to inspect it and take dimensional measurements. The original leakage had by then stopped completely by self-sealing and thus close visual inspection and measurements were possible (fig. 2). I noted that a spot to the left of where the main leakage had occurred showed early signs of a leakage where a bolt hole had been welded shut as part of installing the reinforcing collar on 9-5/8" in 2001. This spot is visible on the photograph sent to me 1 May by Mr. Correia (fig. 1). Closer inspection of the bolt hole by the main leak showing no crack visible on the weld, (as originally thought), brought up the idea that the leak might be a pin-hole in the weld over the bolt hole (fig 2). Mr. Herbrich took me to well BO-4 that has the same 9-5/8" pack-off as BO-2 (fig. 5). We confirmed that the press plate of the pack-off was dimensionally identical. It was thus clear that the original press plate of BO-2 had been welded to the 13-3/8" pack-off flange as part of the reinforcing work in 2001. The bolt holes had to be closed by welding, and the focus was on locating the leak in that area. I asked for die-penetrant testing of the welds to detect any cracks or holes. Mr. Herbrich arranged for this to be done next day (May 6) by the welding contractor COTUMER. In the evening, I sketched up a new ring patch to be welded over the old press plate to cover the old bolt holes, and also the weld of the reinforcing collar (fig. 7). The water seeping into the cellar of BO-2 was measured by Mr. Eric Lesne to have conductivity of 20 milliS/cm, and silica 170 mg/kg, confirming that this was local brackish groundwater and not deep reservoir fluid. This confirmed that there was not an underground leak from the well.

**Figure 2. Photograph of leak area on BO-2 when I arrived. The leak had stopped due to self - sealing when the wellhead temperature dropped and thus the annular pressure.**

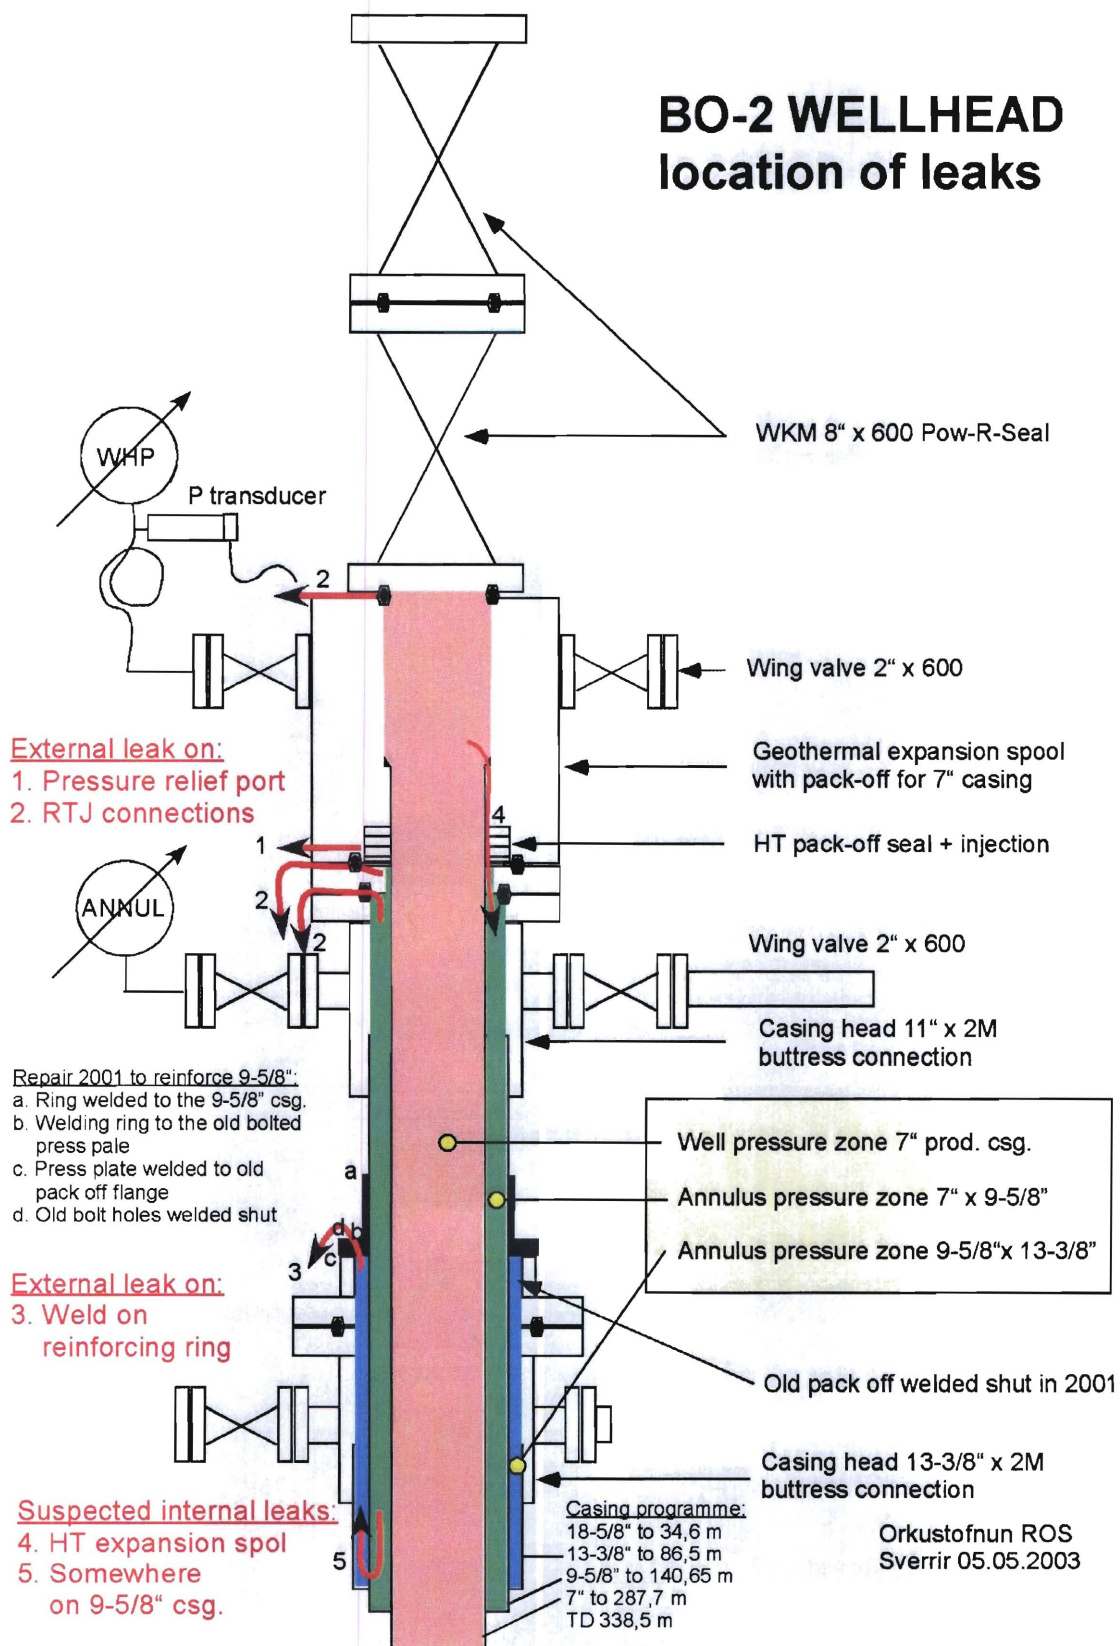
In order to confirm suggestions that the 9-5/8" casing was broken, the pressure in the second annulus (blue colour in fig. 3) would have to be the same as in the first annulus (green colour in fig 3). As the wing valve on the 13-3/8" casing head is the original one, and has been on the well for 32 years (or since 1970?), there were concerns that the pressure could not be measured due to the condition of the valve. Further inspection by Mr. Herbrich revealed that two studbolts on the pressure side of the wing valve were so corroded that only one-third of the stud was still there (fig. 13). Attempts to drive out the remaining bolt failed and it was thus decided to weld the flanges together in four places with four 20x20 mm rods (fig. 14). This job was completed late in the

I informed them that the work outlined in the TOR had all been successfully accomplished. The work was carried out in the order originally laid out and there were now no known external leaks on the wellhead. Pressure measurements on the wellhead of 14.2 bar-g WHP (tan color in fig. 3) and in the first annulus of 2.7-3 bar-g (green on fig.3) moreover confirmed that the 7” production casing was without leaks and also the expansion spool. This was good news and now only pressure in the second annulus (blue on fig 3.) had to be measured to see what the condition of the 9-5/8” casing was. If that casing was also pressure-tight, the well was in the original design condition as far as redundancy is concerned and with a new wellhead and expansion spool. The old part of the wellhead had two stud bolts corroded away and the first 1 m of casing below the 13-3/8” casing head was the most suspect and set for outside corrosion. The well is 32 years old and has been the sole supplier of steam to the existing 4.7 MW plant. By bringing the well on stream very slowly and minimizing thermal cycling on the wellhead by keeping it hot when not in use, will minimize thermal stress. I told them that the items covered in this report, with the positive results in solving the known leakage problems with well BO-2, could influence the decision whether to use the well for a few more years or abandon it immediately. Such a decision will have to take into consideration many factors outside what was covered in the TOR during these three days and would rest with CFG.

Figure 3. Drawing of BO-2 wellhead showing location of possible leaks and pressure zones.

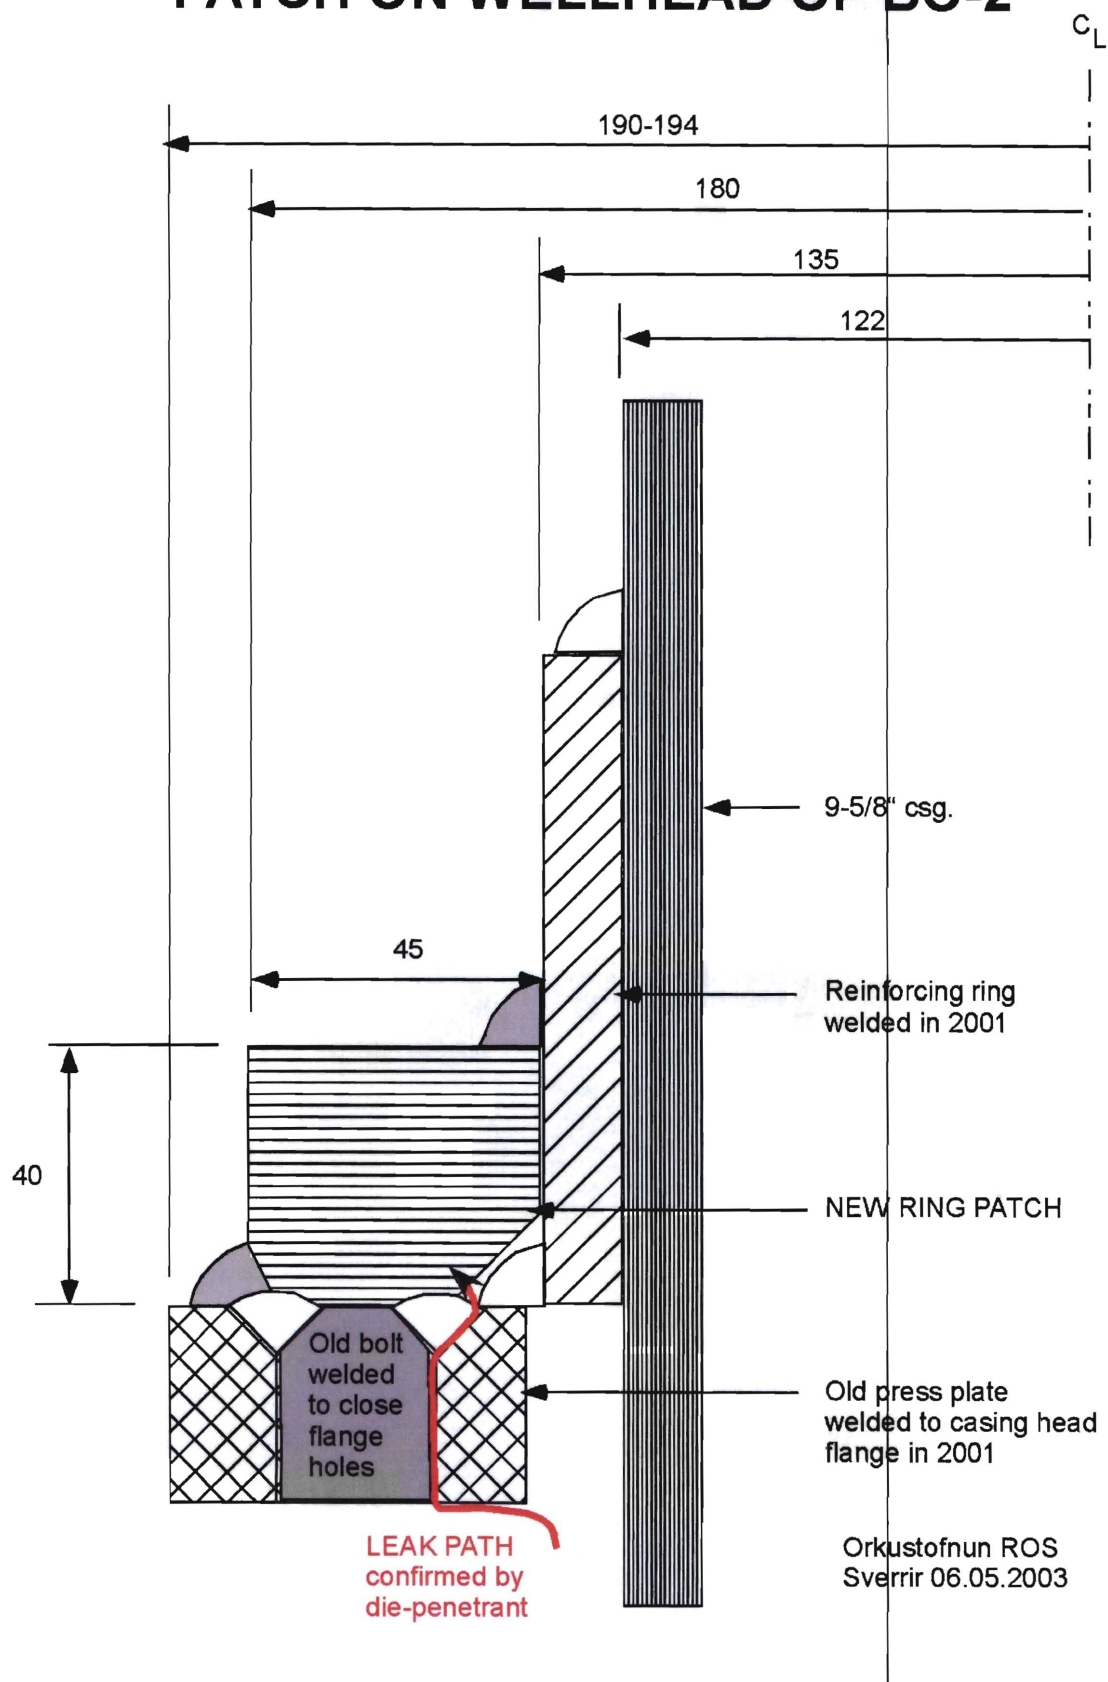
# PATCH ON WELLHEAD OF BO-2

Figure 7. Drawing shows where the leak was – a pinhole defect of a weld. The drawing also shows the design of the ring-patch to cover the leak. The patch was welded in place May 6<sup>th</sup>.

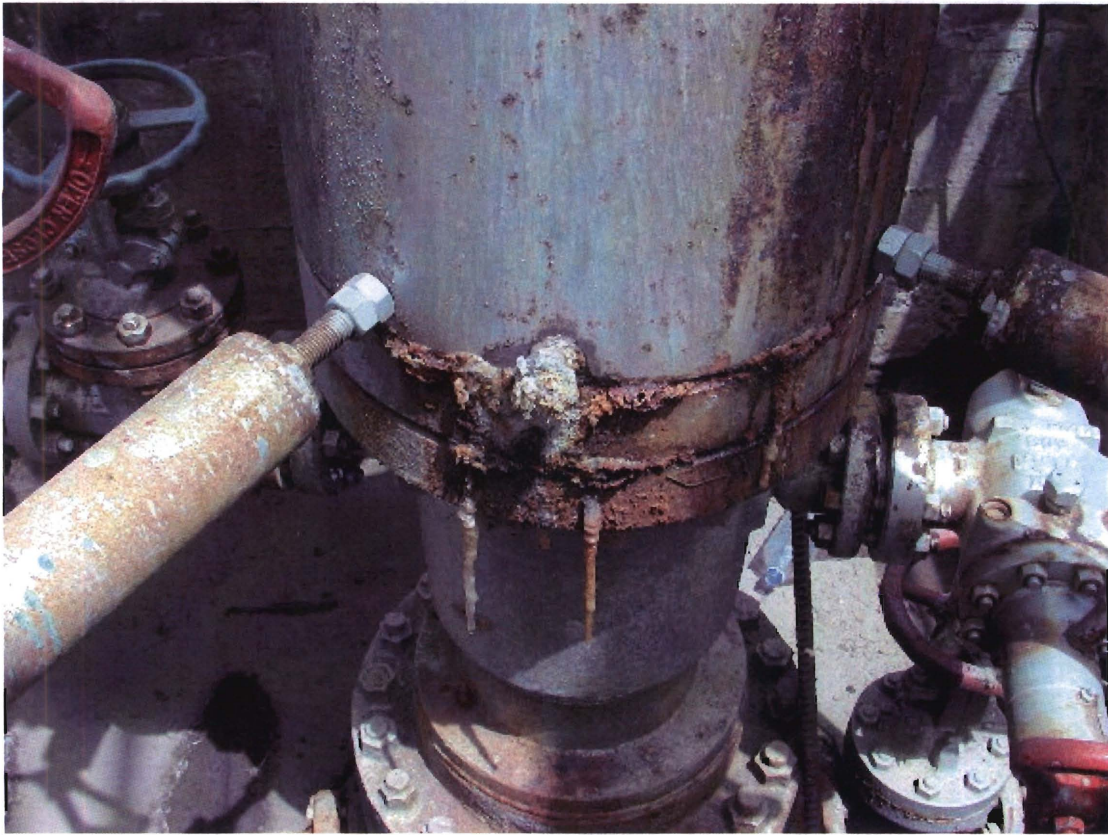
**Figure 10. Leak on pressure release tap and between flanges on the expansion spool of BO-2.**

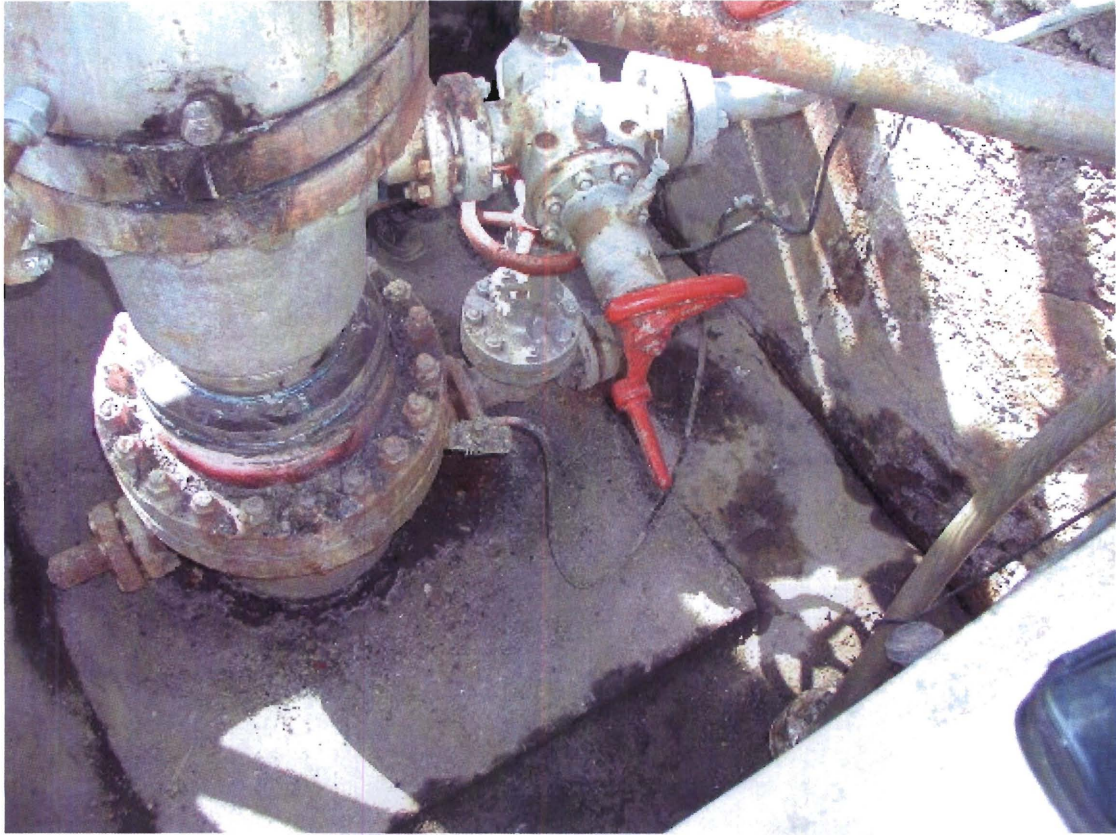
**Figure 12. Two bolts were rusted away on the lowest wing valve. Valve since 1970.**

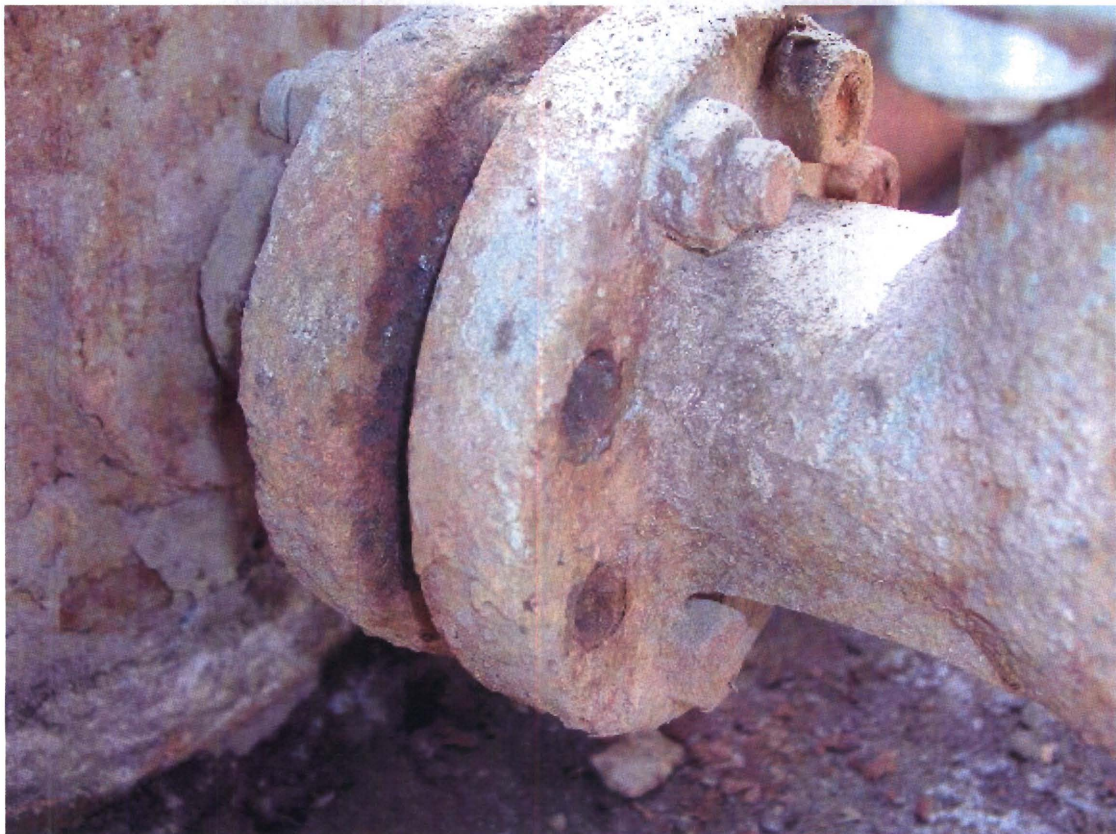
**Figure 13. Close-up of bolts missing from flange on 13-3/8" casing head.**

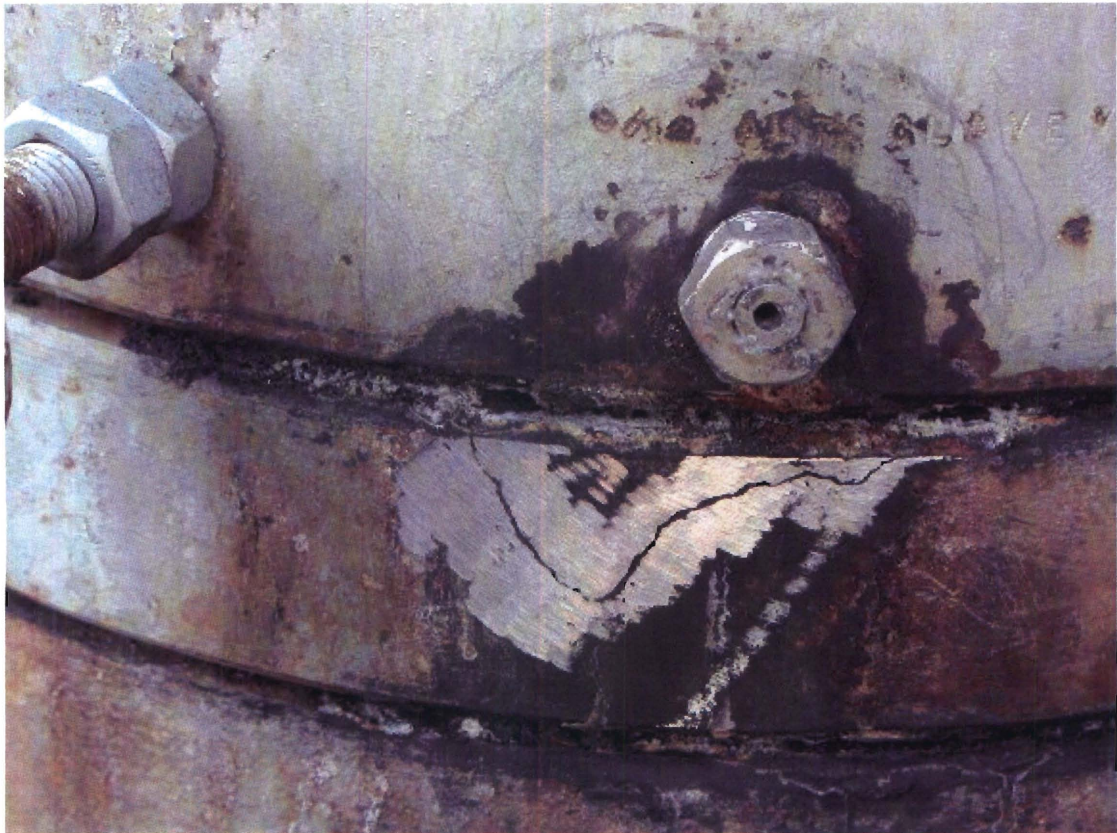
**Figure 15.** From under the scale deposits on the expansion spool a crack showed up on the flange just below the pressure release port. If it propagates deep it could result in leak.
