## CASING FAILURE ANALYSIS AND PROPOSED REPAIR FOR WELL OW-740A IN OLKARIA GEOTHERMAL FIELD

**Nahashon Karanja Nzioka**  
Kenya Electricity Generating Company,  
Olkaria | Off Moi Southlake road  
P.O Box 785-20117, Naivasha  
KENYA  
*Email: nenzioka@kengen.co.ke*

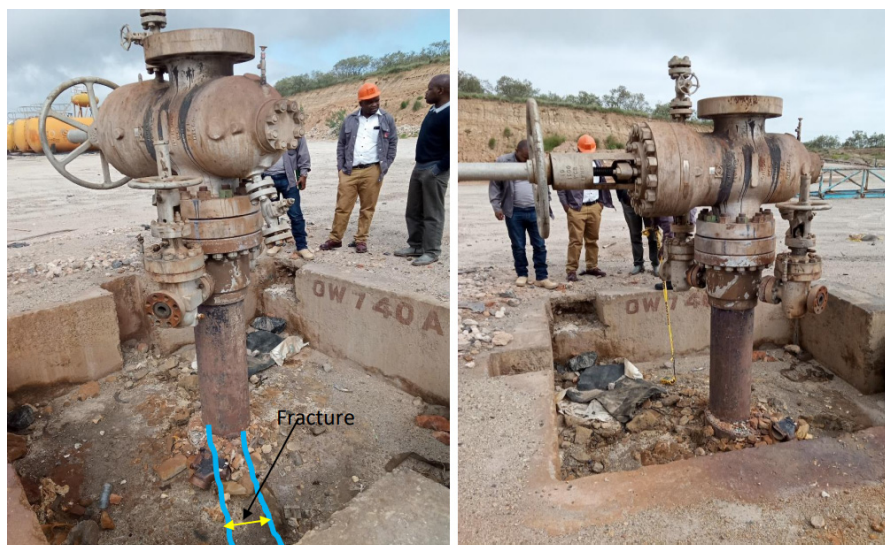
FIGURE 2: Situation at well OW-740 at the initial stages of steam leakage development (July 2019)

The well was drilled in 101 days using two rigs in two sections and was completed on March 27, 2018. It was designed as a production well to supply steam to the proposed Olkaria VII power plant project (KenGen, 2017). Exactly one year and four months after the completion of the well, on July 3, 2019, steam leakage was reported during a well-sitting committee forum. The steam leakage developed between the surface and the anchor casings. In addition, there was observable steam leakage also at the master valve and along a fracture at the bottom of the cellar which is trending in E-W direction as shown in Figure 2.

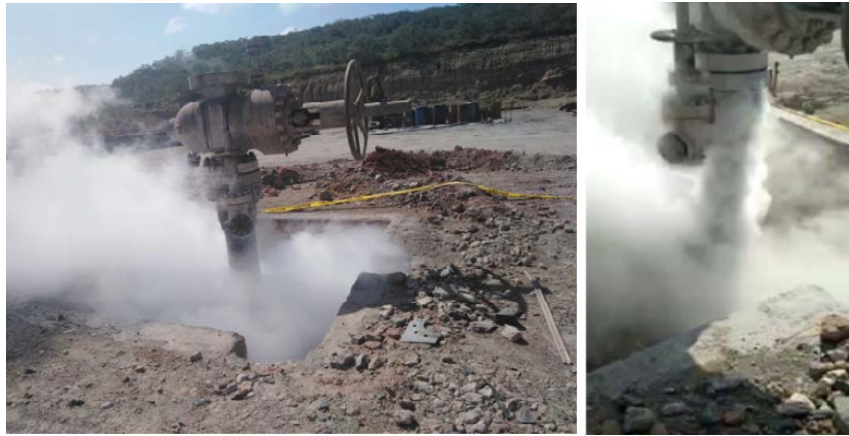
FIGURE 3: Steam leakage at later stages of development

This leakage increased over time to the point that fumaroles developed at the well pad in the areas surrounding the cellar and it could soon become uncontrollable if it was left uncontained (Figure 3). It was at this point that a quenching operation was recommended to lower the wellhead pressure and investigate the cause of the steam leakage. Quenching was done on 8<sup>th</sup> of August 2019 at a rate of 25 l/s using a high-pressure triplex pump cementing unit and after 4 hours the well was successfully killed. Continuous pumping was allowed so that a logging operation could be conducted. A multifinger caliper survey suggested that the casing had parted at various locations, i.e., 187 m, 198 m, and 318 m depth.

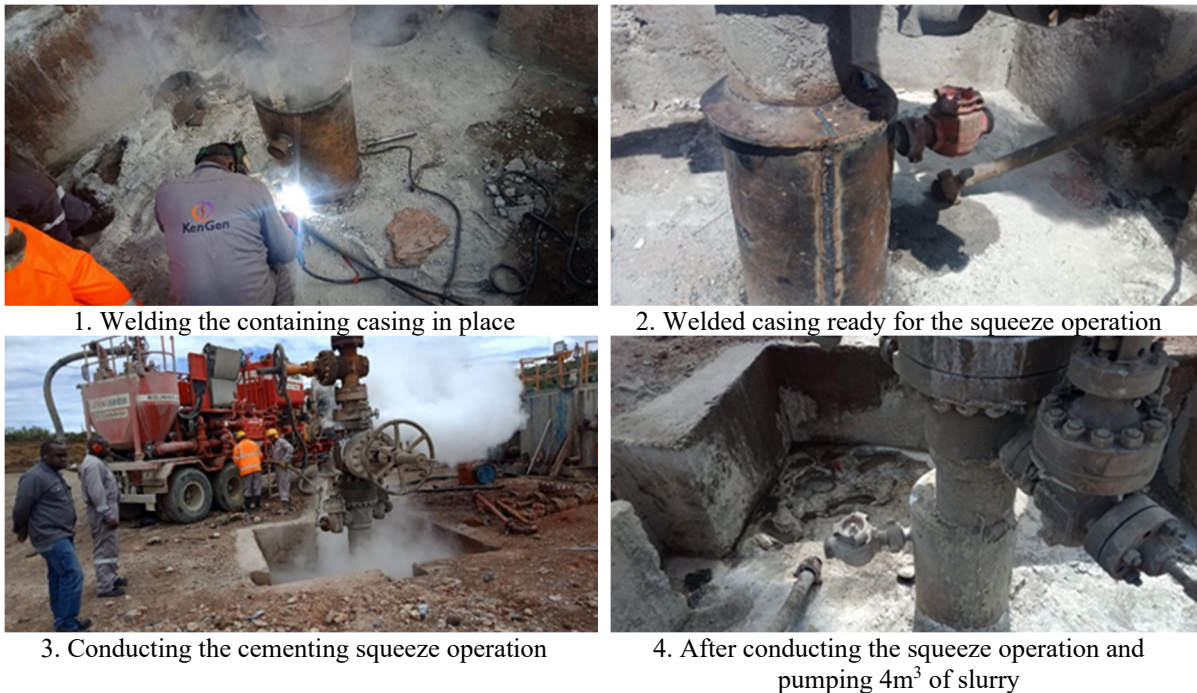
FIGURE 4: Squeeze cementing operation at well OW-740A (KenGen, 2019a)

1. Welding the containing casing in place

2. Welded casing ready for the squeeze operation

3. Conducting the cementing squeeze operation

4. After conducting the squeeze operation and pumping 4m<sup>3</sup> of slurry

After the survey, the well was let to discharge vertically to avoid pressure build-up. Furthermore, the additional containment measure of conducting a squeeze cementing operation was done to try and seal the conduits that were transmitting steam to the surface. This was done by welding two halves of the 20" casings in place, then pumping through a valve to squeeze as much cement slurry as possible while the well was discharging. The volume of cement slurry pumped during this operation was about 4 m<sup>3</sup>. This process is documented in Figure 4. After the squeeze cement job, leakage between the casings stopped including steam escaping between fractures.

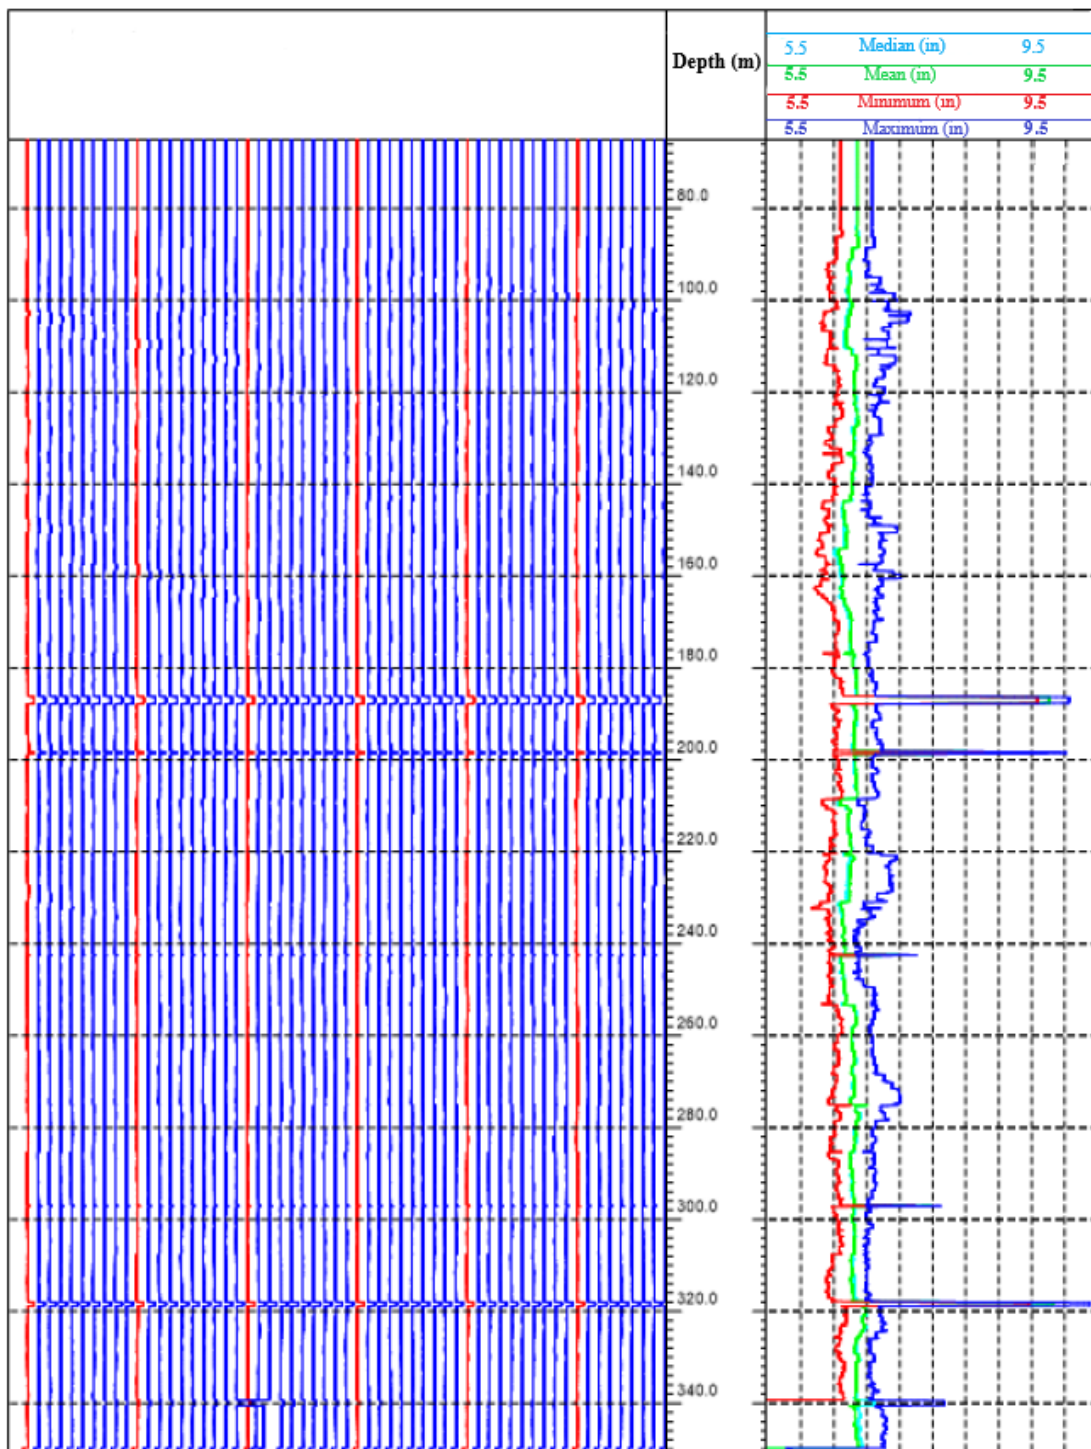
FIGURE 8: Full range calliper results (KenGen, 2019b)

A quenching operation was conducted on 8<sup>th</sup> August 2019, followed immediately by a casing inspection survey. At first, a dummy run was done to establish clearance in the production casing. While the water was continuously being pumped, a PT survey was carried out to a depth of 350 m. Thereafter, the casing calliper tool was run while cold water was being pumped. This was performed by a MAC60 tool which is a 60 multi-finger, starting at 350 m depth moving upwards to 50 m. The survey was not run deeper because there were signs that the well would kick again. The result of the survey is shown in Figure 8.

The survey shows three locations where the casings have parted. These are at 187 m, 198 m, and 318 m depths. The full extent of these damages is presented in the expounded view in Appendix A and B.

The parted casings at 187 m and 318 m depths seem to indicate a perfectly circular increase in internal diameter that may be attributable to the parting of casing. The breach at 187 m is the widest suggestive of a typical casing failure which may be due to sudden thermal stresses caused by sudden quenching of the well. The casing breakage at 318 m is the likely origin of passageways for steam to the crevices leading to the surface. The casing breakage above is inside the anchor casing and should not cause steam leakage unless the anchor casing is broken as well.

The data analysis for well OW-740A revealed that the well has parted casings at 187 m, 197 m, and 318 m depth. It is safe to assume that the casing failed due to induced thermal stresses on the steel casings due to sudden cooling through a quenching operation. Further analysis of the drilling data shows that the well experienced tight hole and obstructions during drilling at between 350 m and 560 m depth. This obstruction was troublesome to the point that running the production casings was a challenge that necessitated the removal of one casing joint during the casing installation. This may have contributed to the casing string not being properly cemented around the obstruction which may have caused the eventual break of the casing around the 318 m point.

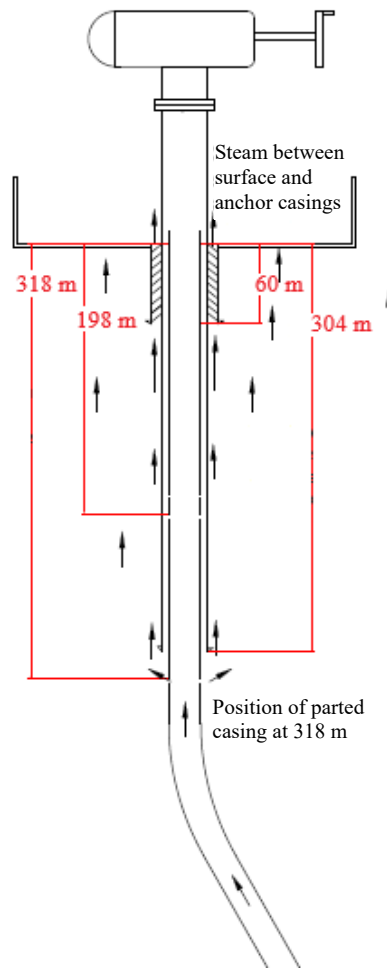
FIGURE 9: Possible flow of steam in well 740A due to the parted casings

Due to parted casings, flow of steam to the surface becomes possible as shown in Figure 9. With time this flow between anchor casings and the surface intensified as steam found its way to the surface.

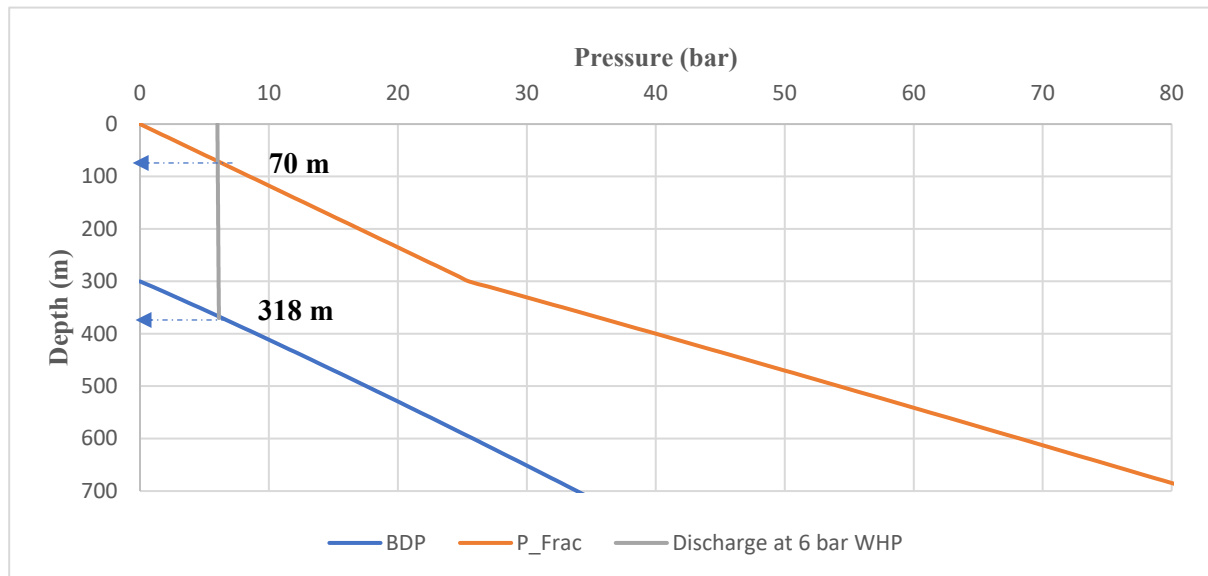
FIGURE 12: Pressure at the parted casing relative to the containment pressure of the formation (the dotted line shows the intersection of pressure and formation pressure curves)

From the plot, we see that the minimum depth that the formation can contain this pressure is about 70 m. Therefore, at the point where the casing has parted (318 m) the rock has enough containment strength to sustain the discharge from the surface. It is however not strong enough if the well is shut in.

Currently, the well is under vertical discharge. We have seen from Figure 12 that it is safe to let the well discharge as this does not pose any danger to the surface equipment as the pressure exerted at the parted casings is well below the containment pressure of the formation. Based on the conducted case studies, we have ruled out the method of repair by drilling a relief well as employed at Malitbog in the Philippines because it will be very complicated to drill a relief well since the well is deep, and the chances of hitting

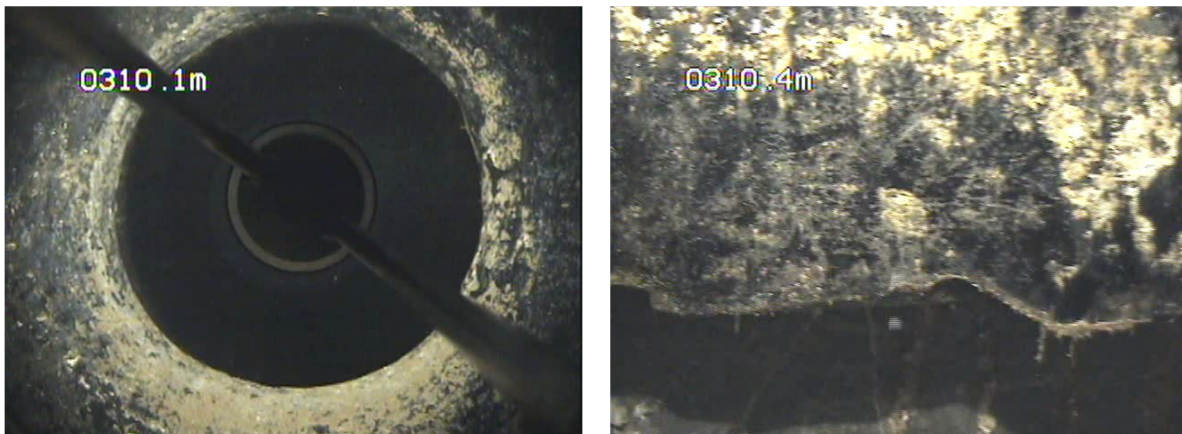
FIGURE 13: Pictures showing damaged casing at 310 m  
(photo courtesy of HE-53 casing report by Mannvit, May 2011)

The well was allowed to set and after a few days, the top of cement was found to be at 134 m. A method was chosen to repair this well which involved drilling the well to the liner hanger and stopping at about 2-3 singles from it. Cleaning was done and subsequent inspection of the 9 -5/8" casing was done to ascertain the extent of the damage of the casings (Figure 13). Afterwards, a 7" casing was run and cemented in place.

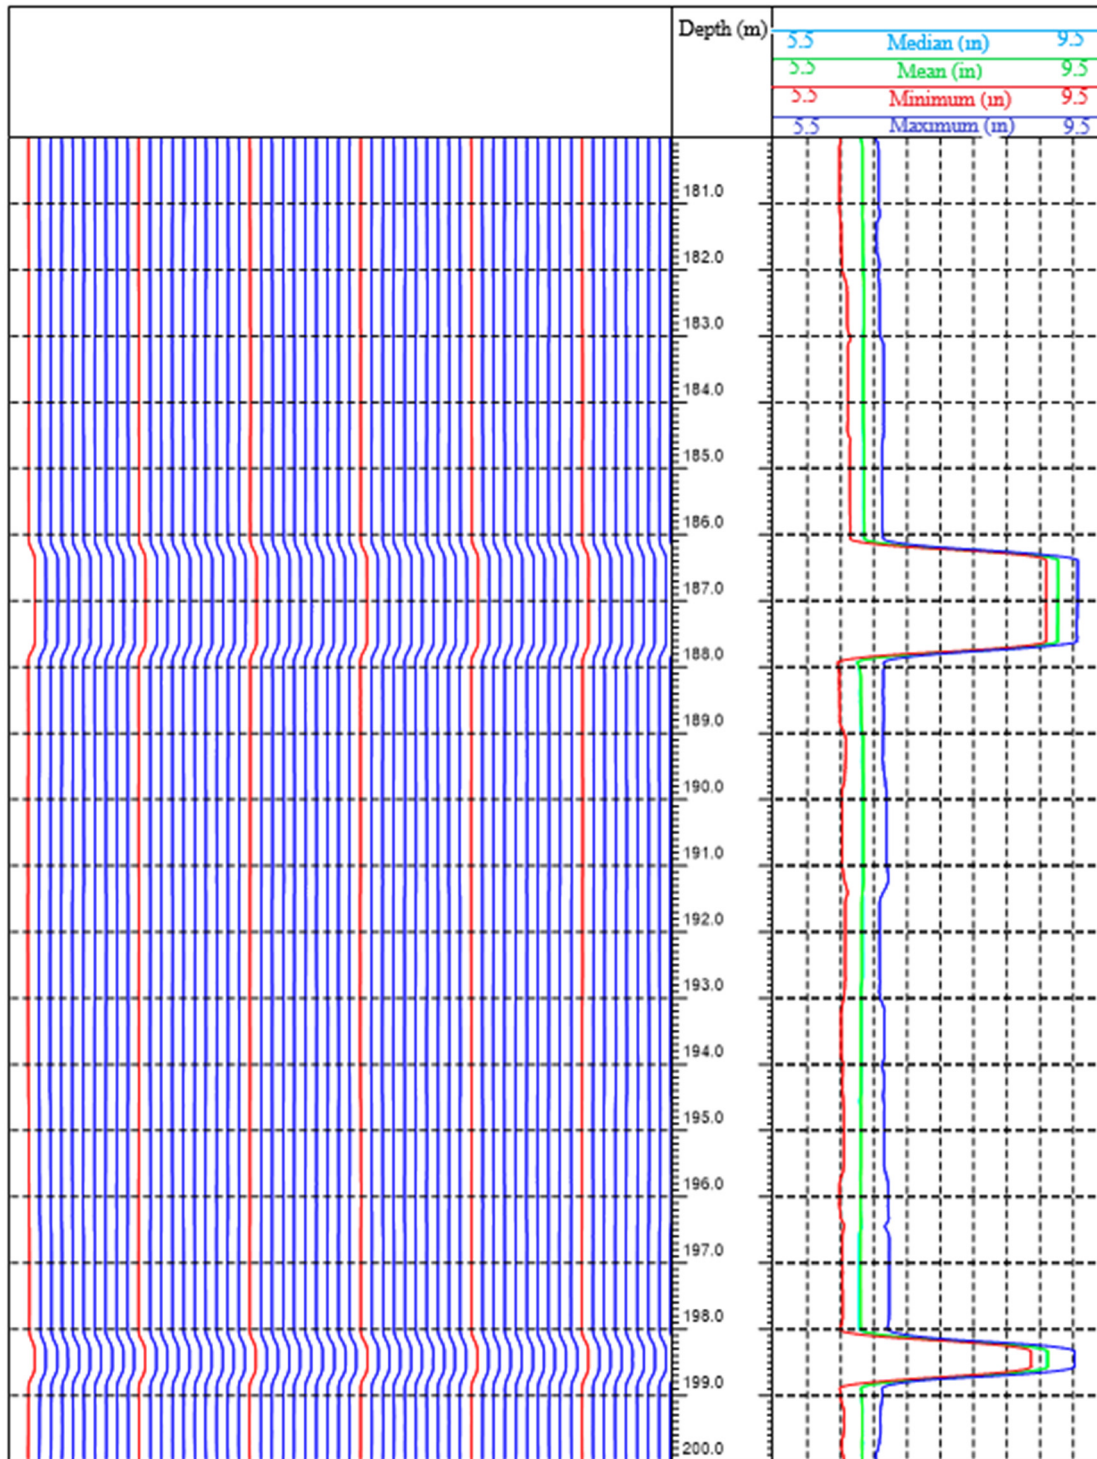
**APPENDIX A**

Localized calliper logs at 180-200 m depth showing casing parting at 187 m and 198 m at well OW-740A

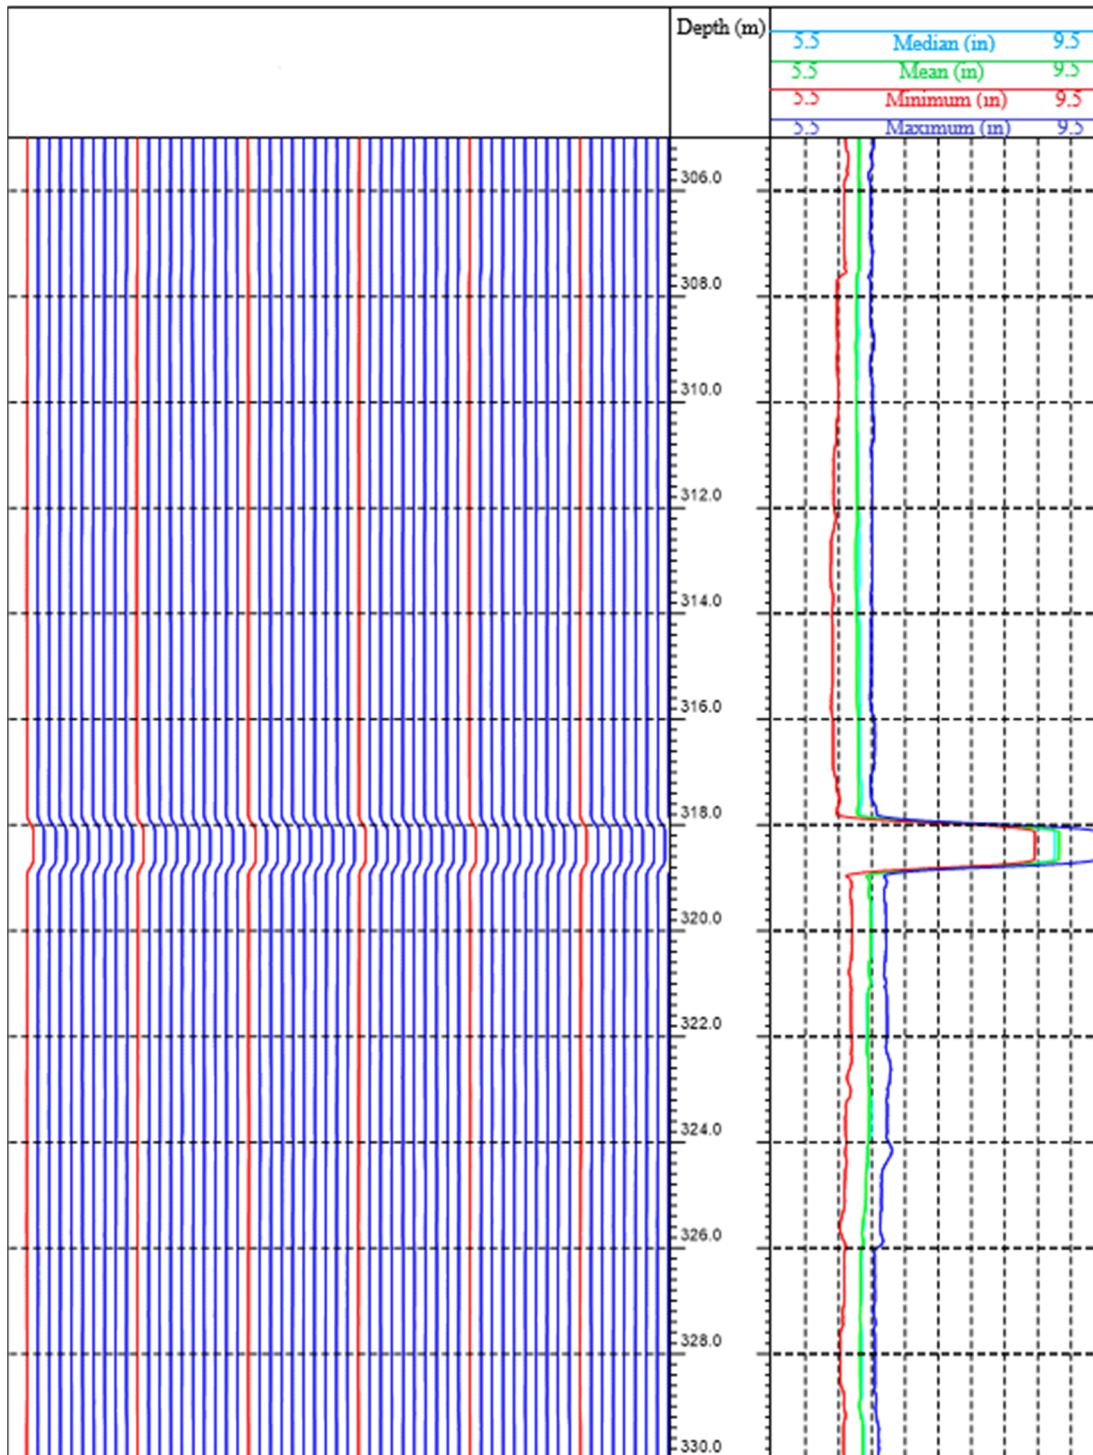
**APPENDIX B**

Localized calliper logs at 305-330 m depth showing casing parting at 318 m at well OW-740A
