FINAL REPORT

510-000323	Incident		
Aircraft:	Boeing 757-200	A/C registration:	TF-FIR
Engines:	2 Rolls-Royce RB211-535	Type of Flight:	Scheduled, IFR
Crew:	8 – no injuries	Passengers:	144 – no injuries
Place:	Denmark N56°30,7 E010°07,7	Date and time:	11.01.2007 at 1642 hrs. UTC

Synopsis

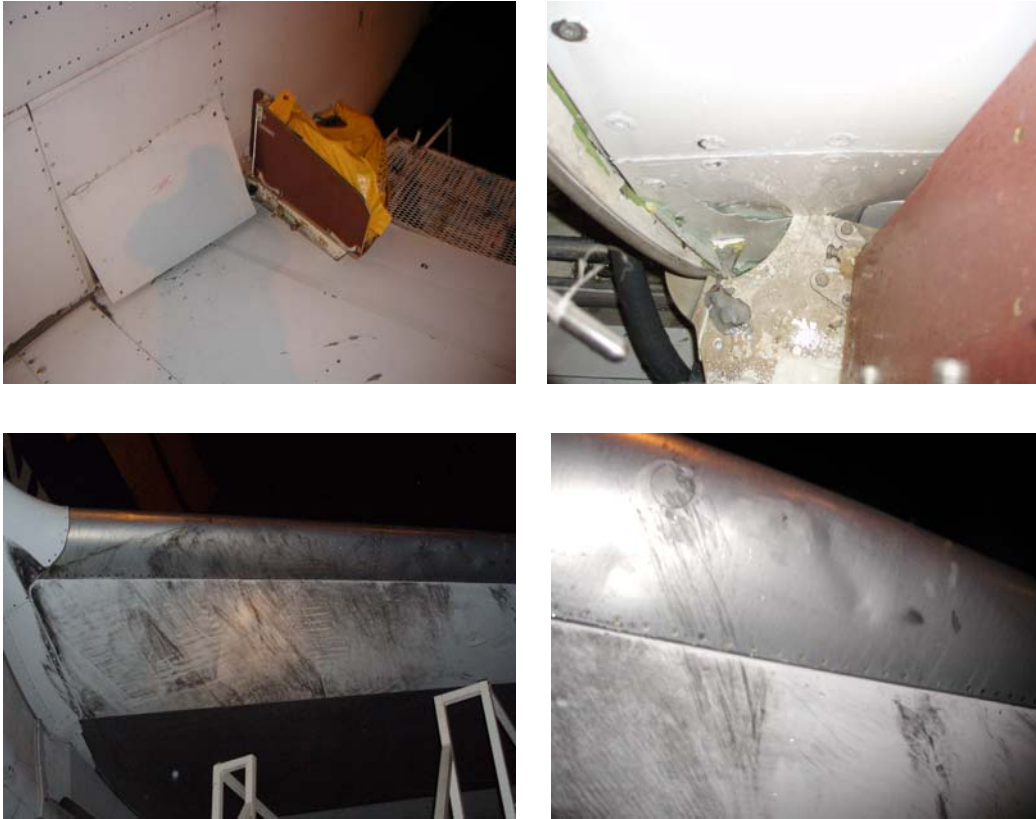
The structure around the off-wing escape slide compartment and the left stabilizer was substantially damaged.

The stabilizer had several impact marks on the leading edge. Also the white collared panel aft of the leading edge had several impact marks.

When the slide carrier deployed the slide carrier restraining hook was not able to resist the air stream forces. It broke up and caused the slide carrier to over-rotate. The aft outboard corner of the slide compartment structure was substantially damaged by the over-rotated slide carrier.

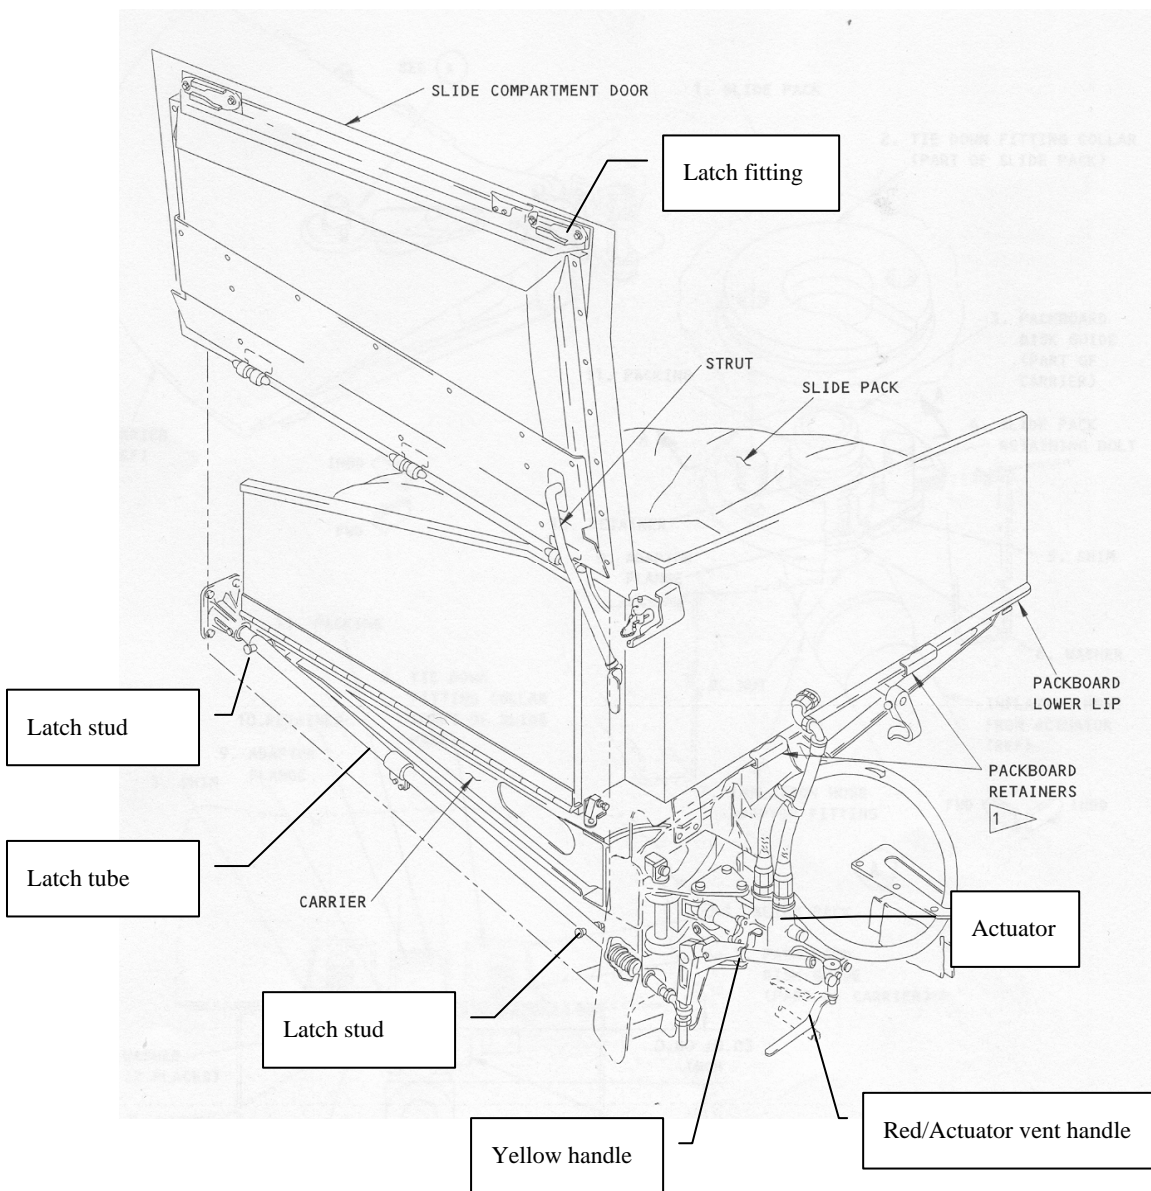
The slide carrier lock mechanism was intact and it was possible to lock the carrier into the carrier lock assembly operating the yellow/round crank handle.

The carrier lock fitting had scratch marks on its outer portion. Operating the yellow/round crank handle without pushing hard inwards on the carrier, allowed the carrier lock pin to scratch the outer portion of the carrier lock fitting. The right hand side carrier lock fitting was also examined and the same type of scratch marks was found. It was not possible to lock the carrier without pushing the slide compartment door hard inwards.

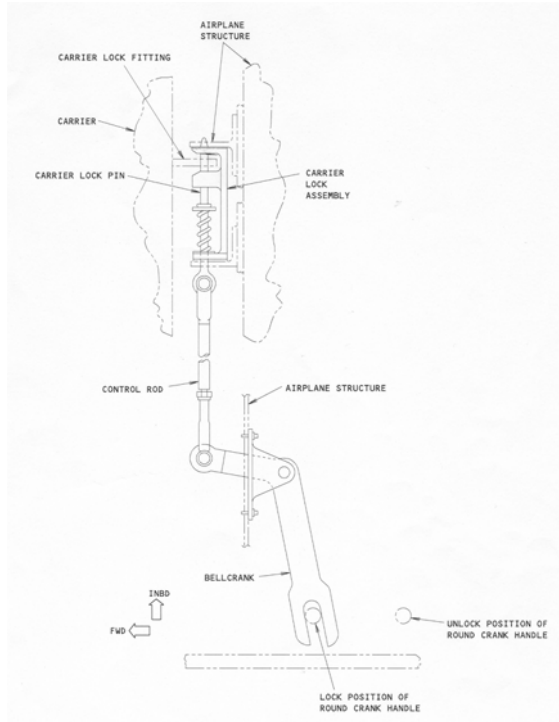
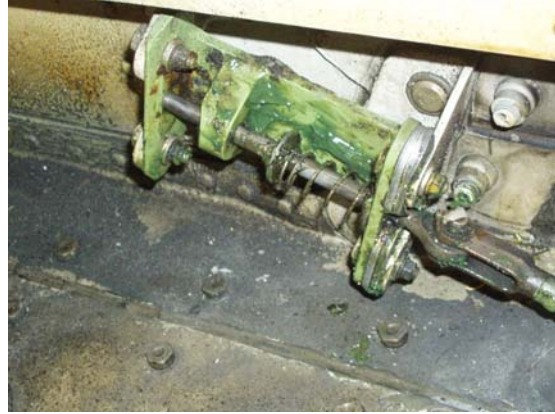
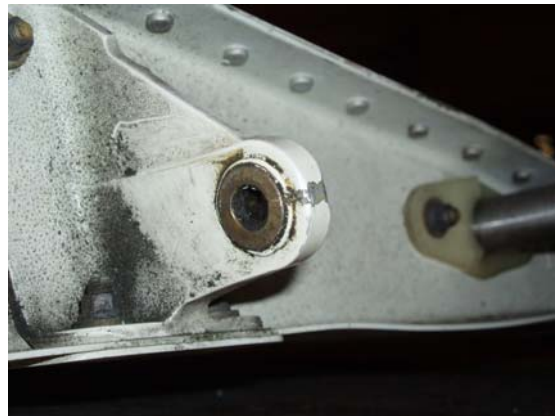
Investigators opened and closed the slide system several times according to the procedure described in the Boeing Aircraft Maintenance Manual (AMM) 25-65-09. The system functioned normally and the carrier and compartment door was found satisfactorily locked at all attempts.

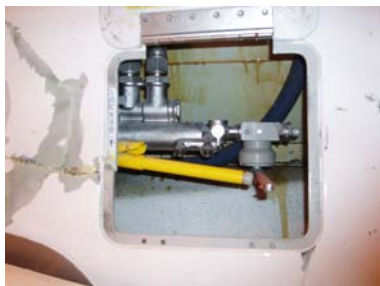
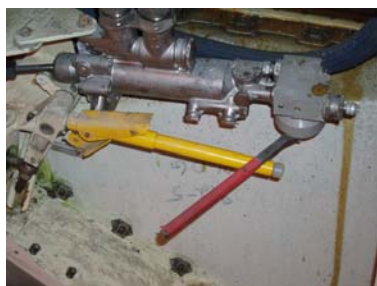
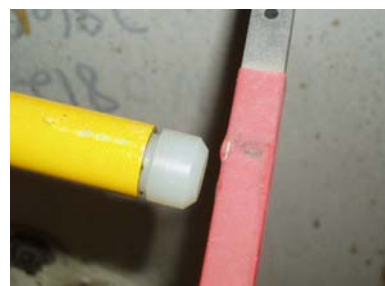
The down and locked position of the yellow/round crank handle in relation to the red/actuator vent handle was found inappropriate.

The red/actuator vent handle was turned 90 degrees outboard to the manual position to disarm the inflation system. It was necessary to raise the yellow/round crank handle to give the red/actuator vent handle space enough to be operated inwards.

It was necessary to raise the yellow/round crank handle to give the red/actuator vent handle space enough to be operated inwards. This movement of the yellow/round crank handle could partly unlock the door and be the reason for the door to be insufficient locked. It could also be the reason for the slide carrier to be unlocked.

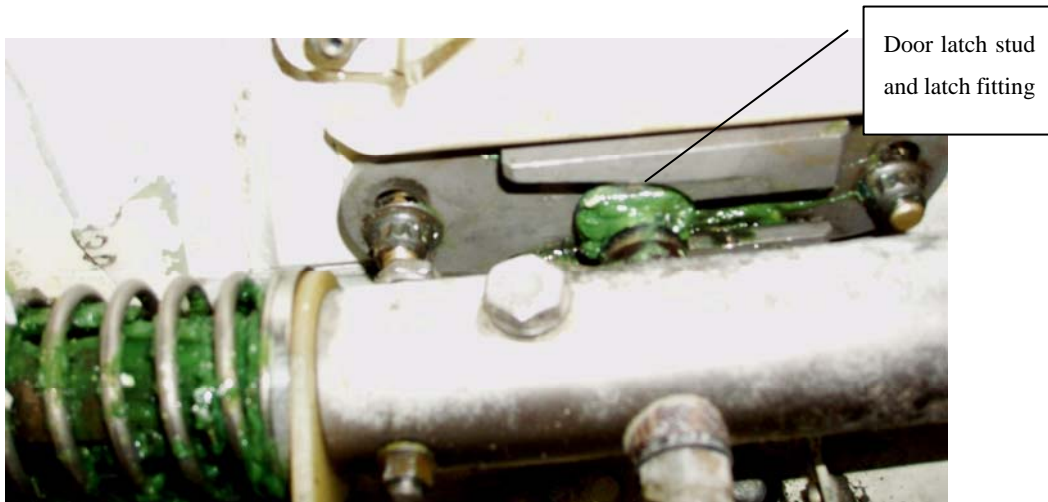
During this process, the investigators once observed, that the latch studs were not engaged properly in the latch fitting slots. The door was closed and the EICAS light “L Wing Slide” was out, indicating that the door was closed. The door was flush with the fuselage of the aircraft.

With the door in a closed position, it appeared visually to be locked, but the door was not properly locked. The picture below was taken from the main gear wheel well showing the above mentioned lock situation.

When the slide carrier was in place and the compartment door was closed it was physically and visually impossible to verify that the carrier lock pins were fully engaged and the latch studs were fully engaged in the latch fittings. It was only possible by using a borescope from the landing gear wheel well.

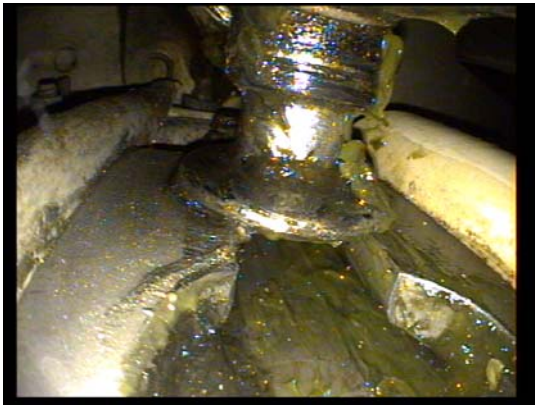
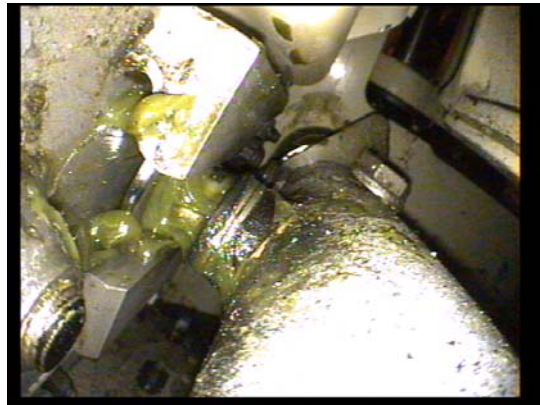
The investigators managed to close and lock the system allowing the forward compartment door latch to be unlocked.

The left borescope picture shows the forward latch unlocked and the right picture show the aft latch locked.

The EICAS light “L Wing Slide” remained out, indicating that the door was closed.

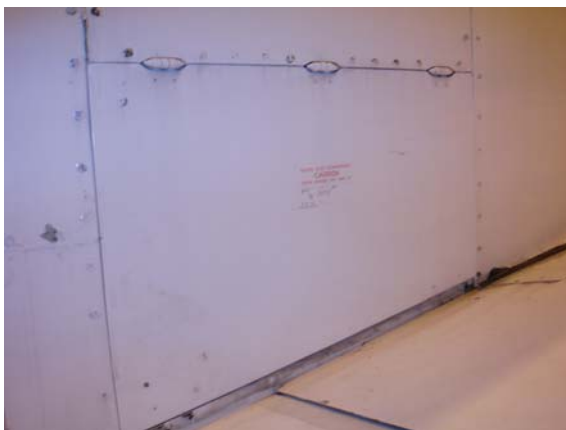
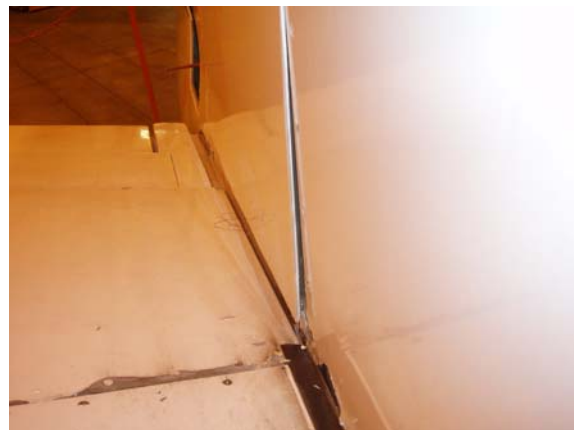
The door was not flush with the fuselage at the lower forward side.

The investigators managed to lock the right hand side slide compartment door leaving the forward latch open and the door not flush with the fuselage. The AIBD is aware of this possibility, but found no evidence to support this scenario during investigation on the left hand side compartment door.
