GEOLOGICAL REPORT

THE AREA OF SOUTH WESTERN ICELAND

CONTAINING THE PROPOSED DAM SITES

BY
DR. L. HAWKES
AND
G. KJARTANSSON

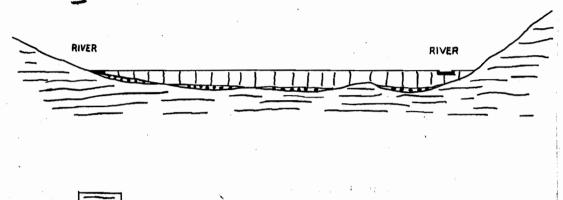
boundary of the lava to the slopes of the older rocks, and this is the situation at all the dam sites, save that of Klofaey, so that one end of each dam will abut against the older rocks and the other end against the lava. At Klofaey the river course is wholly in the lava, but not far from its boundary. In generalised section the situation is:-

Older basal'ts and tuffs

The Thjorsa lava

Loose valley deposits; sands, gravels, peat etc. (pre lava)

The lava thins towards the boundary. We saw its base in the Urridafoss gorge only, where it is about 15 ft. thick - and this is very close to the original boundary. Away from the boundary it must be much thicker. Beneath the lava loose deposits of the pre-lava valley flow may be expected to occur in places - they are seen in the Urridafoss gorge - but they may be absent. We do not anticipate that such loose deposits are of any considerable thickness at the dam sites - had they been so the fast flowing currents would have cut deeper channels.

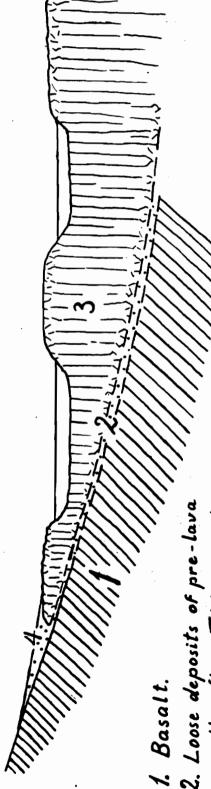
Section I.

and we have no doubt that the island is of lava also. Mr. Barrie reported that the river had an even depth of about 3 feet with hard bottom throughout. The whole channel must lie in the lava: The older rock of the western slopes to the lava is compact grey basalt. The line of junction of the lava and the older rocks is obscured by loose blown sands here, but there is probably only a small thickness of loose deposits, if indeed any at all, between the base of the lava and the solid basalt of the old valley floor. Section I gives a general picture of the probable situation here.

It appears that the projected spillway channel to the south would run along the boundary of the lava. Unless lined one would expect considerable seepage through the vesicular lava and through any loose deposits which may be present below the lava. In the section the surface of the lava is depicted as a general flat one, but in detail it is irregular and clinkery with slight depressions. Such depressions may be filled with blown sand. - They are easily seen and their size can be quickly found by digging.

2. Loose deposits of pre-lava valley floor. Thickness unknown - may be absent.

Djórsá lava.

4 Wind-blown sand

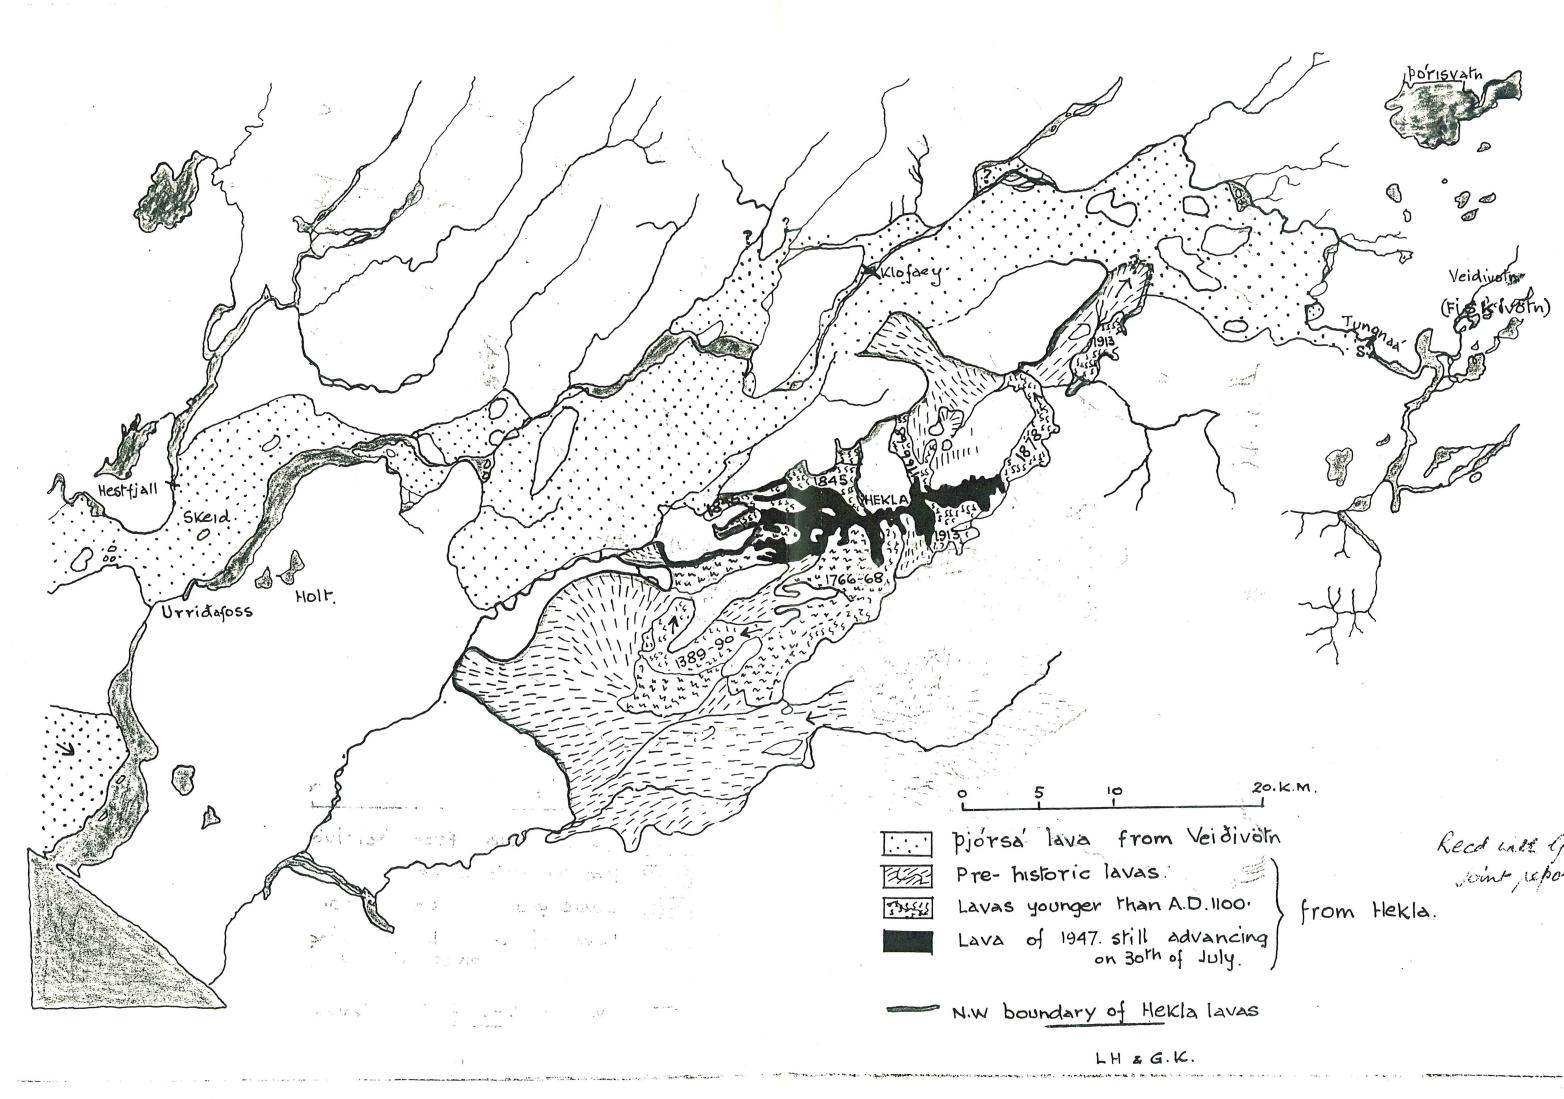
- Tungnaá valley below the Fiskivötn lakes

Here there is a broad valley (about 2 km. across) of lava with the Tungnaa river flowing along its northern boundary to the higher ground of the older rocks. See Section IV. The older rocks here are pillow lavas and tuffs. The higher parts of this area are waterless - which indicates clearly the high porosity of the tuffs. The surface of the lava at "S" is only about 3 - 4 m. above the river level. There is no gorge to take a dam of 25 metres such as had been suggested to us - nor is there any such gorge in the neighbourhood.

1 Tuffs and pillow lavas.

2. Djórsá lava.

3. Loose seree.
