URRIÐAKOT

FORNLEIFARANNSÓKN 2010 FRAMVINDUSKÝRSLA

Urriðakot 2010

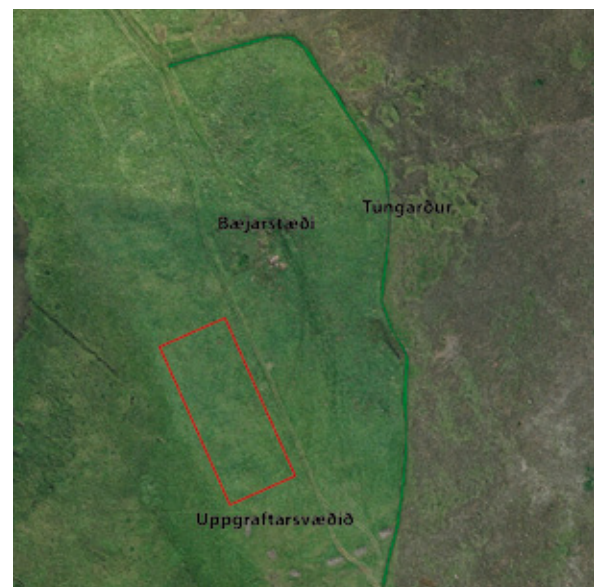
Uppgraftarsvæðinu var skipti í tvo hluta, A og B, og tóku þeir mið af könnunarskurðum sem voru grafnir árið 2007.

Uppgraftarsvæðið er orðið um 900 fermetrar að stærð.

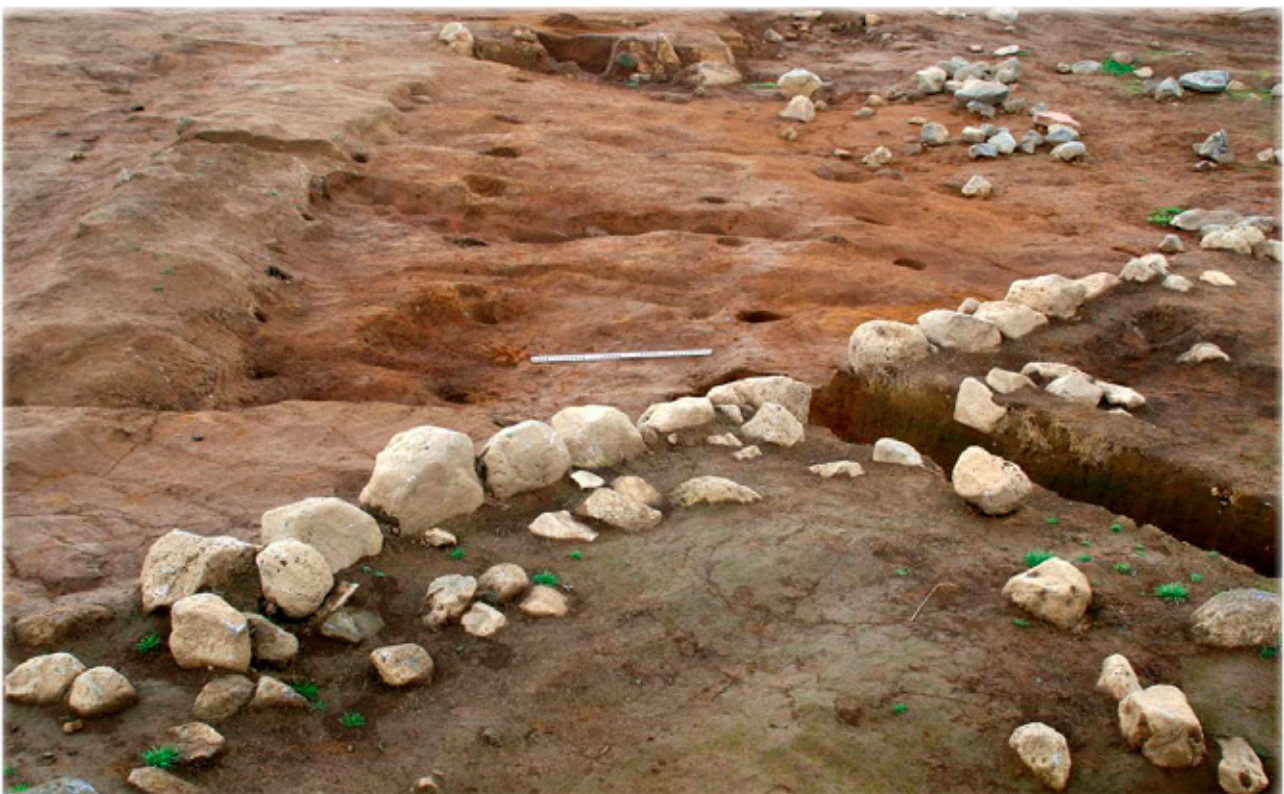
Skáli [10]

Skálinn [10] er á uppgraftarsvæði A. Hann snýr norður-suður en hefur ekki að fullu verið grafinn. Áætluð lengd hans er 14-16 m að utanmáli.

Austurveggurinn [27408] virðist heillegur og inngangur, að líkindum bakdyr, sunnarlega á honum. Aðalinngangur var trúlega á vesturvegg en lítið er eftir af honum. Hugsanlega hefur hann verið rifinn einhvern tíma í fyrndinni og orðið að víkja fyrir miðaldabyggingum á svæðinu, en rannsókn er ekki lokið á þessu svæði. Mótar fyrir seti [23056] á austurveggnum innanverðum og aftan við hann meðfram veggnum fundust tólf stoðarholur.

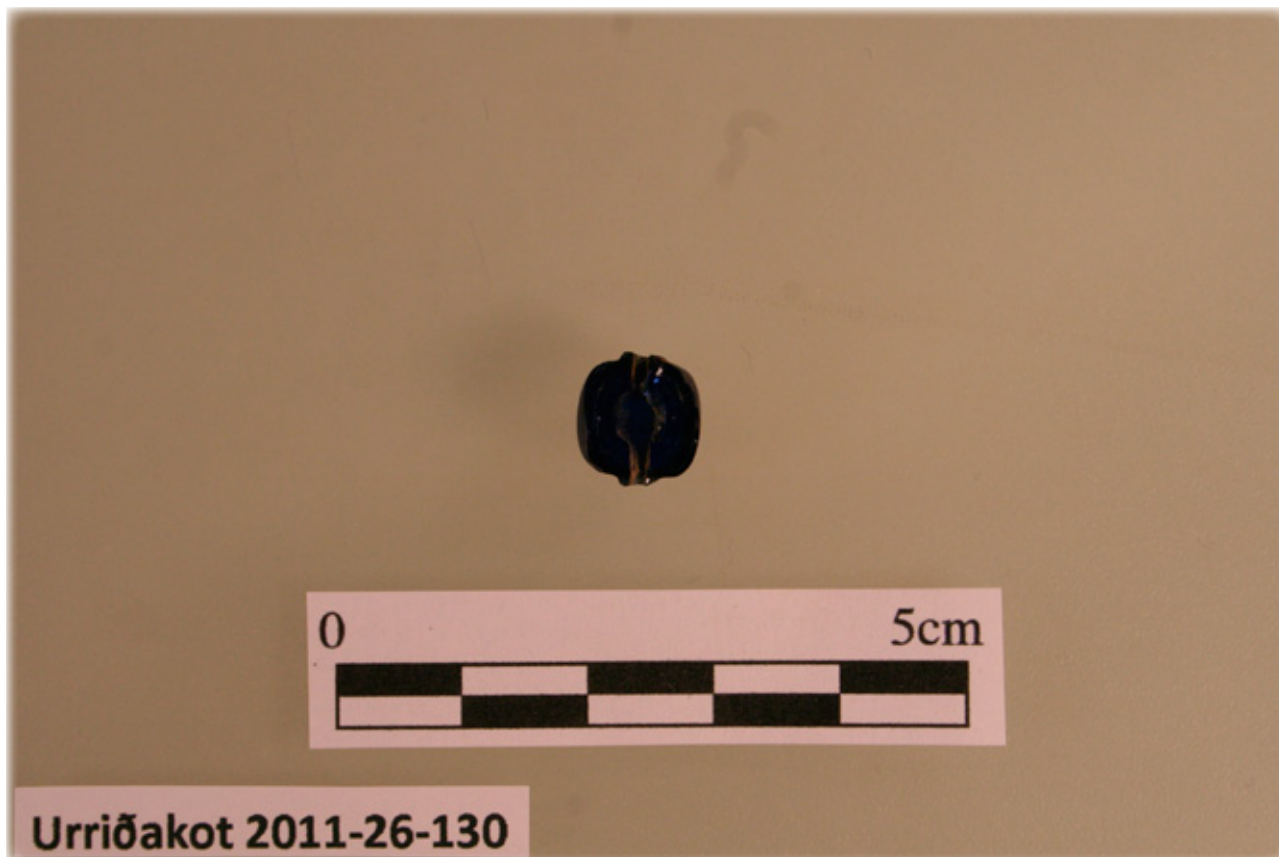
Perla sem fannst í skálanum [10]

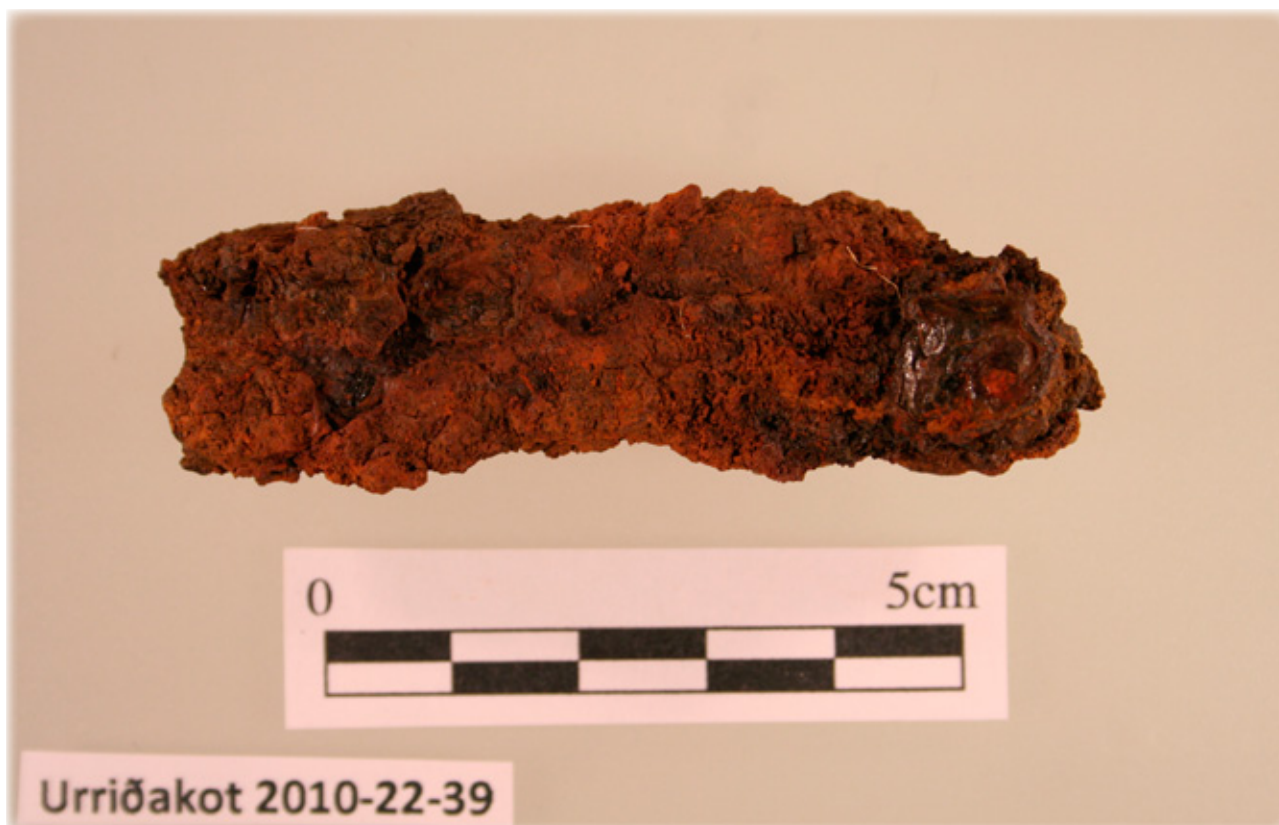
Hnífur sem fannst í skálanum [10]

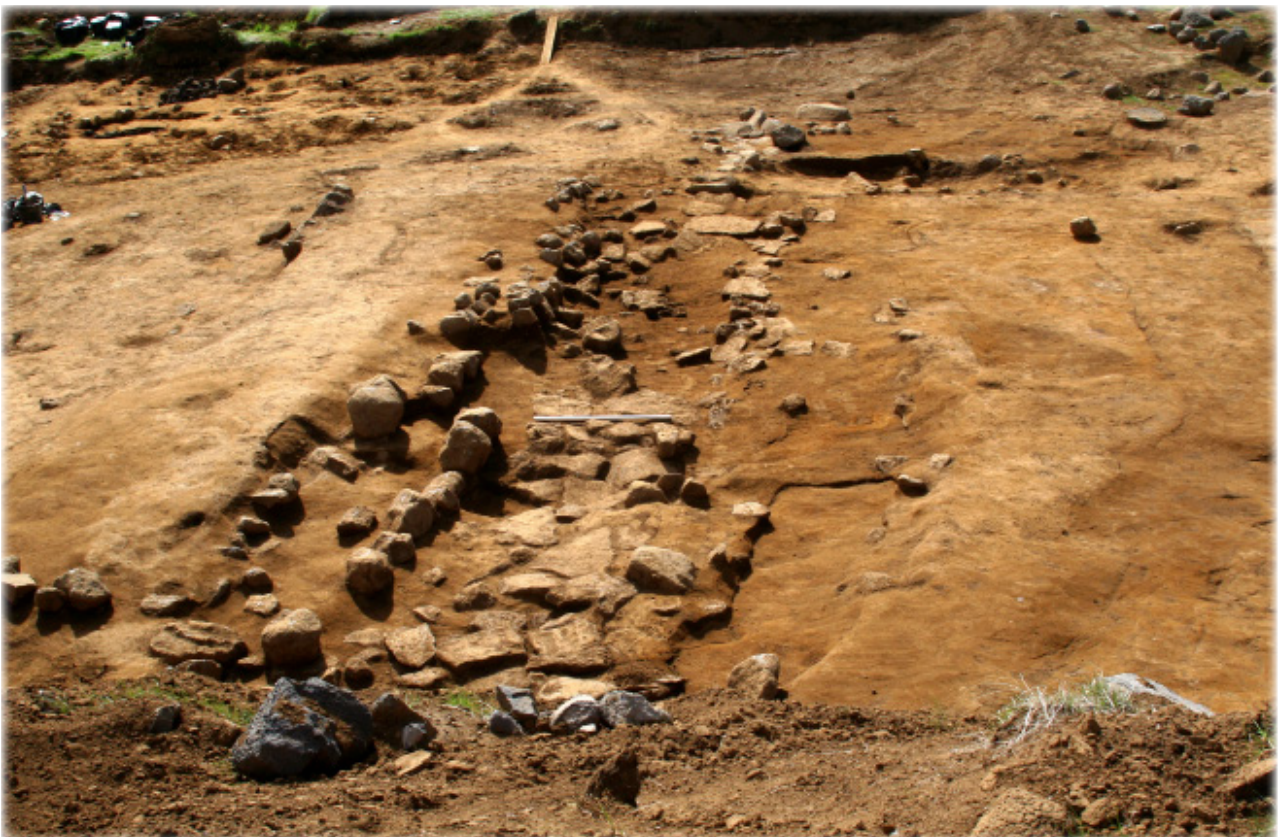
Fjós [15]

Suðurveggurinn í fjósinu [37500] er 11,9 á lengd og mesta breidd er 1,9 m. Norðurveggurinn [36945] er 9,5 m á lengd og breiddin 1,7 m. Ekki hafa margir gripir fundist í fjósinu, ein gul perla (F: 2010-26-126) og þrír járnaglar.

hvernig það hefur verið nákvæmlega uppbyggt. Við lok rannsóknar komu í ljós stoðarholur og munu þær væntalega skýra betur hvernig þak og uppbygging fjóssins hefur verið þegar uppgreftinum vindur fram.

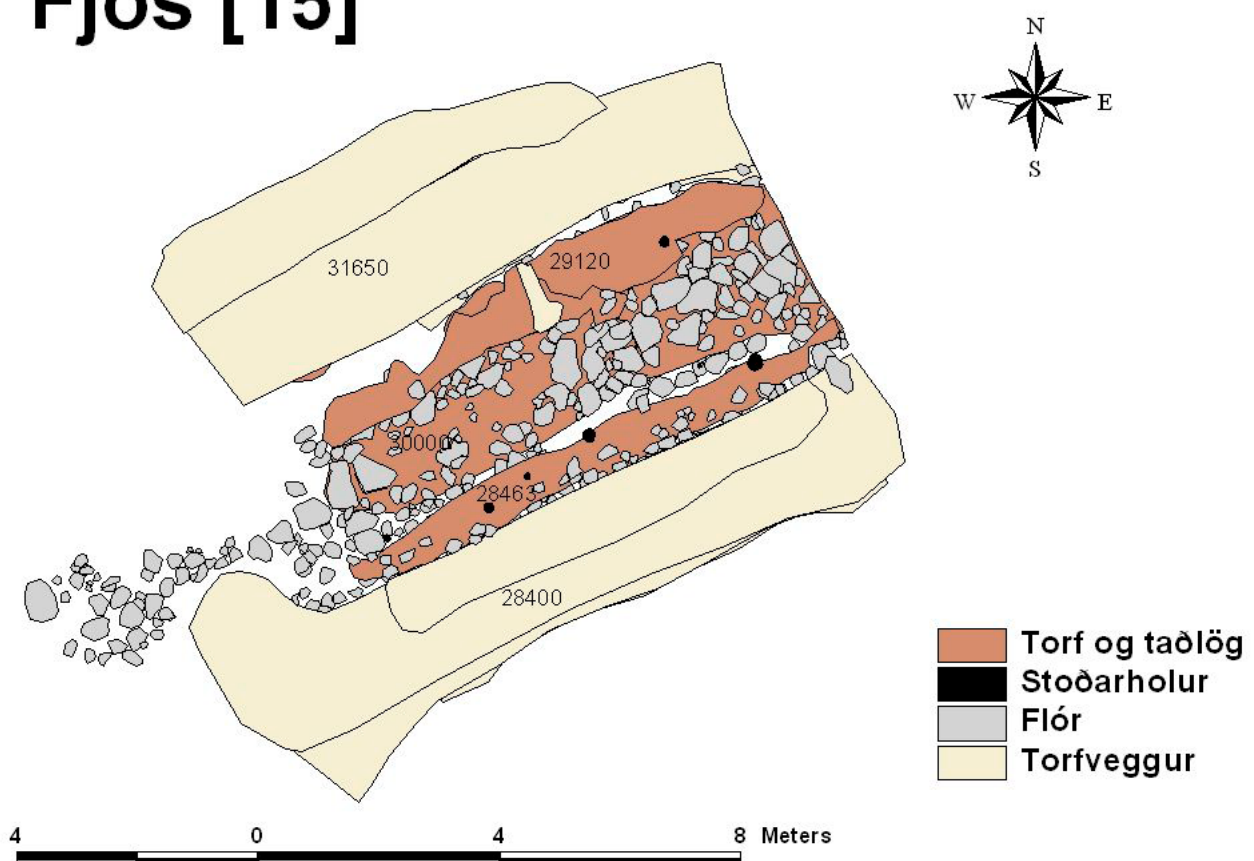
Soðhola [17]

Soðhola eða seyður fannst á svæði A, 15 m vestan við skálann [10] og fjósið [15]. Hún er 1,45 m í þvermál, næstum hringlaga og er full af brenndum steinum og kolum. Í henni voru lítið eitt af brenndum dýrabeinum.

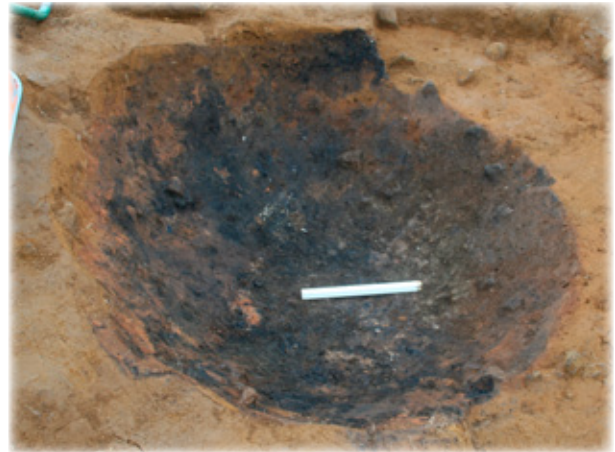
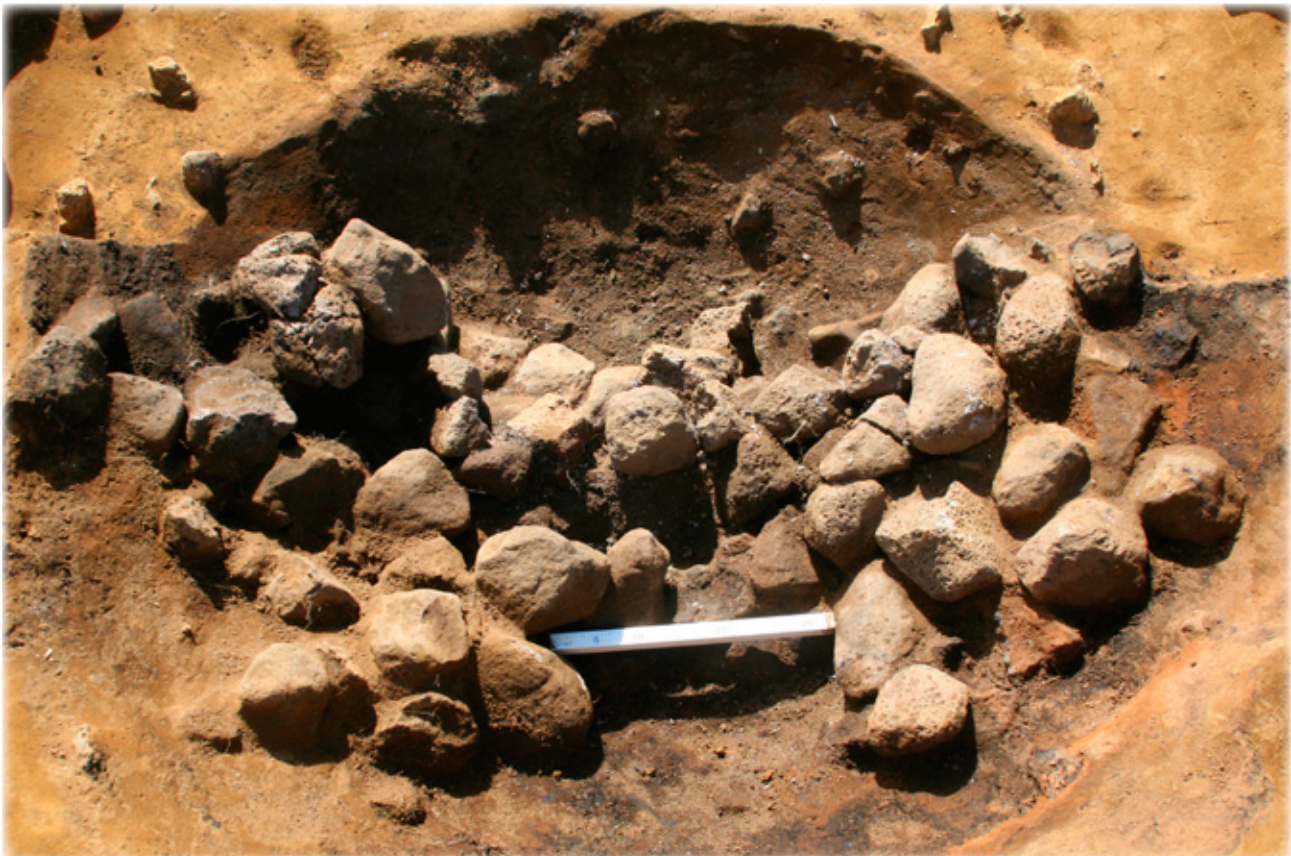
Soðhola á svæði A

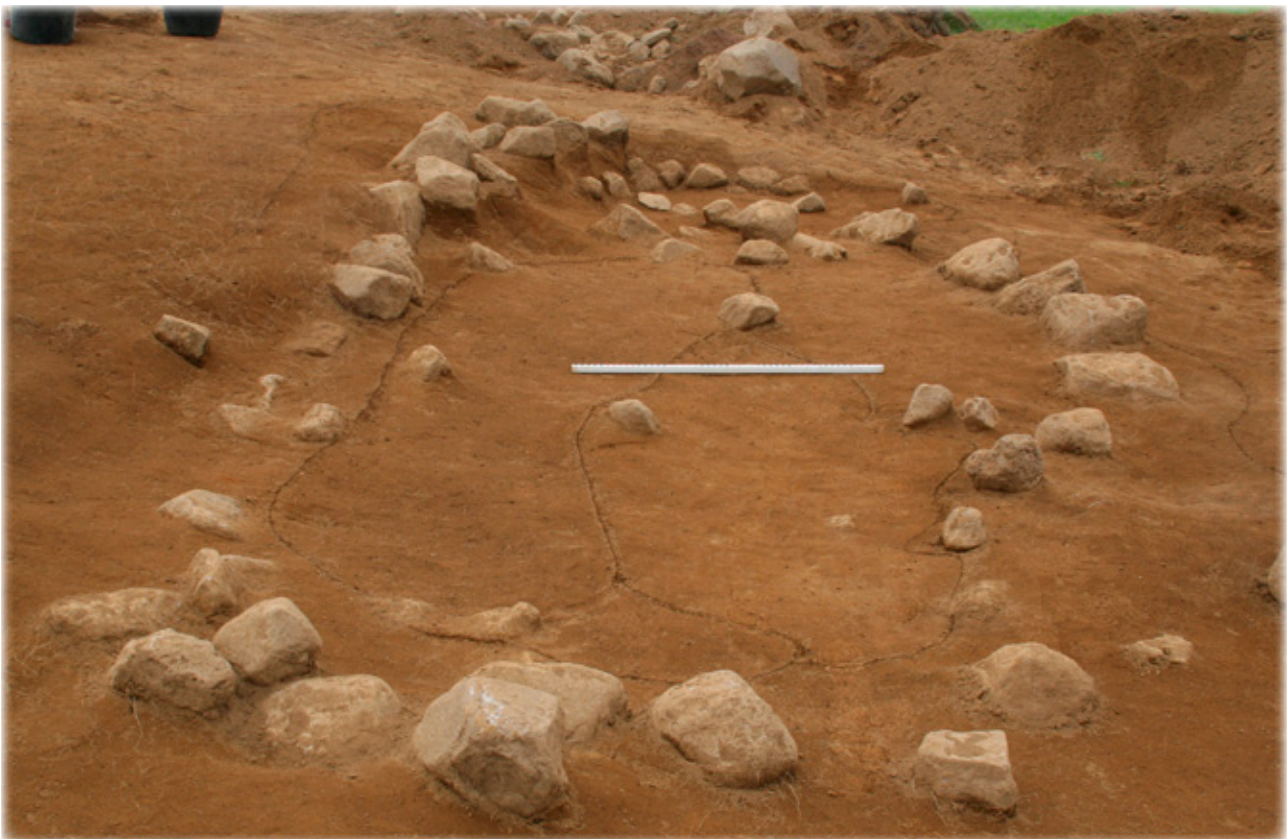
Jarðlög í mannvirki [18]

Torfið í austurveggnum [25317] er mjög þunnt og rýrt og blandað fokjarðvegi. Torfleifarnar er aðeins að finna í kringum steinana, annað er blásið upp, og ekki fannst nein miðaldagjóska í því. Ekki er ólíklegt að inngangur í mannvirkið hafi verið á vesturhliðinni eða norðurenda því að vegghleðslan austan- og sunnanmegin er órofin.

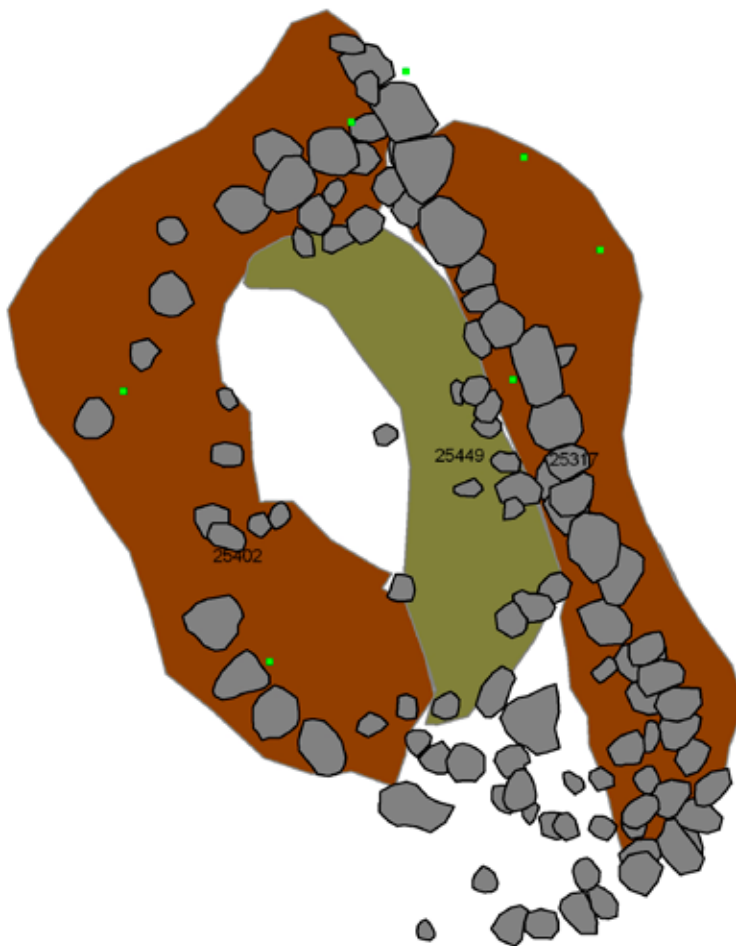
Mannvirki 18

Svæðið er ekki fullrannsakað en hlutverk mannvirkisins gætið skýrst þegar það hefur verið fullgrafið og niðurstöður greininga liggja fyrir.

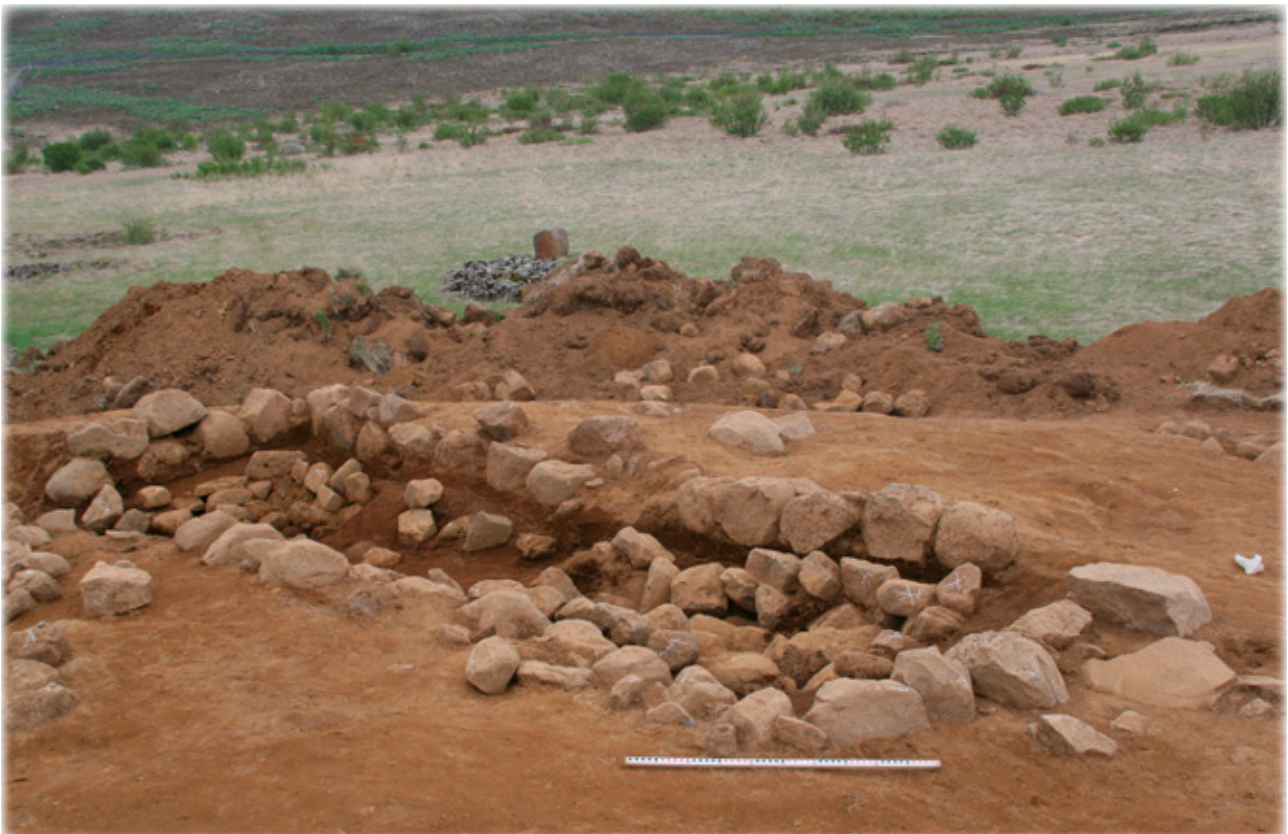
Mannvirki [19]

Greinilegur niðurgröftur er inni í tóftinni og hefur innri veggjahleðslan verið hlaðin utan í niðurgröftinn. Niðurgröfturinn var fullur af steinum af sömu stærð og eru í steknum. Líklega hefur stekkurinn verið felldur ofan í sjálfan sig eftir að notkun á honum hefur verið hætt. Aðeins neðsta steinaröðin í ytri veggjahleðslunni er eftir á sínum stað sem bendir til þess að steinarnir í fyllingu niðurgröftarins séu upphaflega úr ytri hleðslunni þó eitthvað af þeim gæti verið úr þeirri innri.

Tveir líklegir inngangar eru á stekkjarrústinni. Annar er á suðvestur hliðinni en þar er gat í steinhleðslunni. Hinn er á tóftinni framanverðri, í vesturhorninu, en þar er að finna nokkra flata steina sem gætu verið steinhlaðin stétt.

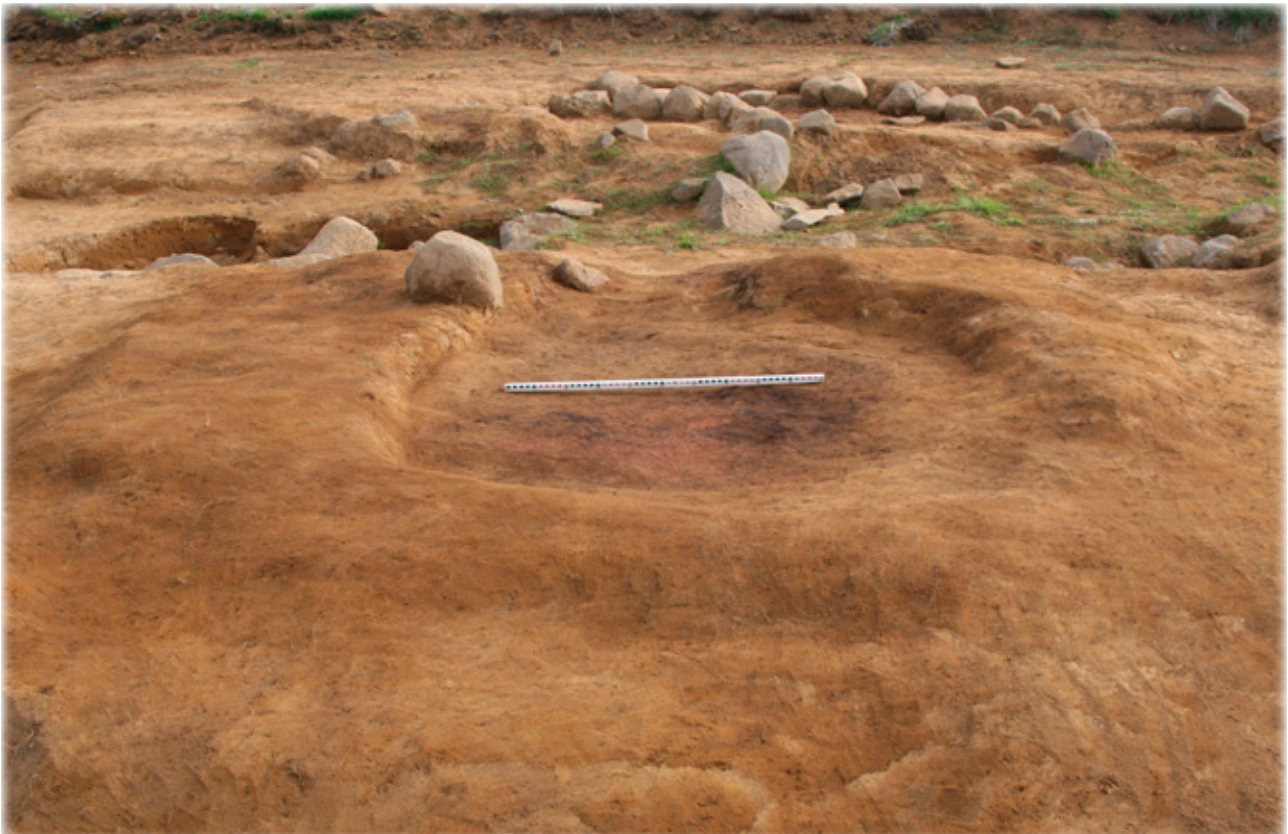
Mannvirki [20]

Mannvirkið snýr í NA-SV og inngangur í tóftina er á norðvesturhliðinni. Ekki var þaktorfið vel greinanlegt í tóftinni en [24780] var túlkað sem leifar af þaktorfi. Svæðið er mjög uppblásið og torfið niðurbrotið.

Að minnsta kosti sex gólffasar hafa fundist í eldhúsinu. Svo virðist sem byggingin hafi verið minnkuð í seinni tíð en greinileg breyting verður á torfveggjum.

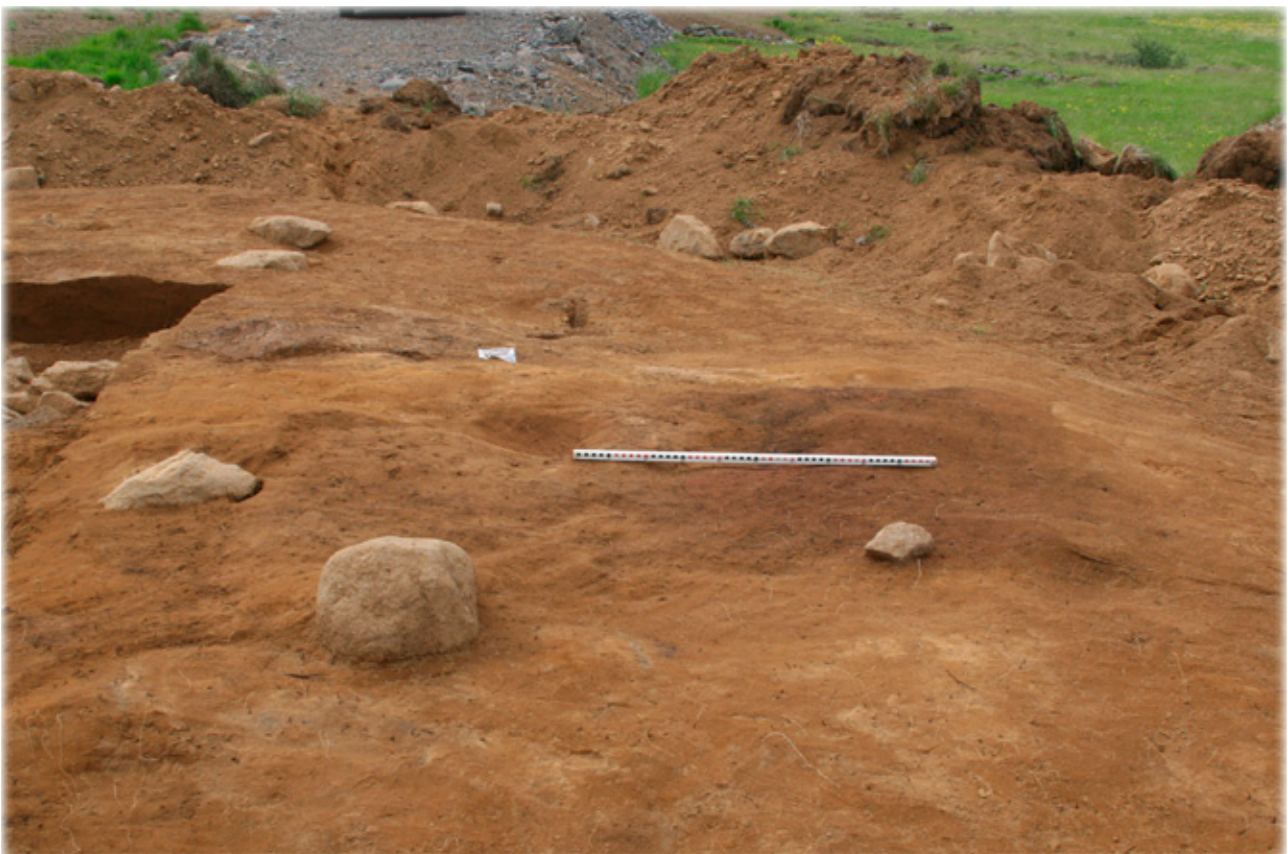
Mörg gólfög fundust í yngri fasanum í byggingu [20]. **Fasi I**, og þar með yngsta gólfagið [25181], var mjög blandað, með móösku, kolum og brenndum beinum. Úti við veggina var meira torf. Undir [25181], í **fasa II**, urðu gólfín minna blönduð. Upp við veggina var torfblandað gólf [34416] og út við innganginn var grænleitt gólf [34383]. Í miðri byggingunni

Gólfag [25181] í fasa I

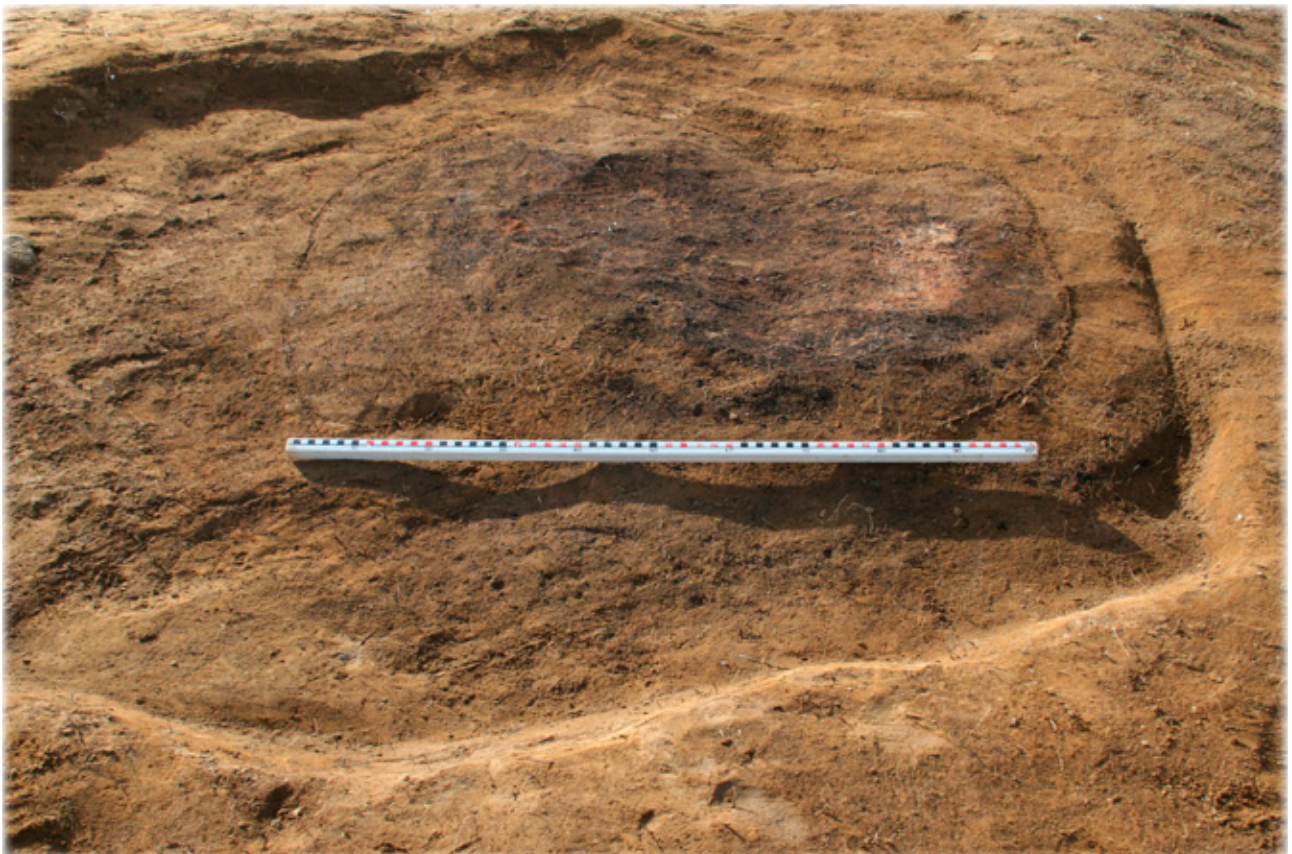
Gólflag [34339] í fasa III

var brunasvæði [34339], mjög blandað móösku, brenndum beinum og kolum.

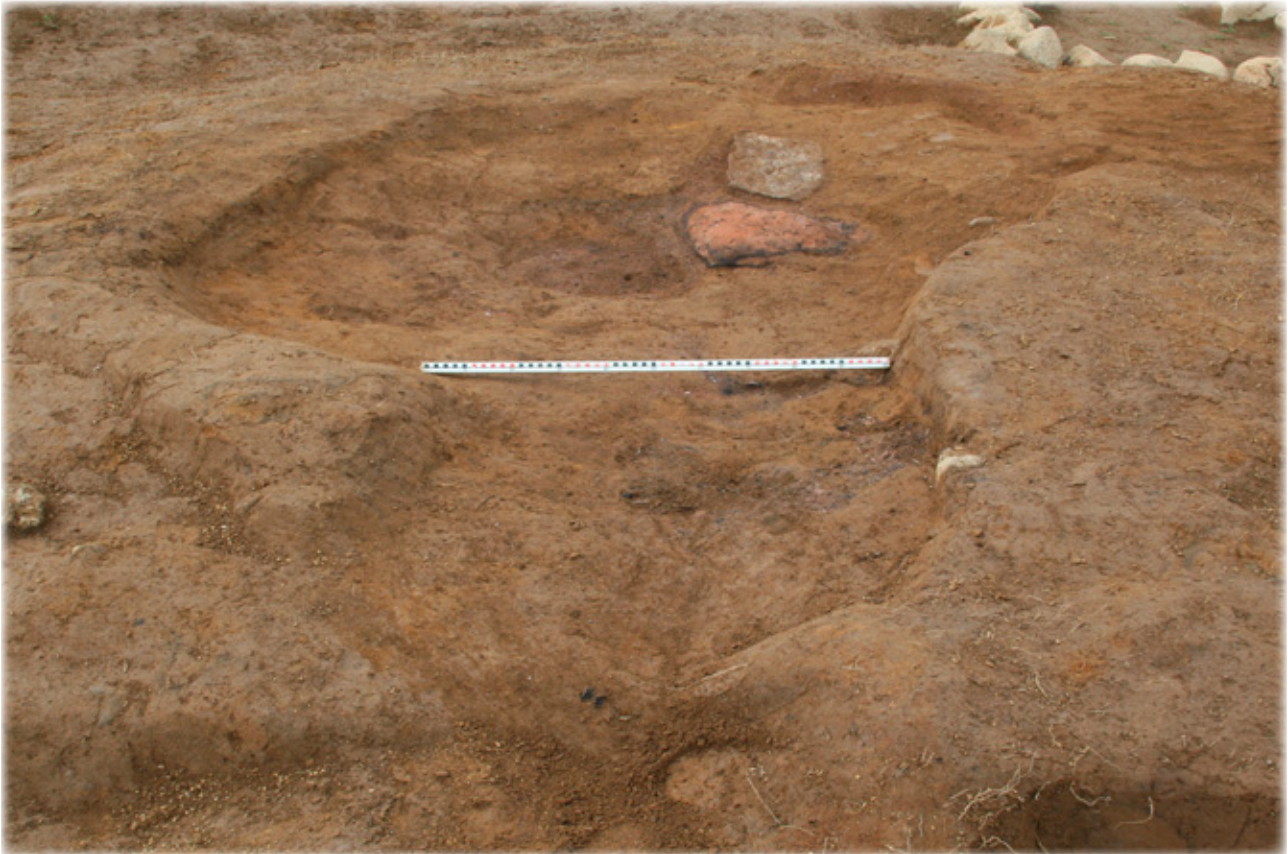
Fasi IV, eldstæði [40499]

Undir þessum gólfögum kom **fasi IV** í ljós. Þar var eldstæði [38659] = [39429] = [40499] og svipuð gólfög og áður, kolagólf [40061] og torfkennt gólf [39590]. Eldstæðið var niðurgrafið og frekar stórt eða um 0,75 x 1,1 m. Við hliðina á því var 30 x 40 cm flatur steinn. Þykkt torflag var við suðvesturvegginn nálægt eldstæðinu sem er hugsanlega set en uppgreftri er ekki lokið á byggingunni og endanleg túlkun því ekki komin á hreint.

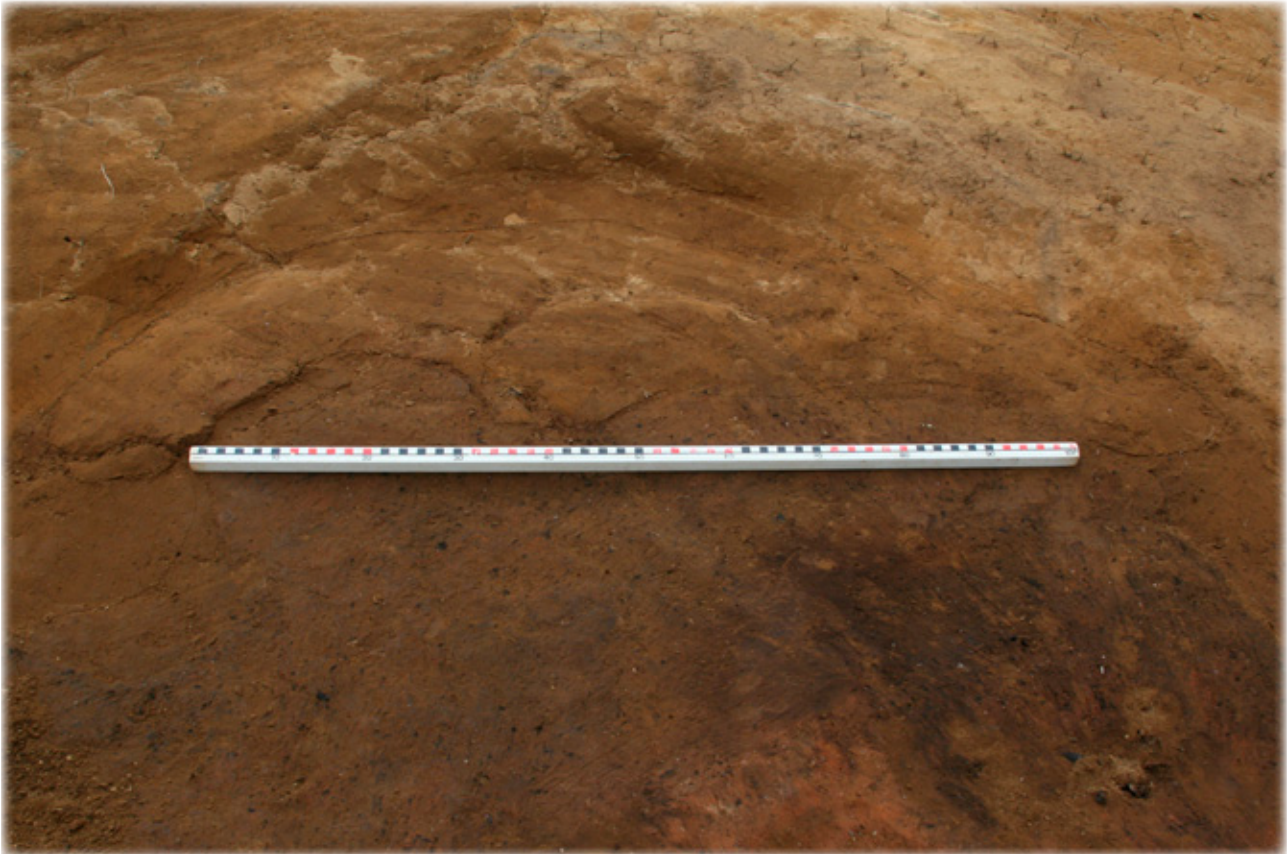
Gólflag [38170]

Nokkrir járngrípir fundust í mannvirki [20], þar á meðal naglar. Einnig fundust nokkur brot af bökunarplötum í eldra byggingarstiginu og í gólfösum IV, kolagólfi [38349] og moldargólfi [38170].

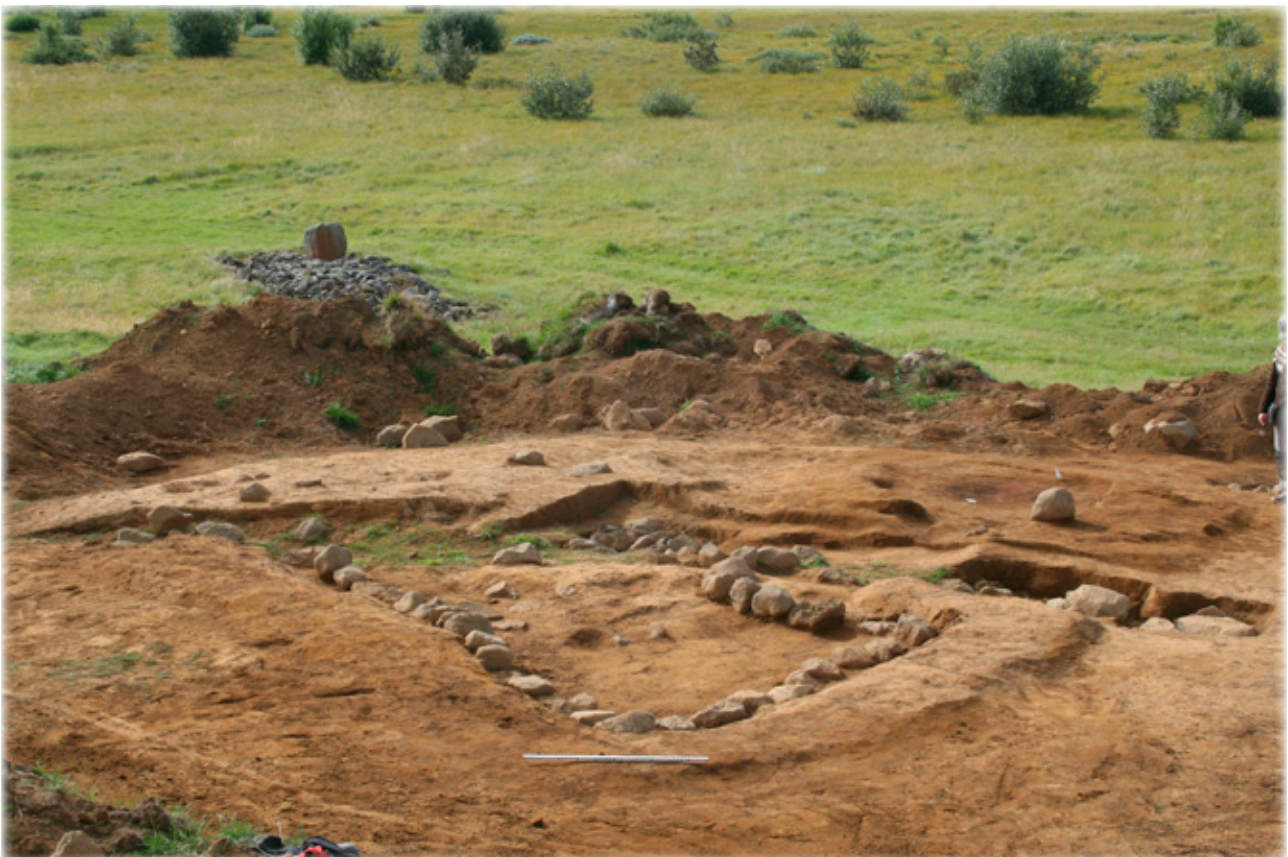
Mannvirki [21]

Tóftin snýr í norður-suður. Veggir hennar eru frekar vel varðveittir, sérstaklega norður- og austurveggirnir [320] (undirveggir [21007], [21037], [21073], [21110], [21145], [35776] og [35808]), og á mörgum stöðum má enn sjá hvernig torfið var uppbyggt. Þeir eru um 1,0-1,7 m á breidd, innihalda allir mikið af 1226

gjóskunni. Sumir voru byggðir með streng, aðrir hnausum eða klömbu og enn aðrir voru með sambland af þessu tvennu og hefur verið hlaðin innbrún úr steinum sem hefur verið ca. 30 cm á hæð en ekki eru neinir steinar í ytri brún veggjanna. Hleðslan upp við austurvegginn virðist þó vera eitthvað sigin inn í tóftina. Stór hluti vesturveggjarins og steinhleðslunnar sem líklega var þar er horfinn vegna 19. aldar stekkjartóftar [19] sem byggð var í mannvirkið. Inngangur er inn í tóftina og snýr hann í vestur. Hann er um 80 cm breiður.

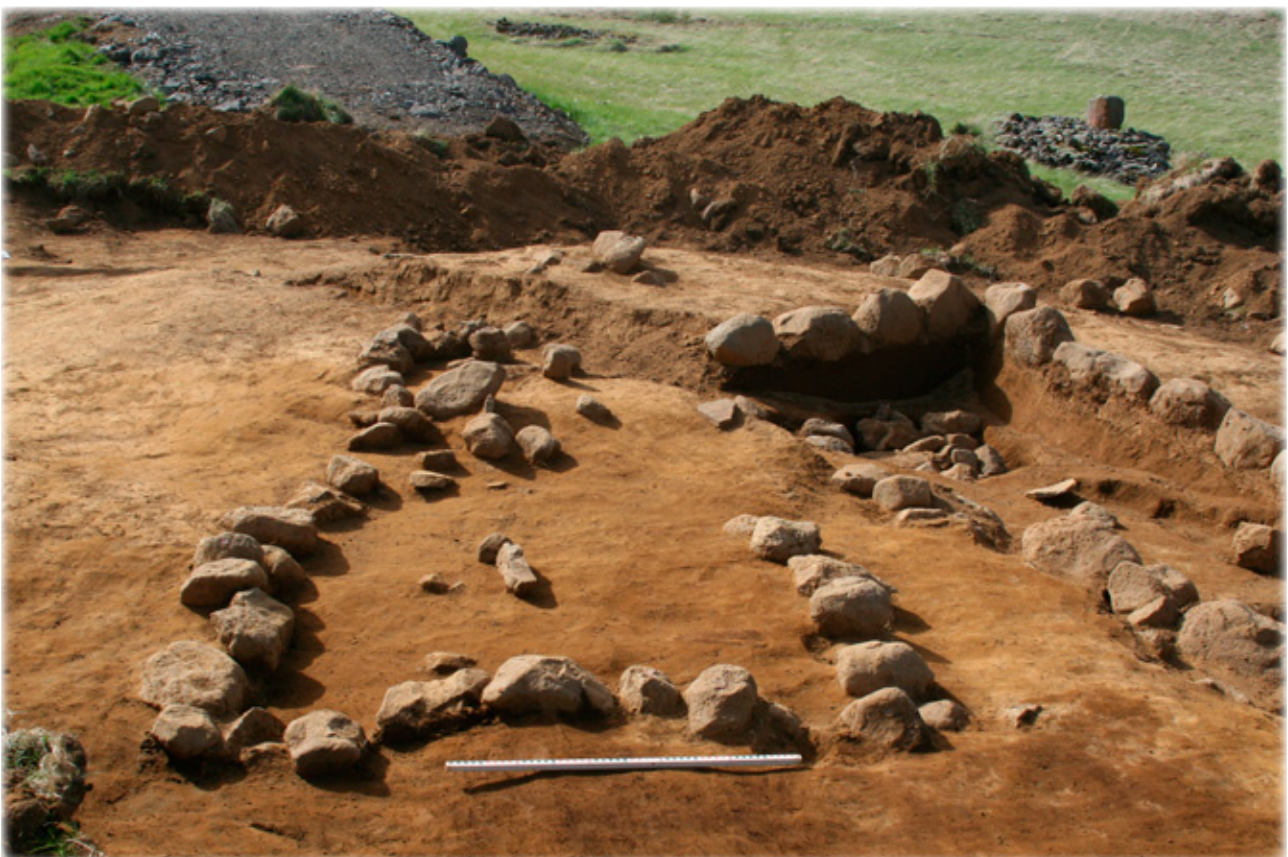
Jarðlög [21110] og [21145]

nokkuð lægra en veggir tóftarinnar og hefur verið túlkað sem hugsanlegt set. Ekki fundust leifar af setum í nyrðri hluta mannvirkisins. Veggirnir í þessari tóft eru óvenju þykkir ef borið er saman við mannvirki frá sama tíma á svæðinu, eldhús [20] og mannvirki á svæði A [12] og er þetta eina mannvirkið sem er með hlaðna innbrún úr steinum. Er ekki ósennilegt að menn hafi viljað einangra húsið vel ef það hefur átt að vera búr eða einhvers konar skemma þar sem matvæli voru geymd. Ekkert bendir til þess að þetta sé skepnuhús en bíða verður með endanlegar niðurstöður þar til tóftin er fullgráfin og öll sýni greind.

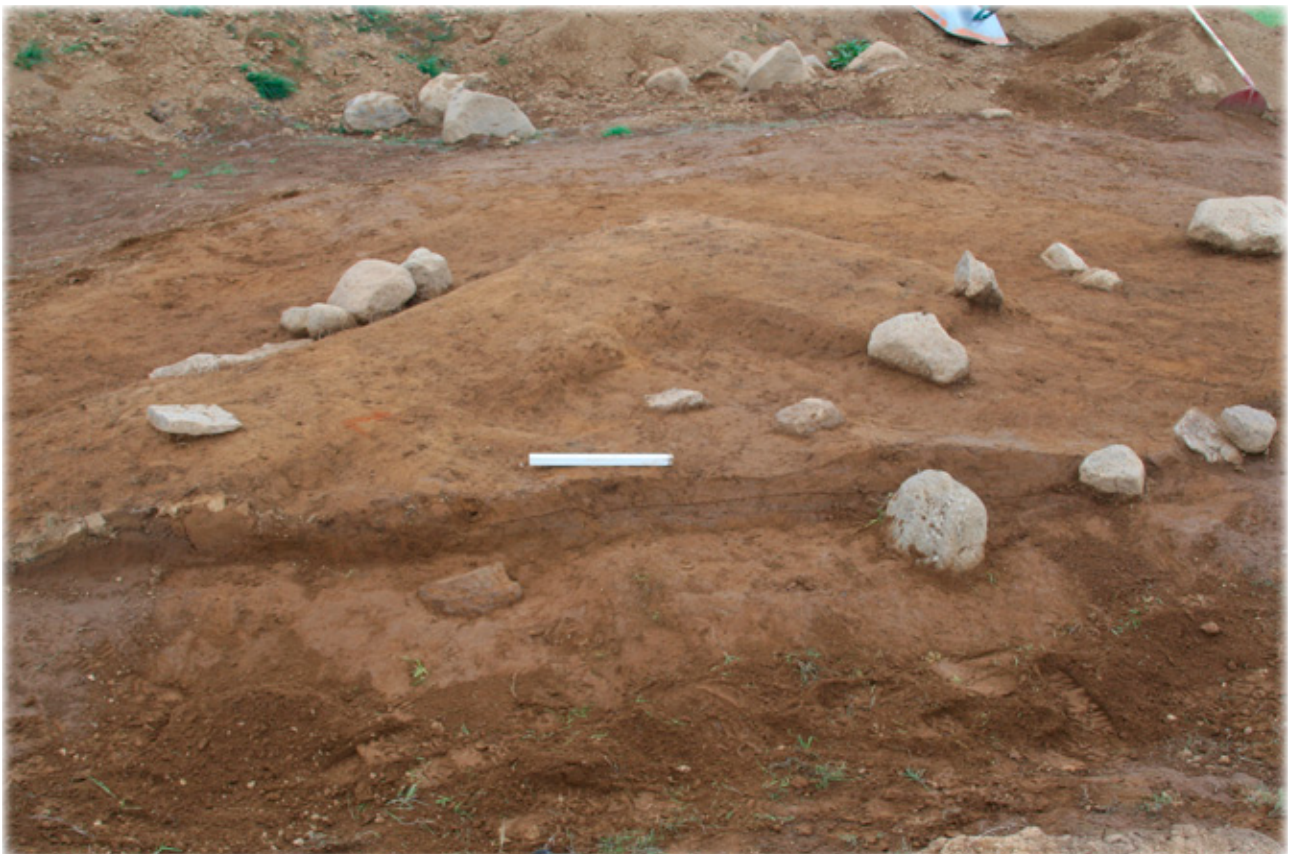
Torfveggir [321] og [322]

The turfwall [321] is on the south side of test trench [300] and it cuts through it and therefore it is not connected to turf wall [320]. [39443] is a part of the wall that looks a bit different from it. There is no structure in it and it looks more like a wall fill than a turf wall. It might have been a repair of some kind, especially since there is a line of stones, as a part of the outer wall. Stones on the outside have not been found in another place in house [21]. The wall has 1226 tephra in it. [321] is a bit different than [320] because it has this outer stone lines but not many structural stones along the inner side. The northwest end of the wall is up against the entrance of house [21] and on the other side of the entrance is turf wall [322].

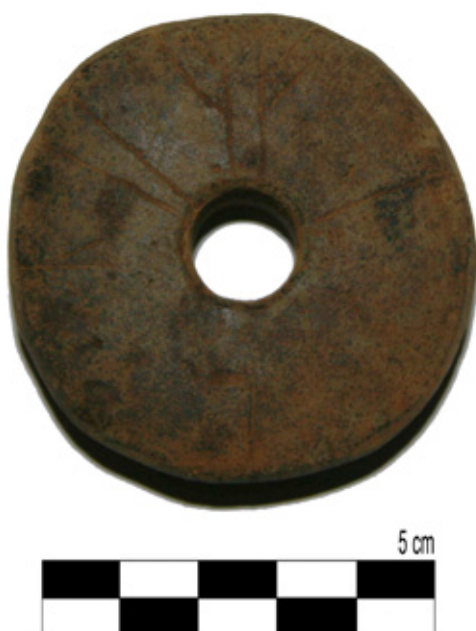
Meðal þeirra eru merkilegir gripir, fyrst og fremst snældusnúðar tveir, annar skreyttur og hinn með áletruðum rúnum. Fátítt er að finna gripi með rúnaristum á Íslandi. Auk þess hafa fundist tvær perlur frá 10. eða 11. öld, bökunarhellur, brýni, sennilega innflutt frá Noregi, járnhnífar, naglar og ýmsar bronsþynnur.

Snældusnúður með ristum rúnum

meðal snældusnúður með rúnaristum í torfvegg [321]. Tveir járngripir fundust í jarðlagi [19494], frekar ofarlega í rústinni. Tveir aðrir járngripir fundust í gólflagi [21987], einn í gólflagi [23456] og annar í gólflagi [34726]. Í gólflagi [39684], sunnan við könnunarskurð, fannst brot úr bökunarplötu. Í veggjarfyllingu í austurveggnum [22806] fannst einnig hluti úr bökunarplötu en hlutar af bökunarplötum hafa líka fundist í mannvirki [20], eldhúsinu.

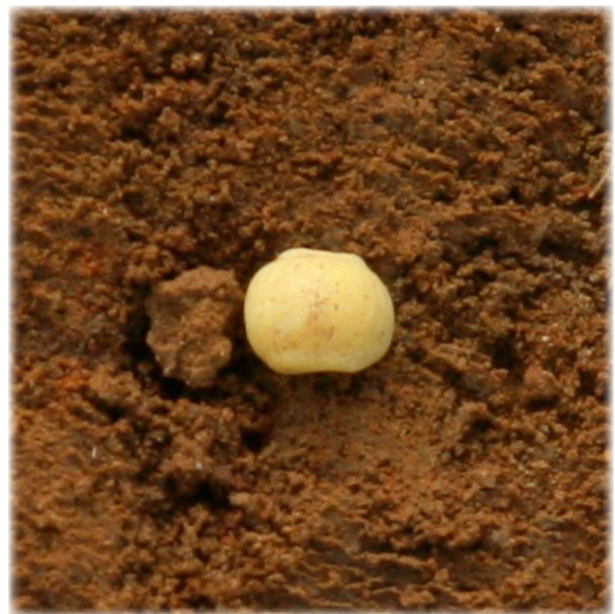
Perla sem fannst í fjósinu [15]

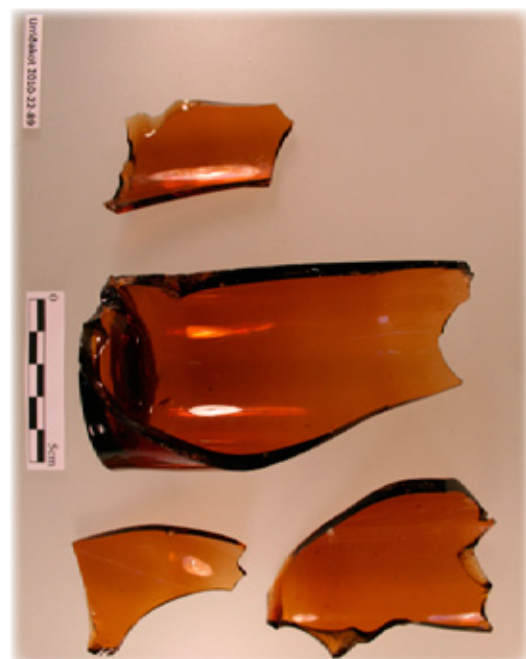
Brot af glerflösku sem fannst í stekknunum [19]
