Westfjords Natural History Institute

**Study of mass movement processes
on slopes above man made structures
in the Westfjord area.**

Thomas CHAREYRON

August 2001

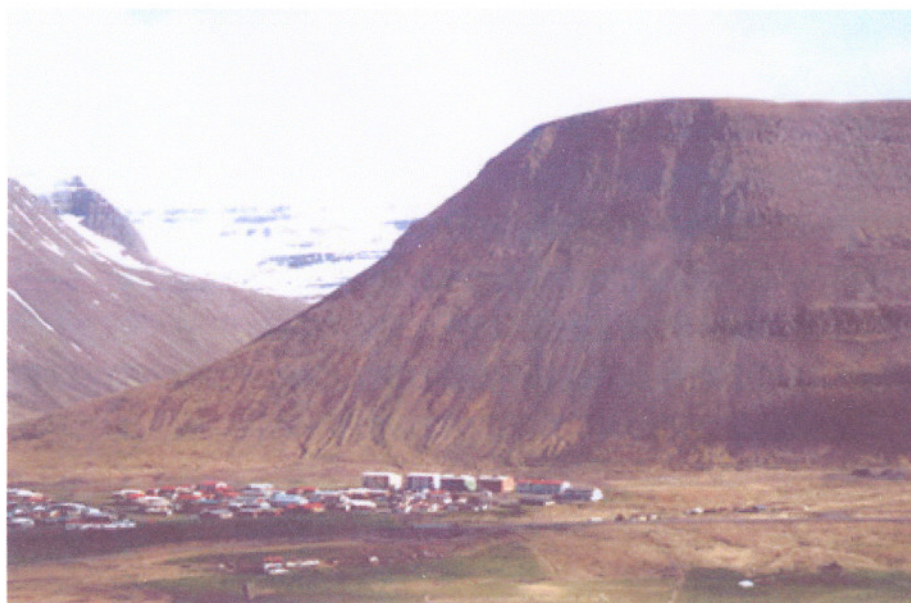
The studied slope extends between Kubbi to the edge of the residential quarter. In the upper third of the slope, the bedrock appears and forms an irregular and eroded cliff with gullies (Fig. 1 & 2).

Figure 2: Overview of Kubbi and Holtahverfi. The slope is facing north.

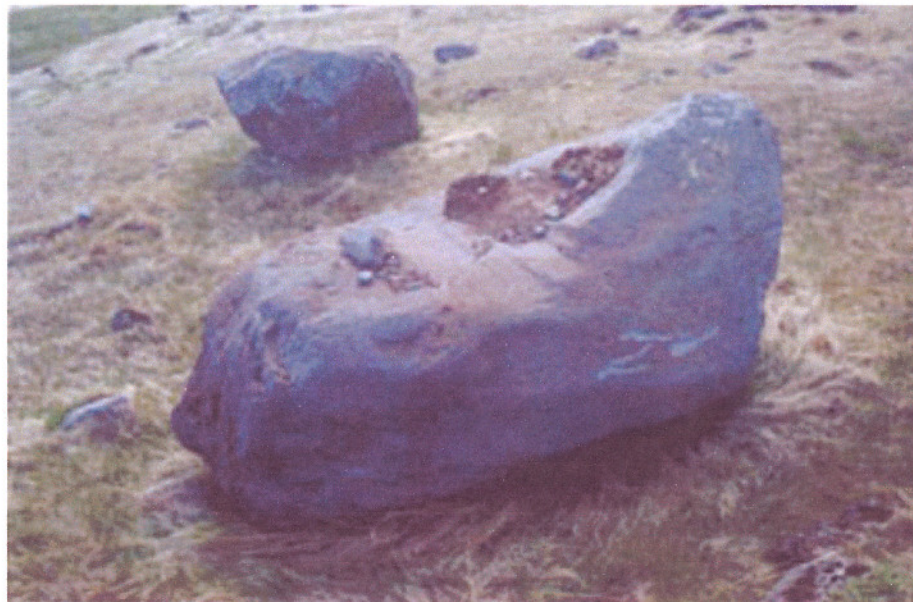
Northeastwards, the slope shows signs of much stronger erosion. The tracks 5 to 9 deeply cut the slope (see appendix, figure 26). They start from gullies dug in the bedrocks at the top of the Eyrarfjall mountain. The tracks are associated downhill with large colluviums. These colluviums coalesce each others, particularly 7 and 8. They are all covered by vegetation and have a fairly regular shape. Only small portions generally situated on the sides of the colluviums are not vegetated and dug by erosive channels. Scattered boulders and stones appear on the surface these colluviums and far downslope, down to the fjord. However most of them have been cleared in the lowest part if the slope as a result of development of roads, buildings and fields. Some finer deposits and sometimes scars can be observed on remote large boulders put on the ground surface (Fig. 3).

Figure 3: Fine grained deposits and scars on a remote large boulder put on the ground at the foot of the inner part of the Eyrarhlíð slope. The bigger boulder is about 2 m long. The picture is taken towards east. The Eyrarfjall mountain is on the right.

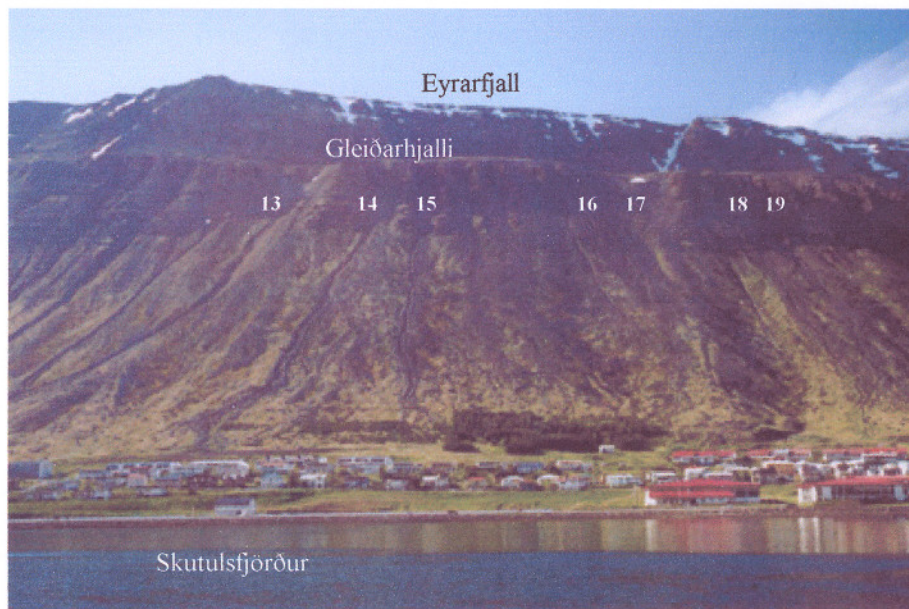
The slope of Eyrarhlíð is steep and is coming down from the levelled Eyrarfjall mountain (724 m.a.s.l.) and interrupted by the Gleiðarhjalli plateau (around 450 m.a.s.l.). See Fig. 1 & 4.

Figure 4: Overview of the inner part of the Eyrarhlíð slope interrupted by the Gleiðarhjalli plateau situated at about 450 m.a.s.l. In the background the top of the Eyrarfjall is at 724 m.a.s.l. Part of the Ísafjörður village lay along the fjord Skutulsfjörður. The picture is taken toward the northwest.

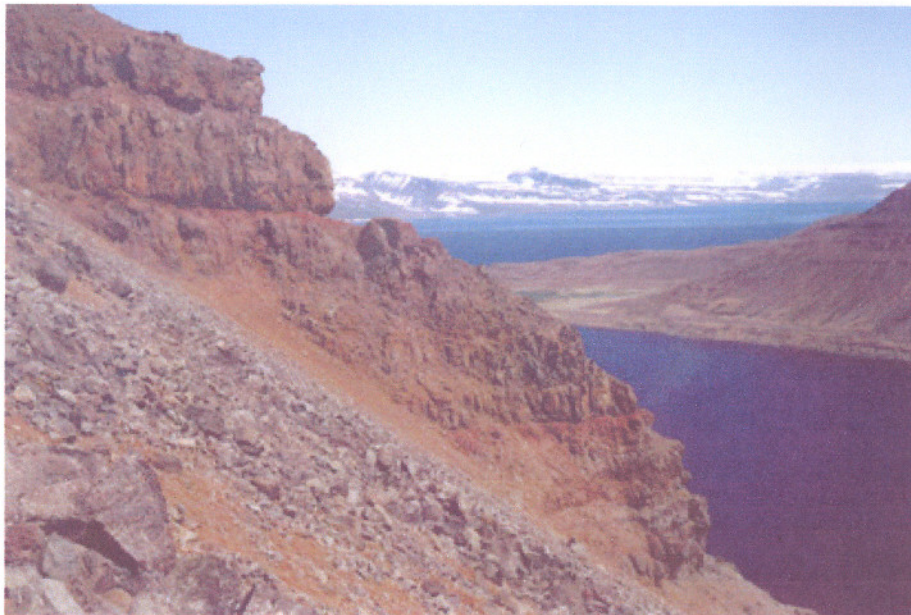
and delimited on the sides by vertical walls. Some isolated instable rocks are present. The erosion of the relatively narrow soft soil beds leads to overhanging ends of rockbeds layers (Fig. 6).

Figure 6: Escarpments presenting overhanging rocks, which result from erosion of the soft soil layers. The picture is taken from the gully 17, towards northeast.

Some rockfalls of minor importance can occur anywhere due to the weathering of the bedrock layers. Overhanging beds resulting from the erosion of the soft soil layers, isolated blocks with unstable looking and fractures are widespread. The material may eventually fall and settle in a debris flow or snow avalanche path and so be liable to be reactivated and therefore increase the supply of material involved.

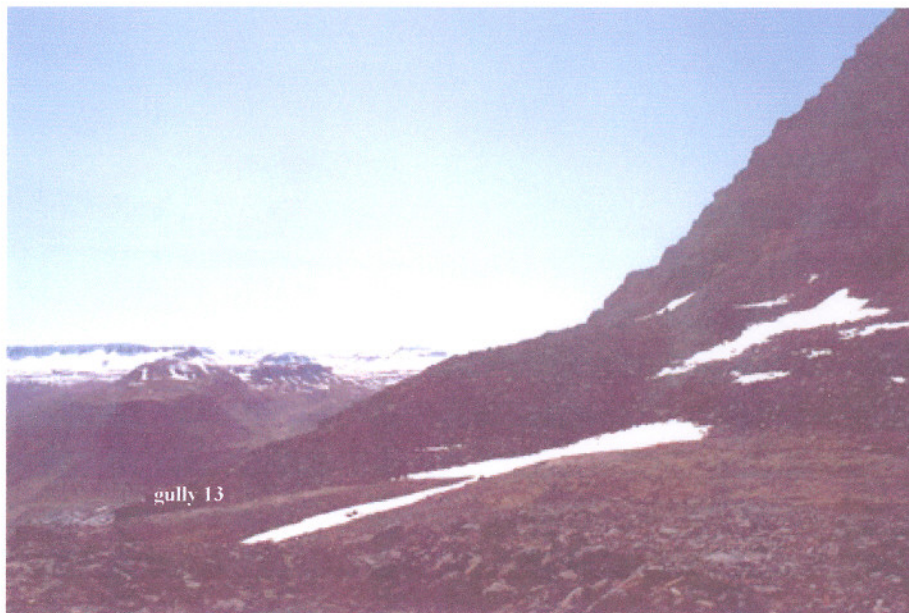
On the sides of the plateau, where it is the narrowest, scree from this cliffs reach the edge of the plateau (particularly the gullies 10 to 13) and are about to be involved again by landslides in the lower part of the slope due regressive erosion into the plateau, supplying important amount of large boulders (Fig. 7).

Figure 7: Western end of the Gleiðarhjalli plateau. Debris from the upper cliff extend down to the down slope limit of the plateau and can therefore be involved by landslides in the lower part of the slope by regressive erosion. The picture is taken towards southwest.

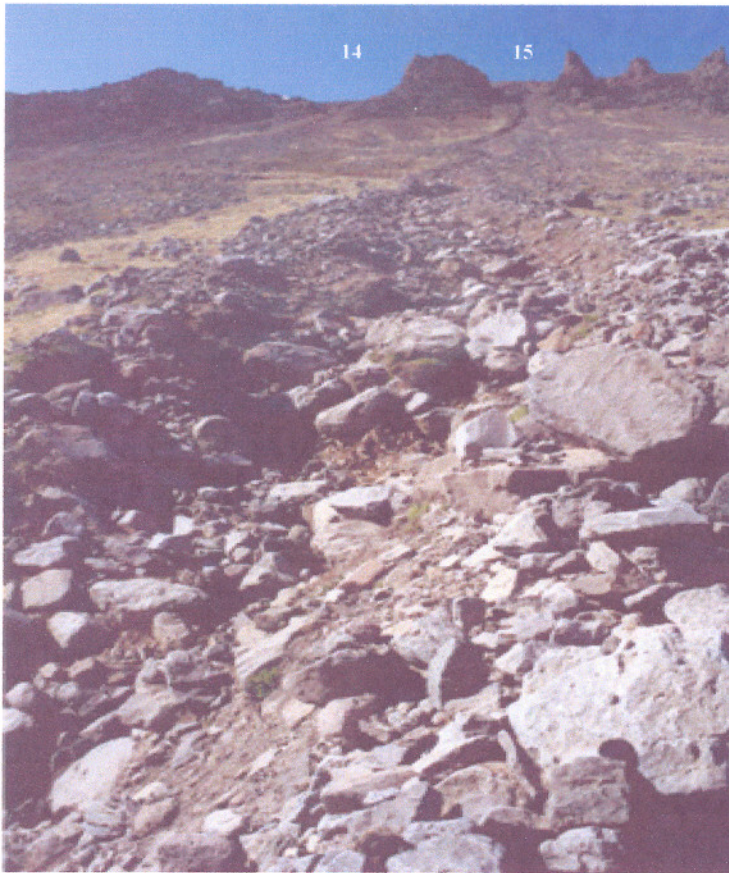
The rest of the slope itself presents different aspects. The westernmost part is travelled through by elongated tracks coming down from relatively short and wide gullies (10 to 16), some of them with lateral ridges or levées (Fig. 8). One even reaches the shield (ditch and debris-made wall) built along the upper inhabited limit. The debris lobes, when present, are smaller than the ones described for the inner part of Eyrarhlíð, without the plateau, in extend and in thickness alike. This part is relatively poor in scree and widely vegetation covered. The scree (particularly boulders) proportion increases eastwards where the non-affected, vegetated areas, are sparser, usually between the gullies axis. The vegetation cover gets more important as the distance from the source areas increases and the slope gets less steep. Scattered boulders sprawl at the foot of the slope. They are particularly sparse westernmost. They are numerous within and to the lower limit of a small forest situated at the lower part of the slope. The upper part of the forest shows signs of landslides effects (broken trees, areas lacking of tree opened on the upper forest limit...) but the rest of the forest is more or less undamaged, i.e. tall trees stand upstream of most of the boulders.

Figure 8: Erosive channel with levées downstream of the gully 15 on Eyrarhlíð.

The westernmost part of the slope (gullies 10 to 16) is dominated by debris flows. Most of the gullies present a channel with levées, sometimes very recent. These debris flows are able to reach the inhabited lower part of the slope, fortunately protected nowadays, as observed recently below the gullies 14 and 20. From the source area, or at least at the opening of the gullies, high on the slope, the path

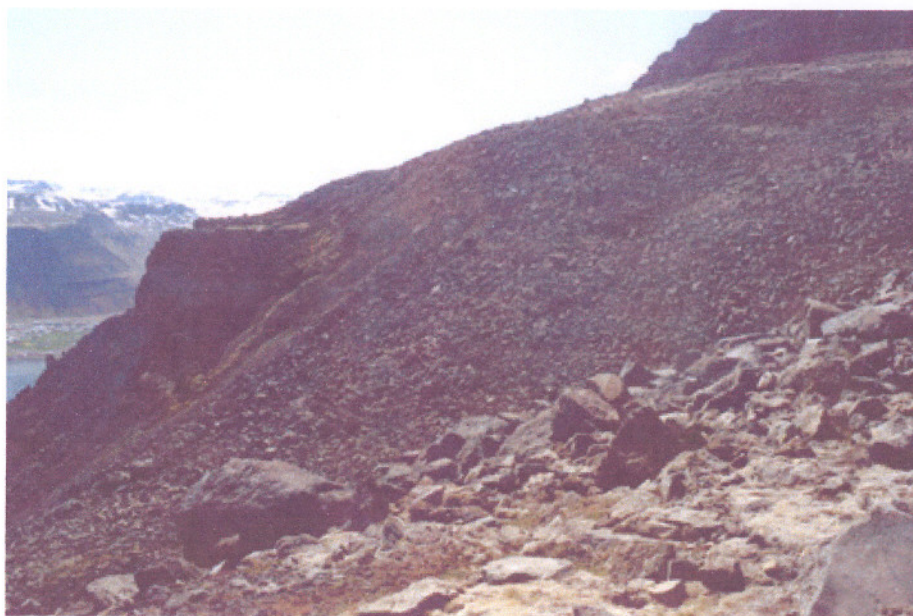
Centrally the wide gully 17 dominates a slope covered by scree (Fig. 9), often of large size (boulders), all the way to the foot of the slope and therefore creating a small hill with a steep front. On the western side, there are some channels but they don't originate from the same gully and look small compared to the quantity of the debris present.

Figure 9: Source area of the gully 17 at the limit of the Gleidarhjalli plateau. A large amount of boulders is present. The picture is taken toward southwest.

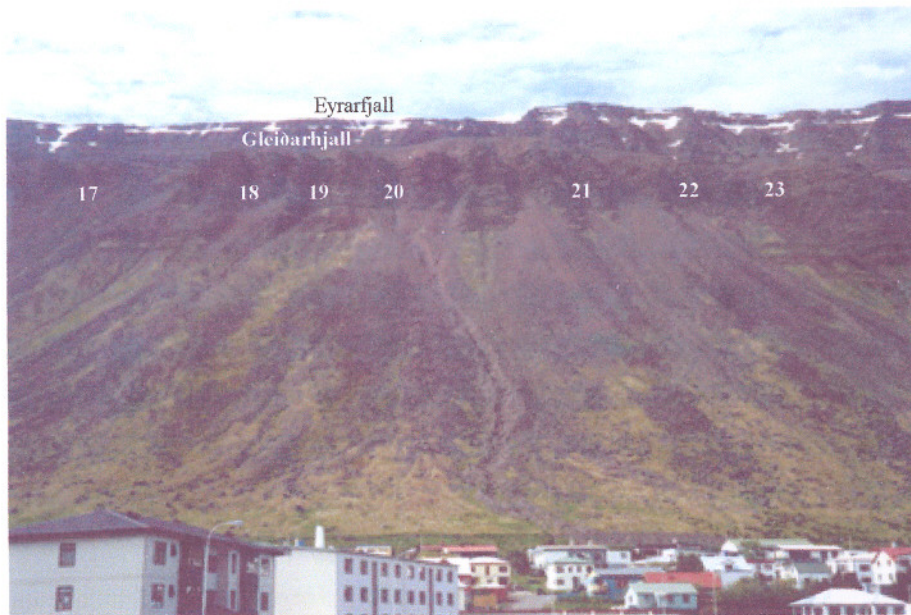
Then, northeastwards, the slope is quite similar that it was west of the gully 17 with a good proportion of vegetation-covered areas (Fig. 10). Large boulders are accumulated in some parts. The channel 20, with nice levées, reaches a shield protecting the houses (Fig. 10 & 11). Scattered boulders sprawl at the foot of the slope. One is encased in a print hollow.

Figure 10: Overview of the outer part of the Eyrarhlíð slope. The picture is taken towards northwest.

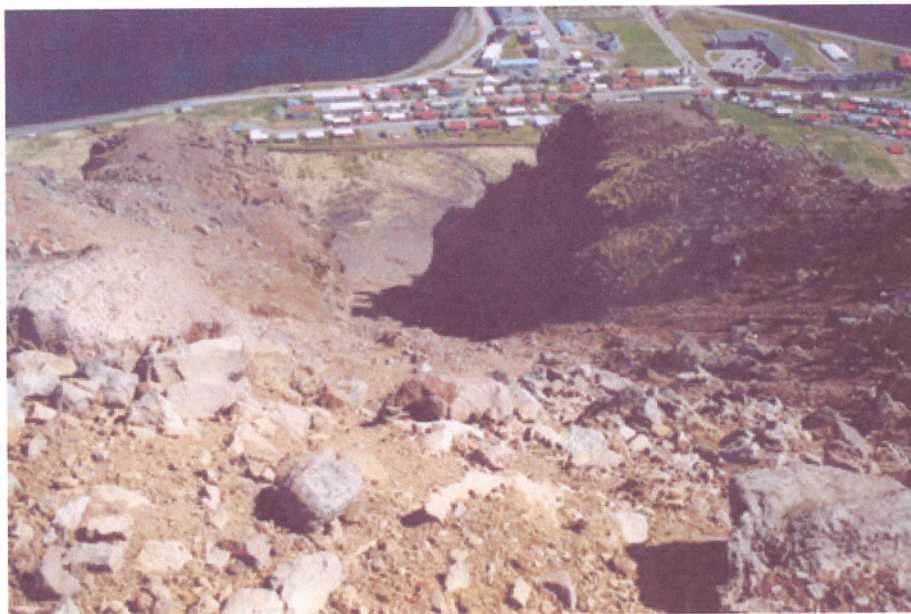
Figure 11: Source area and deep gully on the top of the lower part of the slope Eyrarhlíð. One can see the channel that reaches the shield along the upper houses of Ísafjörður. The picture is taken towards southeast.

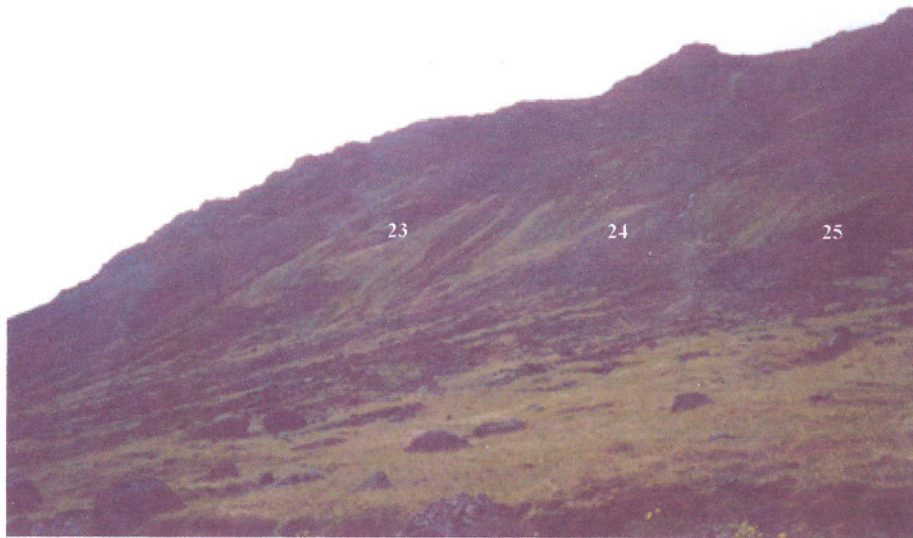
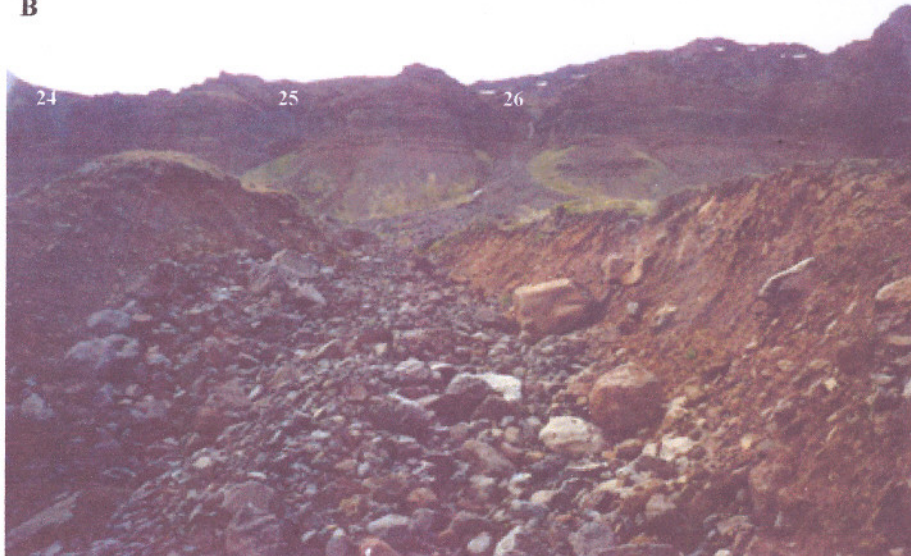
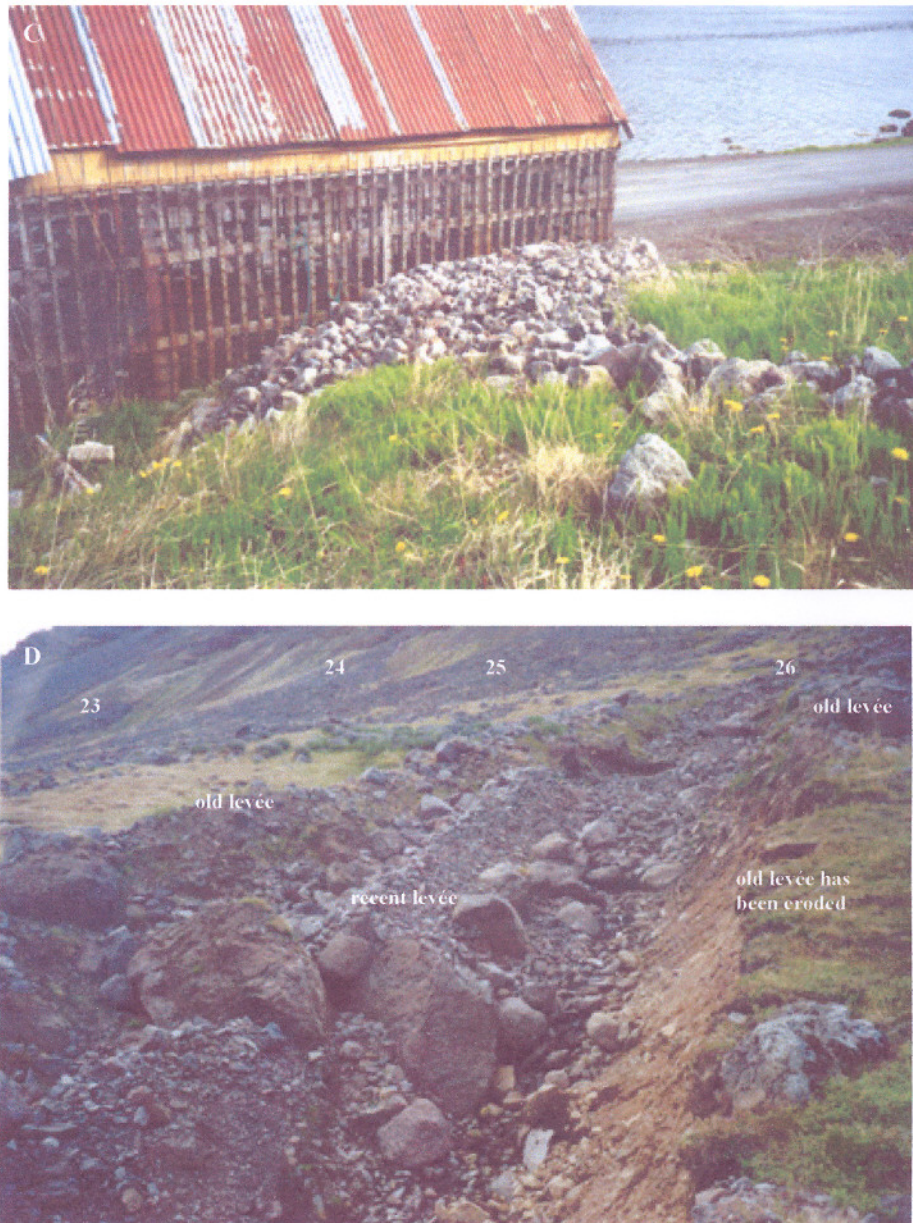
Figure 12: (A) Different morphological aspects between the convex upwards fan 23 and one of the concave upwards fans (24); (B) Large channel (4 m wide) below the fourth colluvium 26; (C) Levées which had reached the road and a building downstream of the colluvium 26. The lower end of the roof is at about 2 m above the initial ground surface level and 50 cm above the new surface; (D) Several successive channels along the same track 26. The two large boulders are about 2 m long.

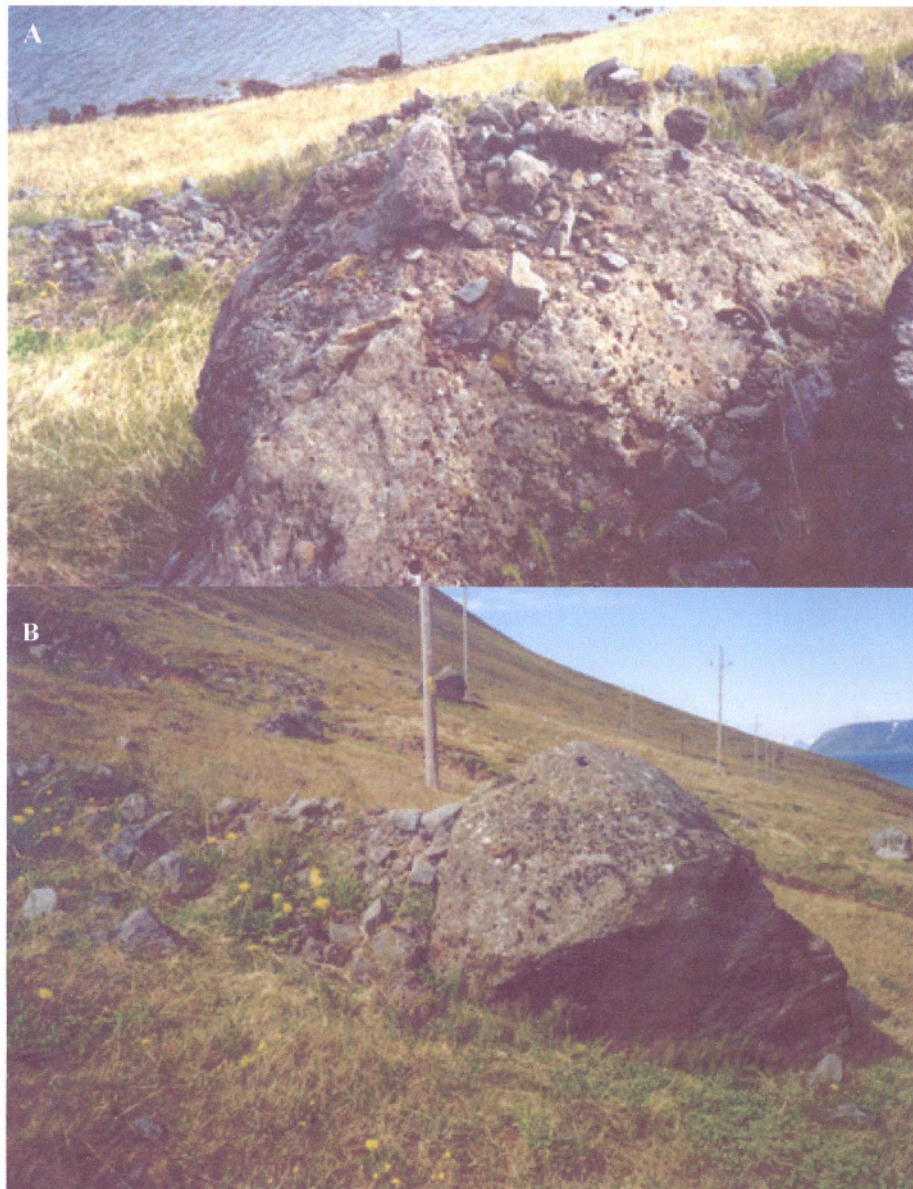
A large number of scattered boulders, sometimes very big, occur all the way down, even to the fjord water in the axis of the small gullies. However these boulders are more dispersed especially as the distance from the source area increases. Smaller debris lie on some of the boulders and some boulders present scars. A triangular deposit of debris “debris horn” lies above a small boulder (Fig. 13 A & B).

Figure 13: (A) Boulder on the ground and covered by finer debris, between the tracks 25 and 26; (B) “Debris horn” above of a boulder. On the two pictures, the photo film box on top of the boulder is 5 cm long.

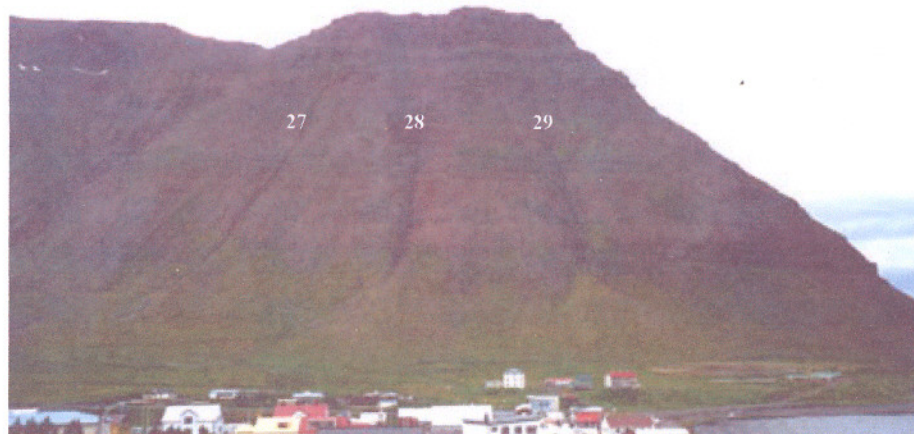
The slope is regular and with three elongated tracks each opening on a colluvium (Fig. 14).

Figure 14: Overview of the south-facing slope above Hnífsdalur. The top of the mountain is at an altitude of 647 meters and the sea appears in the right-low corner.

The studied slope in the Hnífsdalur valley is facing southeast and therefore liable to accumulate important amount of snow under conditions of prevailing wintry wind, even if the accumulation areas are narrow. Therefore snow avalanche activity is high on this slope where debris flows also occur.

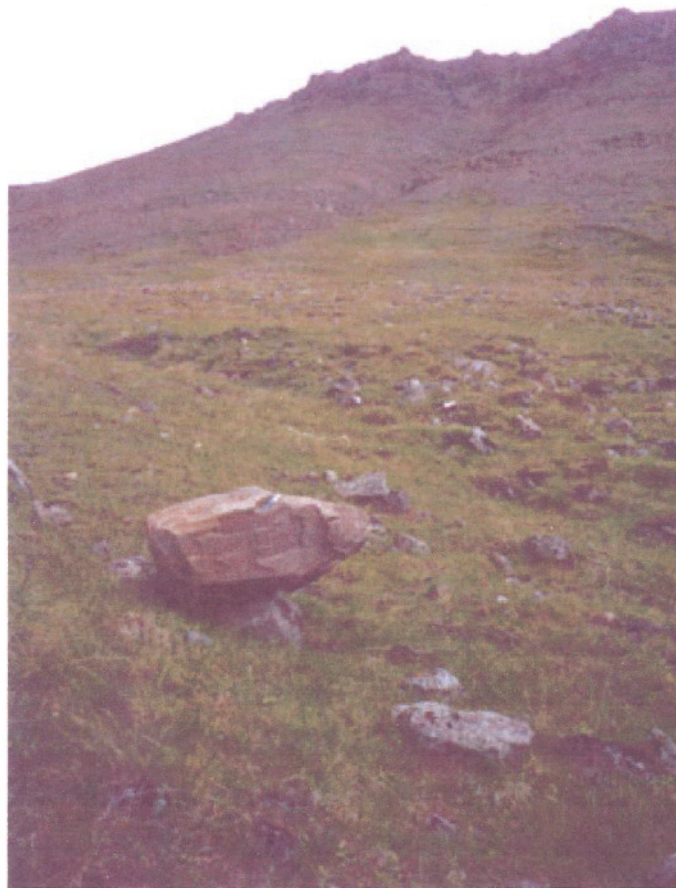
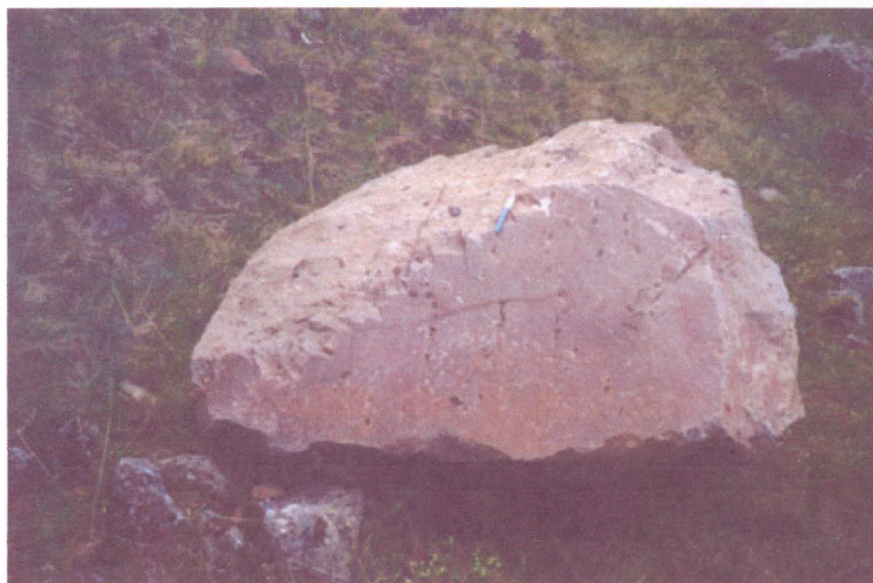
Figure 16, cont.: (B) Boulder along the outer limit. Pen for scale; (C) Close-up of the same boulder. Finer debris lay on its upper surfaces. Pen for scale.

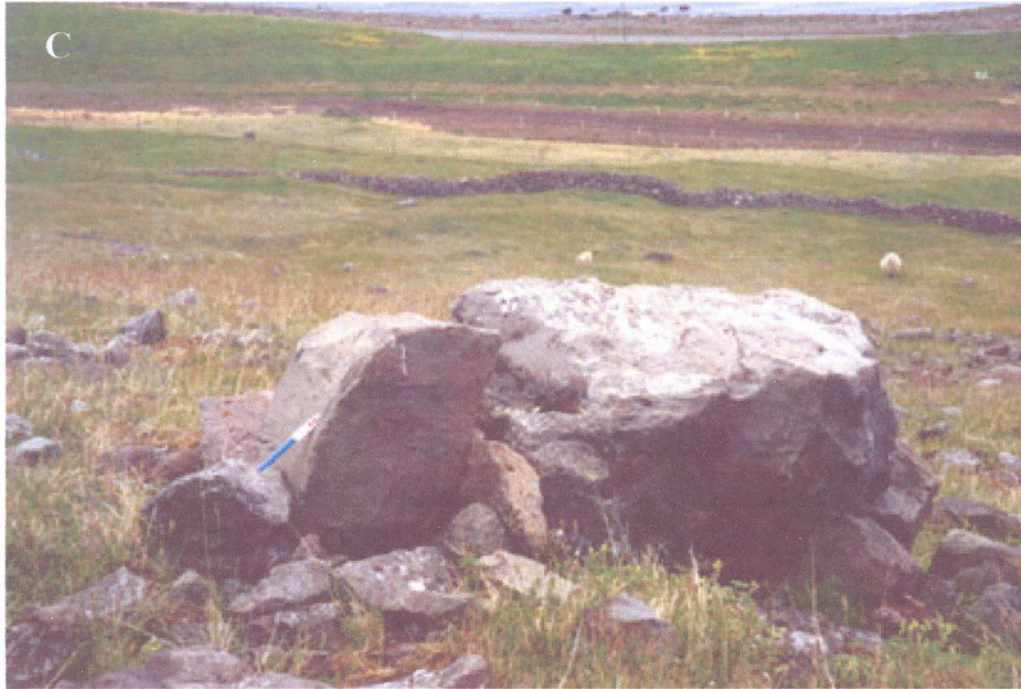
Figure 18, cont.: Colluvium 29 in Hnífsdalur; (C) “Debris horn” situated in the area of the colluvium presenting traces of channels. Pen for scale.

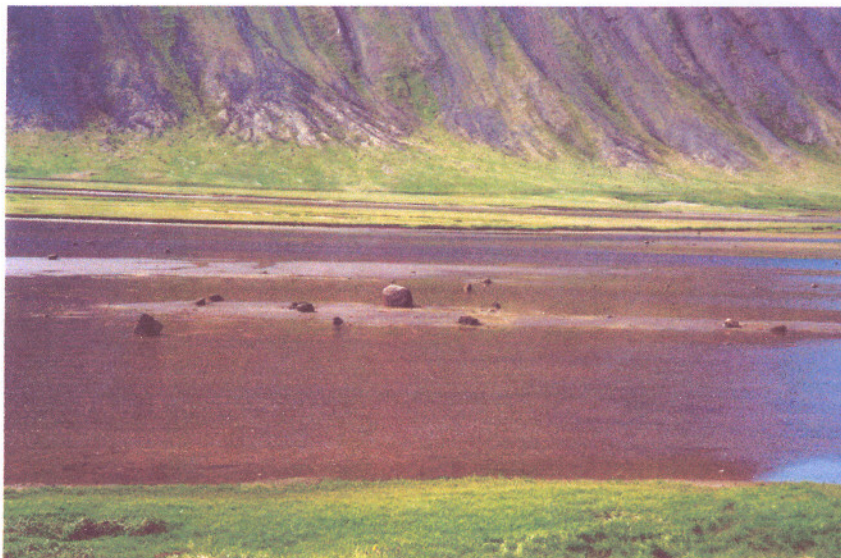
In the second sector, the slope is interrupted at about a quarter of the way by a narrow and almost flat strip underlined by a massive layer of rockbed tilting southeastwards. This sector is the most vegetated of the five. The vegetation covers the lower three quarters of the slope, expanding high on the slope up to the massive layer and also above the flat strip even if this part is mainly covered with scree and smooth. On the lower part of the slope, one can distinguish some small-vegetated tracks. The lowest part of the slope is steeper than it is at the same level in the other sectors due to debris which are however well vegetated (greener than anywhere else). At the foot of the slope boulders are scattered and some of them, sometimes big, lie in the water far in the lowlands (Fig. 18).

Figure 20: Boulders on flat land, in the water downhill of the fourth sector. The picture is taken towards southwest.

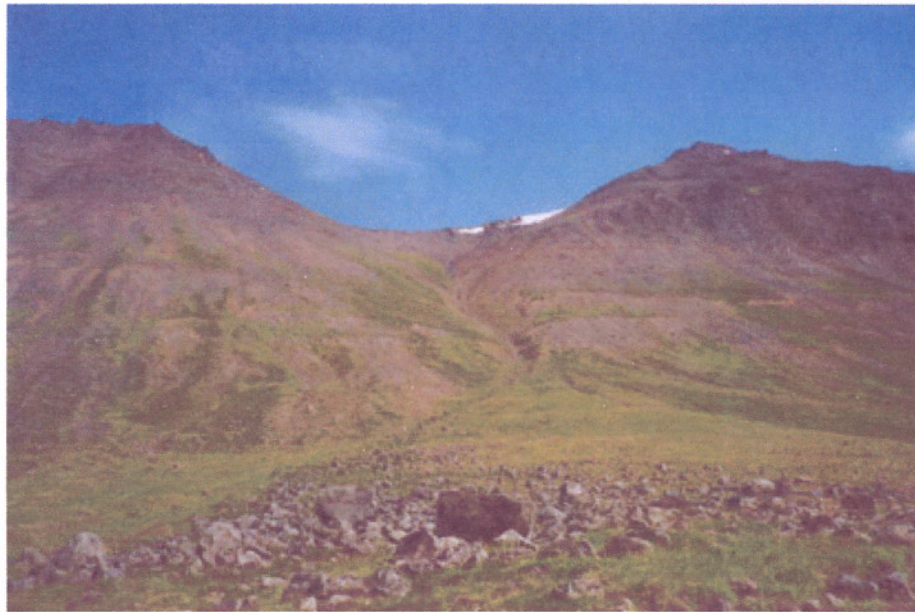
The fourth sector, Urðarskál, is a bowl-shaped source area with a lot of material (stones, boulders) when it gets narrower, and an open channel presenting one large undulation (Fig. 19). The western side is particularly open and is vegetated. The large lobe ends progressively eastwards with vegetation whereas it ends with steeper “front” westwards with boulders. The channel follows the outer edge and is vegetated. The lobe reaches the lower part of the slope, almost flat, close to the fjord water. It extends large compared to its thickness. The slope is about the same as it would be without the lobe. No visible channel is near but a small old and vegetated track is visible on the eastern side. Its surface is regular and smooth with boulders on it. There are more boulders in the distal part, some are quite big (2 metres). The limits are sharp with accumulation of a lot of boulders ending abruptly, even if a couple of boulders lay further down on flat land.

Figure 21: Urðarskál. Bowl-shaped source area and large lobe, which end progressively eastwards with vegetation whereas it ends with steeper “front” westwards with boulders. The picture is taken towards northeast.

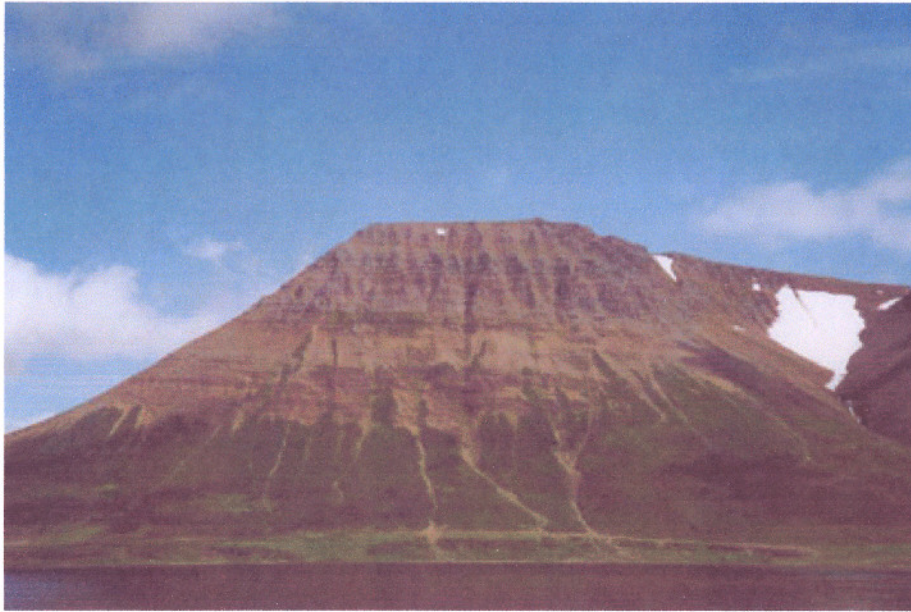
The westernmost sector shows a sharp contrast between the densely vegetated lower part and the bare higher part.

Figure 22: Overview of the westernmost sector of the Lambadalshlíð slope between the edge of the Lambadalsfjall (550 m.a.s.l.) and the Dýrafjörður fjord. The picture is taken towards the northeast.

The first sector is affected by snow avalanches, as showed by the boulders on bushes or in the fjord and broken trees. The tracks result from debris flows, which go across the road down to the fjord where the colluvium is. Rockfalls can occur from the bedrock on the upper part of the slope.

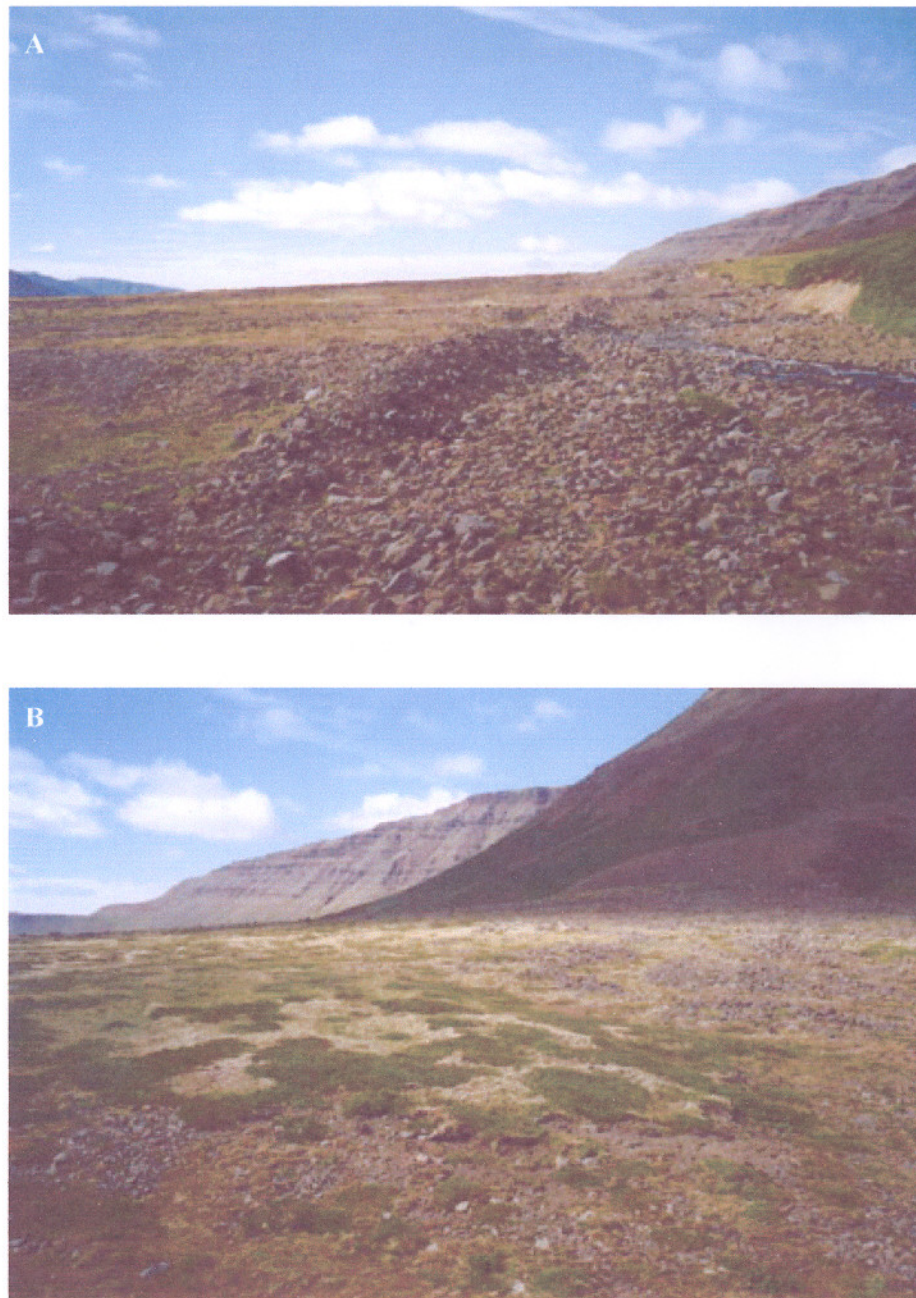
The colluvium in Valseyri is very large and progrades far into the fjord with a very gently slope, forming a large half disc prograding in the fjord (Fig. 21). Some parts are vegetated and boulders are present on the surface. The more proximal part of the colluvium is covered by large stones and looks like a secondary lobe (Fig. 22D). The river flows along the eastern edge, eroding the material from the slope (Fig. 22A). Levées are deposited along the inner side of the river. Then towards the west, the colluvium surface is bumpy, presenting old and vegetated tracks of channels and levées with stones (on the right on Fig. 22B). The relief is fading out but is still obvious. No boulder is present. Then the colluvium is smooth and vegetated by mosses and herbs (on the left on Fig. 22B). No boulder and even no stone is visible. In the central part, some more recent channels form a web less dense than the previously described (Fig. 22C). Some of the channels go through the road all the way to the fjord. Stones are present on the levées and in the bottom of the channels. On the western half of the colluvium, first no channel is present but bushes and boulders are (Fig. 22D), and then in the outer part, channels with levées of stones occur again but vegetation returns the area and boulders are absent. Vegetation around consists of mosses, bushes and herbs. Boulders and stones are put on the surface. Some of the boulders are quite large (2 meters) and far on this very gentle slope.

Figure 24: Different aspects of the large Valseyri colluvium. From the East to the West: (A) river along the western edge of the colluvium with levées and erosion from the slope. The picture is taken towards northwest; (B) Transition between an area with old and vegetated tracks of channels and levées (right) and a smooth and well a vegetated area (left). The picture is taken towards north-northwest.

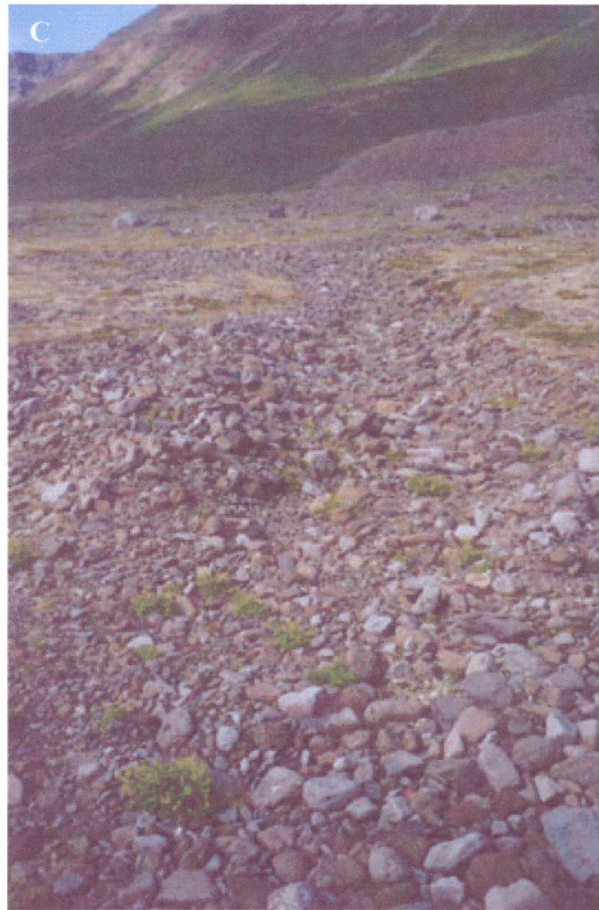
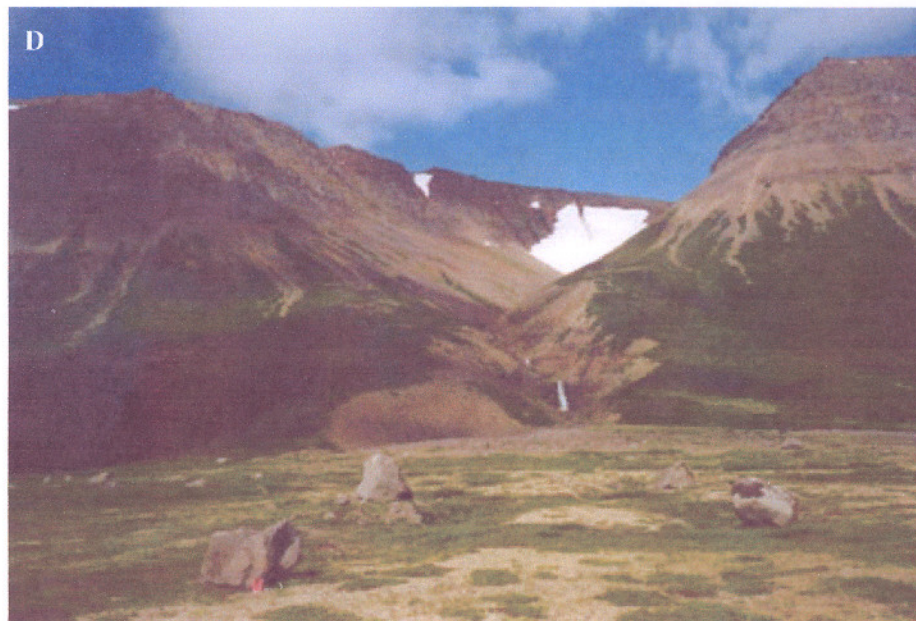
Figure 25, cont.: Different aspects of the large Valseyri colluvium. (C) Central part with a web of channels more recent but not as dense as on (B left). The picture is taken towards north; (D) Smooth and well vegetated area with large boulders. The notebook is 20 cm high. The picture is taken towards northeast.

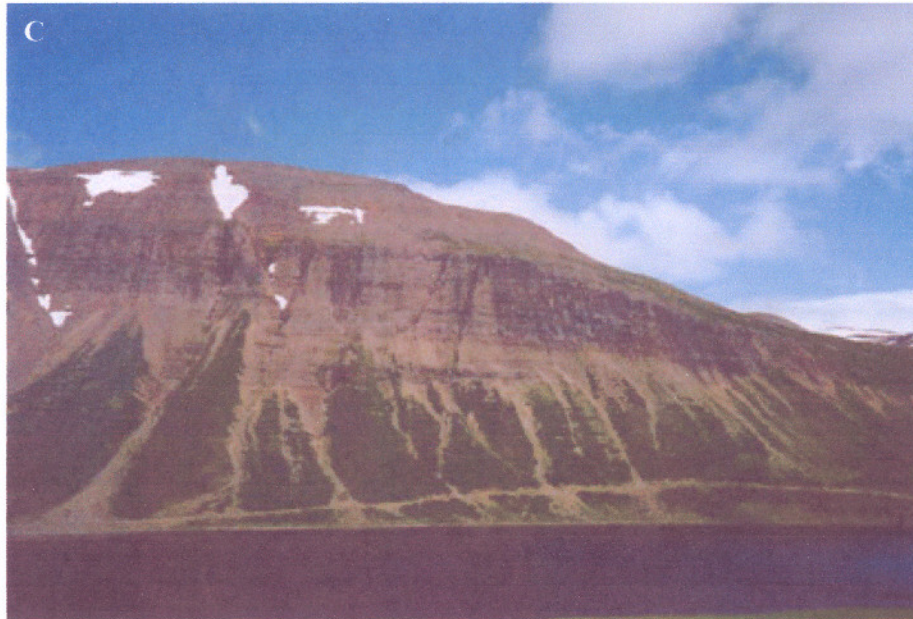
Figure 27, cont.: Overview of the third sector of the Lambadalshlíð slope, from the West (A) to the East (C). The channels get more and more frequent eastwards and are the widest centrally. The picture is taken towards northeast (A and C) and north-northeast (B).

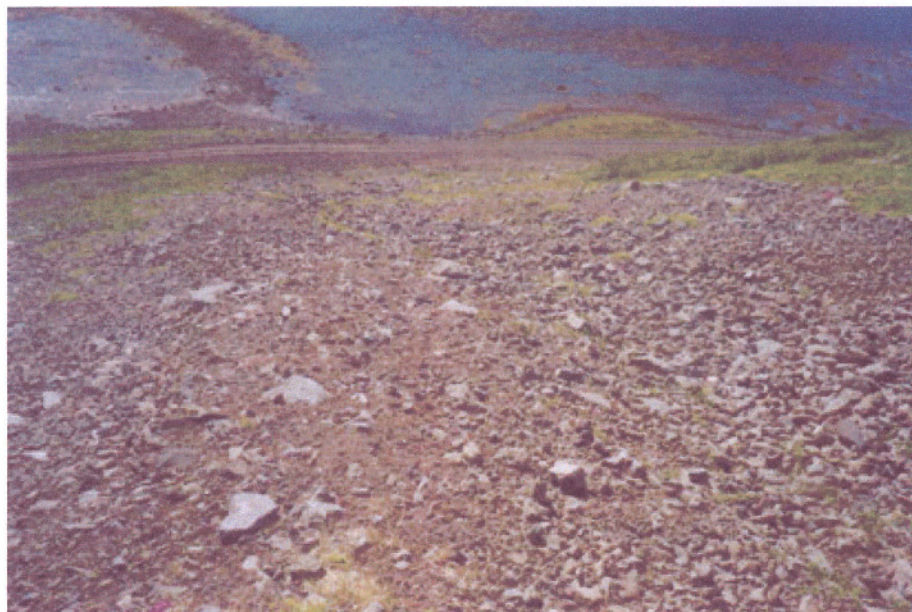
Channels, with very variable width but in the mean quite wide, are scree covered and associated with small lobes slightly prograding onto the fjord. Boulders are scattered, sometimes in the fjord water. Above the fjord is one lobe with stones and vegetation. In the tracks the stones show impact scars. Vegetation is present. Some kind of levées of fine debris and undulating channels filled with stones are observable (Fig. 24).

Figure 28: Detail of the low part of a track in the third sector of the Lambadalshlíð slope. Note the prograding lobes in the fjord. The picture is taken towards southeast.
