ÞÓRISVATN

GEOLOGICAL REPORT

Volume II

February 1970

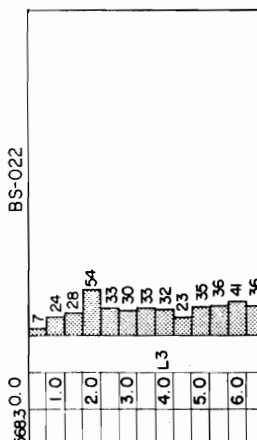
Hæð E Ft Mys	Dýpi Depth M	Skýringar Legend	Högg á Blow per 0.5m
5683.0.0	1.0		17
	2.0		24
	3.0		28
	4.0		54
	5.0		33
	6.0		30
	7.0		33
	8.0		32
	9.0		23
	10.0		35
	11.0		36
	12.0		41
	13.0		36
	14.0		40
	15.0		32
	16.0		36
	17.0		40
	18.0		32
	19.0		36
	20.0		41
	21.0		40
	22.0		32
	23.0		36
	24.0		40
	25.0		47
	26.0		82
5577.10.6	27.0		40

Staðsetningar, sjá fylgiskjal 3.12 og 3.14
Locations, see Exhibits No. 3.12 and 3.14

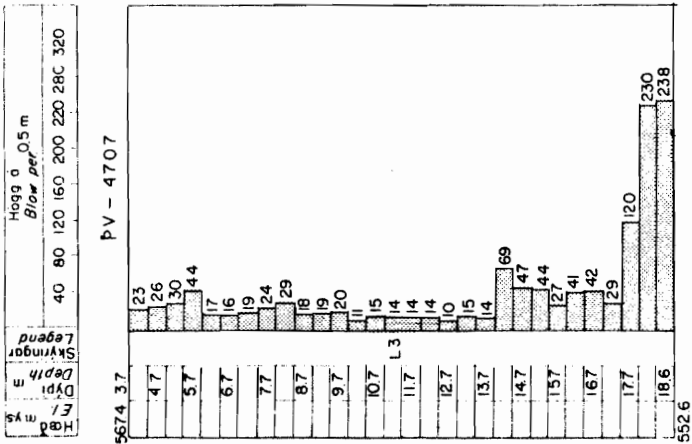
LANDSVIRKIJUN
 The National Power Company
 VERKFRÆÐISTOFA SIG THORODDSEN S/F
 Thoroddsen and Partners
ORKUSTOFNUN
 ÞORISVATN VATNSFELL
 Borro - borholur PV 4100-4310
 Borro Soundings
 Nov 59 HT/P Tr 53
 Bl. 3 of 4 Bb 5.333 Fr 9079

Skýringar, sjá fylgiskjal 3.28
 Staðsetningar, sjá fylgiskjal 3.12
 Legend, see Exhibit No. 3.28
 Location, see Exhibit No. 3.12
