**X-Ray diffraction analysis of deposits from
the Fuji 30 MW turbine at Svartsengi,
Iceland**

REPORT
Sþ-SSJo-MÓ-2002/01a
21 June 2002

Report for: Hitaveita Sudurnesja
Authors: Sverrir Thorhallsson
 Sigurdur Sveinn Jonsson
 Magnus Olafsson
Date: June 21st 2002.

X-Ray Diffraction analysis of deposits from the Fuji 30 MW turbine in OV-5 at Svartsengi

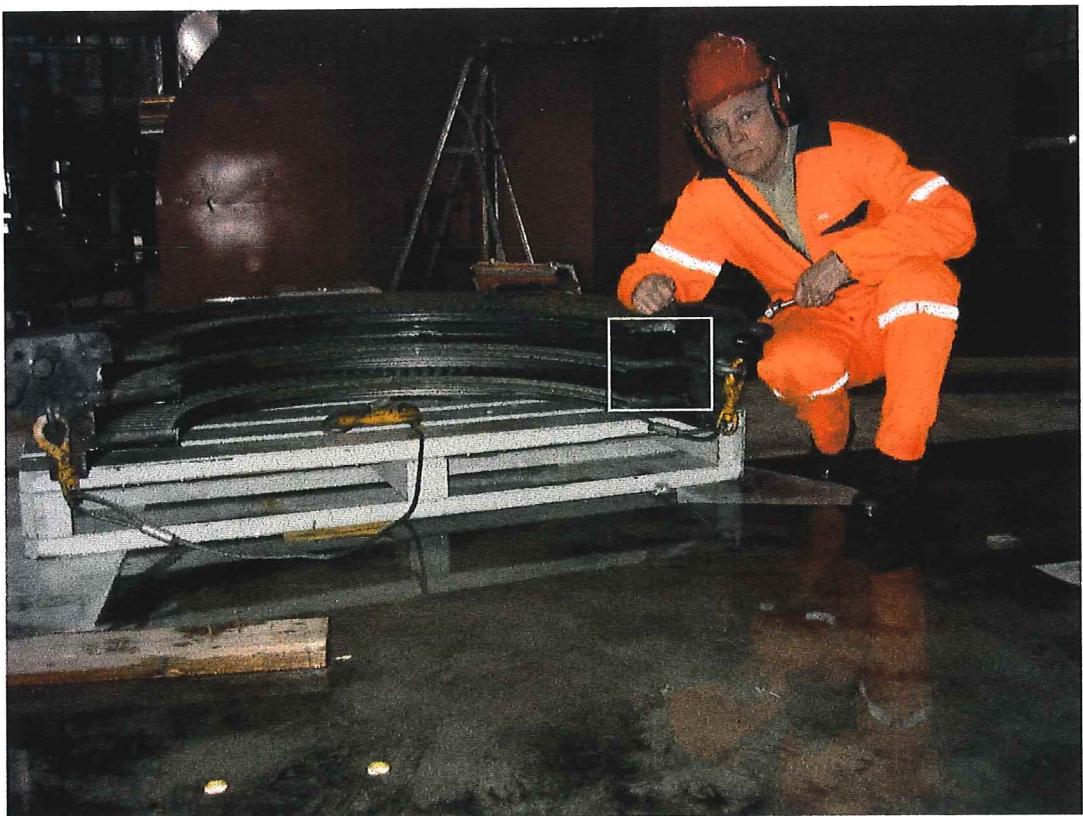
Figure 1. Blade holder #1 where samples #1 and #2 were collected.

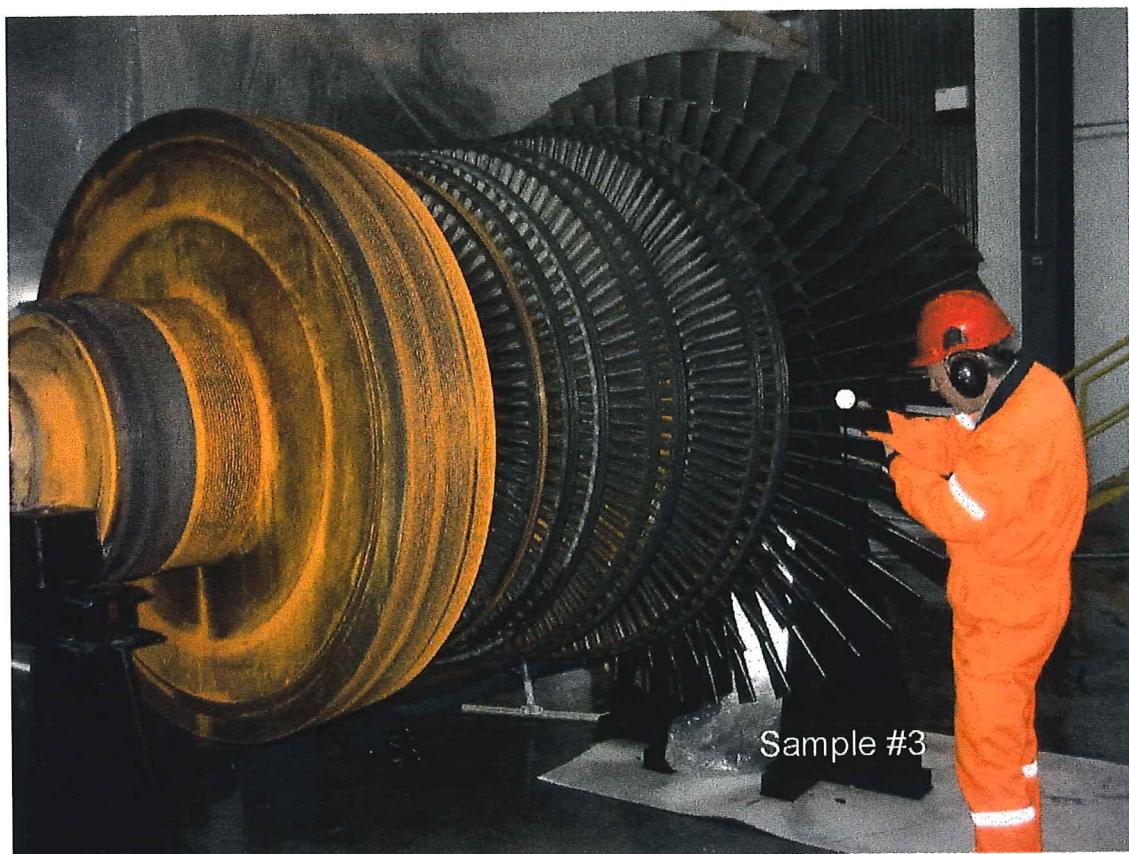
Figure 4. Turbine rotor after washing. Sample #3 was a very – very thin film from the 8th stage.

Sample scraped from the back of moving blade of stage 8. A very-very thin crust was collected from the blade, but previously the blade had been washed with high-pressure water. A very high background is an indication of a very high iron content, and peaks for iron compounds are present (magnetite Fe_3O_4 , pyrite FeS_2 , pyrrhotite FeS) similar to sample #02.

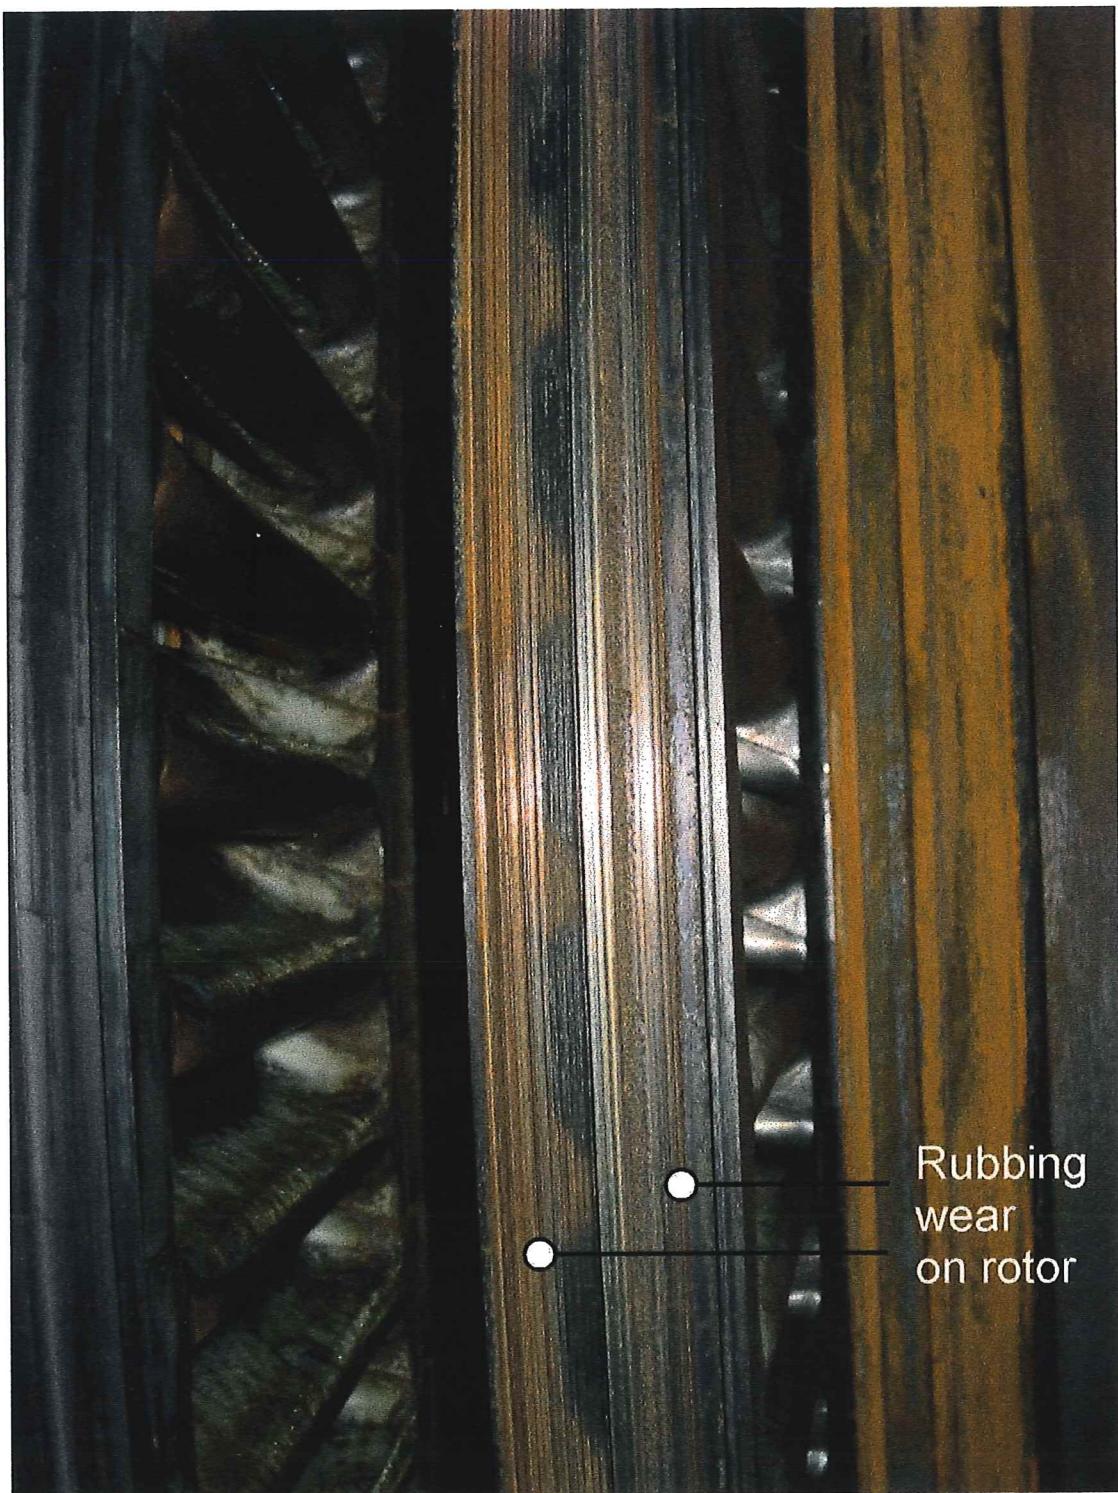
Figure 5. Rotor wear on 1st stage shroud opposite the sealing fins where sample #2 is taken.
Photograph taken after initial high-pressure water washing of turbine rotor.

Sample taken in sealing fins opposite the tip of the first turbine stage (moving blades) (Fig 2). The shroud of the first stage was worn down (Fig. 4). The sample is moderately crystallized, showing rather high background radiation due to a high content of iron, but the bulk of the sample is a mixture of iron-compounds, mostly iron oxide (magnetite Fe_3O_4 , magnetism not confirmed) but iron sulfides FeS and FeS_2 are also present. The iron could be on some other oxidation state. One peak from anhydrite CaSO_4 is present but carbonates are absent and so is amorphous silica.

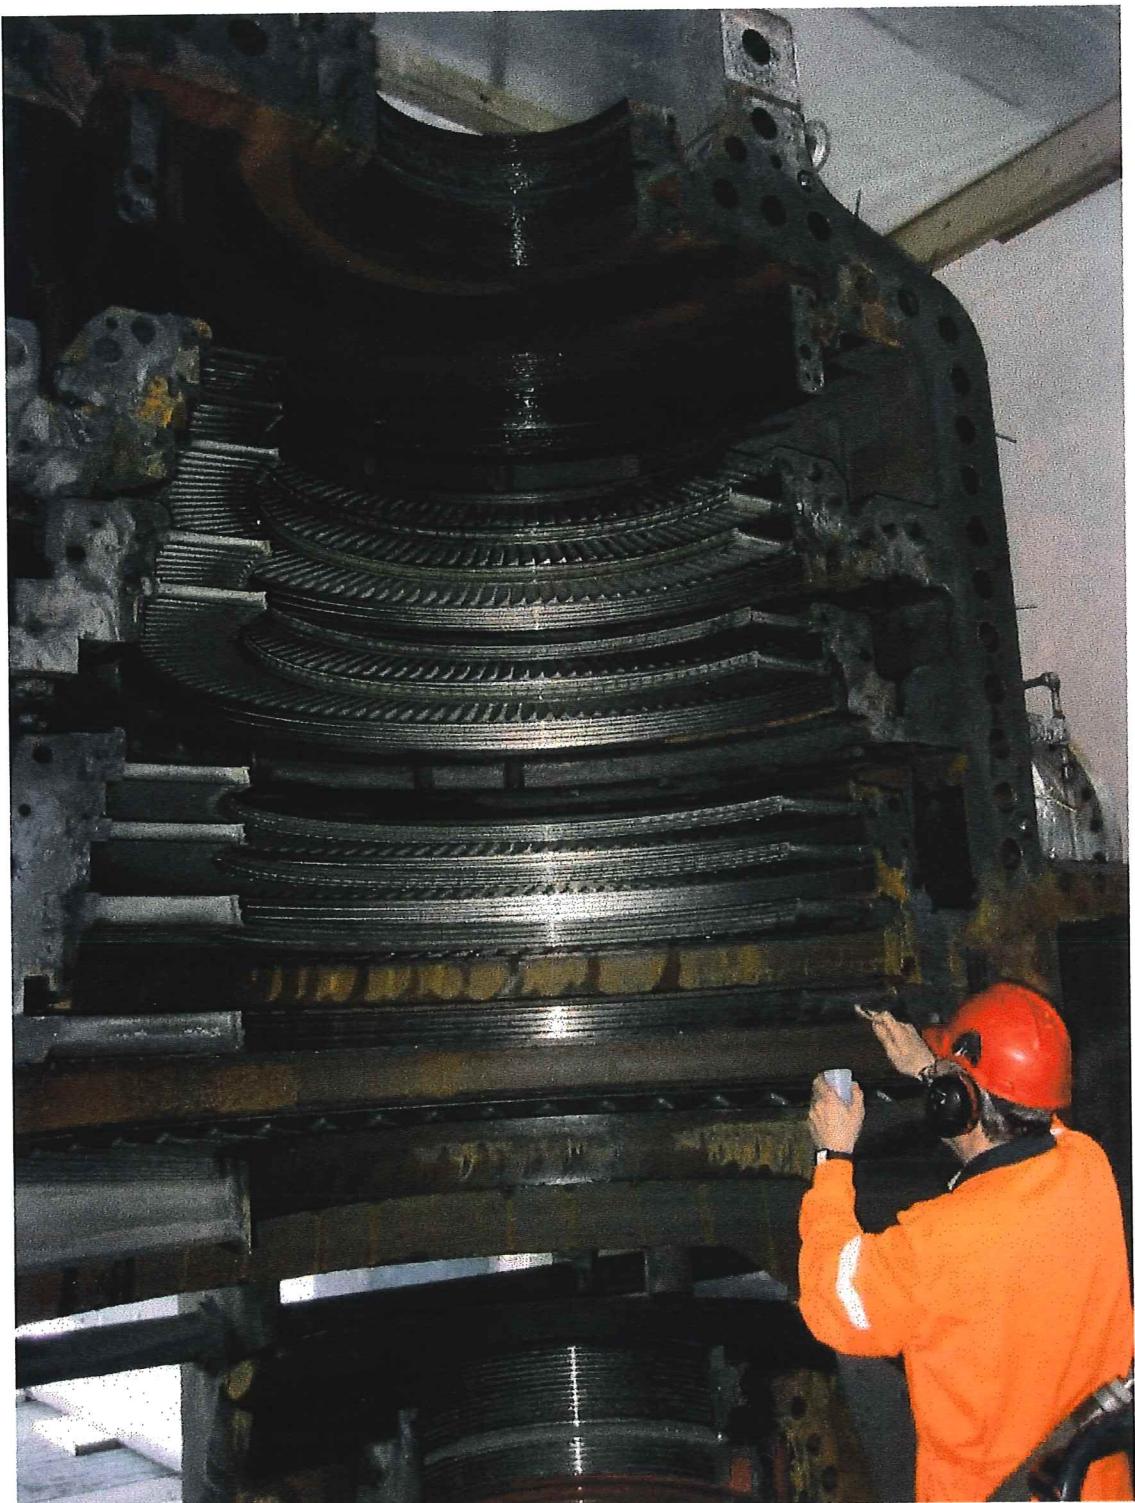
Figure 6. Upper half of turbine casing after initial high-pressure water washing. No deposition was remaining that could be removed for analysis.

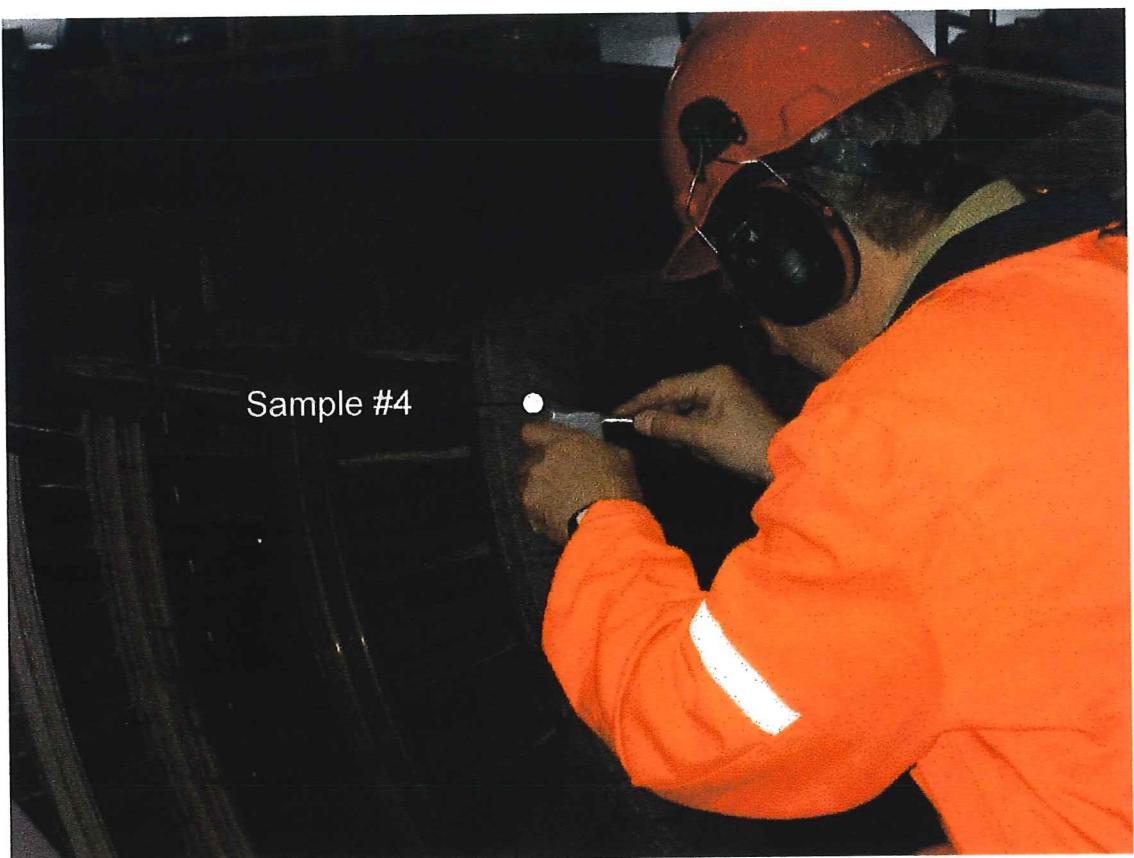
Figure 7. Sample # 4 in lower half of turbine casing.

Sample taken from lower half of the turbine casing, by the eighth stage. Background is high (high Fe-content) and the mostly abundant crystallized phase is the iron-carbonate siderite (FeCO₃). Other iron compounds are also present (magnetite? Fe₃O₄). A trace of sylvite is present (KCl).
