Holtavirkjun

Geological Report

Geological Investigations 2001-2006

Report no.: LV-2007/054

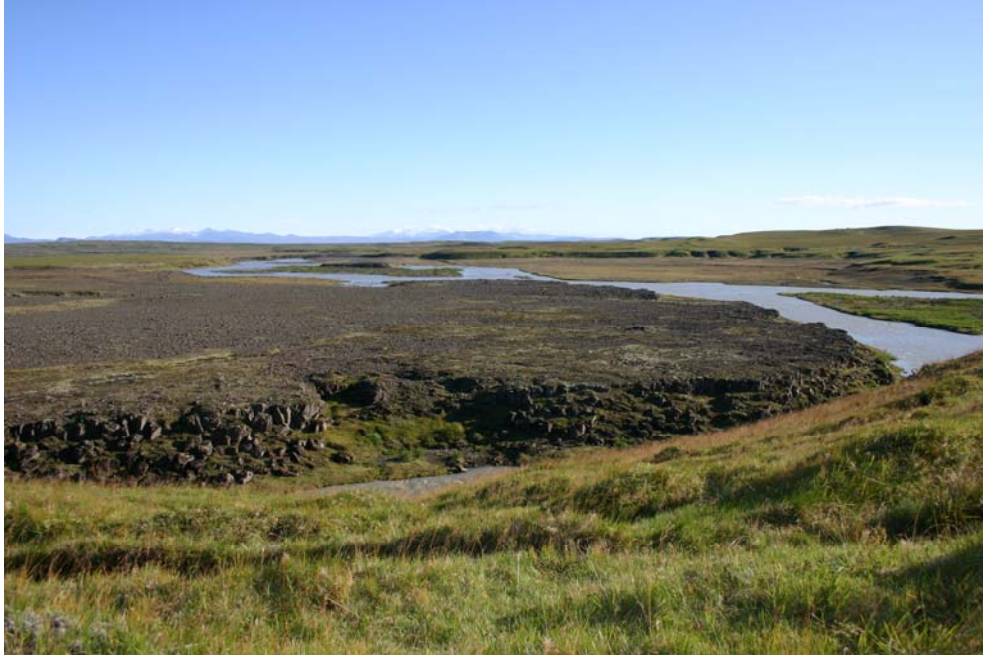
Figure 1-3. The Þjórsá lava at the dam and weir site. The scoria of the lava has been eroded away by the river.

course has been north of the weir and also north of the cube jointed tholeiite in Þinghólar. (see Drawing 8). The lava is rather thin near the main dam at the gorge of Þjórsá River (down to 4 m in NK-40) and in NK-37 it was not found. After the eruption the river found a new path down at Hestafoss and it flowed partly over the lava and eroded away the top scoria of the lava (see drawing 8 and fig 1-3). The gorge at Hamarinn was eroded later.

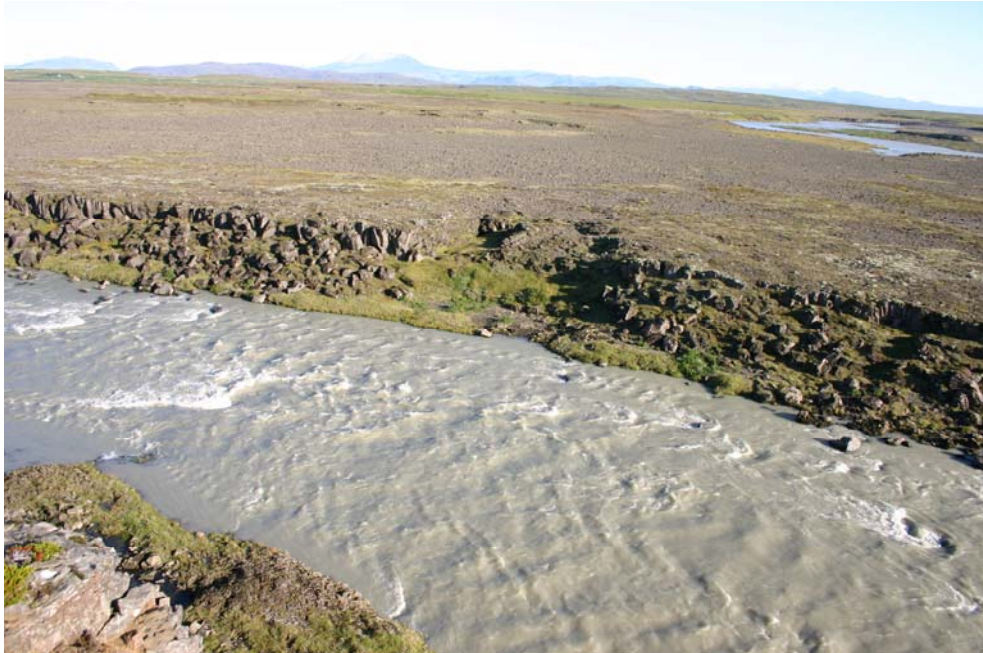
Figure 1-4. The Þjórsá river gorge at Hamarinn and the weir site in background

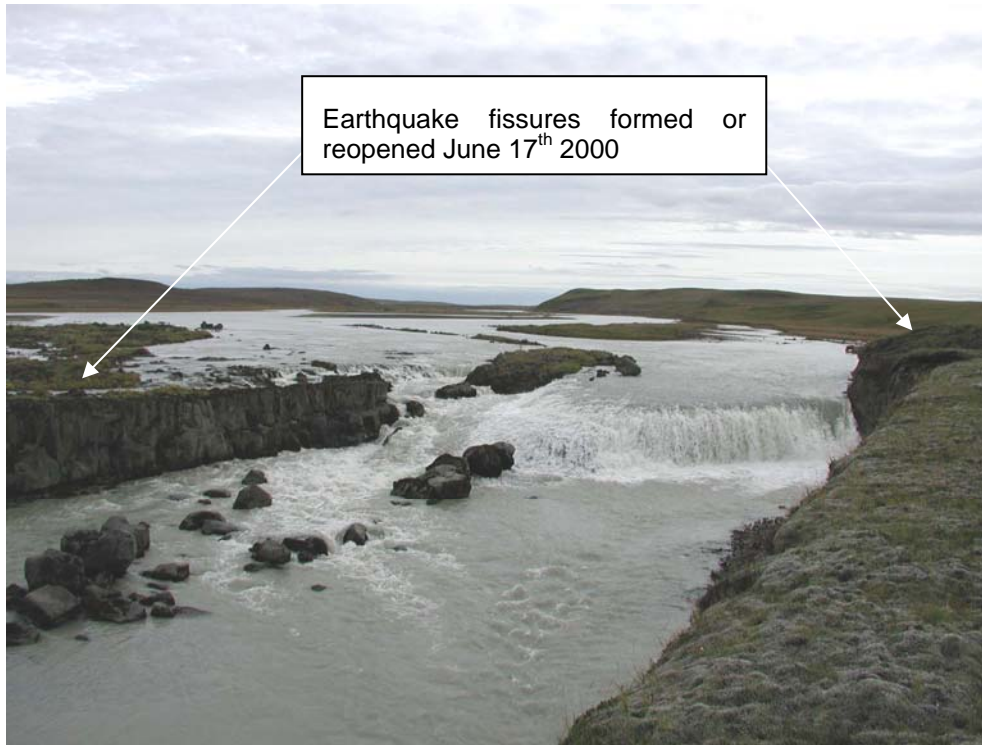
Figure 2-1. Earthquake fissures at Hestafoss. Fissures have also shaped the riverbed.

A fissure set (3) strikes near Hestafoss and the farm Lækur. These fissures are part of the fissures related to the earthquake of June 17th 2000 just south of the project area. The fissures at Hestafoss are quite obvious and signs of movements were visible in the area just after the quake on both sides of the river, but they have not been included in previous mappings. They are quite narrow and display irregular openings of ~5 cm and sometimes up to ~10 cm. A fissure was found near the river just north of the Lækur farm and another one between the farm houses (Andrés Eyjólfsson 2007 pers.com). Fissures of this set can be traced some distance to the north from Hestafoss in the island Árnes. According to the current plan the weir will cross these fissures. Springs related to the fissures can be seen just below Hestafoss.

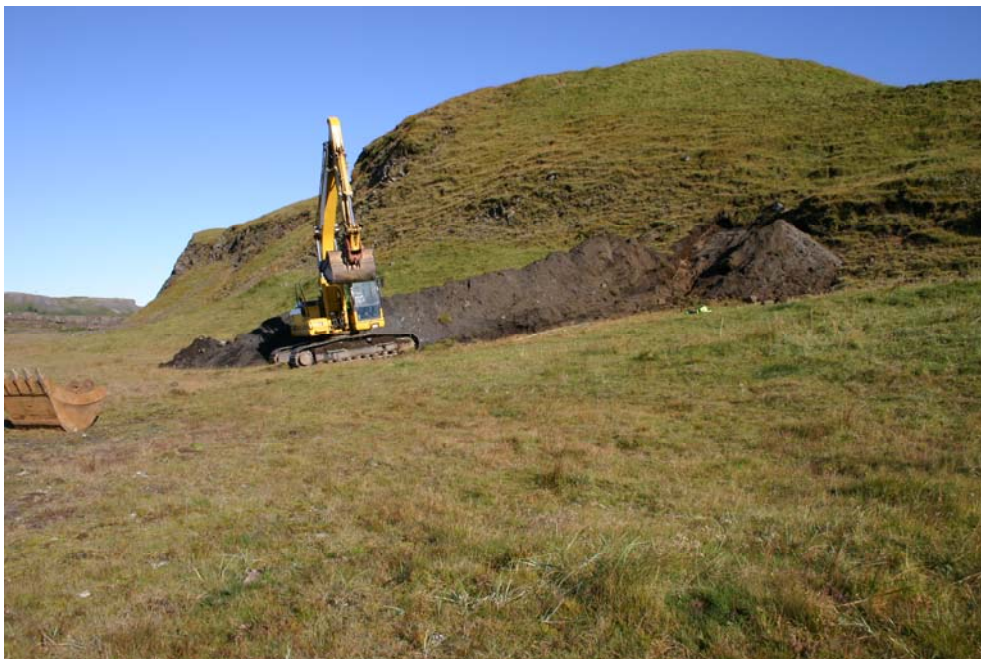
Figure 2-2. Fissure trench AK-1 at Akbraut farm.

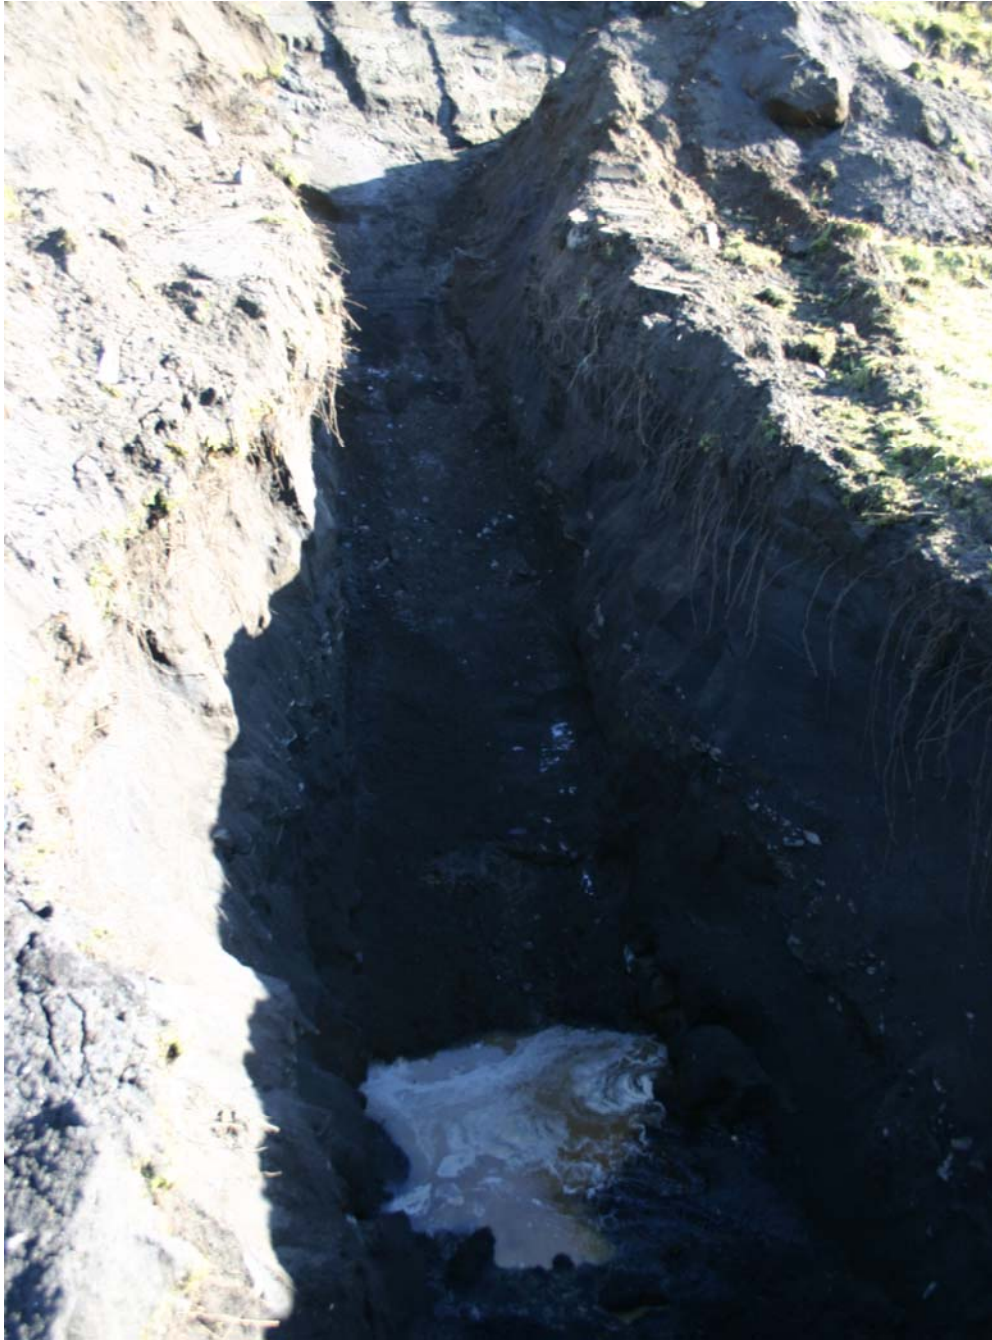
Figure 2-4. Fissure trench AK-1 just after excavation. Unsure signs of a fissure or fault are in the shadow at the light spot just above the inflowing water.

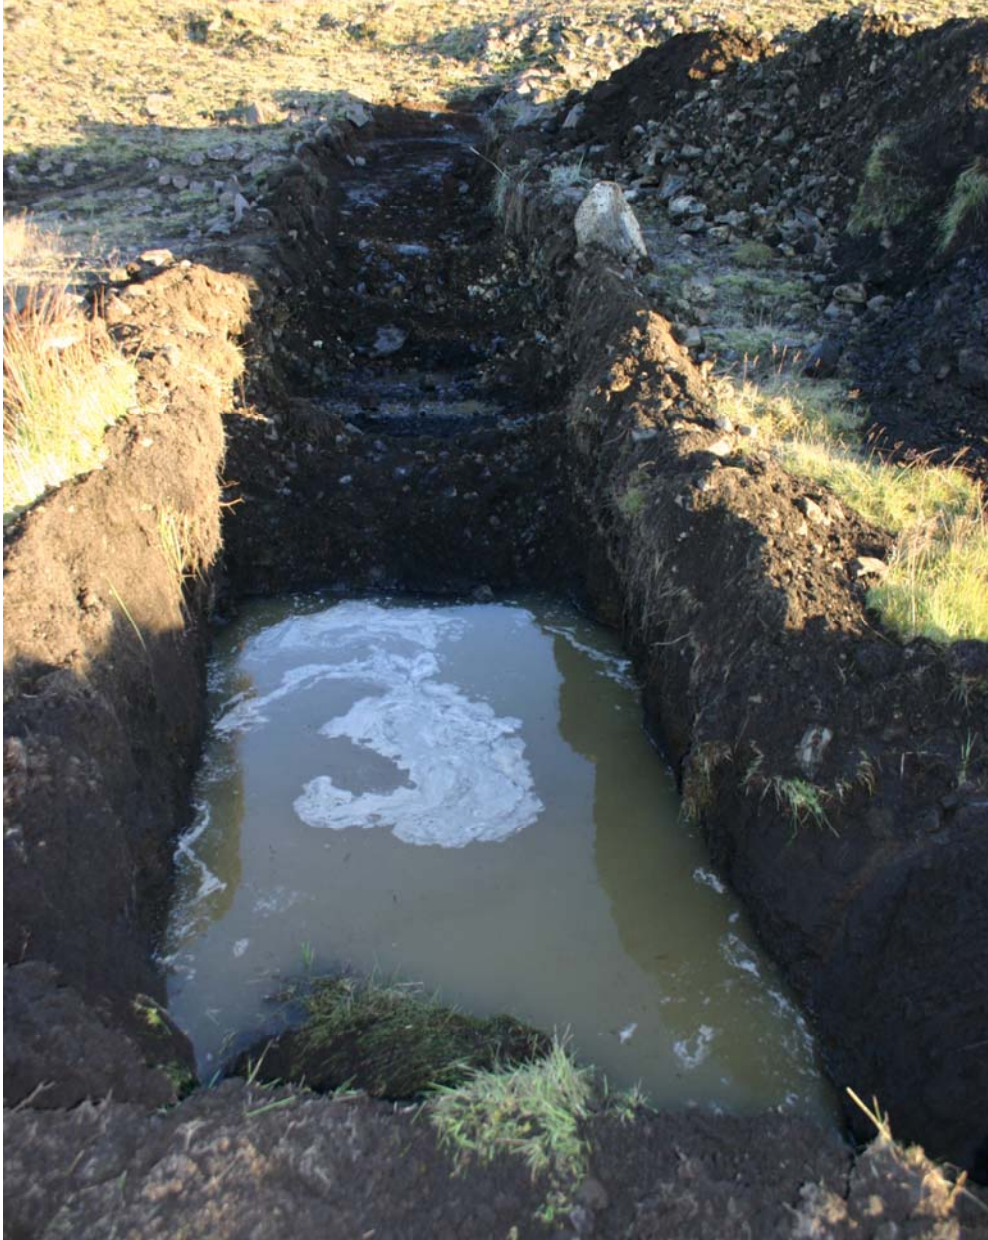
Figure 2-5. Fissure trench AK 3 in process of excavation. The inflow of groundwater made the study difficult

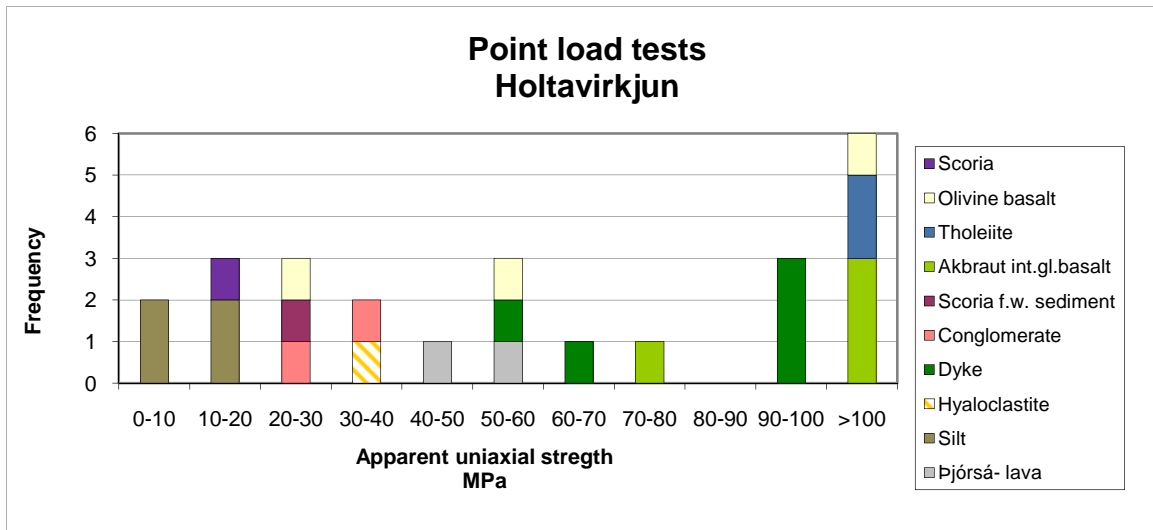
Figure 4-1. Apparent uniaxial strength of different rock types, estimated from point load tests.

Point load tests were carried out as soon after drilling as possible. The core is 45 mm in diameter and conversion factors were used to calculate IS50 and the "apparent" UCS calculated accordingly. The results from the point load tests and calculated apparent UCS are shown in Annex 6.2. The overview of apparent UCS is summarized in the following histogram, see figure 4-1.

The conversion feature of 18 was used to calculate the apparent USC value. The conversion factor chosen is in good concordance with the individual basalt types but is maybe too high for the softer rocks, for instance the siltstone. It was however used in the case of the softer rocks as no other values were available.

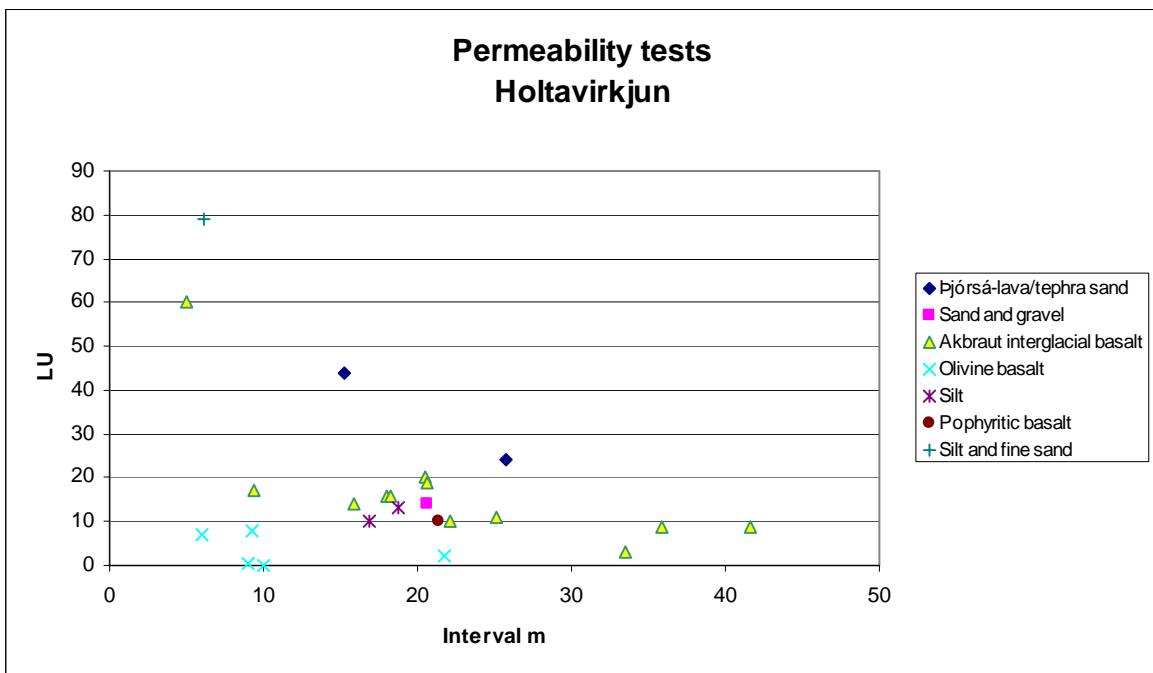
Figure 4-2. Length of tested intervals vs. permeability in Lugeon values.

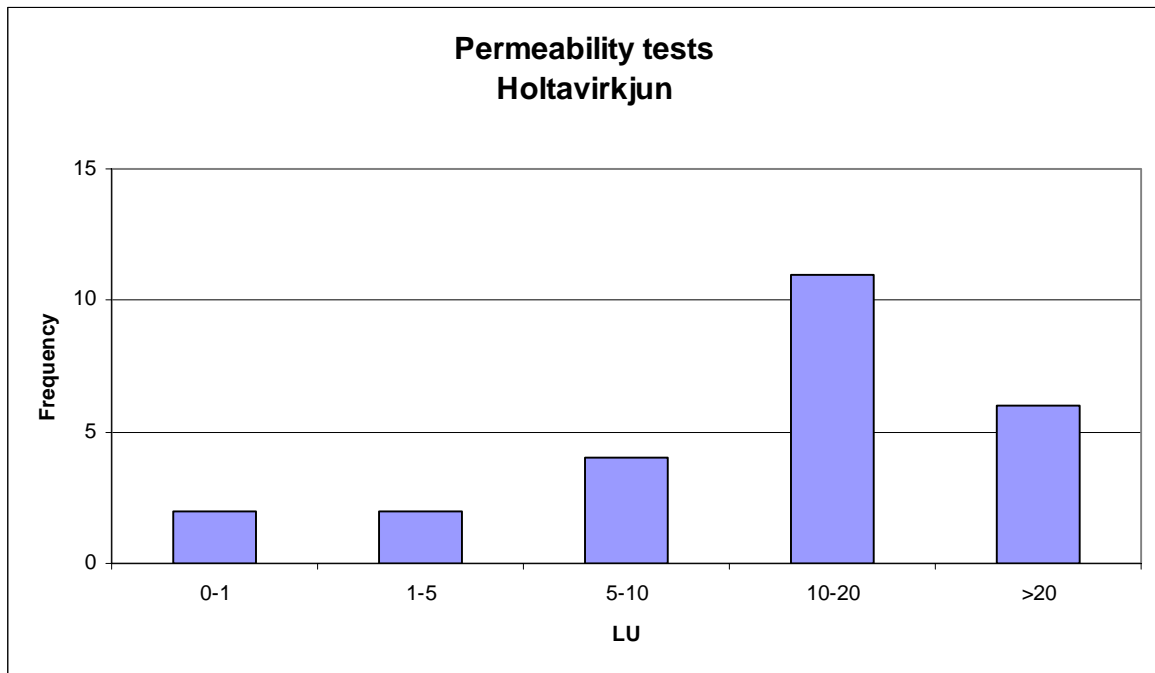
Figure 4-3. Distribution of permeability values.

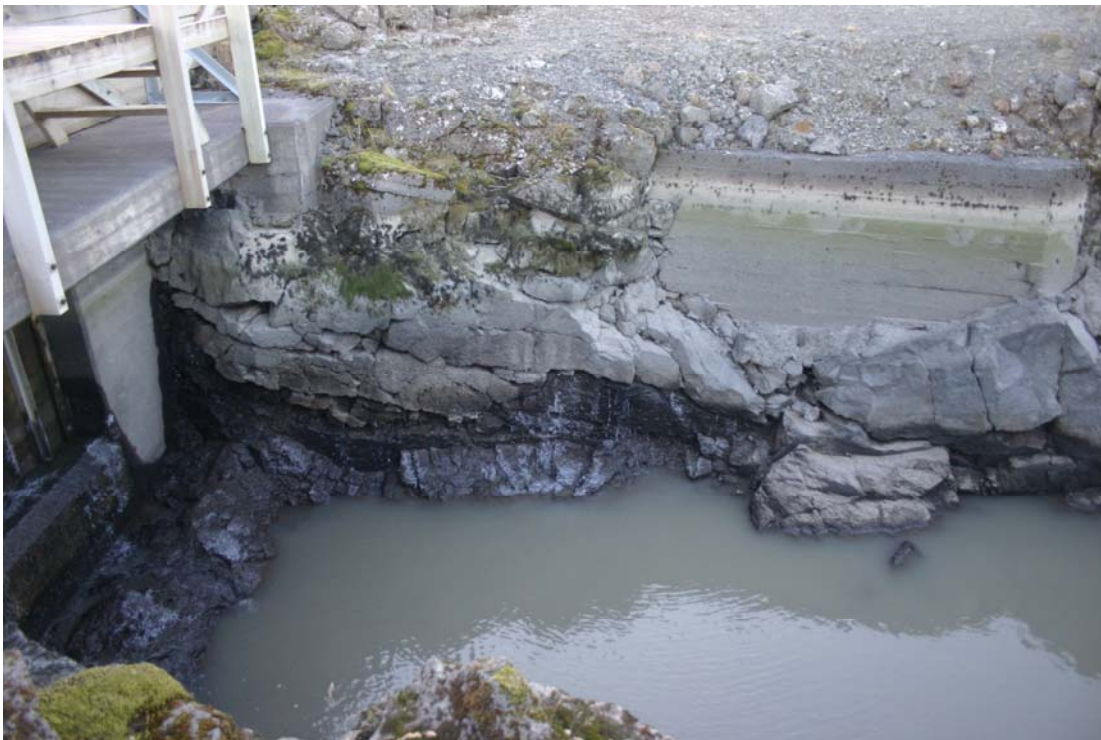
Figure 4-: Leakage from top section of the Þjórsá lava into salmon waterway at Budi waterfall.

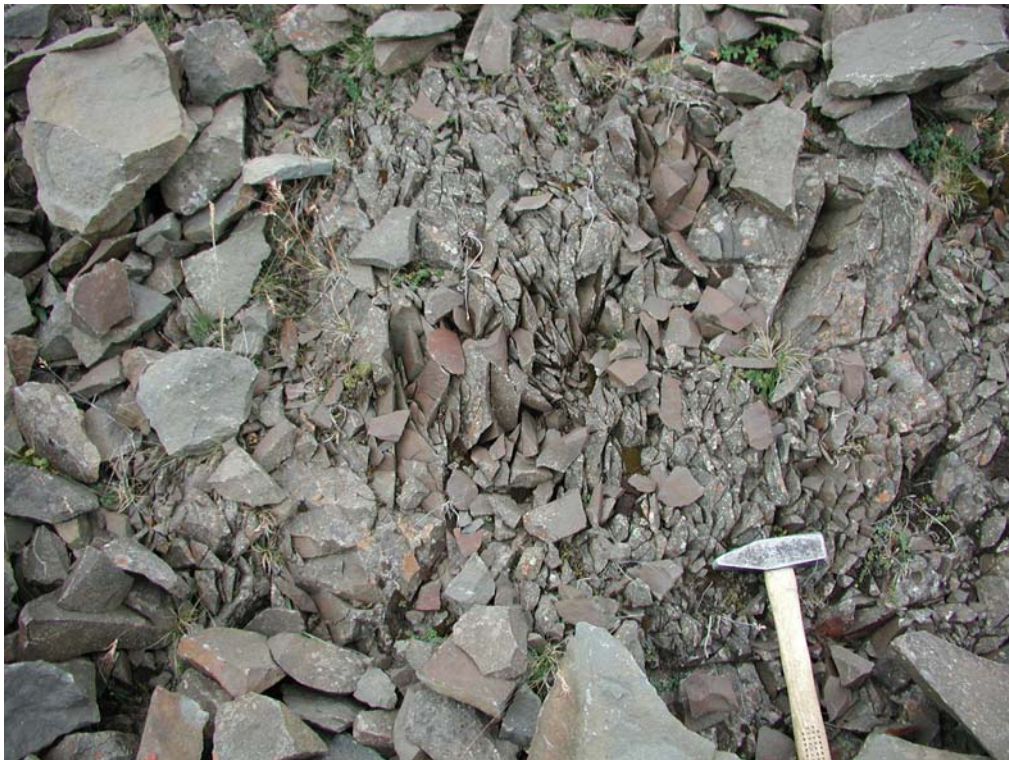
Figure 5-1. Highly jointed basalt in Hamarinn

The excavations for approach channel, concrete penstocks and powerhouse will be performed mostly in Akbraut interglacial basalt (AIB). The AIB layer forms Hamarinn itself. It is sound olivine basalt and little altered. Joints and fissures are covered with dark glossy clay minerals. It is highly jointed in at the east flank of Hamarinn and also just west of NK-41. The joints indicate probably fissure zones, one at the proposed powerhouse site and another (possibly several others) on the east flank of Hamarinn and in the gorge of Þjórsá (see drawings 10-12). The powerhouse will be founded on the scoracious lower part of the AIB formation and/or in the olivine basalts and conglomerate of the STG formation. The scoraceous part of AIB was only found in one hole NK-41, thus it is quite conceivable that the scoria thins out to the east and the area just east of the present powerhouse site seems to be considerably less fractured than the present site. The apparent uniaxial strength of the older rocks varies considerably. The basalt layers from 50-150 MPa and the scoria and conglomerate appear to have strength of 20-40 MPa. The AIB has high apparent USC strength of 180-220 MPa and the scoria is competent with apparent USC of 20-40 MPa. Despite the fissure zones the permeability is in the range of 10-60 LU where the most common values are 15-20 LU. Magnetic and VFL survey were carried out at the powerhouse site and they indicated an anomaly at the present powerhouse site. The anomaly was interpreted as a fault zone and the presence of it was confirmed by drilling NK-41. The most likely location of the fault zone is shown in drawings 10-12 and 14.
