Archaeological Impact Assessment of a (Lagning Ljósleiðara) Fibre Optic Cable Route in Bæjarsveit, Borgarfjörður

LAGNING LJÓSLEIÐARA Í BÆJARSVEIT Í BORGARBYGGÐ

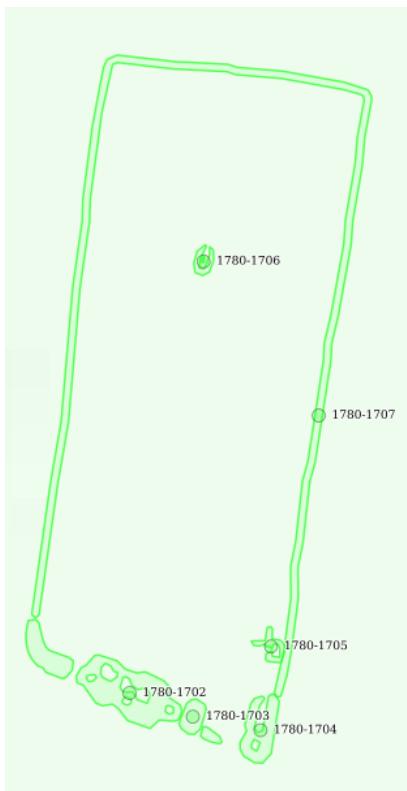
Fornleif Nr: 1780-1702 (Tóft), 1780-1703 (þúst), 1780-1704 (Tóft), 1780-1705 (Tóft), 1780-1706 (Tóft) & 1780-1707 (Keldur garðlag). GPS: **64° 37.688'N, 21° 32.235'W** (ISN93: **378.683, 460.979**) See site plan below.

Plan of the archaeological features at Keldur
(map.is/minjastofnun)

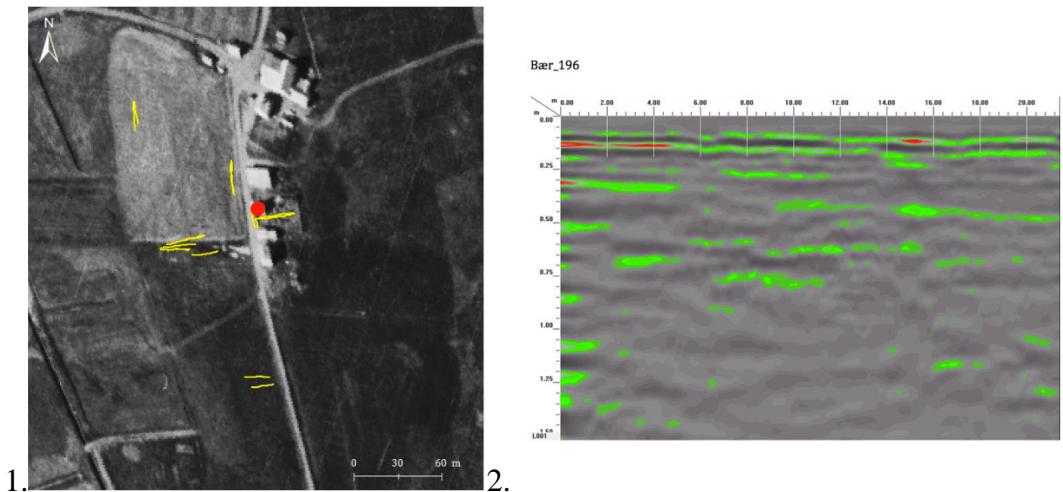
Geophysical survey was conducted in 5 locations around the Bær church (See image below) but results were inconclusive owing in large part to the soil conditions and uneven ground (þýfður jarðvegurinn). One area of potential was noted amongst the five areas scanned and produced more resistivity than the others. The results are shown below. No further archaeological trenching was carried out though.

1. Annotated aerial photo showing geophysied locations at Bær. Location of Bæjarkirkja marked with red dot. (Kristjánsdóttir 2014, 8)

2. Results of geophysics resistance survey at Bær. (Kristjánsdóttir 2014, 14)

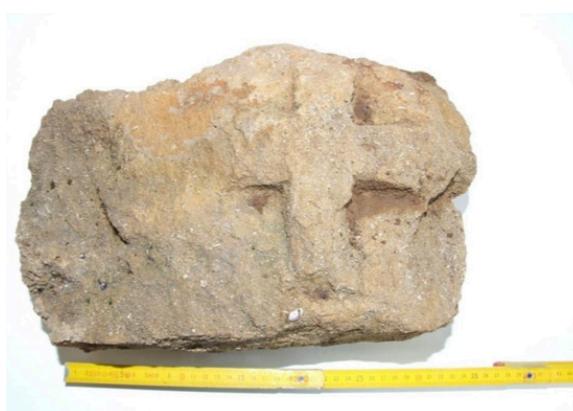
Image. Carved stone with cross recovered from spoil heap at Bæjarsveit (Kristjánsdóttir 2014, 9)

Dating the stone accurately has proved difficult but specialists from Norway have proposed that this represented an entrance stone to a holy shrine rather than a grave marking stone. Kristjánsdóttir feels this stone is the best evidence so far uncovered to identify the location of the former moastic site at Bær.

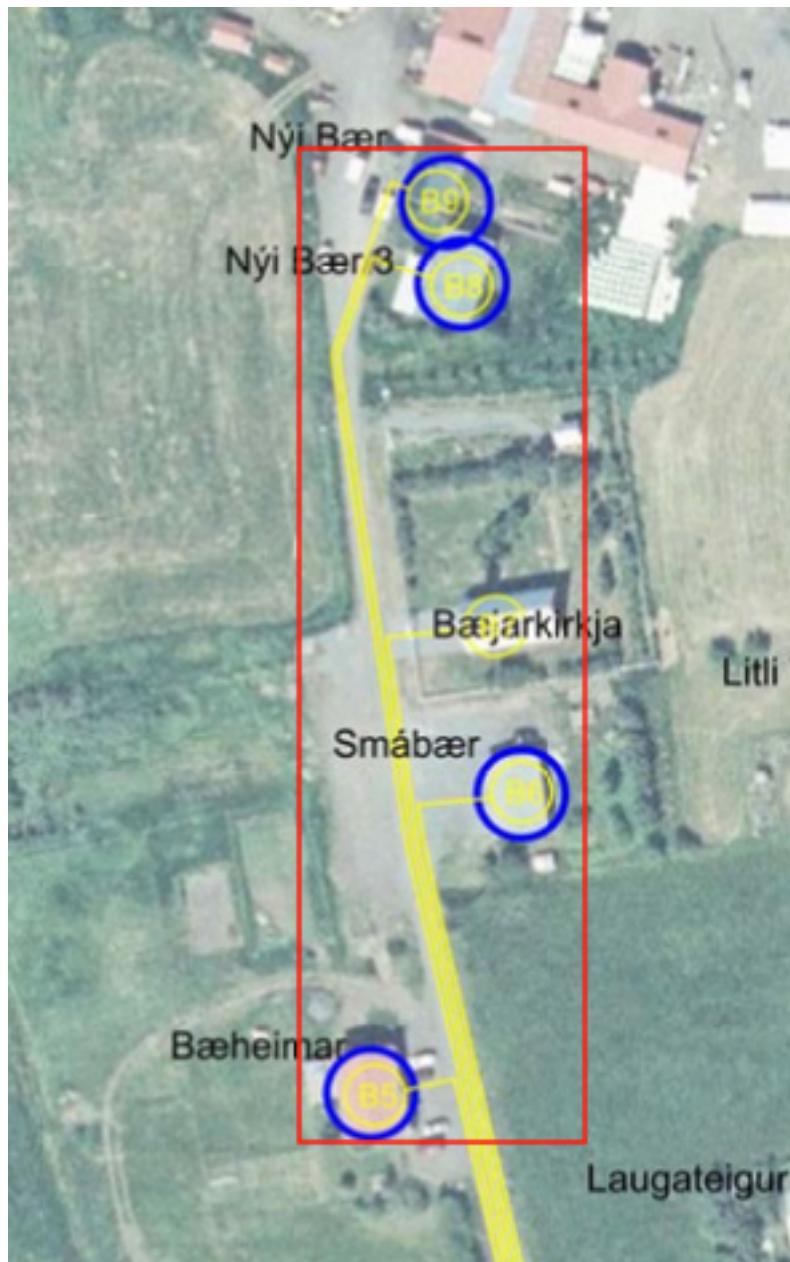
Proposed area (within red) of archaeological monitoring along Bæjarvegur and in proximity to Bæjarkirkja.

Along Bæjarvegur while it is planned to use pre-existing trenches and cable routes there will be some areas of the works here where this will not be possible and a new trench will need to be opened for the cable line. For this reason it is recommended that all the works along Bæjarvegur within a proximity of 50m to Bæjarkirkja be archaeologically monitored. This is due to the fact that this area was previously known to have been the site of a monastic cloister in the 11th Century and the precise location of the cloister is not currently known. Therefore any works in proximity to the modern day Bæjarkirkja may expose and impact archaeological evidence from the monastic site. Furthermore, re-exposing the old trenches of the electric lines which were excavated in the past without an archaeologist present may show up some archaeological features in the section faces of the trenches which were not recognised at the time by the machine operators and offer an opportunity to record archaeological features.

It is therefore recommended that the works in the fields at Hellur and along Bæjarvegur should be archaeologically monitored and as its a small enough area, that a bucket machine excavator should be used in these locations instead of the plough machine being used in the other areas of the route. This is mainly so the monitoring archaeologist can see the underlying stratigraphy which is not possible to do when using the plough machine. The two areas recommended for archaeological monitoring are highlighted within the red lines on the images below.

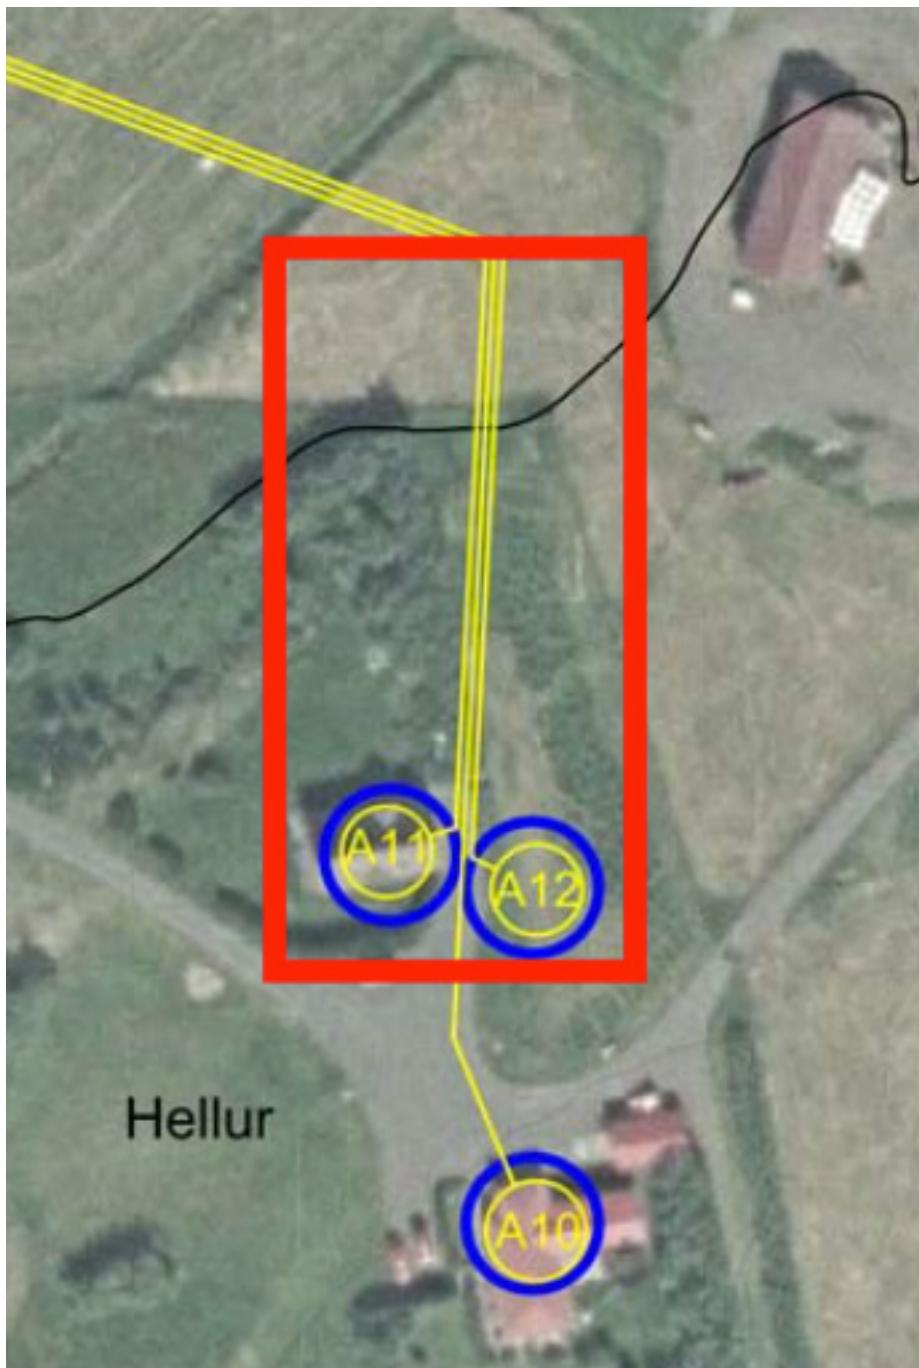
Proposed area of archaeological monitoring at Hellur.

The vast majority of the total area of the proposed route is highly unlikely to impact any pre-existing archaeological remains. Two potential areas of impact are at Hellur where the line runs through a green field area and the area around Bæjarkirkja where the previous site of a monastic cloister is believed to have been located during 1030-1049AD. Although no above ground features were observed at Hellur during the survey, one area of potential may be to the North West of the structure A11 where the ground sloped sharply and showed some unevenness and possible disturbance. There may be some potential for archaeological features at this point.

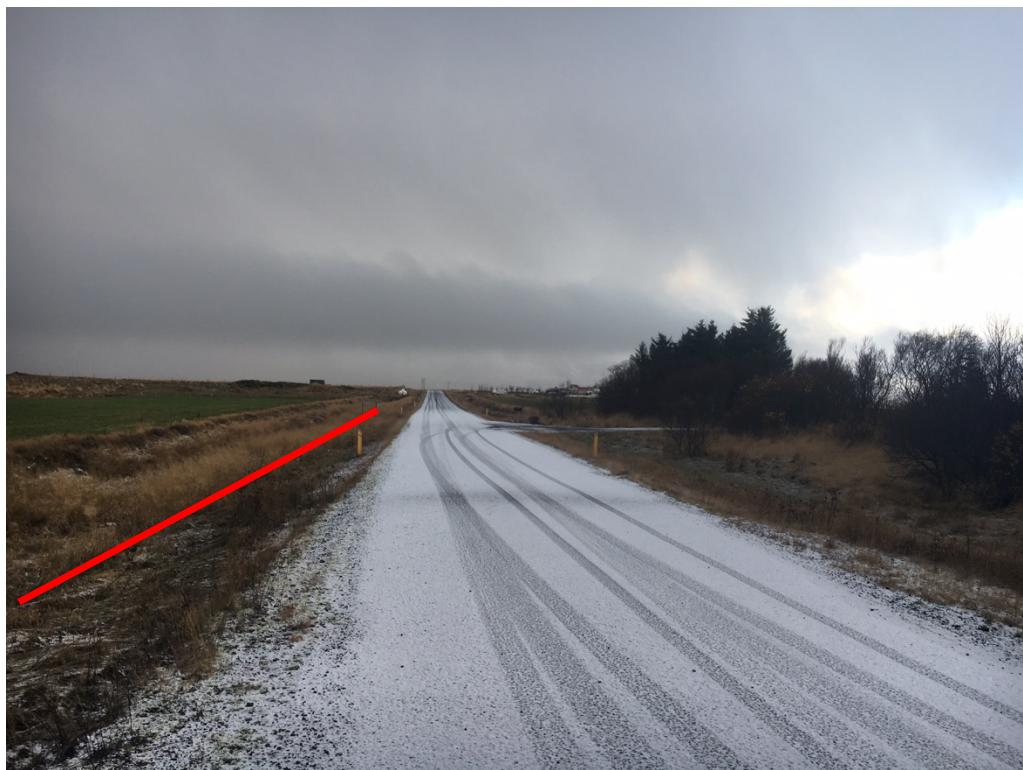
4. Looking South along Bæjarsveitarvegur (531) from Laugarhóll. The proposed route of the cable is to the left of the road between the road and the drainage ditch as indicated by the red line.

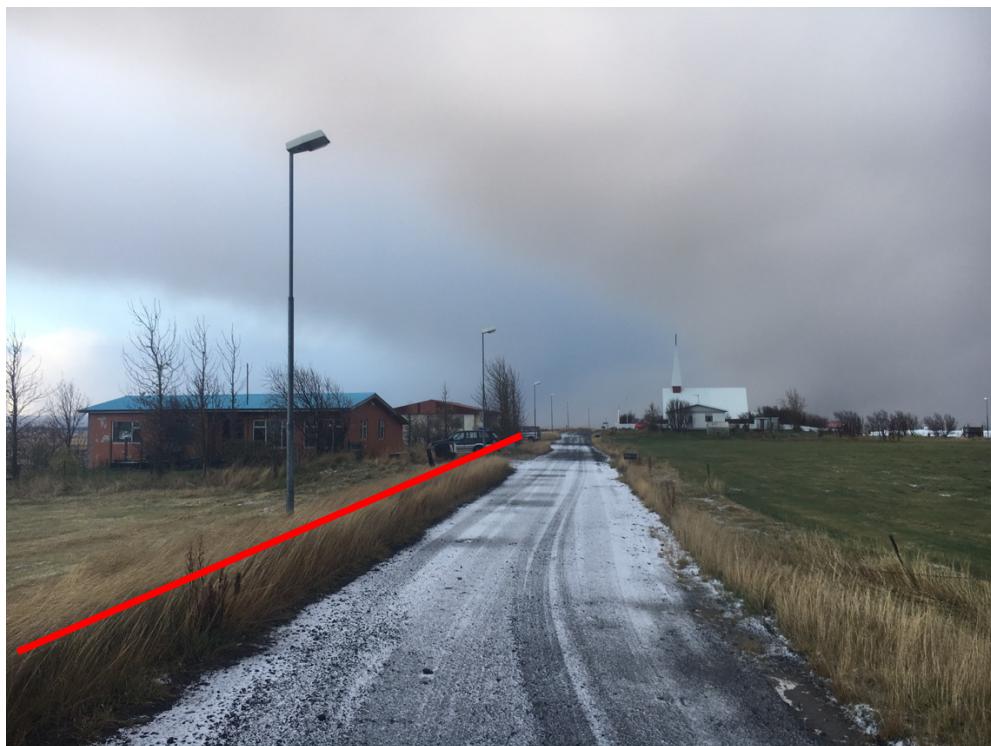
6. Looking North along Bæjarvegur. Bærjarkirja is on the right of the image. The proposed route of the cable will be to the left of the road and plans to utilise the pre-existing trenches for electric lines/street lamps as indicated by the red line.

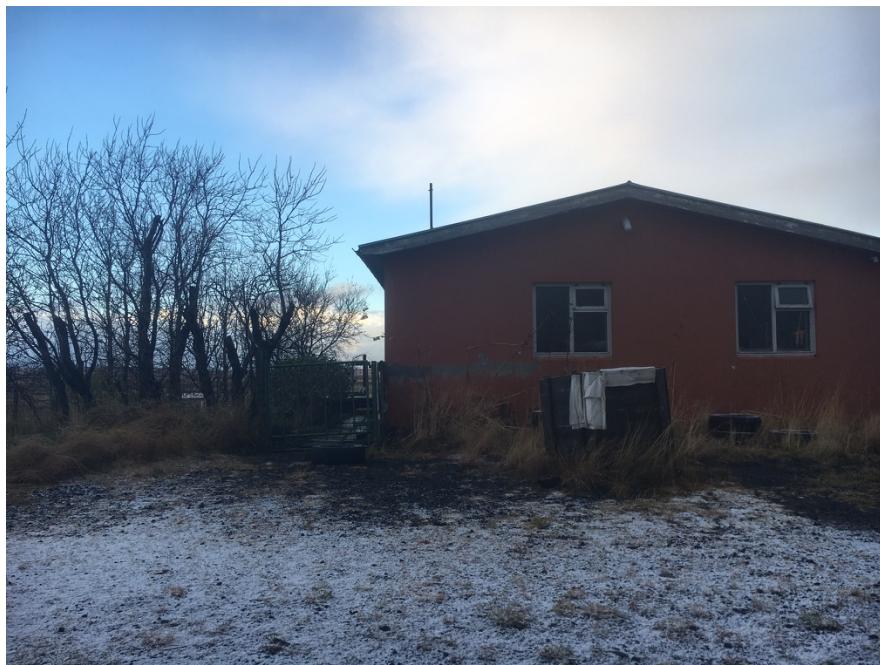
7. House B4 at Bær. A trench will be dug from the roadway to the edge of the house.

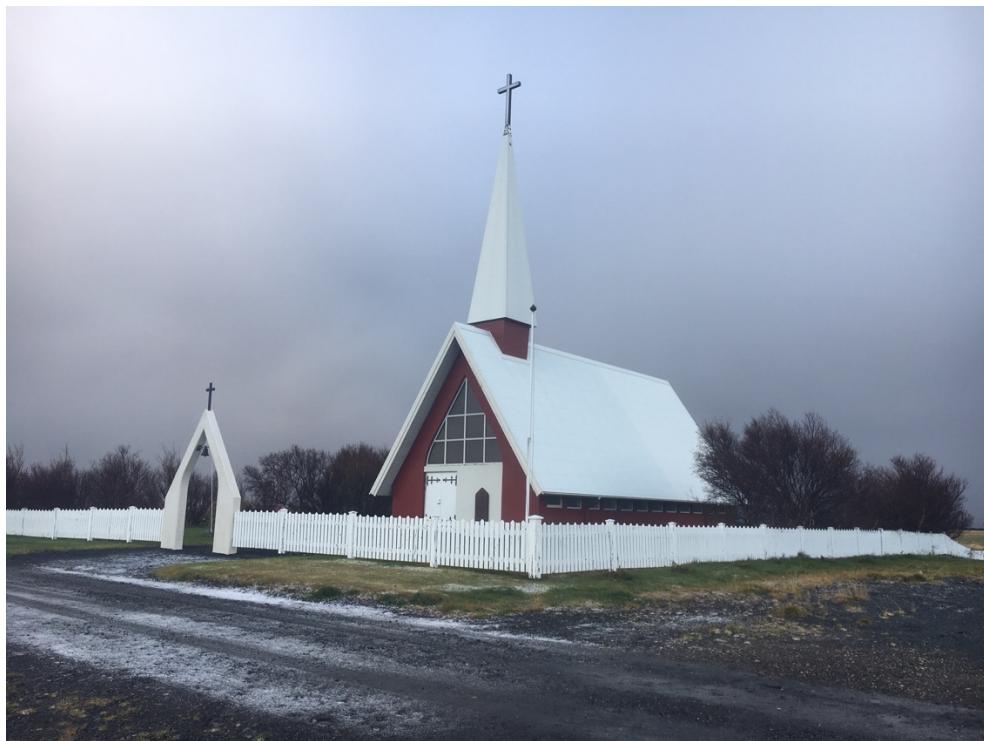
8. Modern church at Bær built in 1967. It is believed to overlie the site of a monastic cloiser which existed at Bær from 1030-1049AD. Here a pre-existing pipe line will be used to connect the cable to the church so no digging or ploughing will take place at the site.

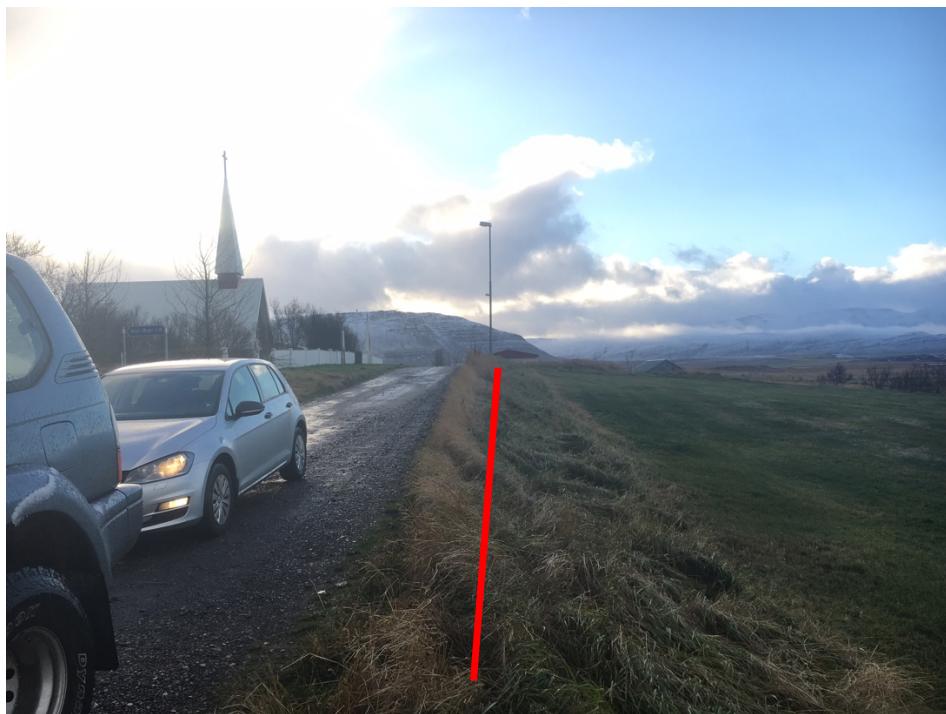
9. Looking South along Bæjarvegur. Bæjarkirkja is on the left. The proposed route of the fibre optic line is in the middle of the image and will utilise the pre-existing trenches cut for the street lamps as indicated by the red line.

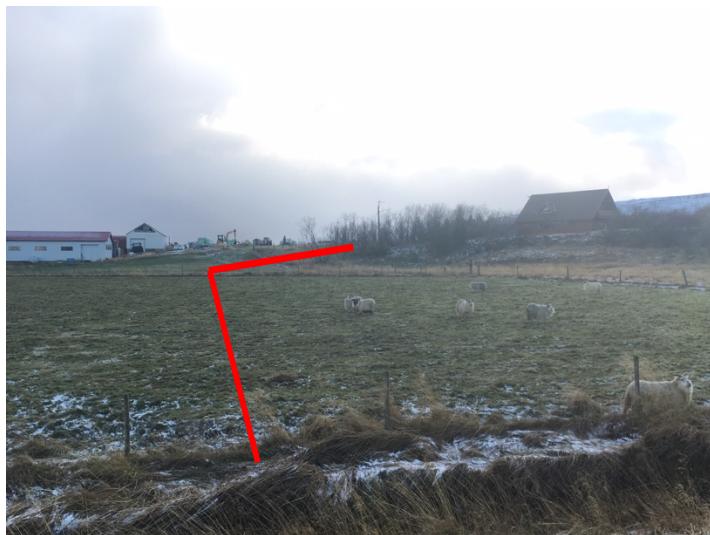
10. Looking South East towards the farm at Hellur. Houses A11 & A12 are visible. The proposed route of the cable will cross this green field area and turn southwards to link with these houses as indicated by the red line. This area is recommended to be archaeologically monitored during the cable laying.

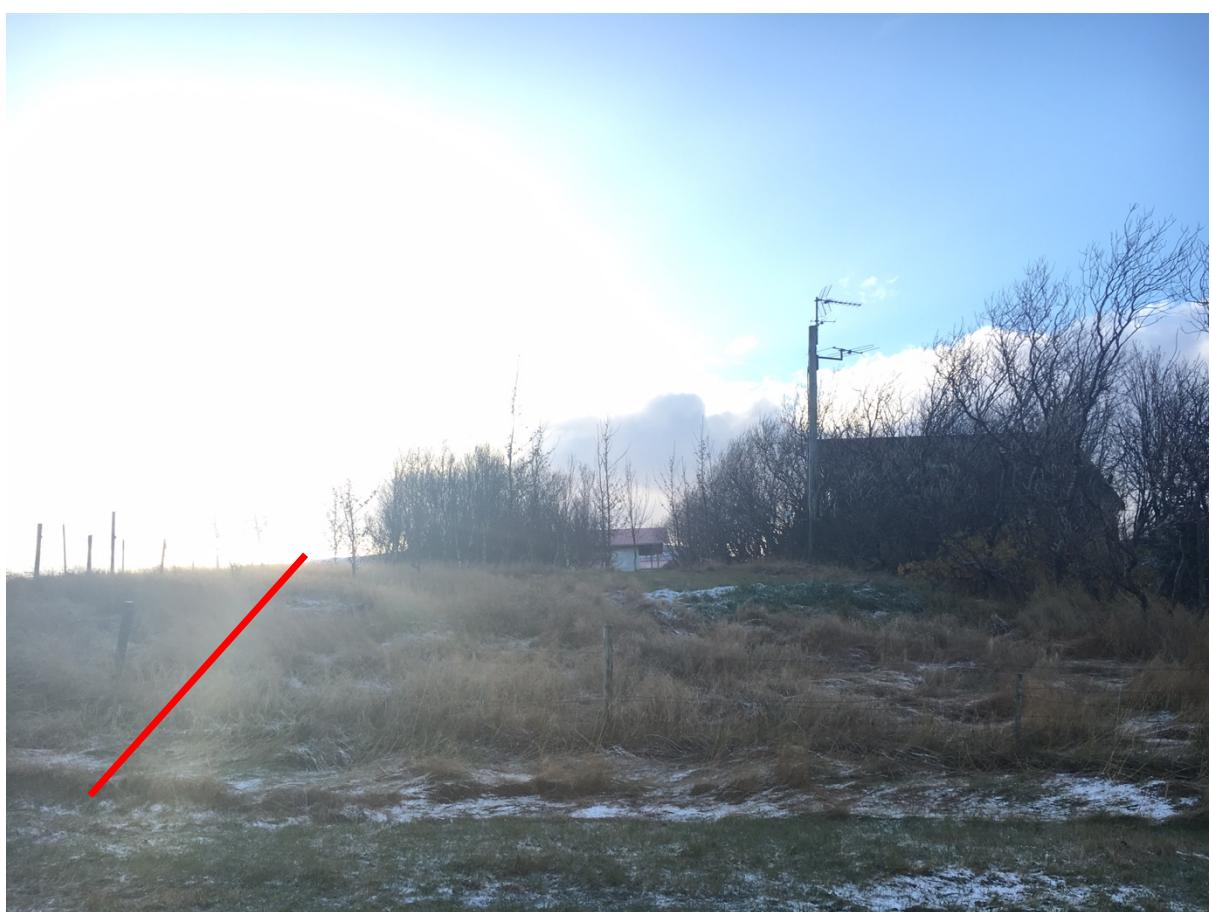
On Friday 28th of October, I walked the entire route of the proposed fibre optic cable line to access it for potential archaeological impacts. No obvious underlying archaeological features were immediately identified during this visual inspection survey. The cable line is proposed to run along the edge of Bæjarsveitarvegur (513) between the modern road and drainage ditch (See Image 6). This area has previously undergone a lot modern landscaping and machining during the construction of the road and ditch. No archaeological features were identified in this section of the route. One green field area will be impacted during this project and this is located at the farm of Hellur (See Images 10-12). Approximately 150m of the cable line will run through here. During a visual inspection of the fields being impacted at Hellur no potential archaeological features were noted. However some area of potential was observed in directly north east of structure A11 (See Image 12). Here the ground was uneven.

12. Looking South East towards houses A11 & A12. The proposed route of the cable will run approximately in the area where the red line indicates.
