Nesstofa on Seltjarnarnes

National Museum of Iceland
Historic Buildings Collection
The Medical History Museum of Iceland

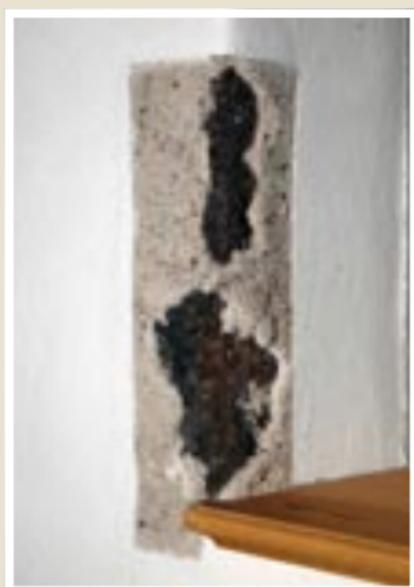
Icelandic basalt with Danish lime mortar in window surround, upper floor.

On the gable wall by the window, the method of construction, using cut basalt rock with lime mortar, may be seen. At the edge of the window the original lime mortar is visible. The panel wall between the middle loft and the adjoining room shows traces of the original doorway and hinges. On a horizontal beam are old pegs, probably used for hanging up ropes or goods. Traces of original wall paint were found. The floor-

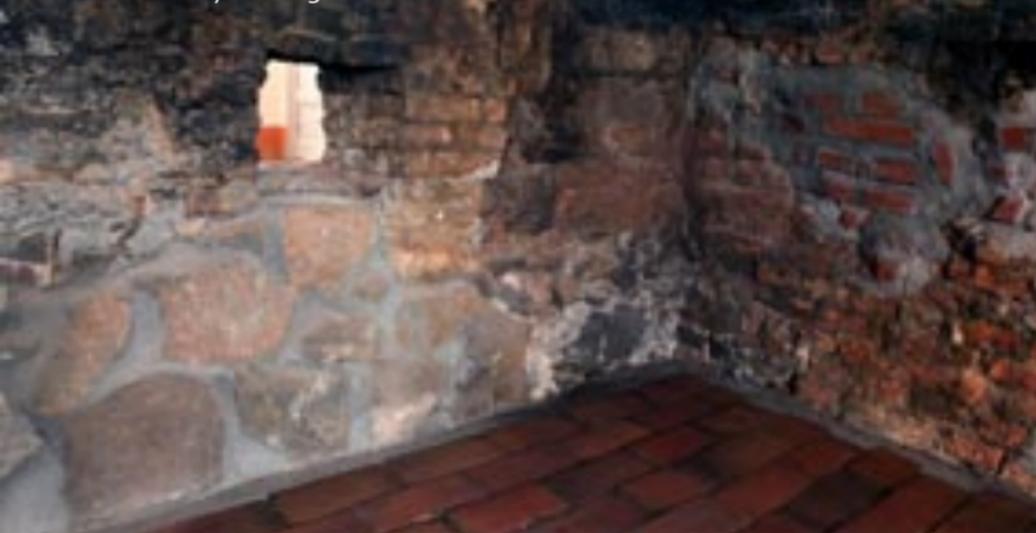
Under the chimney-breast in the laboratory on the ground floor.

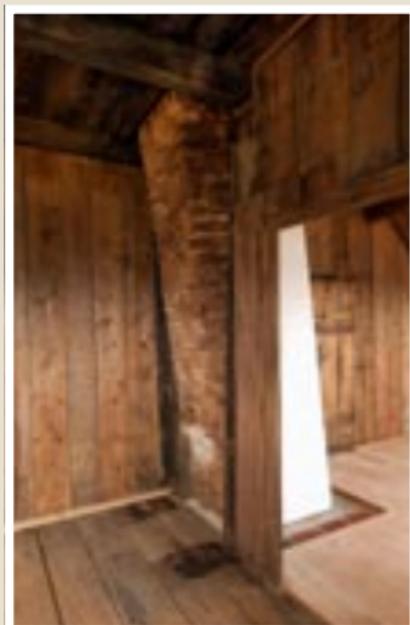
Restoration and renovation in the north rooms on the upper floor.

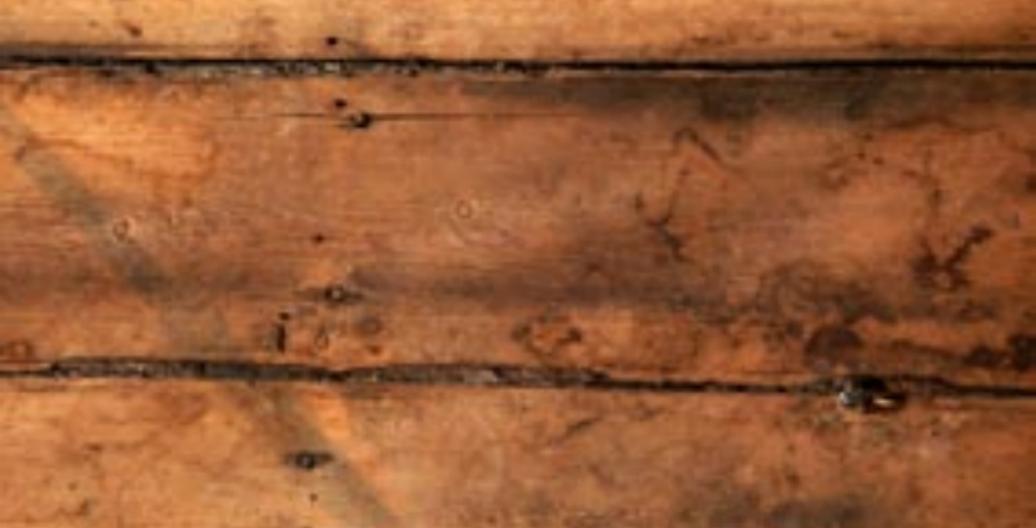
Original double floorboards with
varved clay in the cavity.

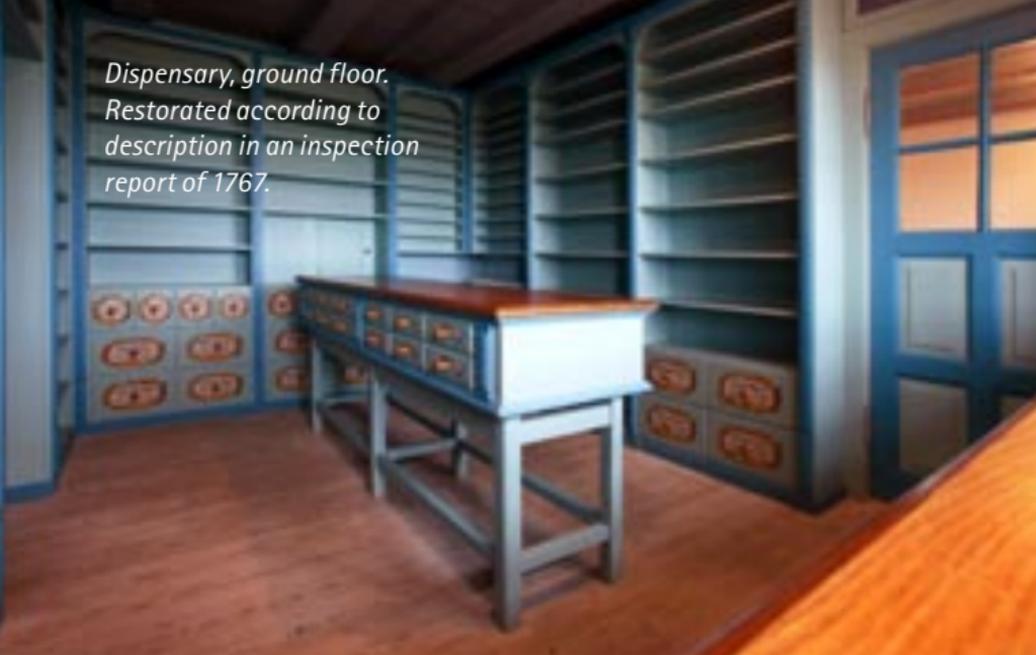
*Dispensary, ground floor.
Restored according to
description in an inspection
report of 1767.*

The fittings and colour scheme of the dispensary are restorations, as described in the inspection report of 1767. Traces of the pale blue colour were revealed on examination of the walls, while the sky-blue colour is according to the description. The report of 1767 describes the painting over the door in detail, and mentions that the Director of Public Health had "two tablets with symbols" made. One, above the door to the examination room, depicts Iceland's coat of arms and atop it three crowns; the other, over the main entrance, shows "A Pelican, the symbol of mercy, Scales as a symbol of justice, an Anchor signifying hope and patience, a Horn of Plenty as a symbol of

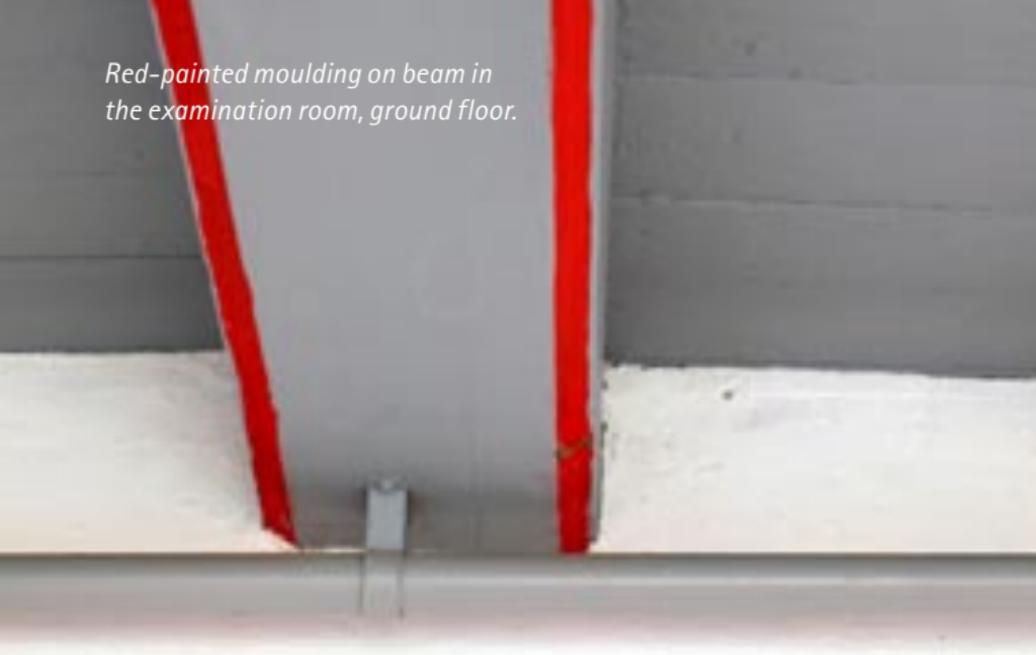
Red-painted moulding on beam in the examination room, ground floor.

The glass door is old, but not original. According to the inspection report of 1763 there was a glass door between the dispensary and the examination room. The ceiling is painted in pearl-grey, while the mouldings on the edges of the beams are painted red, similar to the drawing room. The main pigment is cinnabar, which is listed among the pigments sent to the construction site at Nes in 1761. No evidence is available regarding the colour of the walls, and so they are left white. The surface of the walls has recently been limewashed. The floorboards have been renewed. **D**

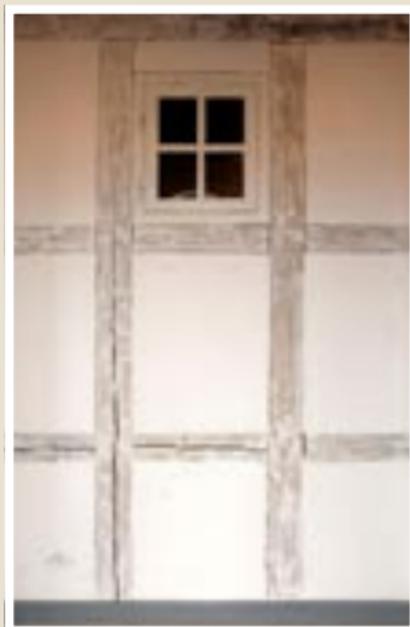
Restored timber-frame wall in the west entrance.

In the vestibule is a restored timber-frame wall built in 1980 in accord with a description. In the wall is a small window, which provided some daylight to the dispensary lad's room. The floorboards have been renewed. From the vestibule, turn right into the dispensary.

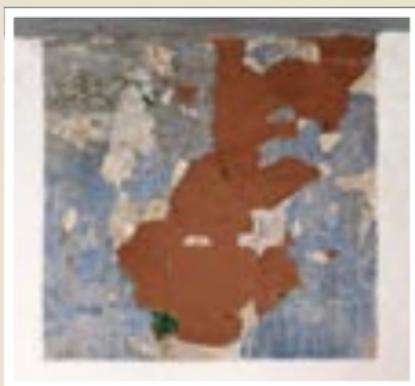
Paint traces on wall, east entrance.

On the north wall traces of several layers of paint are visible. Wall surfaces have been remade in accord with the oldest layer, and limewashed white. The blue colour, ultramarine, was popular in the 19th century. The most recent, red, layer is oil-based paint, probably of early 20th-century date. Earlier layers are painted with pigmented limewash. The floor is new. A larder was originally located beside and under the stairs. The stairs lead up to the upper floor.

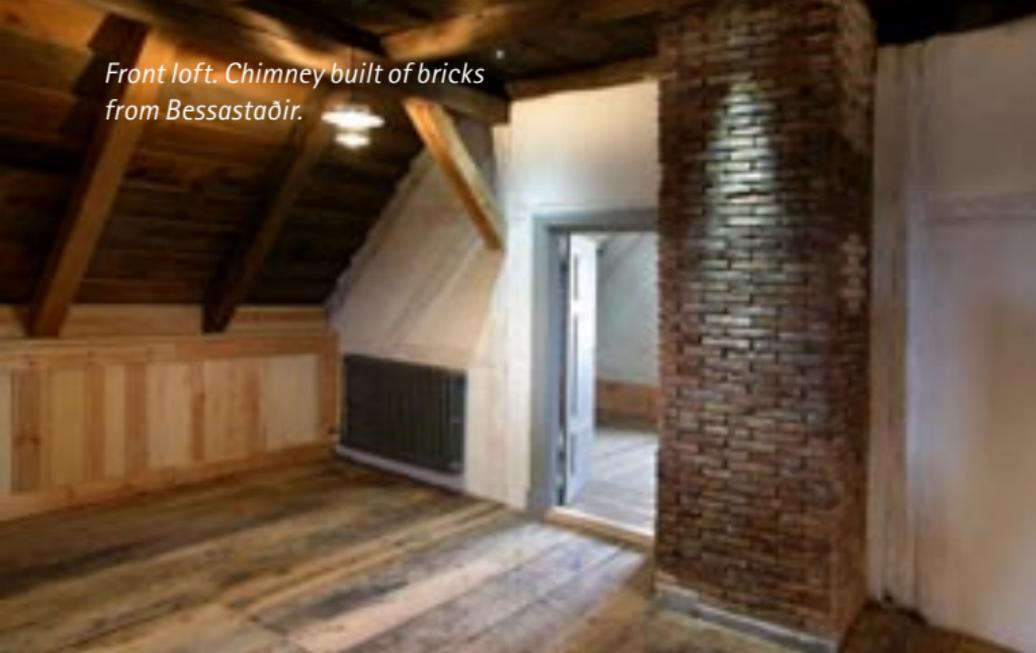
Front loft. Chimney built of bricks from Bessastaðir.

At the same time as construction began on Nesstofa, work also commenced on a new governor's residence, Bessastaðstofa (Bessastaðir House, now the presidential residence). Nesstofa was completed first: the governor was keen that there should be no delay to the work at Nes. His goodwill regarding the project is illustrated, for instance, by that fact that when bricks failed to be delivered to Nes from Denmark, he had part of a chimney at Bessastaðir dismantled, and sent the bricks to Nes.

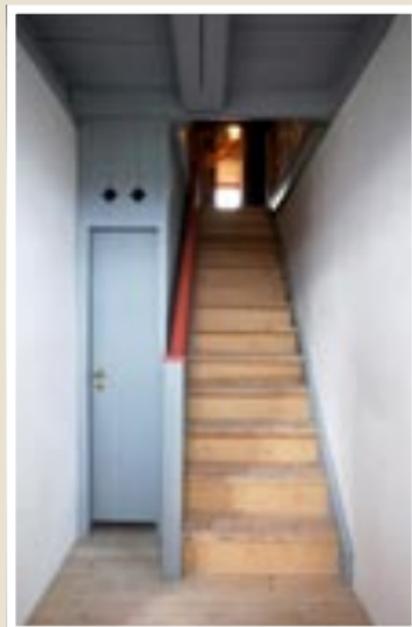
Remade staircase, east entrance.

The staircase was rebuilt in 2007. Plans for the stairs were based on research on the building, and also took account of stairs in Viðey Church (1772). The original stairs were closed

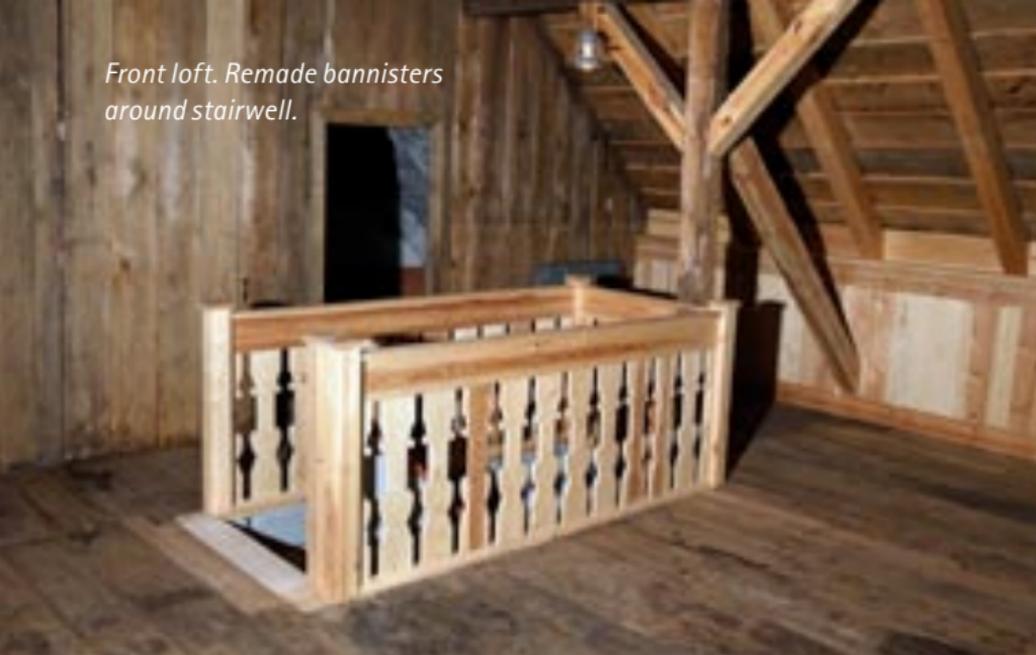
*Front loft. Remade bannisters
around stairwell.*

In the middle section of the loft the roof timbers are visible: one strut on each side, and beneath them posts buttressed on three sides by struts. Collar beams and rafters are also exposed. The clinker-built roof (of overlapping boards) is largely untouched, caulked with strips of woollen cloth soaked in tar. The roof has been renewed at the western side, where a large dormer was removed in 1980. One of the faults noted in 1763 was the lack of banisters around the stairwell, but by 1767 this had been rectified. Low vertical walls beneath the sloping roof are new, installed to conceal modern ducting for heating and lighting. The floorboards are original, partly untouched. On a beam in the kitchen were traces of another stairwell, constructed in 1774 when the building was divided lengthwise. These traces are still visible.

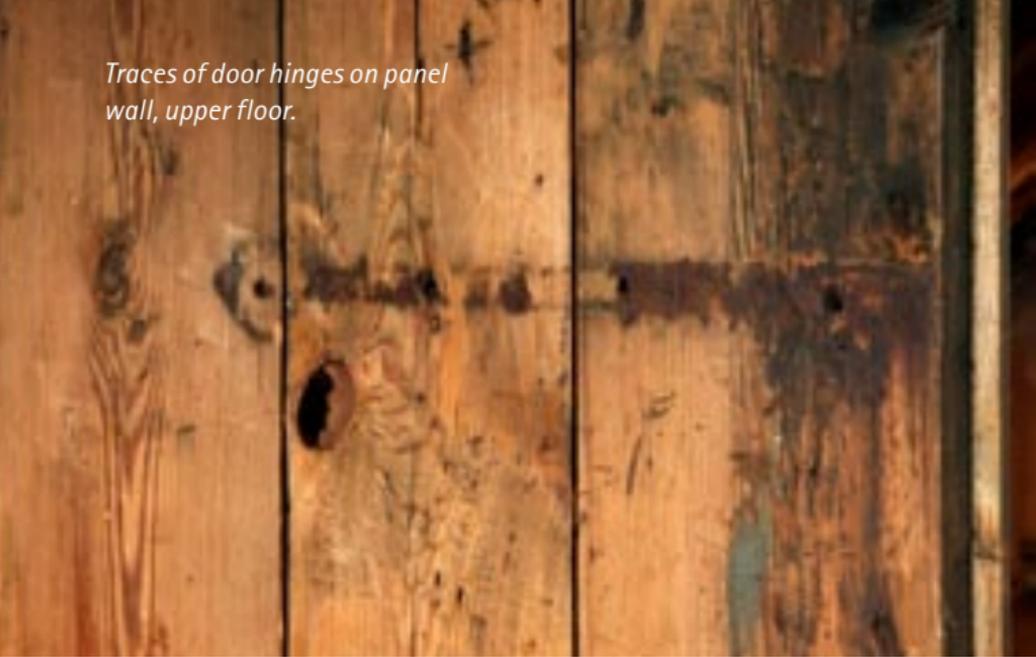
Traces of door hinges on panel wall, upper floor.

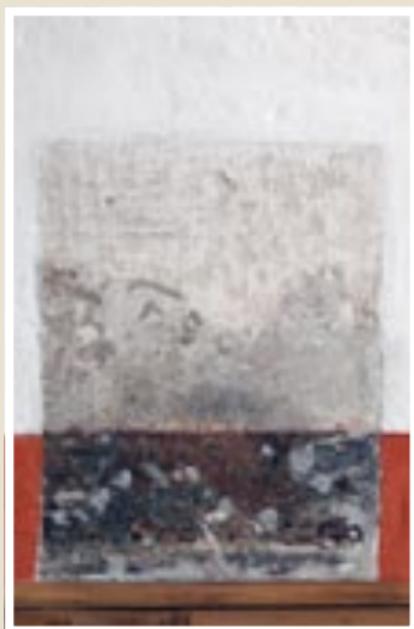
Original paint traces in the drawing room.

On a ceiling beam near the exterior wall, traces of paint layers are visible. Mouldings on the edges are coloured red. Close to the floor on the partition wall and gable wall are traces of red colour on the plinth, and pale grey on the walls. The uneven

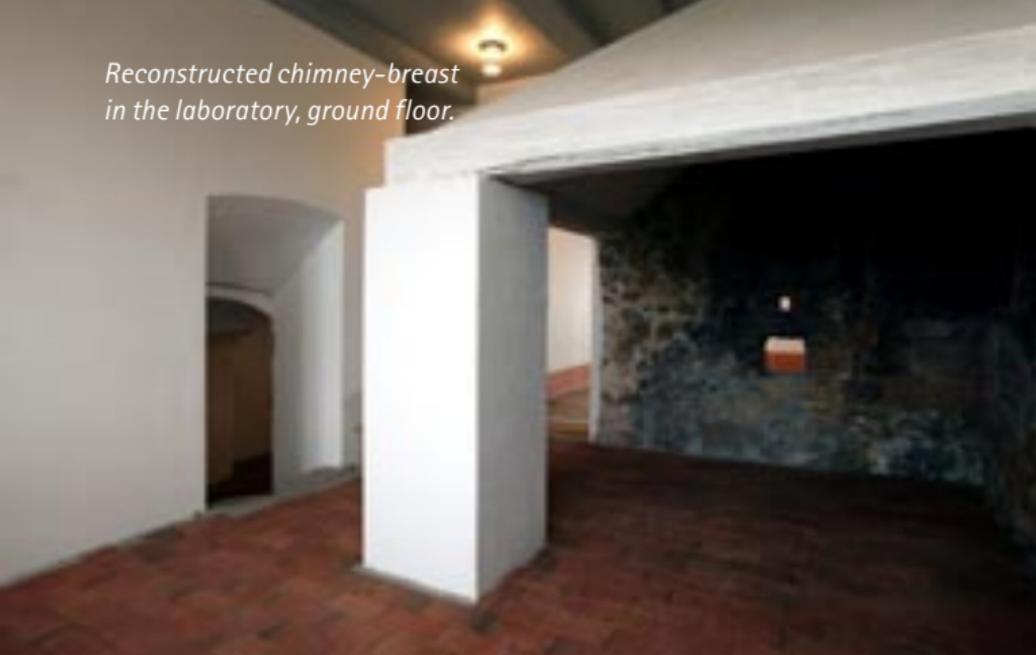
*Reconstructed chimney-breast
in the laboratory, ground floor.*

The oldest description of the buildings specifically mentions the size of the hearth in the laboratory: A large tapered chimney which passes up through the roof at the north end of the house, and is three-and-a quarter ells square (an ell was about 60 cm). Research on the partition wall and mid-

dle wall revealed traces of both the chimney breast and the beam which supported it. Research on the floor-supports gave unambiguous evidence of the location of the corner post. The chimney-breast was thus reconstructed, based on reliable evidence. It is a striking feature in the laboratory: medications were prepared beneath it. The actual hearth has not been rebuilt, but its size can be deduced from visible traces. In the fireplace are openings for fuel and smoke, which remain in their original form. The walls have recently been limewashed. In the laboratory is a brick floor dating from 1980. Also installed at that time are replica shelves for equipment used in making medical preparations. Both are based on old descriptions.

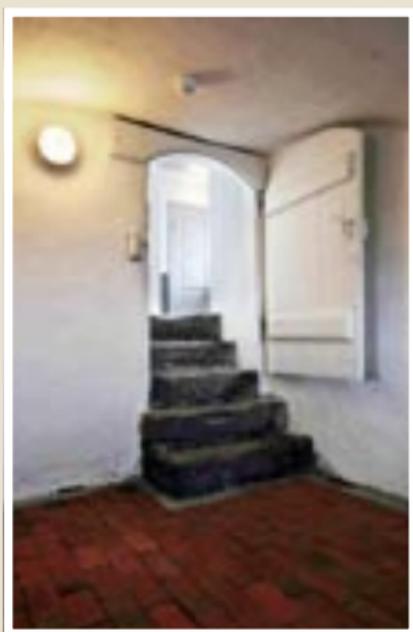
Original cellar stairs.

Over the cellar is a storage loft. The original form of its roof was deduced from traces found on the northern gable end of Nesstofa. The stairs to the loft are in their original location. The steps have been renewed, and the lower section can be removed, in accord with the original description.
