# Archaeological investigations in Hvalseyjarfjörður, Eystribyggð 2005

*Orri Vésteinsson*

Fornleifastofnun Íslands  
FS388-05301  
Reykjavík 2008

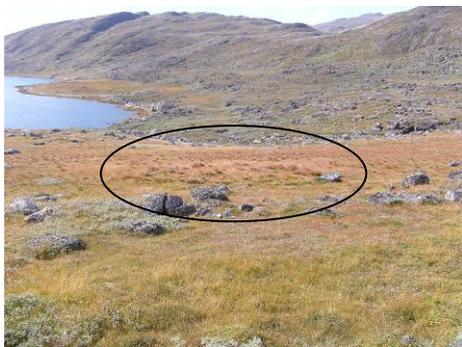
**Ruin 1, looking SW.**

**Ruin 1.** Multi-celled structure, some 15x10 m in size, with three cells in a row on the eastern side and two on the western. The ruin is

covered in high grass but stones are frequent and in places aligned rows. The ruin is low, suggesting a single rather than multiple phases of use.

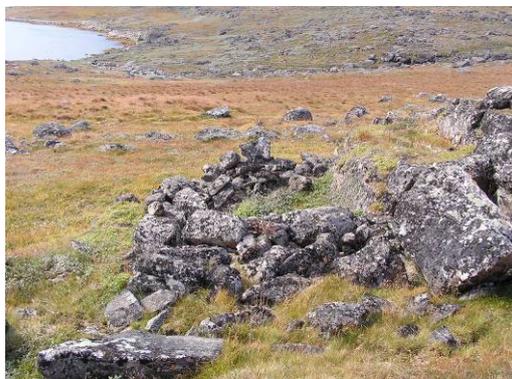
**Ruin 2.** A 4x3 m stone wall built at the side of a boulder. The wall is very thick (1-1,5 m) and mostly collapsed but in places survives up to 4 courses. No opening is discernible.

**Ruin 2, looking west. Ruin 1 in the background, to the left.**

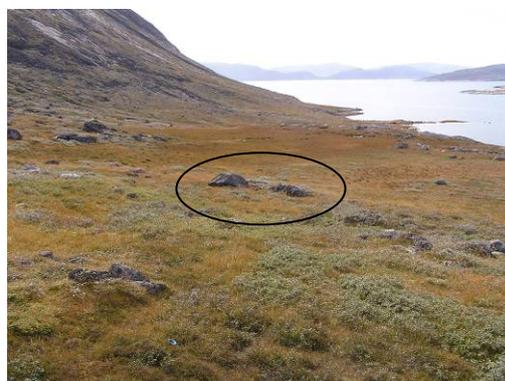
**Ruin 3.** A 4x3 m stone-built cell incorporating natural boulders in the construction. It has a door opening to the south-west and on that side there are in an area of c. 3x3 m traces of an additional or earlier structure.

**Ruin 3. Looking south, from ruin 2.**

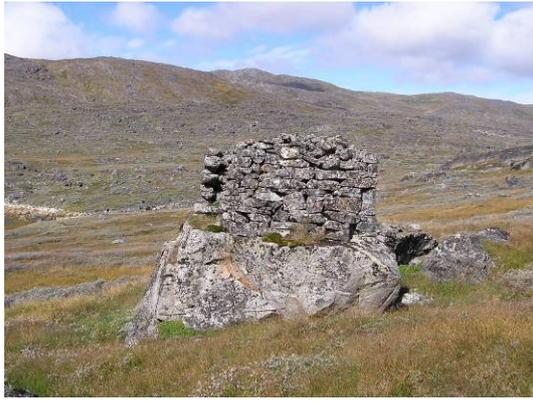
**Ruin 4a.** Perched on a nearly 2 m high boulder this rectangular (5x5 m) dry-stone construction survives up to 10 courses with the NW corner being best preserved and the north, east and west sides largely intact whereas the southern side is completely collapsed with only the lowest course surviving. The walls are c. 1 m wide and survive up to a height of 1,8 m. The surviving sides have no opening and it is difficult to see how the structure could have been entered without the aid of a ladder.

**Ruin 4a, looking west.**

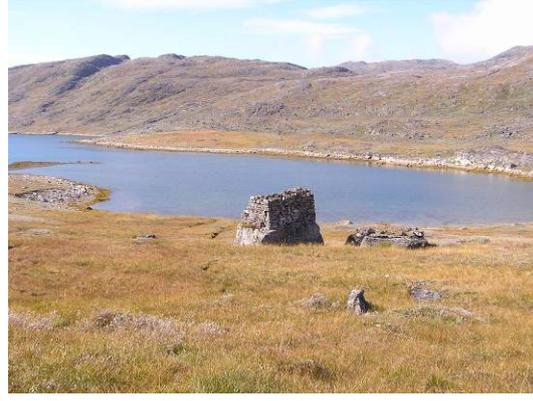
**Ruin 4a to the left and 4b to the right, looking southwest towards the main farm across the inlet.**

**Ruin 4b.** This seems to be the remains of a similar building on an adjacent but lower boulder which would have allowed direct access to the structure. Only a scatter of stones remain on the boulder. This ruin seems to be 4a's predecessor – robbed for the building of the other one. Judging from the remaining foundations this earlier structure does not seem to have been completely rectangular.

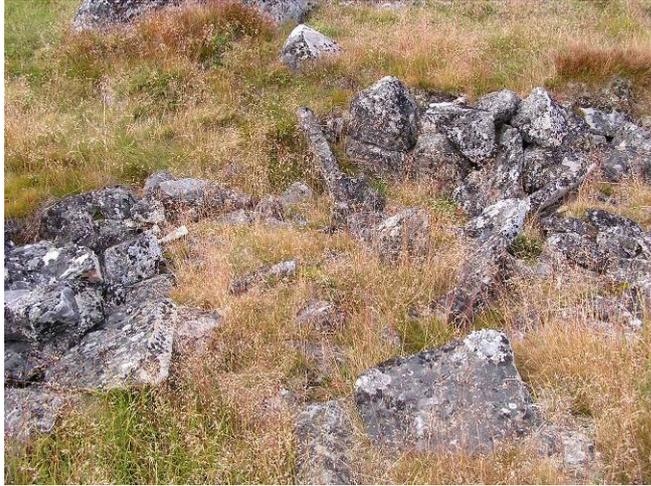
side). In the southern room there are still upright flat slabs suggesting that this was a byre and the larger room a hay-barn. It is remarkably similar to the byre and barn excavated by Jouko Voionmaa in Lundur in W-Iceland in 1939. The ruin is on top of a slight mound and remains of earlier phases can be detected on the eastern side,

**Close-up of stall partitions in ruin 5, looking west.**

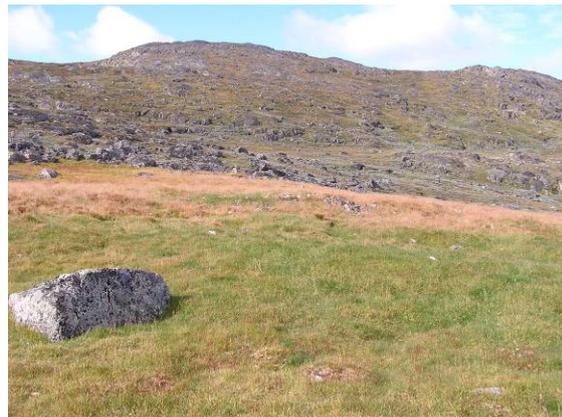
**Ruin 7.** The farm mound is quite extensive, 45x25 with up to eight definable cells, mostly lining up in a single row on the western half of the mound. The mound is inside 1 m high and does not seem to represent many phases of vertical phasing but its large area may be a function of horizontal displacement of buildings. Largely covered in vegetation but lines of stone

**The farm mound, ruin 7, looking west.**

as visible in places and one of the cells is full of collapsed building stone. There are also suggestions of more cells or rooms in other parts of the mound.

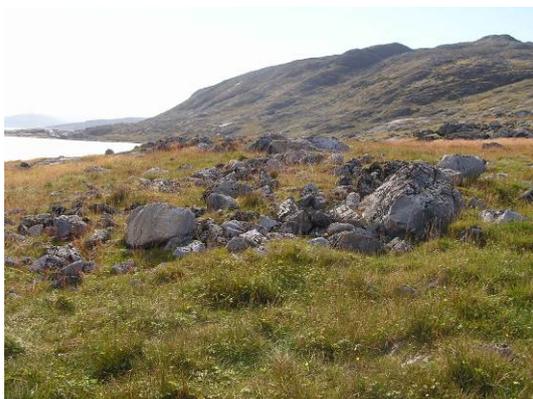
**Ruin 8, looking south. Ruin 8a on the crest to the left.**

**Ruin 8.** A stone-built rectangular building, completely collapsed, measuring 13x7 m. The walls seem to have been very wide, perhaps suggesting rebuilding. There are 2 large slabs among the jumble of stones which could have been used as stall partitions.

**Ruin 8a.** A 10x7 m pile of stone on exposed bedrock. It is possible that the foundations of north- and west walls are covered in soil and vegetation to the side of the exposed rock, in which case this may have been a small enclosure similar to 10. It looks like it has been robbed.

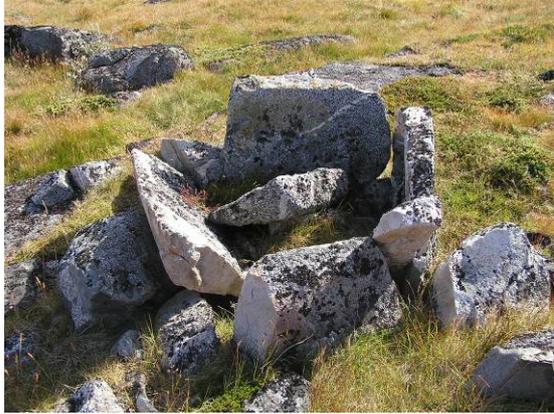
**Detail of the stone-box in ruin 9, looking east.**

**Ruin 9.** A stone-built house, 14x8 m, which may have been divided in two rooms. There is a well preserved stone box by the northeast corner. In Iceland such boxes are associated with storage and smithies, and this would in fact be a typical location for a smithy.

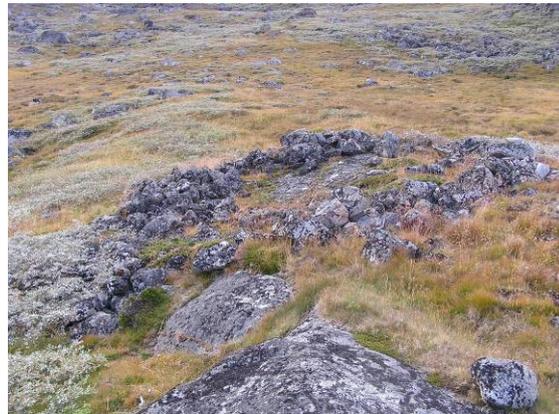
**Ruin 10.** Sub-rectangular enclosure built of stone on an exposed piece of sloping bedrock. It measures 15x10 m. There is possibly an entrance in the northwest corner. This enclosure is some distance from the main cluster of ruins, on the northern side of the brook.

**Ruin 10, enclosure, looking southwest.**

It has similar dimensions as comparable enclosures at Ø282 and Ø84.

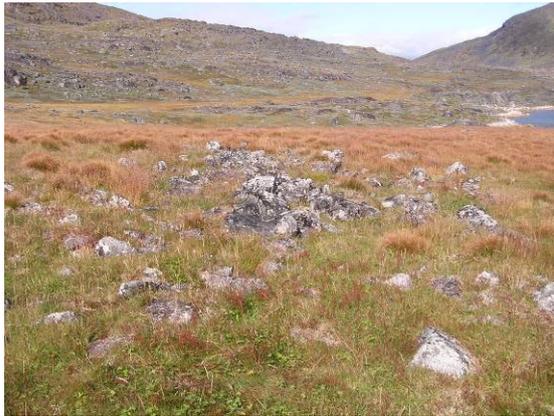
**Ruin 13, looking NNE.**

**Ruin 13** (7a in Berglund's report). A rectangular spread of building-stone, 15x10m, aligned nearly N-S. Seems rather too wide for a house, but too small for an enclosure. Its location at the corner of the farm mound would be consistent with a chapel but the alignment of the structure speaks against such an interpretation.

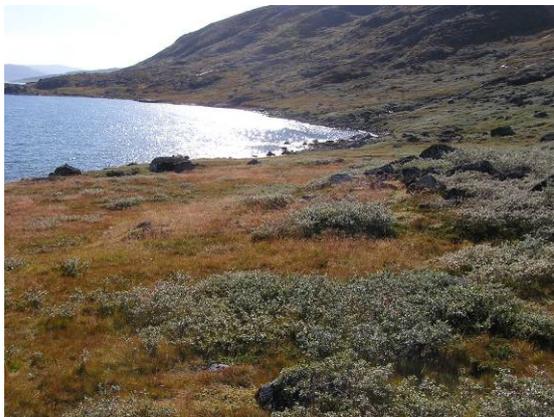
**Ruin 16 in the foreground, partially obscured by the willow. Ruin 17 above centre of picture to the left. Looking south.**

**Ruin 16** (13 in Berglund's report). A stone-built enclosure, ca. 10x10 m, with walls marked by double rows, but only a single course. No collapse is visible so either this structure has been robbed or the stone foundations never stood higher. Albrethsen detected a possible division of the structure in two halves, both with entrances to the east.

**Ruin 17** (14 in Berglund's report). A stone built structure, measuring 12x6 m, with a possible small cell on the southern end. Marked by a single line of stone, with only one course.

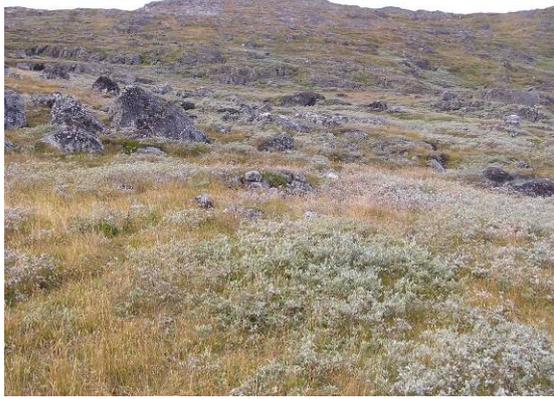
**Ruin 18, looking west.**

**Ruin 18** (9a in Berglund's report). A 10x6 m ruin divided into 3 cells. Stone facings are visible on the insides in the western half of the ruin, with the northwest cell most distinctive, with up to 4 courses of stone. A doorway connects it to a smaller cell to the east but the cell on the southern end has no discernible entrance.

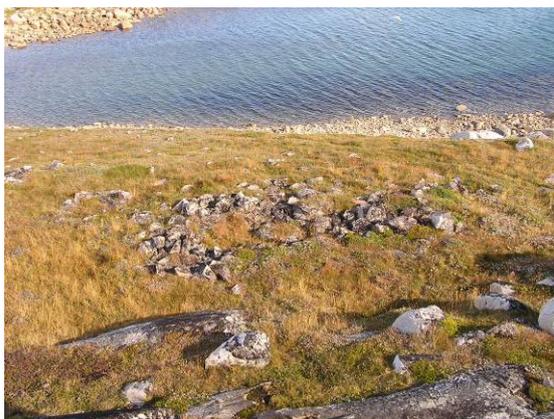
**Ruin 11, looking east.**

**Ruin 11.** On a narrow ledge, some 75 m SSW of the farm mound (12) this ruin is at the extreme end of lowland on the western side of Kanasut inlet. It measures 15x5 m and is divided in three cells. The middle section is largest and built largely of stone while the cells to either end of it are smaller (the northernmost is tiny) and seem to have more turf.

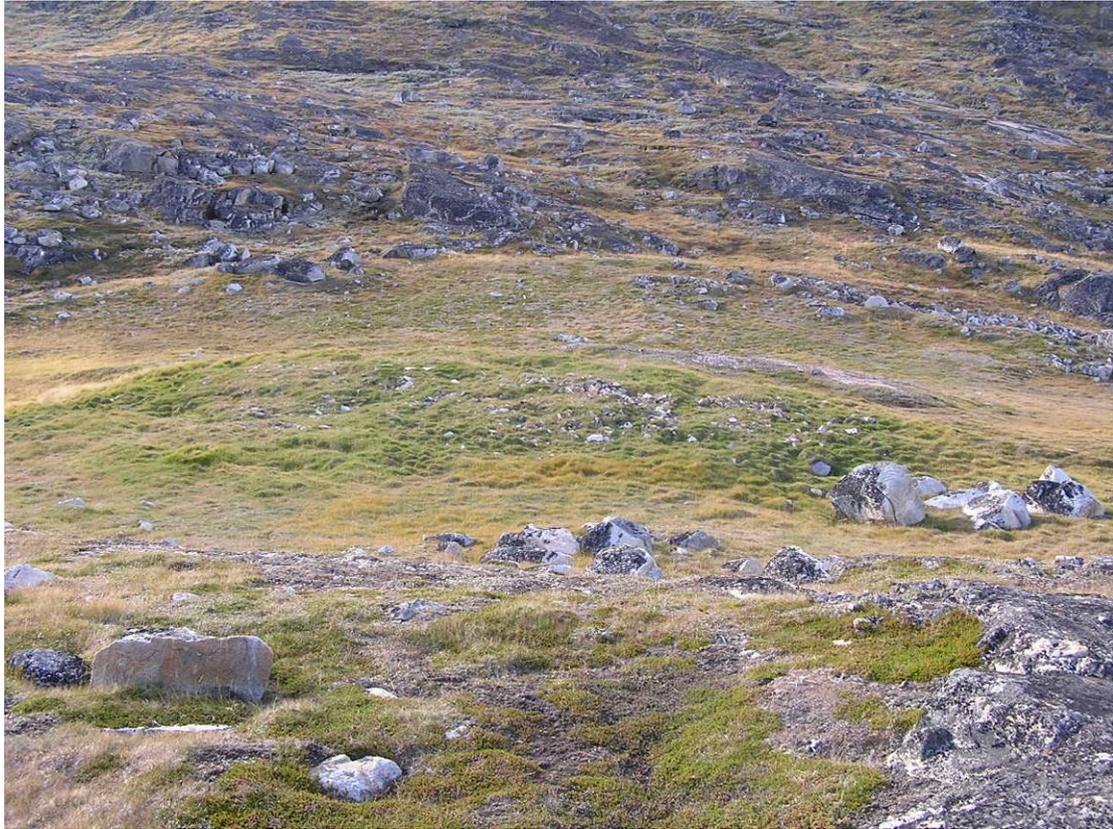
**Ruin 12, looking west.**

**Ruin 12.** The farm mound of the fjord farm is the most substantial ruin in the whole of at Ø80. It measures some 40x30 m, and unlike the mound (7) at the main farm, seems to be the result of substantial build-up of structural debris. The thickness may be as much as 2 m but the mound has accumulated on a slope so the actual thickness of deposits may be less. On top some 6 sub-rectangular cells are visible, all measuring 3-5 m a side, arranged in two parallel rows. Some lines of stones are visible and there are scatters of stone here and there but mainly the mound is covered in grass.

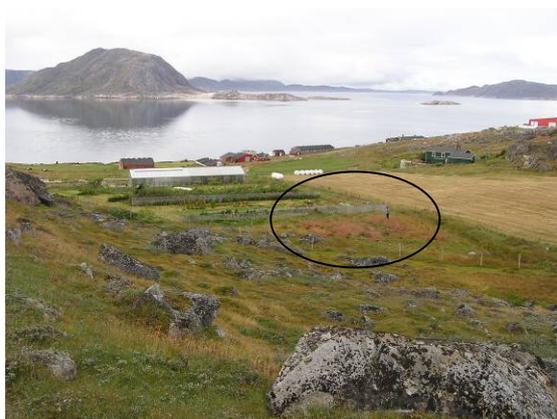
**Ruin 1, looking southwest.**

seen behind the green-house which is highest up the slope on the eastern side. There is also a sizeable bump where no 7 is marked, but no house shape can be discerned there anymore – stones from the field have been piled up there and damage no doubt made to the ruin in the process. Ruin 1 is elongated, possibly divided in 3 rooms with 1-2 annexes to

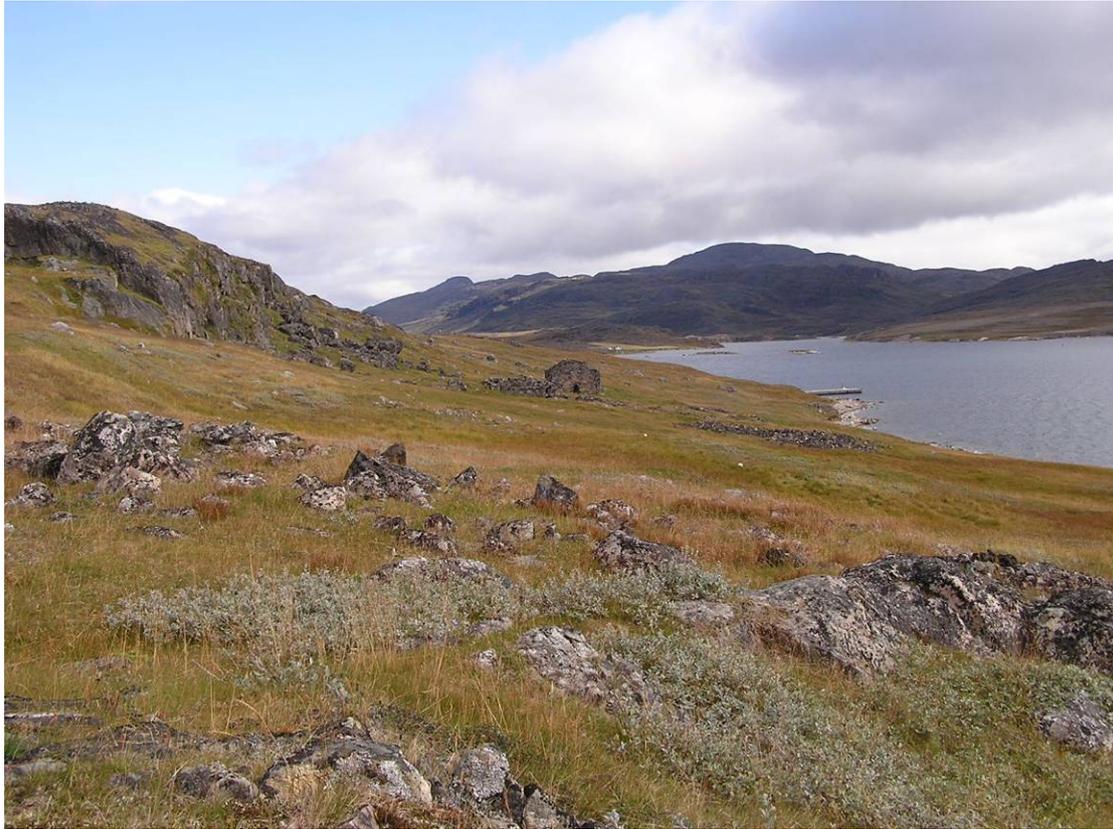
I failed to identify ruins 2-5 and the well does not look like a man-made feature – more like a natural spring. There are more springs (or rather upswells of groundwater from underneath the slope) further up and further west in the home-field so there is not an apparent lack of water sources – although this can of course be changeable according to season and precipitation. I made a very rough measurement of the home-field which seems like it could have been some 8 ha. Large parts of that area have only very low growing grass – even at the end of summer – and large parts are also quite stony. There is really only a 2-3 ha area SW of the farmhouse where the grass grows to any considerable height. This part is essentially wetland although not very boggy. In addition to the home-field, with no doubt variable off-take, there will have been meadows, e.g. northeast of the circular enclosure (14) and further west (of ruin 1) where there is now a short stretch of flat *mói* with low vegetation before the coastal strip narrows and turns into a scree with surprisingly lush vegetation. In places the willows grow to more than 2 m. While this represents greater hay-making potential than at any of the other sites visited in Hvalseyjarfjörður in 2005, it is not much if cows made up a sizeable proportion of the 15 heads of cattle, which Roussell found room for in the two byres. This only adds up if

**The home-field in Hvalseyjarfjörður farm, looking eastwards towards the church (8)**

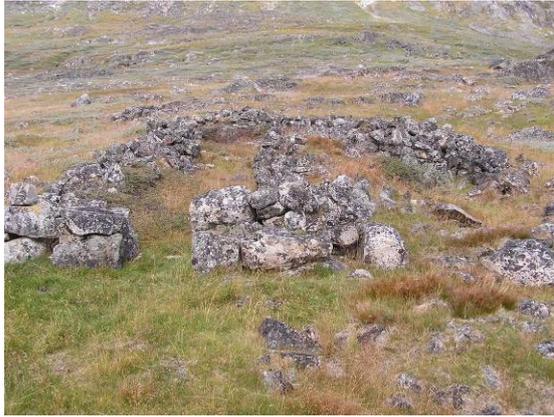
**Ruin 1, possible byre at the western edge of the home-field, looking north.**

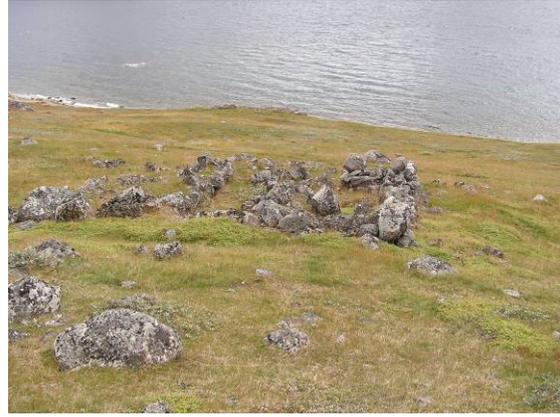
**Ruin 11, a possible stable, looking south.**

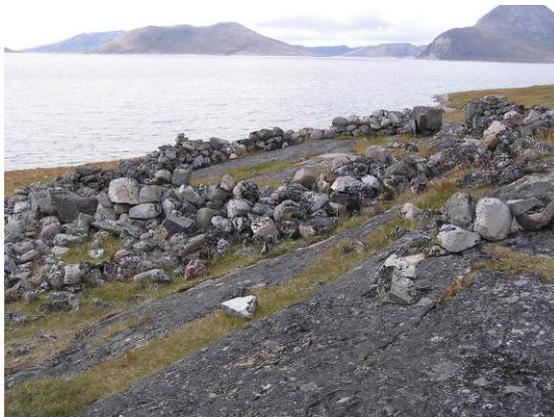
**Ruin 14, a circular enclosure, looking west.**

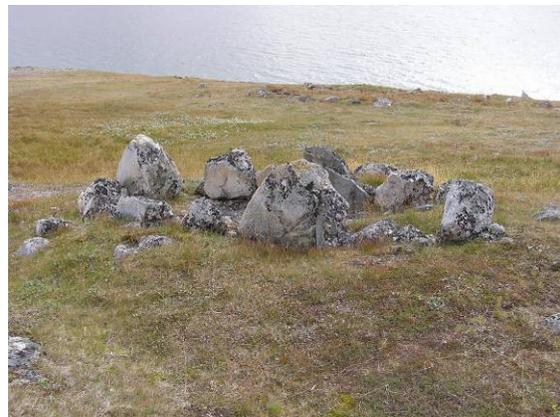
**Ruin 15, "Gröf Þorsteins farsærks", looking south.**

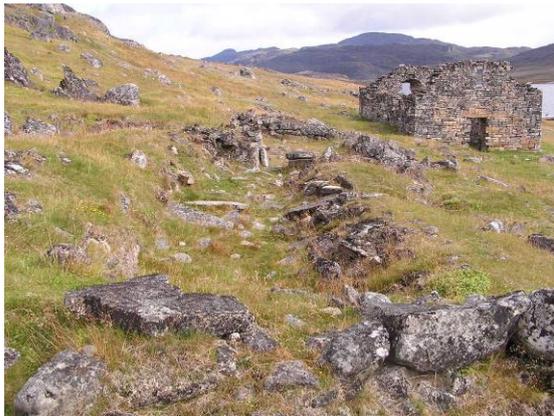
**Ruin 7, a byre in the central complex, looking east.**

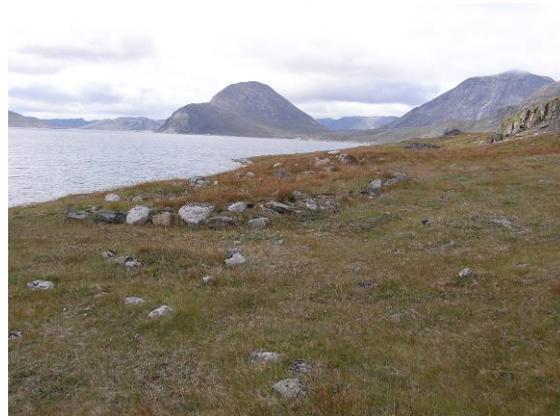
**Ruin 13, a possible stable, looking west.**

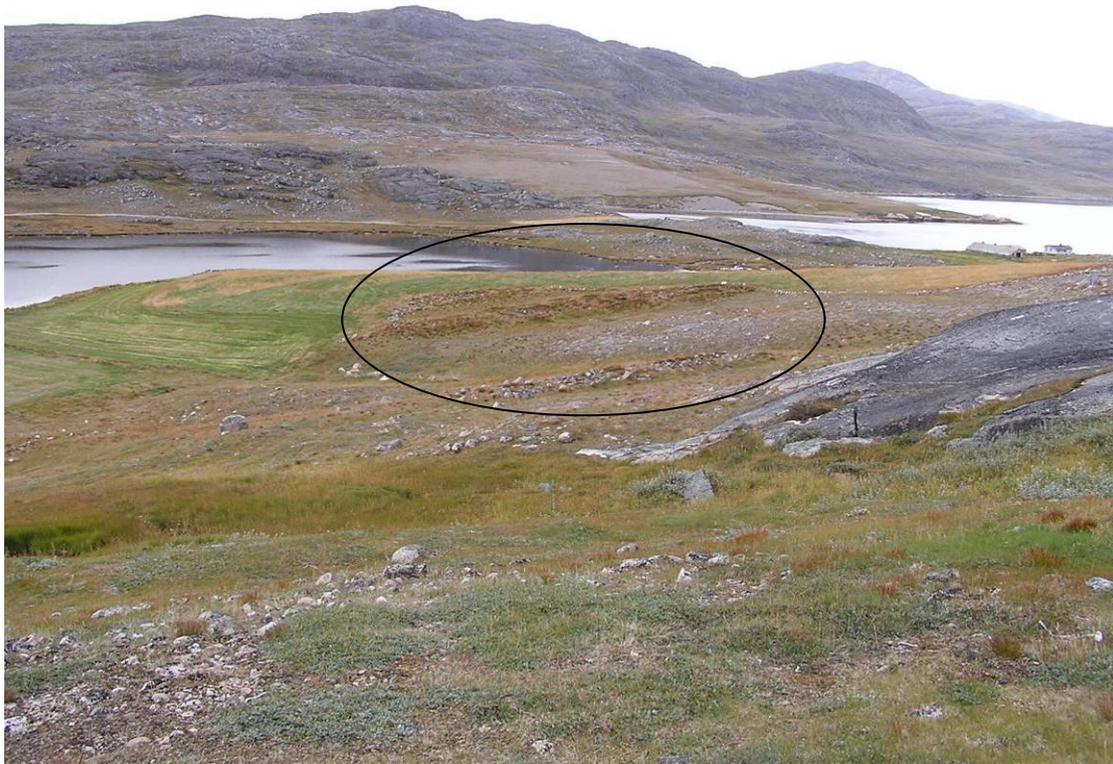
**The central cluster of ruins in Ø83a, looking southeast. Ruin 22 in the foreground, 20 in the middle and 21 along side it.**

trenches along wall-lines – and in places through walls it seems – attesting to his activities. This building clearly has different phases. The lower (northern) end has compartments with separate entrances which are not an integral part of the complex and there are also signs of rebuilding in the main complex. This massive building is on an incline, sloping from south to north, whereas ruin 21 is more or less level. Ruin 21 is also wider on the inside, 3+ metres instead of 2+ metres in 20, perhaps suggesting that ruin 21 may have been a dwelling. There is a trough-like structure along the centre of the floor in what would be the hall (second room from the south) in ruin 20, with some 40 cm between rows of stones creating edges on either side. This is too narrow, whether for a central aisle of a dwelling or a paving in a byre, and there must be another explanation for it. It is reminiscent of a similar structure in one of the buildings in Pingnes although there the distance between was even less.

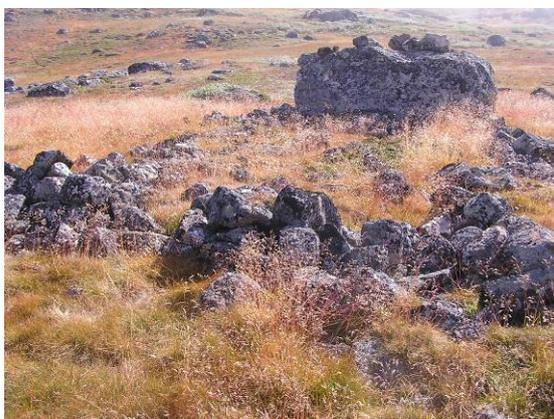
**Ruin 1a, looking east.**

**Ruin 1a** is a stone-built house or fold, 8x5 m, with an entrance to the northwest. Its south-eastern end abuts a large sub-rectangular boulder. There are also stones on top of the boulder and a wall stretching south-westwards from it.

**Ruin 1b** is a 9x6 m pile of stones in front of the entrance to 1a. Both 1a and 1b are clearly built on the remains of earlier structures.

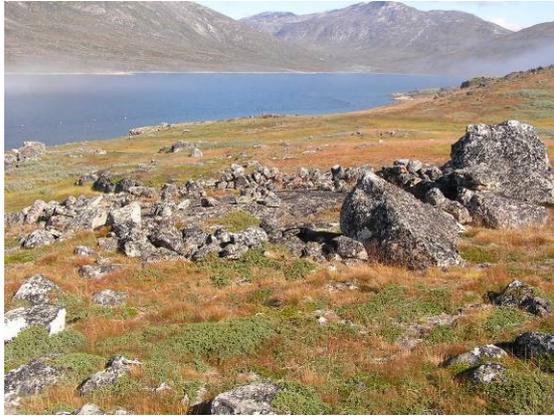
**Ruin 2.** A sub-circular enclosure measuring 14x10 m, built of stone on exposed bedrock. The northern side has collapsed onto the rock but the southern side incorporates 3 boulders and here there are up to 2 courses.

**Ruin 2, looking ENE.**

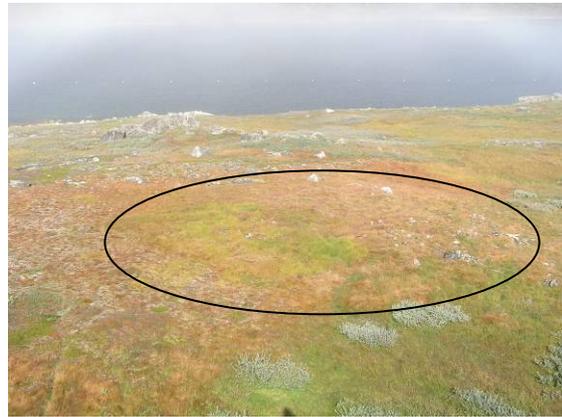
**Ruin 3.** The farm-mound is quite extensive (30x20 m) and is completely over-grown although single course wall-lines can be discerned, describing a cross-shape. The mound is ca 1 m thick. There is a very green patch on the upper/western side, no doubt a midden, and another, not as pronounced, on the north-eastern side where it merges into a bog which separates the farm mound from ruin 4. This latter midden has potentially organic preservation.

**The farm mound, ruin 3, looking north.**

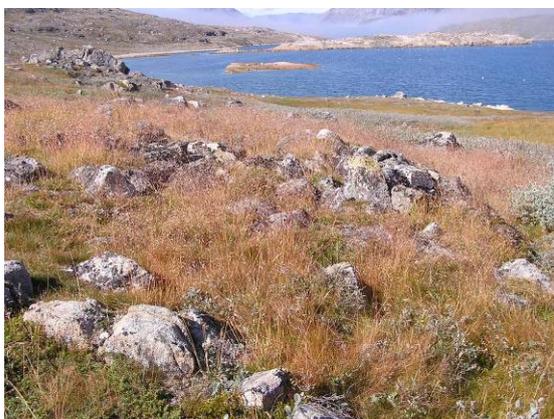
**Ruin 4** is built of stone on a small dry patch in the middle of the bog. It is completely collapsed. It measures 8x6 m.

**Ruin 4, looking west.**

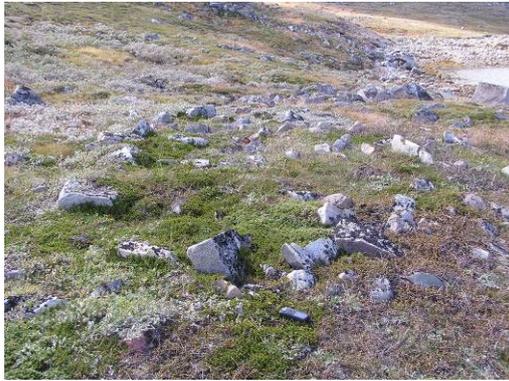
**Ruin 6, looking west.**

**Ruin 6.** In Vebæk's description he talks about ruin 6 as the fold up in the mountainside east of ruin 5 – and there it is, here labelled 9. On the plans however ruin 6 is shown down by the shore, west of the other ruins. It is really only a scatter of stones forming an oval, 8 m long and 4 m wide.

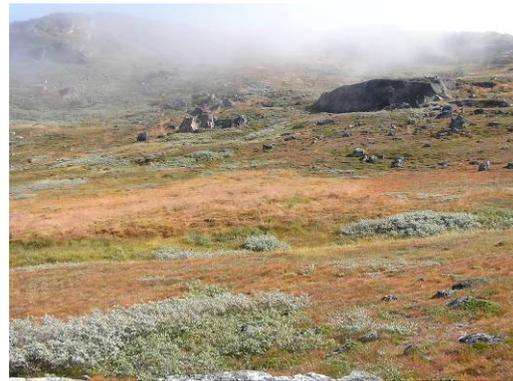
**Ruin 7** has not been registered before. This is quite an extensive series of bumps at the upper end of the home-field. It may be a farm-mound or a cluster of turf ruins which have fused into an amorphous mass. There are several depressions but nothing

**Ruin 7 is indicated by the paler, higher growing grass. Looking ESE. Ruin 9 is under the large boulder upslope to the left.**

which can convincingly be suggested as rooms or cells. The ruin is covered in grass. There is just a scatter of stones at its NE end where a red-painted stick has been placed to mark the place (such sticks are by most of the ruins). It is some 40 m long and 20 m wide.

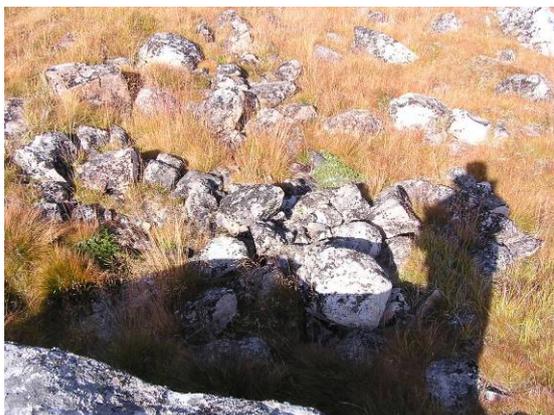
**Ruin 8** is a pile of stones on the slope northeast of ruin 1. It is at the edge of the home-field, adjacent to a large boulder.

**Ruin 8, looking west**

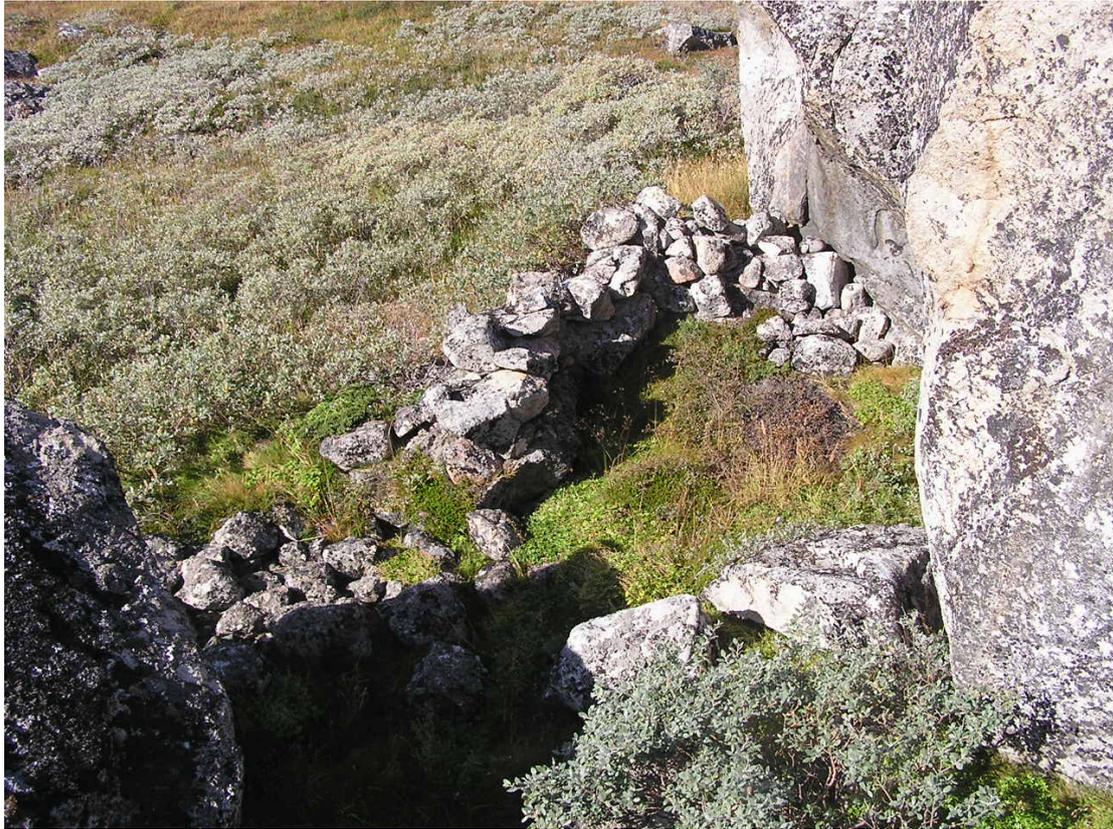
**Ruin 9, looking west.**

**Ruin 9** is a 7 m long stone-built wall creating a small pen in between three large natural boulders on the slope north of the home-field. There are three courses still standing but the wall never seems to have been much higher. There is a gap in the wall and south of that it has collapsed completely.

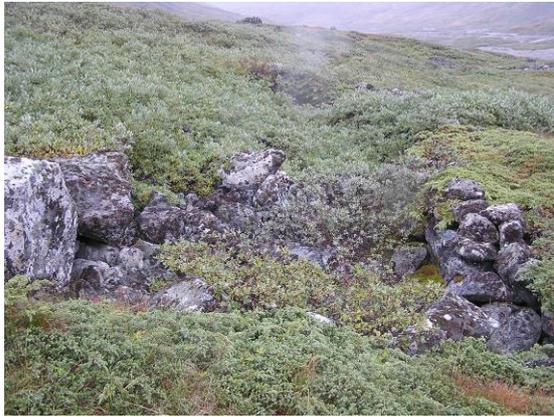
**Ruin 1** is 13x6 m, aligned north-south and built up against a low rise. There are up to 4 courses in the stone walls on the inside but these are largely collapsed. There is a doorway on the southern side of the eastern wall.

**Ruin 1, looking northeast.**

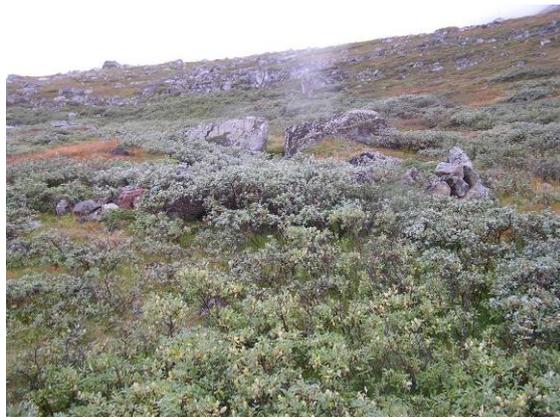
**Ruin 2** is 17 m southeast of ruin 1 and is aligned more SSW-NNE. It measures 12x8 m and the stone built walls survive up to three courses in the NNE gable. The SSW gable is partly formed by two large natural boulders on either side of the entrance.

**Ruin 2, looking southwest. The two large boulders form the SSW gable.**

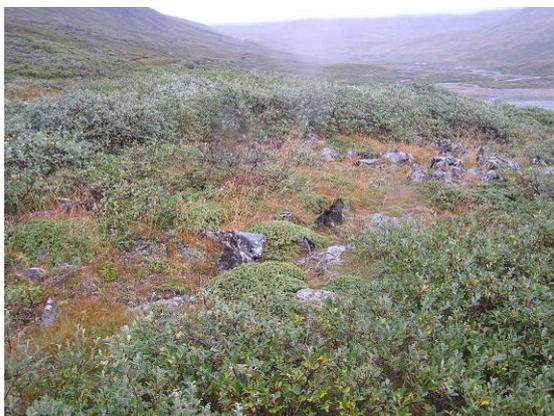
**Ruin 3** is 70 m NNE of ruins 1 and 2. It is almost 30 m long and 10-15 m wide. Collapsed stone walls indicate at least 2 cells but this has clearly been a complex building with more than one phase.

**Ruin 3, collapsed walls, looking NNE.**

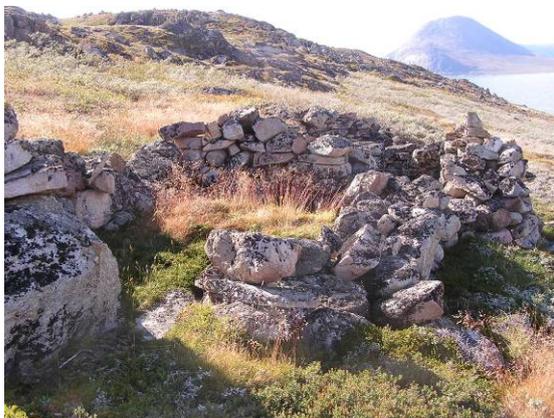
Ruin 1, the easternmost cell in the foreground, looking west.

completely missing but the western half is built of stones and is deliberately rounded off, indicating a doorway. The two easternmost cells both have doors to the north. The stone walls are still standing to a remarkable degree, typically 4-5 courses while the northern wall of the second cell from the east has 8 courses, standing to 1,7 m.

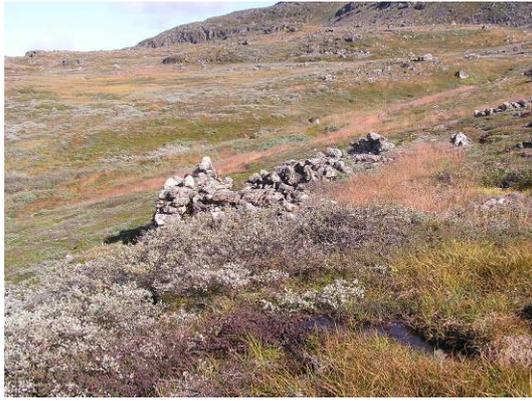
**Ruin 1, spring in foreground, looking ENE. Ruin 2 can be seen on the right hand edge of the picture.**

There is a tiny stream emerging from a spring some 10 m south of the ruin's southwest corner, running tight by its western gable.

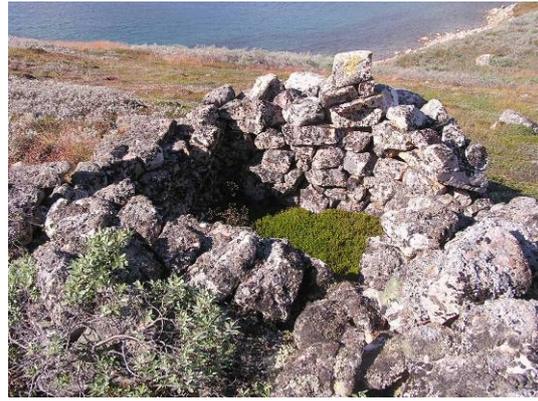
**Ruin 1** is the larger and more westerly of the two. It is 17 m long and mostly 5 m wide. It is formed by a row of four cells, all built of stone apart from the western and northern sides of the most westerly one. These have been built of turf and are overgrown. The eastern half of the north wall of the second cell from the west has presumably also been built of turf, or possibly wood, as it is

**Ruin 1, detail, looking northwest.**

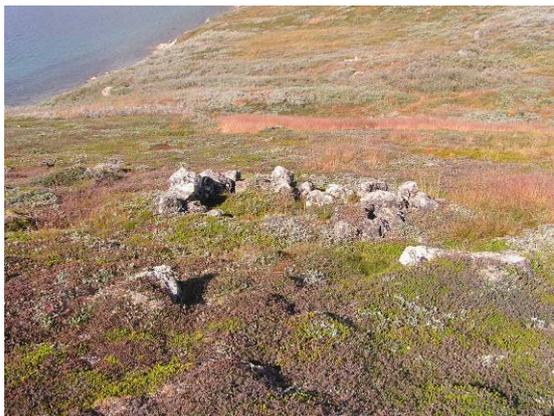
**Ruin 2** is 15 m east of ruin 1. It is a single cell, measuring 3x2 m on the inside, completely level with the ground.

**Ruin 2, looking north.**

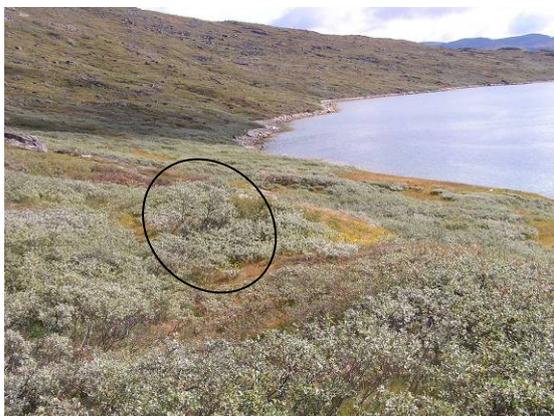
**Ruin 1** is elongated, divided in two with a possible entrance on the western side by the partition wall. It is built of turf and stone, the walls fully collapsed, measuring some 18x7 m.

**Ruin 1, looking southeast over the home-field.**

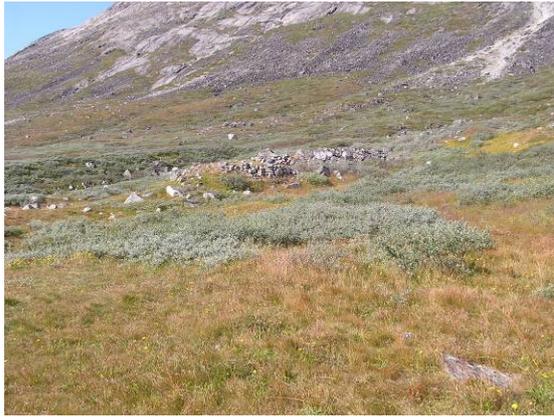
**Ruin 2** is a stone-built circular enclosure constructed at the end of a great scree deposited by the river on its eastern bank. It is some 17x15 m in size, built on a

**Ruin 2, looking northwest.**

south-facing slope, with an entrance on the southern, lower, side. The dry-stone wall is standing up to 1,5 m, 5-6 courses in the northern and especially southern sides, but quite collapsed in places.

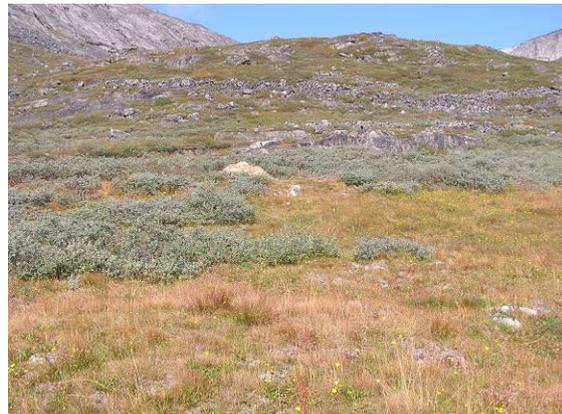
**Ruin 3** is covered in high willows and is difficult to make out except as a 23x13 m elongated mound, probably divided into several cells with a few stones visible but none that arrange themselves into clear wall-lines. This structure has been disturbed by a large pit dug into its

**Ruin 3, looking north from ruin 5, covered by the willow to the right of the whitened up-cast heap. Ruin 9 can be glimpsed on the cliff in the upper right hand corner.**

south-western corner in connection with the planned power-line. Building stones could be seen in the up-cast heap but no

other anthropogenic materials could be seen on the surface of the heap or in the exposed sections of the pit. While such superficial examination is hardly conclusive

it does suggest that ruin 3 cannot have been a dwelling.

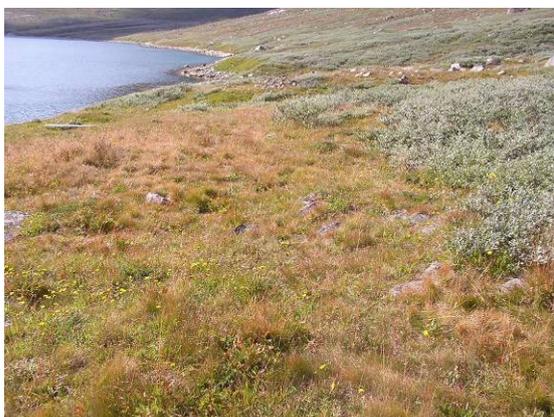
**Ruin 4, looking west.**

**Ruin 4** is an elongated ruin measuring 13x8 m with a small additional cell attached to the south-eastern corner, measuring 3x3 m. The ruin is overgrown with only a few stones scattered about.

This ruin may have more than one phase.

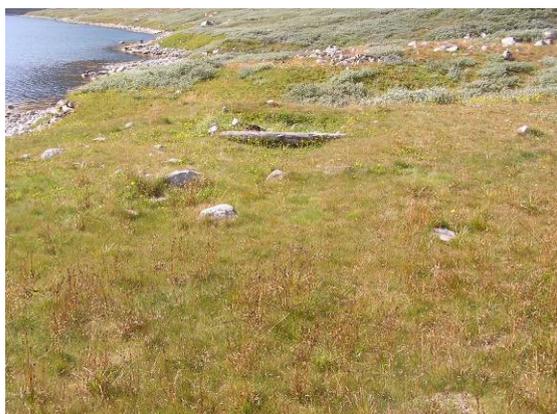
**Ruin 5** is a smaller elongated ruin just south of ruin 4. It is similarly overgrown and measures 9x6 m. There is a possible entrance on the eastern gable.

**Ruin 5, looking west. Ruins 6-7 on the farm mound in the background.**

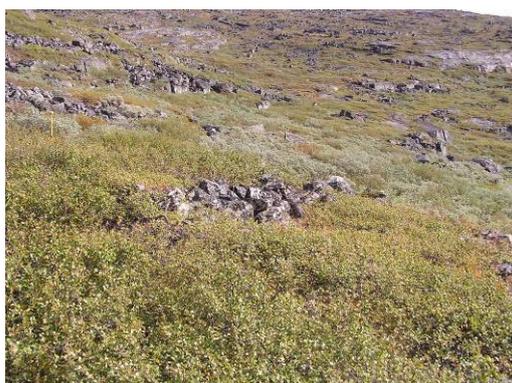
**Ruin 9, looking northeast.**

**Ruin 9** is a heap of stones on top of a rocky outcrop northeast of the main cluster of ruins and outside the home-field proper. A place for a *hjallur*.

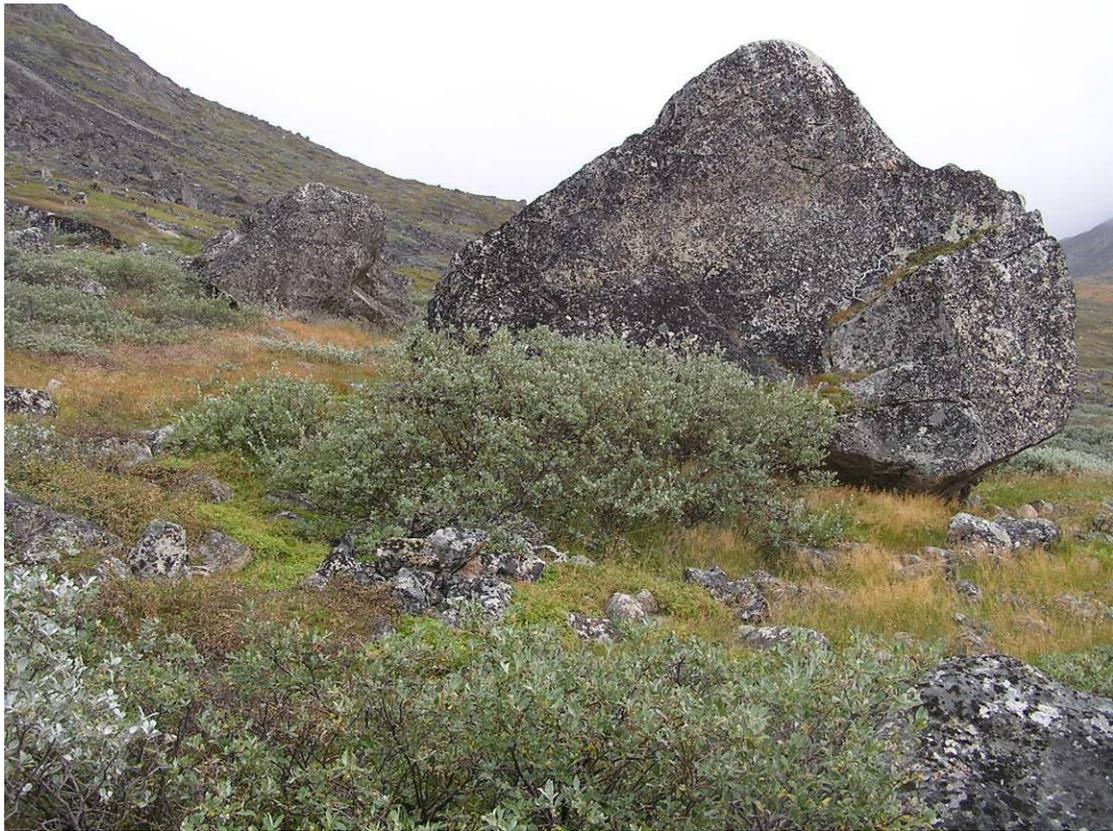
**Ø283 looking ENE. Boulder is A in the foreground to the right with putative walls in front, but boulder B in the background to the left.**

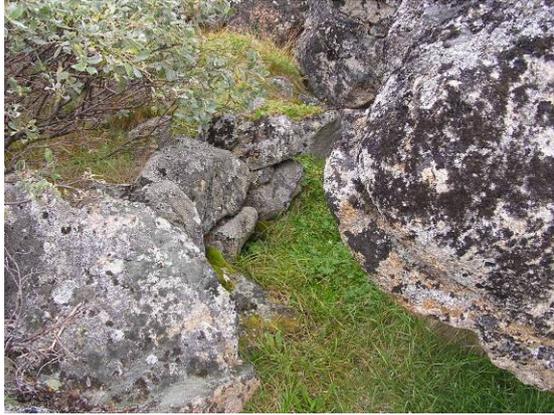
**Close-up of the wall under boulder B, looking north.**

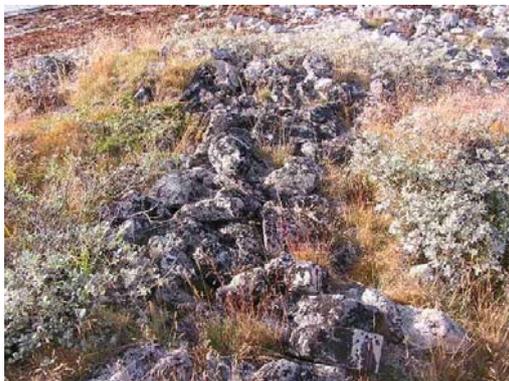
**Detail of collapsed wall on the farm mound, looking north.**

**Ruin 1** is clearly a farm mound, some 25x13 m in size and 1,5 m high. It is eroded on all sides except the south and stones from walls

western, seaward side. The eastern side is presently stable and overgrown but it is clear that the river has previously taken chunks from the mound and will do so again in the future. At the northern tip of the mound there are distinct wall lines, completely collapsed though, but the southern edge is more diffuse and merges gradually with the home-field.

The farm mound (ruin 1) is on a small ridge causing a kink in the river just before it reaches the sea. The mound has been eroded on both sides, to the west by the sea and to the east by the river, but this does not appear to be progressing very rapidly. Neither does the erosion on the seafront seem to be severe – there do not appear to have been major changes since 1972 when the first map was made. It may

however be gradual and this site could therefore do with a rescue operation sooner or later.

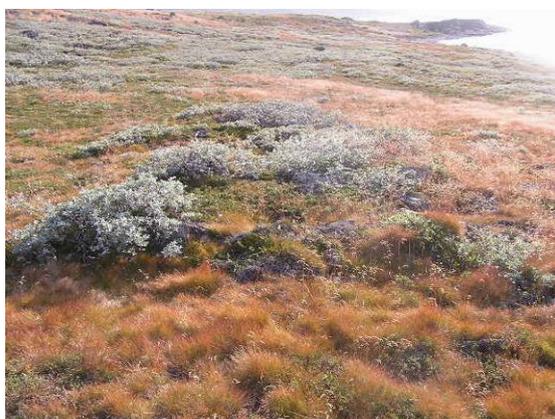
Ruin 2, looking SSW.

**Ruin 2** is elongated, measuring 13x7 m. A kink in the northwest wall may indicate some internal division but this is not discernable on the inside, where there is a scatter of stones in no apparent order. The 1972 survey describes this ruin as “boliglignende” but as it is on a

slight incline it seems more likely to have been an animal stable.

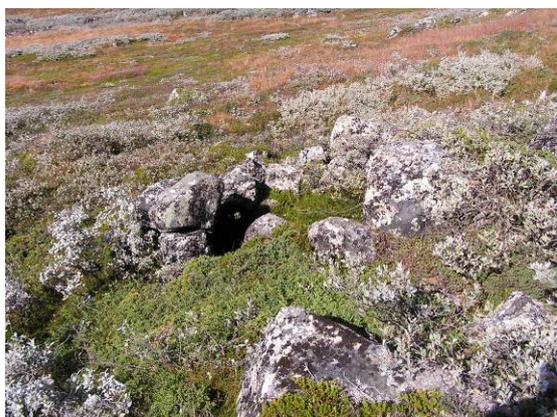
**Ruin 3, looking northeast.**

**Ruin 3** is an L-shaped stone wall built against a boulder at the edge of the home-field. It forms a tiny pen, some 2x1,5 m on the inside, with a narrow entrance on the south side.

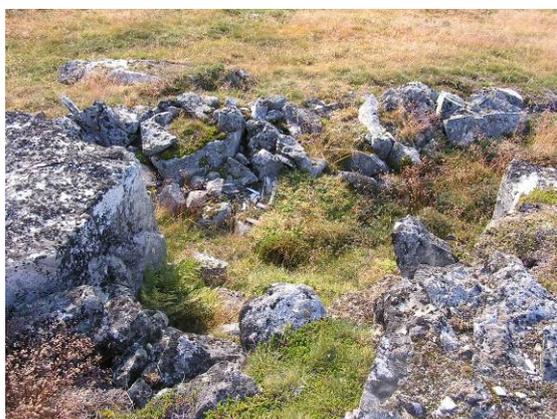
**Ruin 1, looking west.**

**Ruin 1** is a stone walled pen built against a 2-3 m high rocky outcrop. At the front there is a 10 m long wall with an opening in the middle, completely collapsed. A smaller wall, 1 m long, fills a gap between the cliffs at the back and this is more or less completely up-

standing. Further back there is a hint of a third wall, some 1,5 m long.

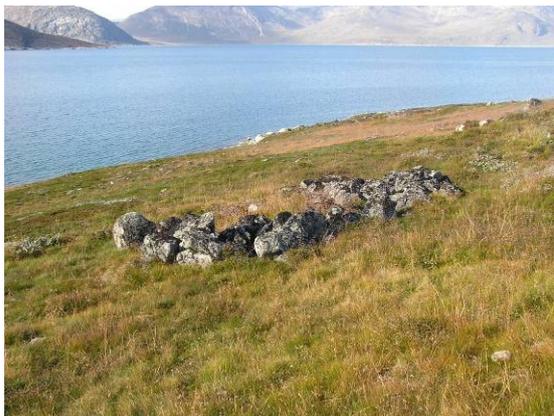
**Ruin 2, looking northwest.**

**Ruin 2** is 20 m down-slope from the pen, a 7x4 m stone-built rectangle with up to 2 courses surviving, but very little collapsed stone around, suggesting that the upper courses were made of turf. This may have been a small hut or a pen.
