SURVEY POINTS AT HIGHLAND HOUSE, SEAVIEW, CODRINGTON AND RIVER IN BARBUDA

REYKJAVÍK 2011
FS458-11031

FORNLEIFASTOFNUN ÍSLANDS SES
INSTITUTE OF ARCHAEOLOGY, ICELAND

This report gives an overview of one aspect of the DGPS survey, which is the establishing of a base station and other reference points on Barbuda as well as the surveying of other points of importance.

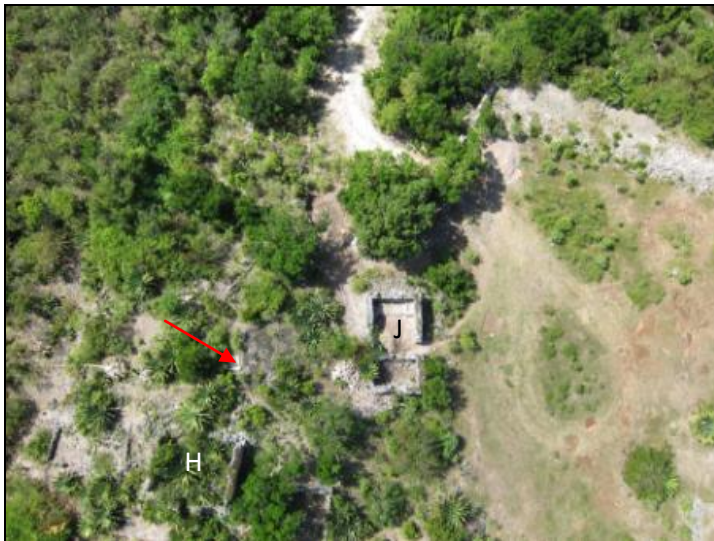
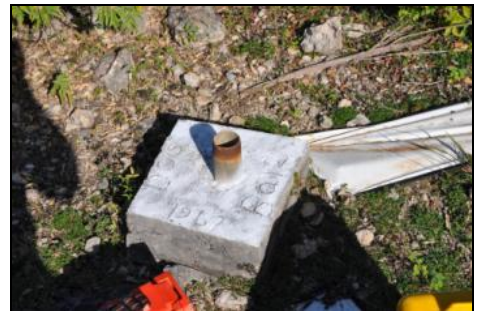
Figure 1. Station Ba12 at Highland House. A: Kite AP of Ba12 south east of house J. Arrow points at station and north. B: Close-up view of Ba12, looking east. (Photos FSI.)

The coordinates for the base point, Ba12, at Highland House were established from a 248 minute run of the DGPS base antenna over Ba12 (centre of the iron pipe), antenna height measured from the top of the pipe. Height of Ba12 was calculated with the base antenna at Ba12 and rover antenna at station C1 on the jetty in Codrington harbour using the height of C1, 0,76m, as established in a 2009 survey carried out in advance of a construction of a fishing factory by the harbour. Reference to Ba12 hereafter, unless otherwise stated, is with the following coordinates and height.

Name	Description/Remarks	E	N	Height
Ba12	Concrete block with vertical iron pipe. 12,1 m SSE of structure J and 6,2 m W of structure H (Watters '85 number 5 and 6 respectively). Centre and on top of pipe.	628.312,117	1.953.610,452	37,165

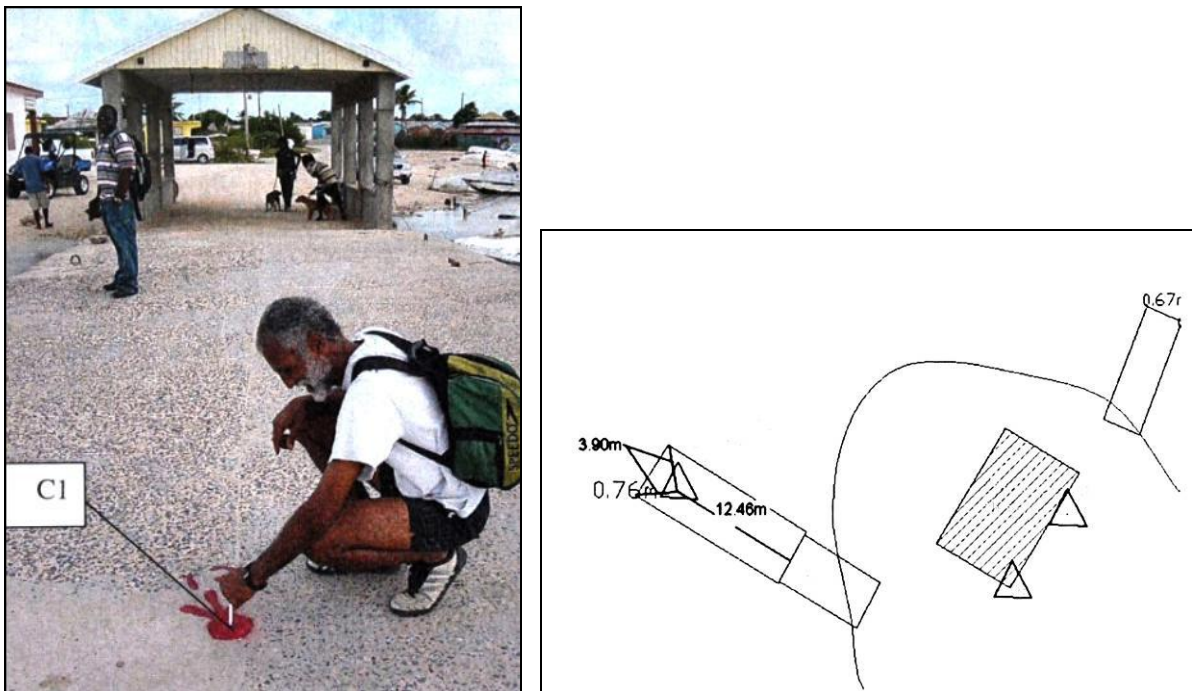
Figure 2. Station C1 on the jetty at Codrington harbour. (Figures from Survey at Project Site 2009.)

Coordinates for station C1, a point on the concrete jetty in Codrington harbour, was established with the rover antenna and the base antenna at Ba12. Height taken from survey conducted in 2009 in preparation of fish factory construction.

Name	Description/Remarks	E	N	Height
C1	SS Steel screw in concrete jetty at Codrington harbour. 12,46 m W from shed and 3,9 m from each outer W corners of jetty.	624.207,616	1.950.989,464	0,760

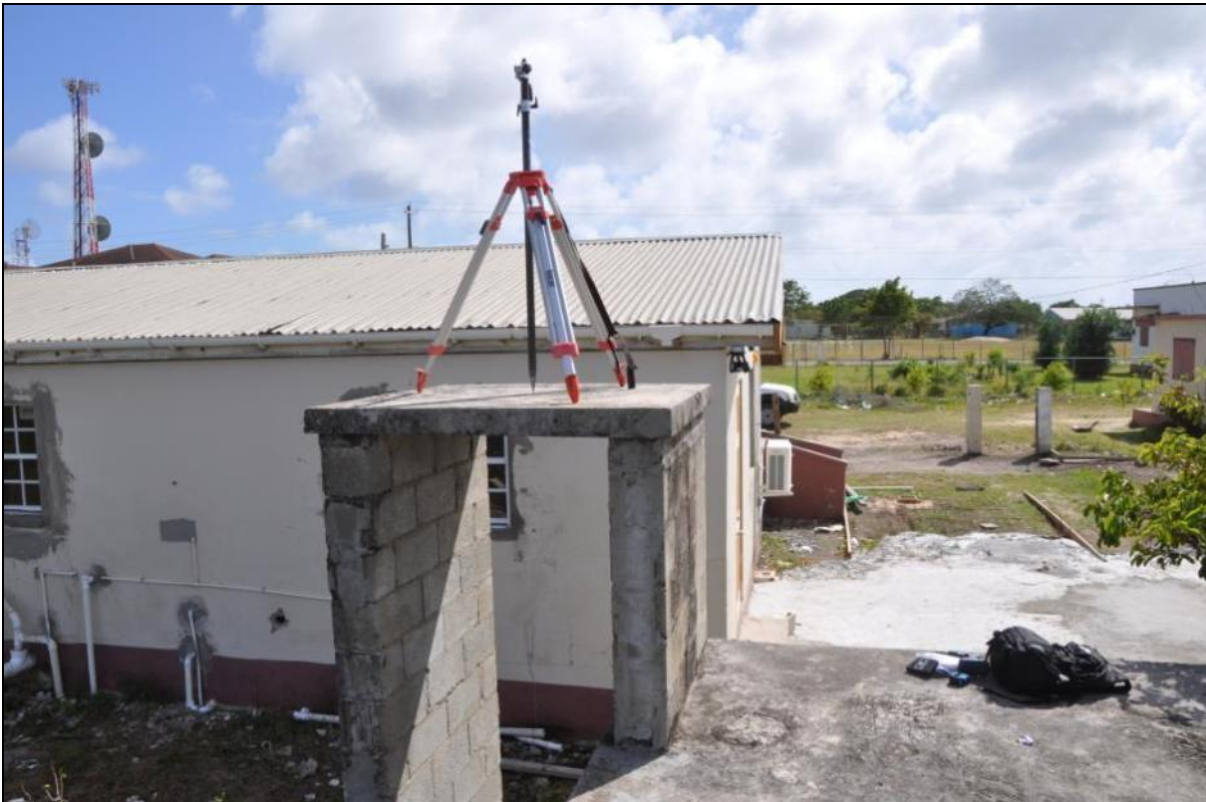
Figure 3. Point BCL01 at Brooklyn College laboratory building. Looking south. (Photo FSI.)

A point by the Brooklyn College laboratory building in Codrington was also measured in with the rover antenna and the base antenna stationed at Ba12.

Name	Description/Remarks	E	N	Height
BCL01	Steel bolt in centre on “roof” of concrete “doorway” or “gate” adjacent to a cistern N of NW corner of lab building.	624.479,473	1.950.962,151	4,993

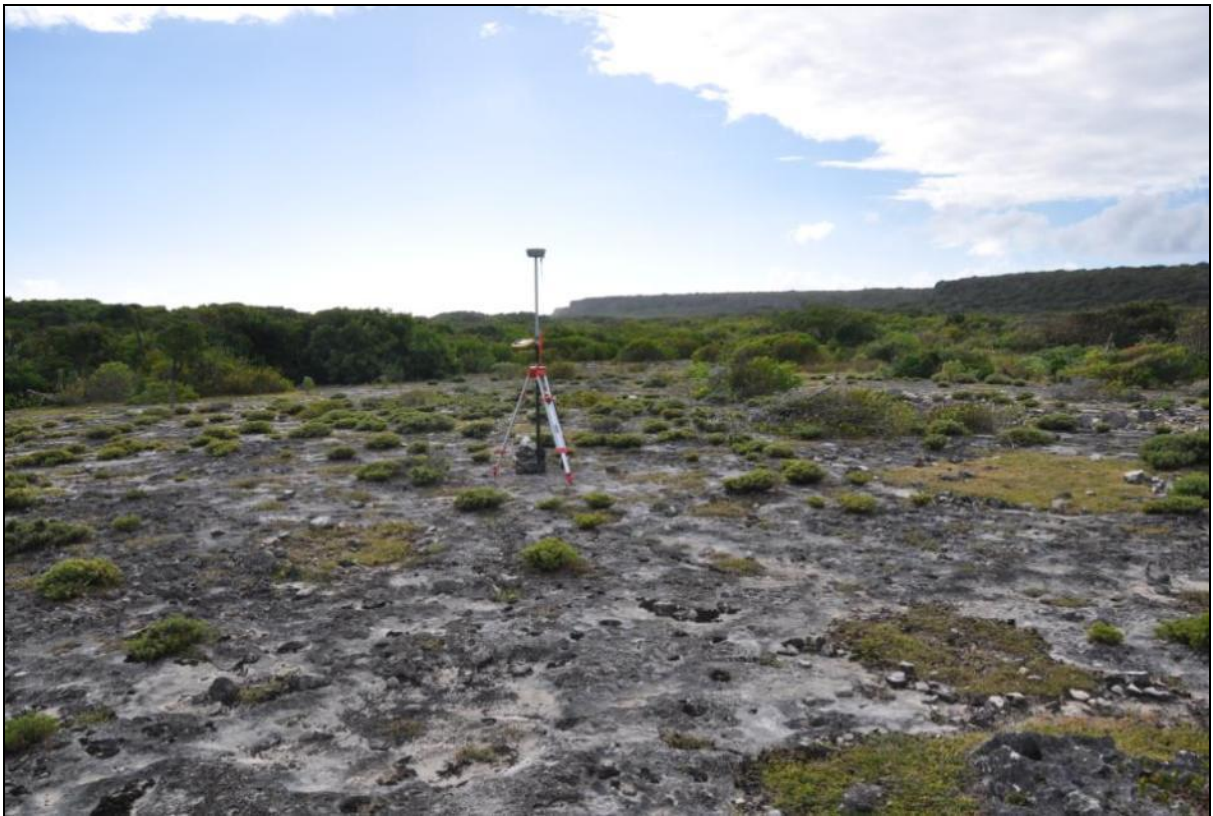
Figure 4. Station SV1 at Seaview. Looking SE. (Photo FSI.)

Name	Description/Remarks	E	N	Height
SV1	Steel screw in bed rock about 110 m SSW of excavation area.	629.892,415	1.954.676,730	4,966
SV2	Steel screw in middle of concrete cistern just inside and about 25 m east of entrance gate to church recreation area. Ca. 250 m west of excavation area.	629.666,919	1.954.808,372	2,245

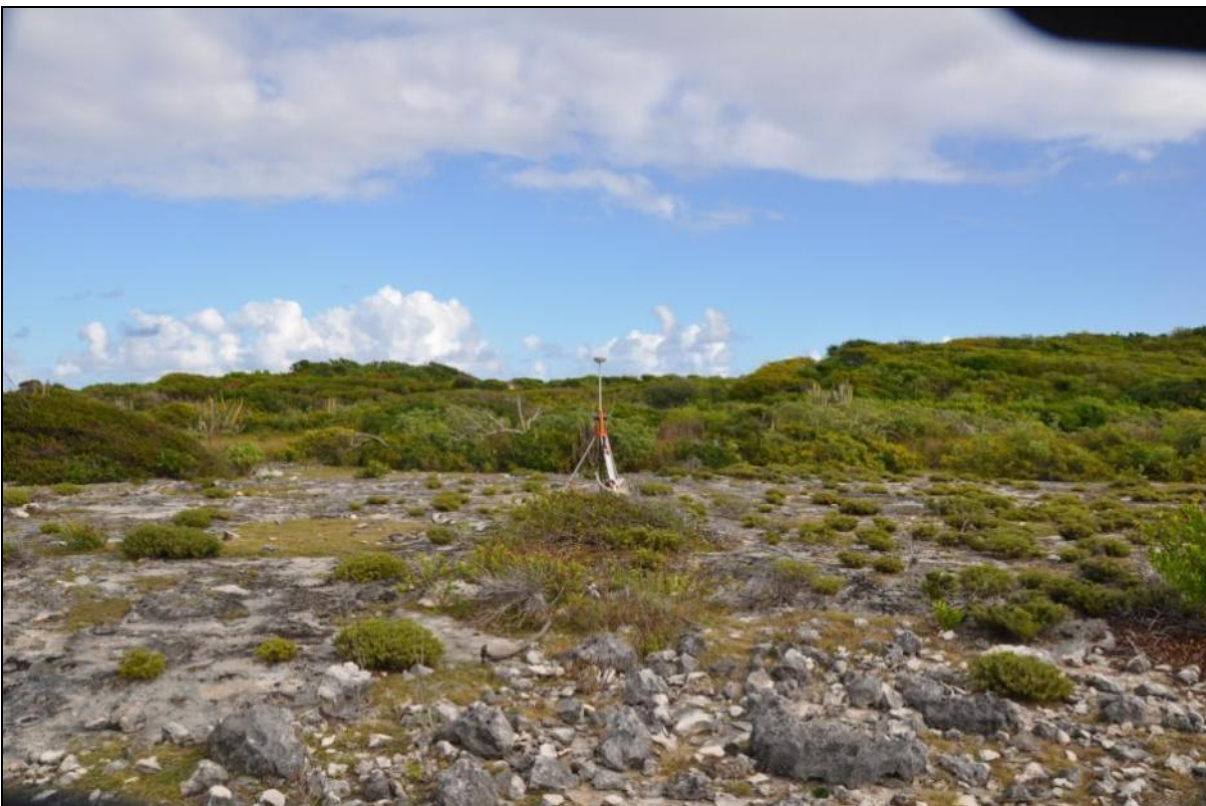
Figure 6. Station SV1 at Seaview. Looking N towards the excavation area. (Photo FSI.)

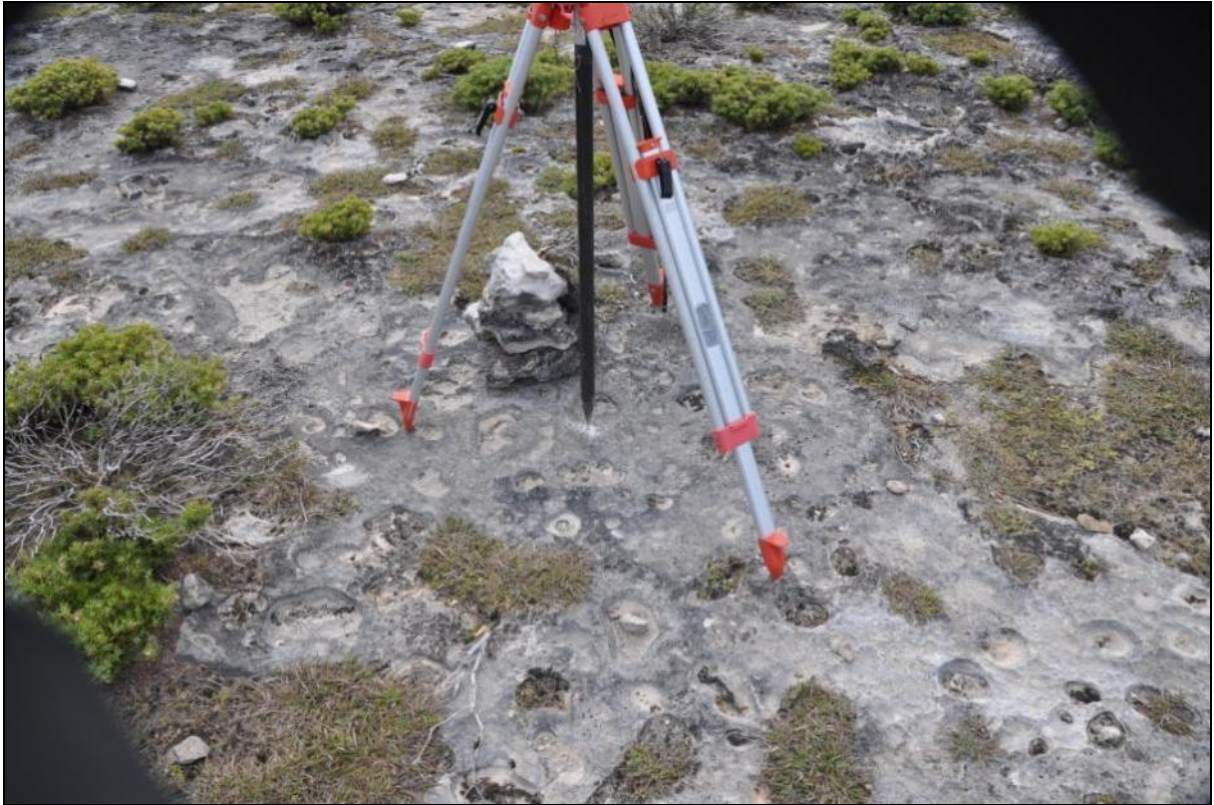
Figure 7. Station SV1 at Seaview. Close up of point. Looking SSW. (Photo FSI.)

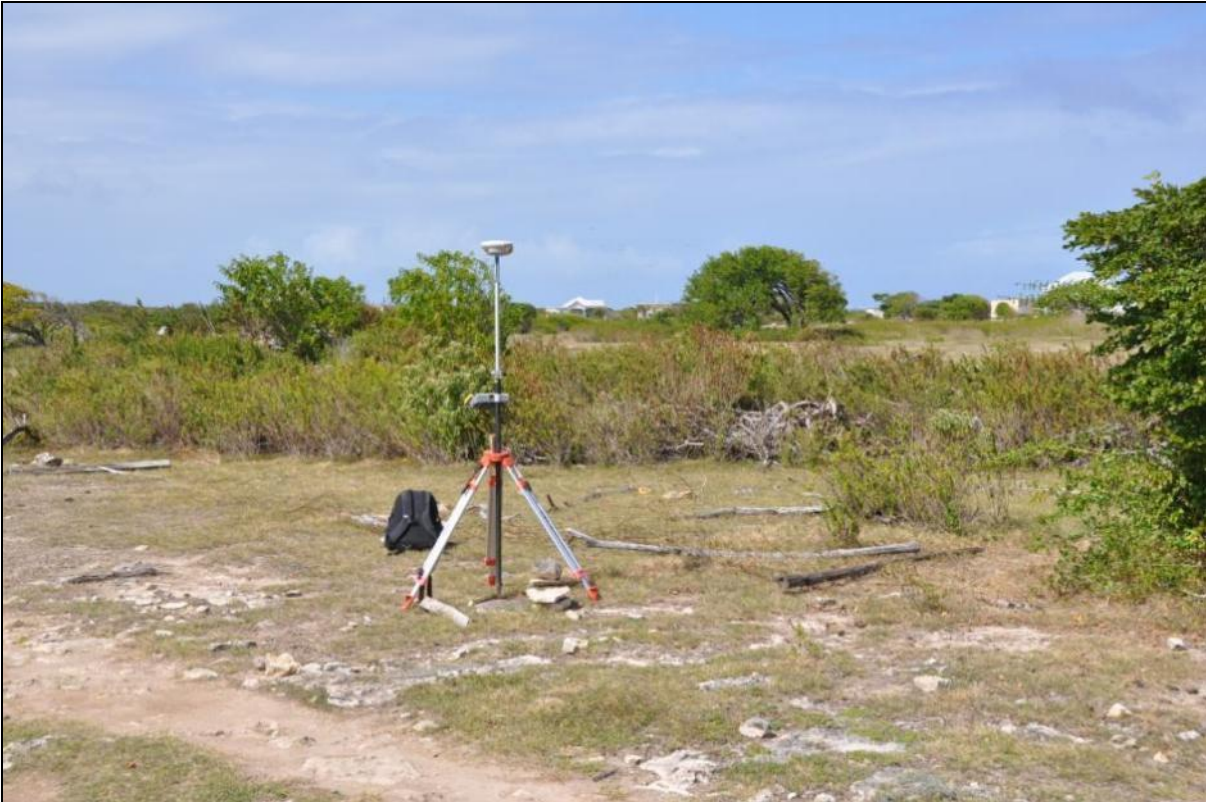
Figure 8. Station SV3 at Seaview. Looking N. (Photo FSI.)

Name	Description/Remarks	E	N	Height
SV3	Steel bolt in bed rock N of track and about 130m SE along it from entrance gate to church recreation area towards excavation area.	629.749,226	1.954.734,501	2,163
SV4	Steel screw in bed rock 5,05m NNW (330° true) from SV1.	629.889,821	1.954.681,095	4,903
SV5	Steel rod W of excavation, one of group of 3.	629.868,630	1.954.768,896	3,457
SV6	Steel rod S of excavation, one of group of 3.	629.873,711	1.954.749,902	3,065
SV7	Steel rod S of excavation, one of group of 3.	629.889,742	1.954.757,818	3,239

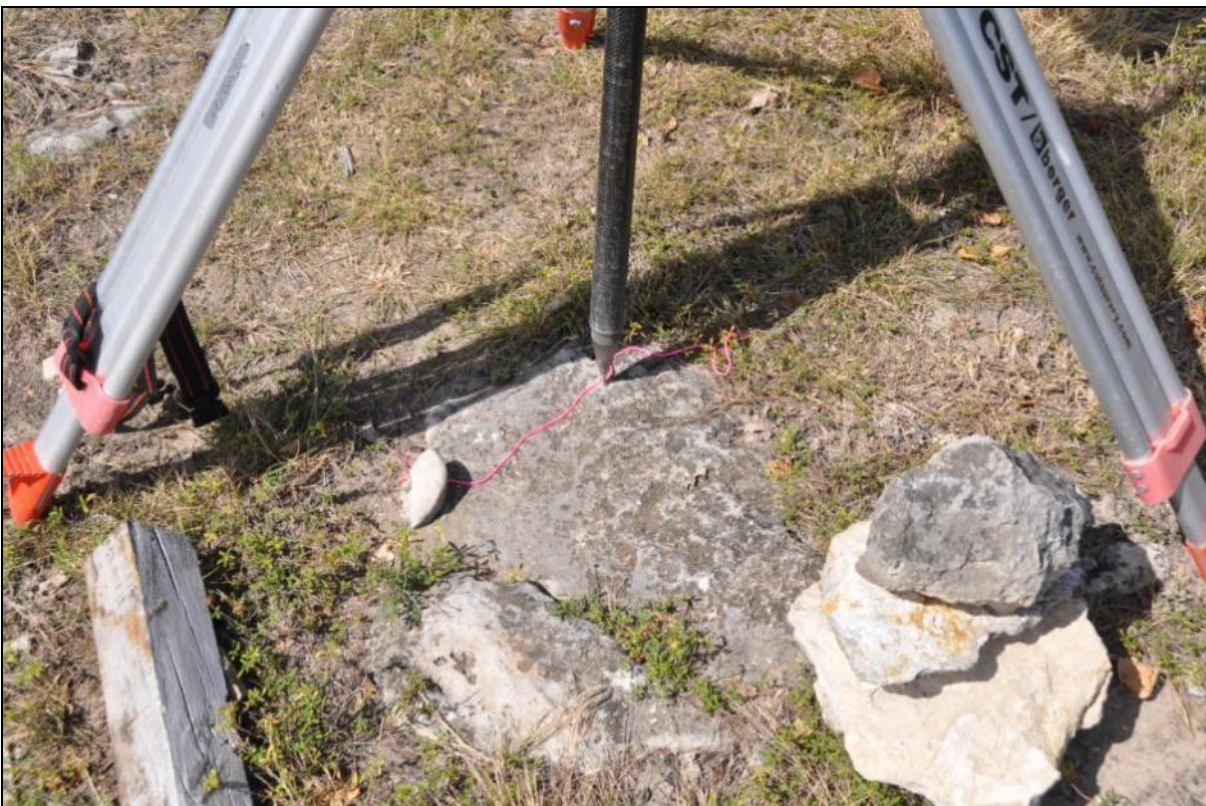
Figure 9. Station SV3 at Seaview. Close up of point. Looking N. (Photo FSI.)

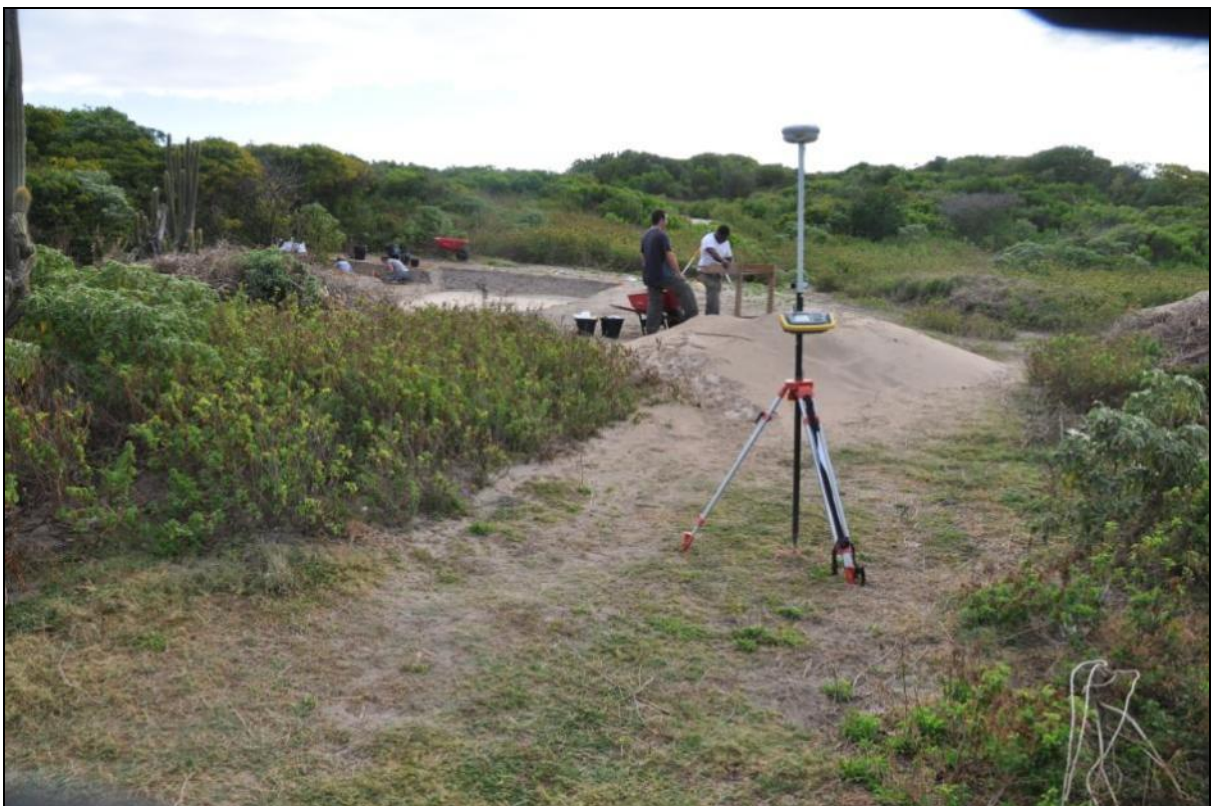
Figure 11. Station SV5 at Seaview. Looking SE. (Photo FSI.)

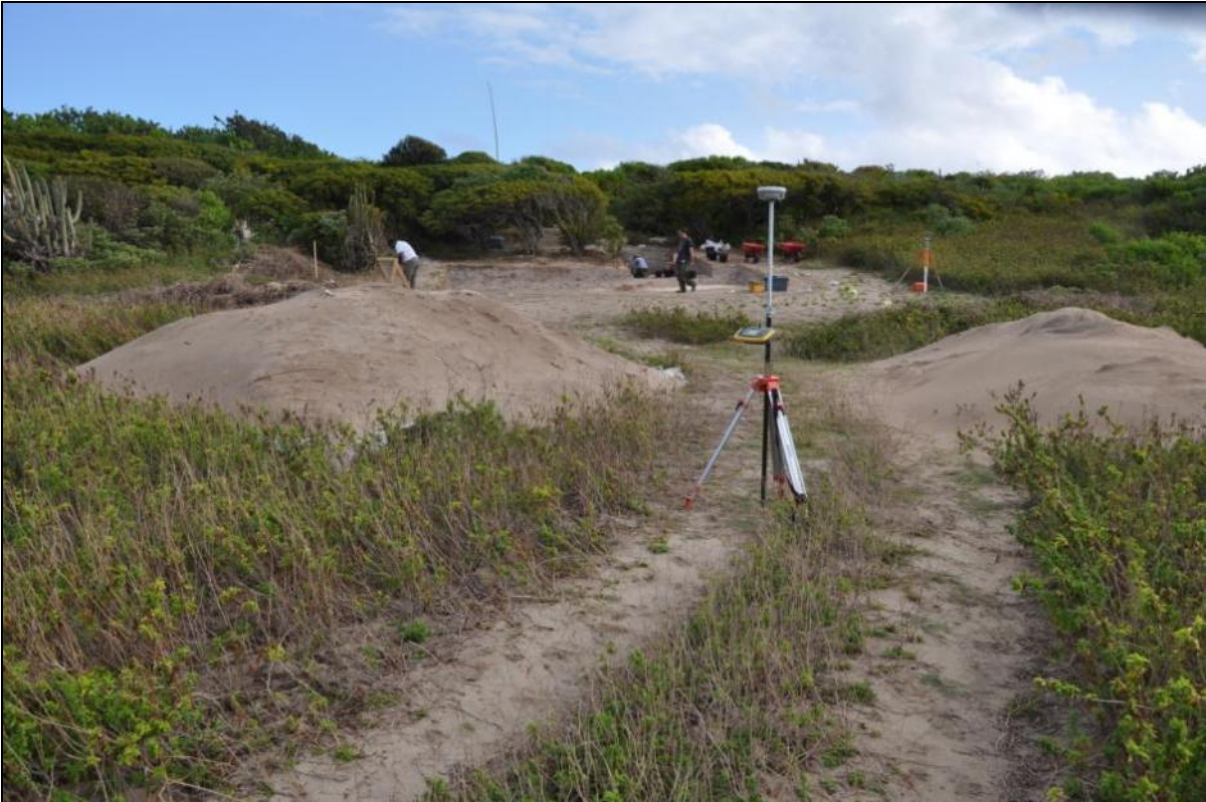
Figure 12. Station SV6 at Seaview. Looking NE. (Photo FSI.)

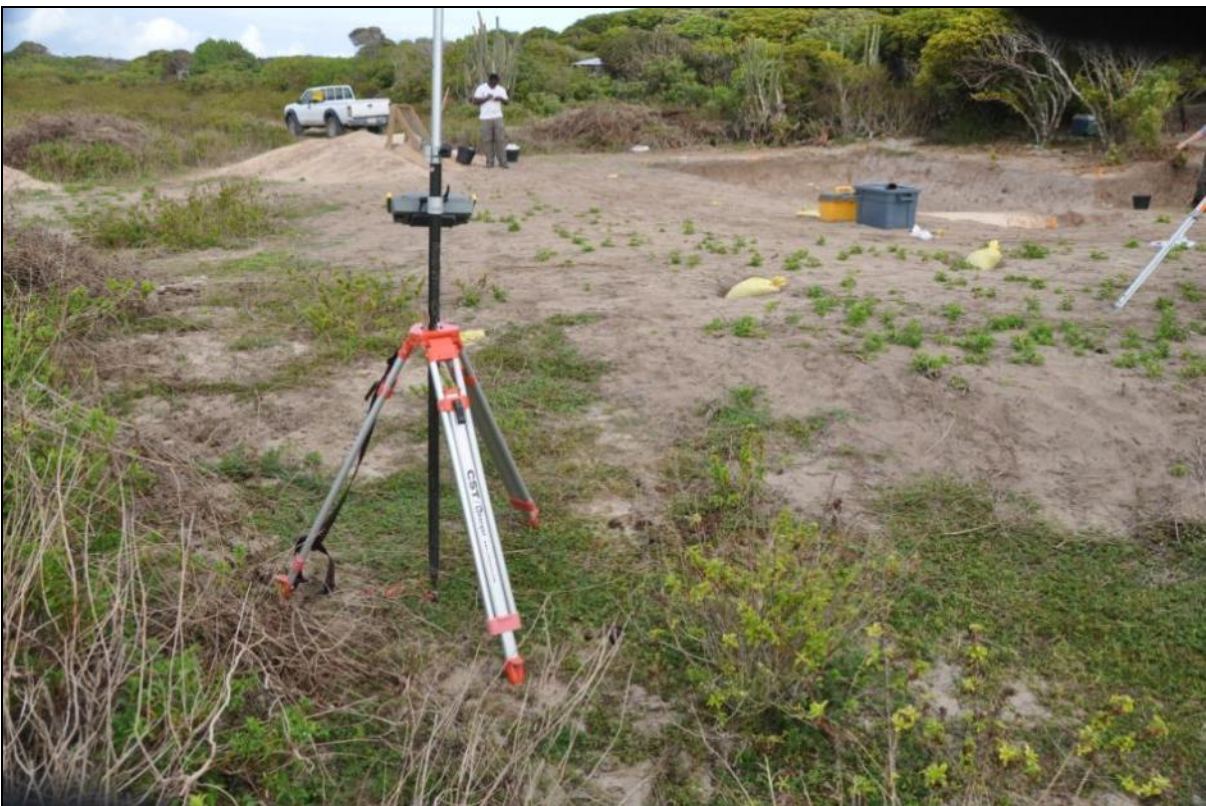
Figure 13. Station SV7 at Seaview. Looking NW. (Photo FSI.)

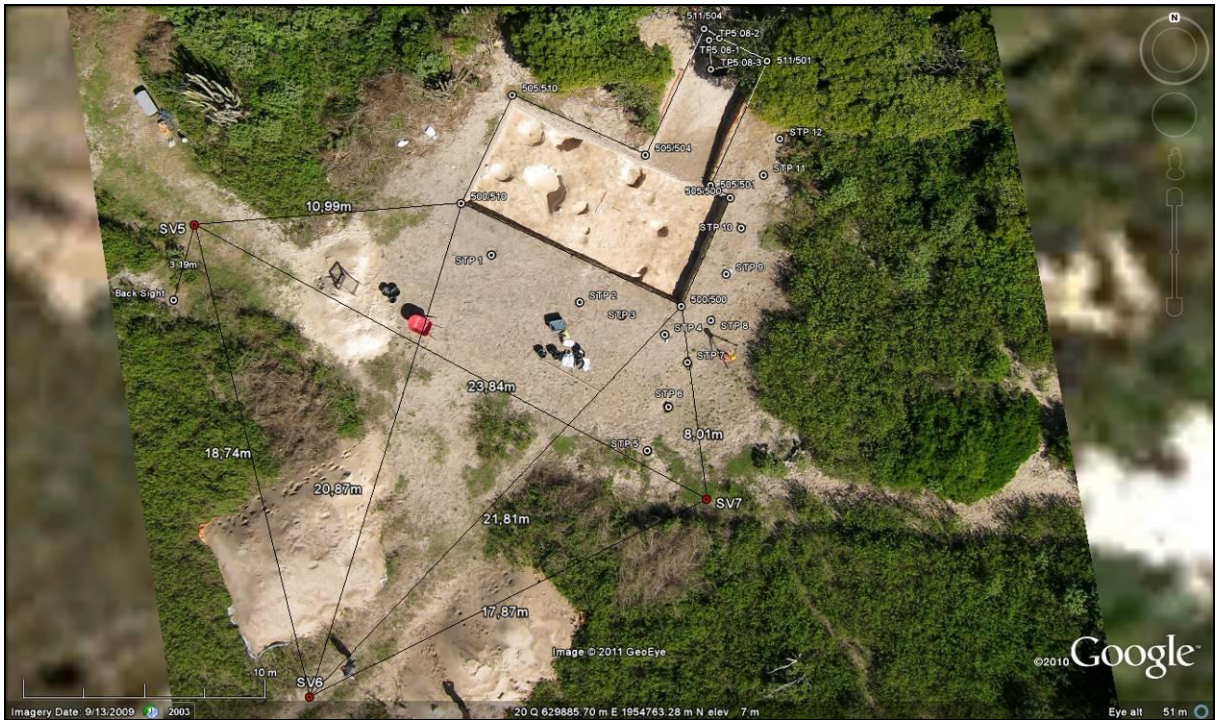
Figure 14. Stations near the excavation trench at Seaview. Points superimposed on a kite aerial photograph imported into Google Earth. Scale not accurate. (Photo FSI/Google Earth.)

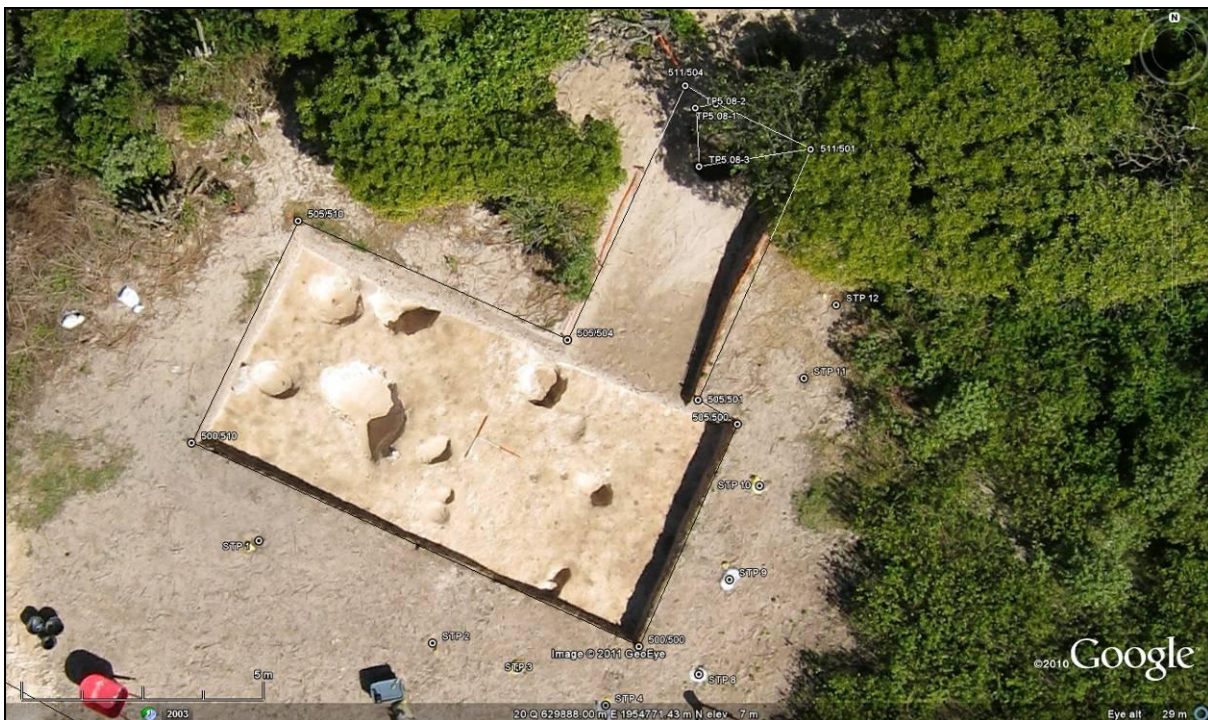
Figure 16. Points marking the extent of the excavation area at Seaview and shovel test pits. Points superimposed on a kite aerial photograph imported into Google Earth. Scale not accurate. (Photo FSI/Google Earth.)

The extent of the 2011 excavation area was measured in with SV1 as base point. The outline of a test pit from 2008, believed to be the number 5 pit, partly exposed in the northern section of the excavation area was also surveyed. Coordinates and height (3,549) for the back sight point for the 2011 excavation were established.

So called shovel test pits, 12 in all, to the south and east of the 2011 excavation area were surveyed in.

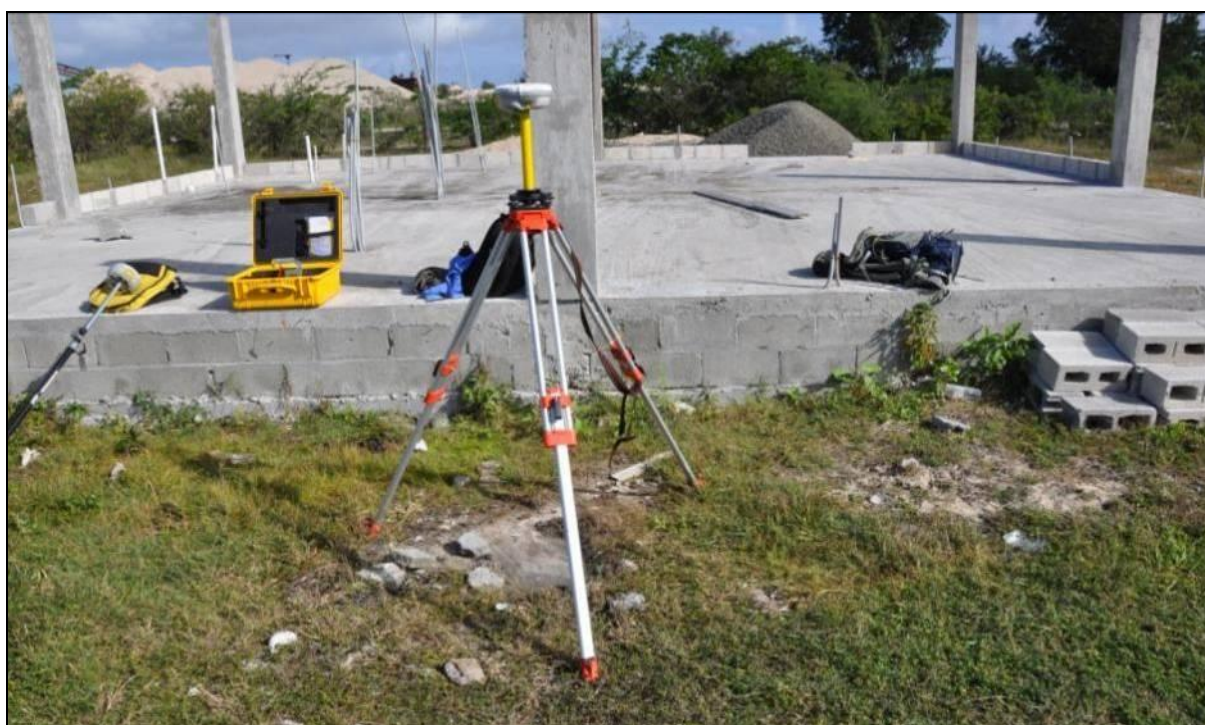
Figure 17. The base station at River. Looking N. (Photo FSI.)

A grid system was established in connection with a small scale rescue excavation at a site called River, approximately 150 m east of the causeway to the harbour on the southern coast of Barbuda. This grid was not tied into the local grid system. A base station was established with a 25 minute run of a DGPS base antenna at a point ca. 160 cm south of the centre of the south site of a house foundation near the excavation site. A proxy height of the base station was calculated from measured sea level height in the nearby harbour, tide tables from St John's harbour, Antigua, and time difference between the two harbours estimated. The base point at River is believed to be within 50 cm accuracy on the east and north axis and within 20 cm for the height. Points in area C were not measured in but added to figure 16 manually.

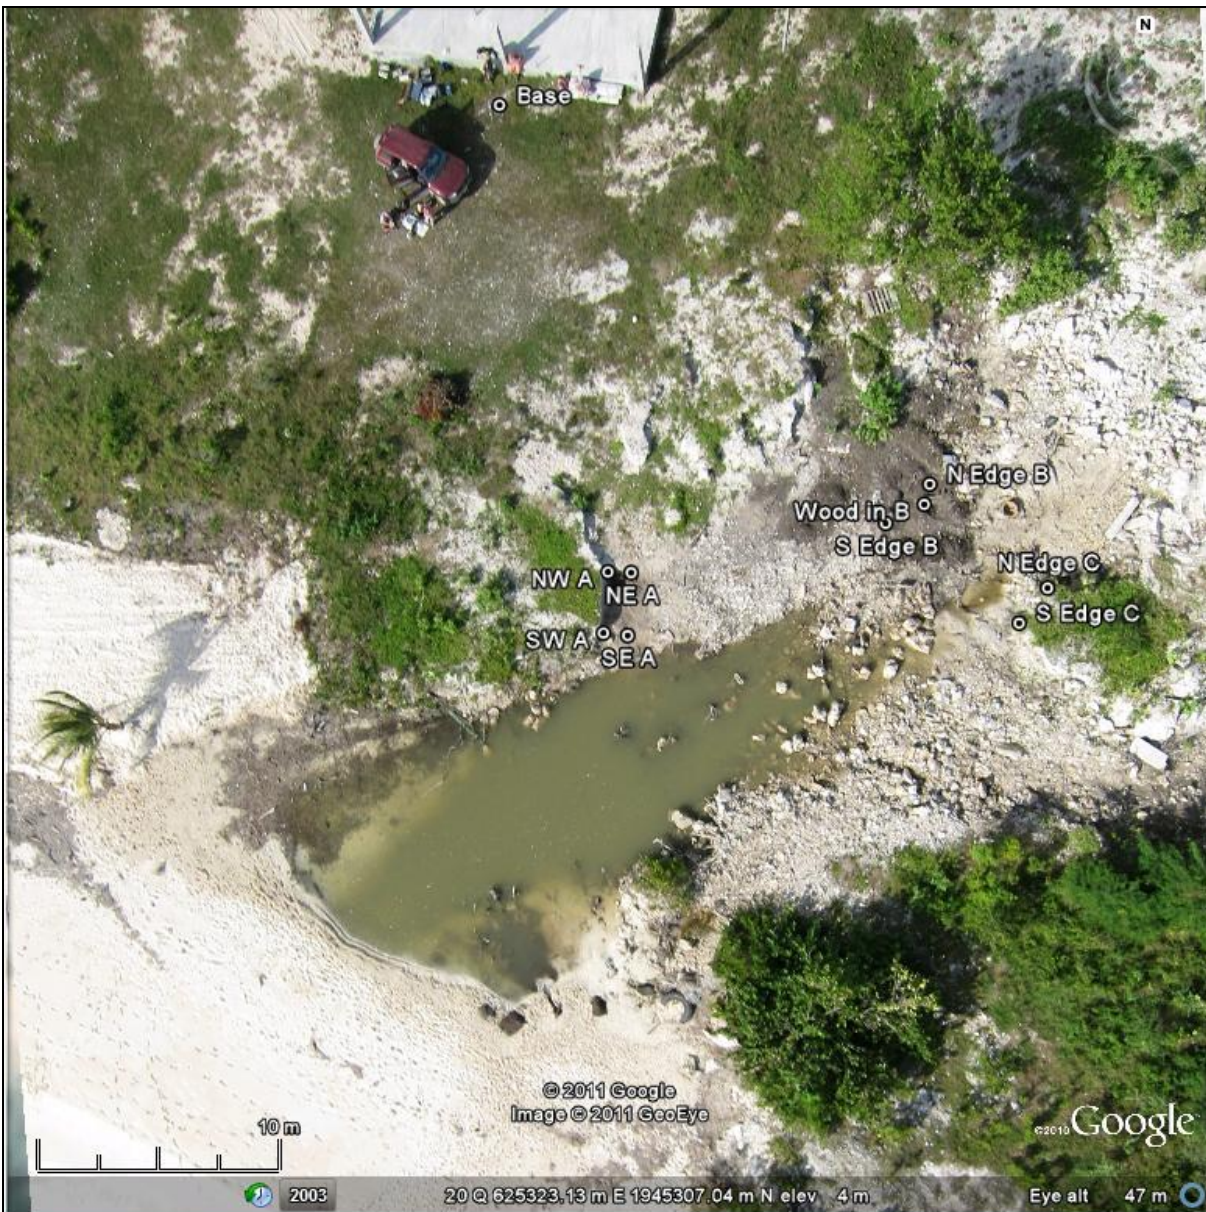
Figure 18. Points at River. Points superimposed on a kite aerial photograph imported into Google Earth. Scale not accurate. (Photo FSI/Google Earth.)

Name	Description/Remarks	E	N	Height
Base	160 cm S of the centre of S wall a house foundation near excavation site	625319.423	1945328.986	1.074
NW A	NW corner of area A	625323.081	1945308.608	0.345
NE A	NE corner of area A	625324.032	1945308.526	0.268
SE A	SE corner of area A	625323.905	1945306.038	0.093
SW A	SW corner of area A	625322.910	1945306.128	0.185
S edge B	S edge of area B	625334.321	1945310.619	0.293
N edge B	N edge of area B	625336.069	1945312.183	0.382
Wood B	Wood-trunk in area B	625335.855	1945311.387	0.136

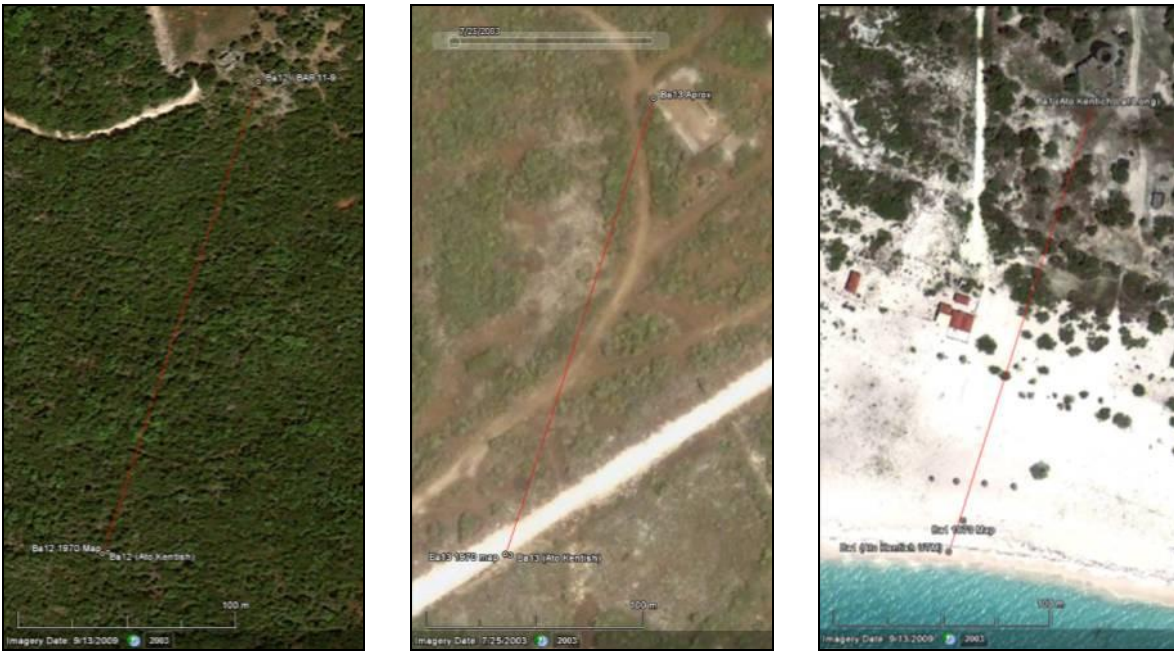
Figure 19. Discrepancy between stations with coordinates from Ato Kentish, with manually measured coordinates from 1970 maps and the location of same stations in Google Earth. Be12 at Highland House left, Be13 at All in Well centre and Ba1 at Martello Tower right. (Photo FSI/Google Earth.)

As stated above it was decided not to make use of coordinates obtained from Ato Kentish, land surveyor at the Ministry of Agriculture and Lands and from the 2009 survey carried out in preparation for a construction of a fish factory in Codrington supplied by Japanese engineers at the site. A certain consistent discrepancy was observed in the data from Ato Kentish and this also applies to some of the coordinates from the 2009 survey on the one hand and the coordinates obtained by initial DGPS measurements by the FSI team and the UTM 20Q grid presented in Google Earth on the other hand (see figures 17 and 18). The position of the points from Ato Kentish and the 2009 survey relative to same stations as seen in Google Earth is consistently ca. 220 m and 199°. The nature of the discrepancy suggests it to be a matter of difference between projections or calculations. Under the circumstances it proved impossible to clarify the root of this problem and rectify it. The FSI's DGPS point measurements were in good agreement with the Google Earth grid. Google Earth, although not accurate down to a metre level, is a useful "safety net" to verify coordinates.

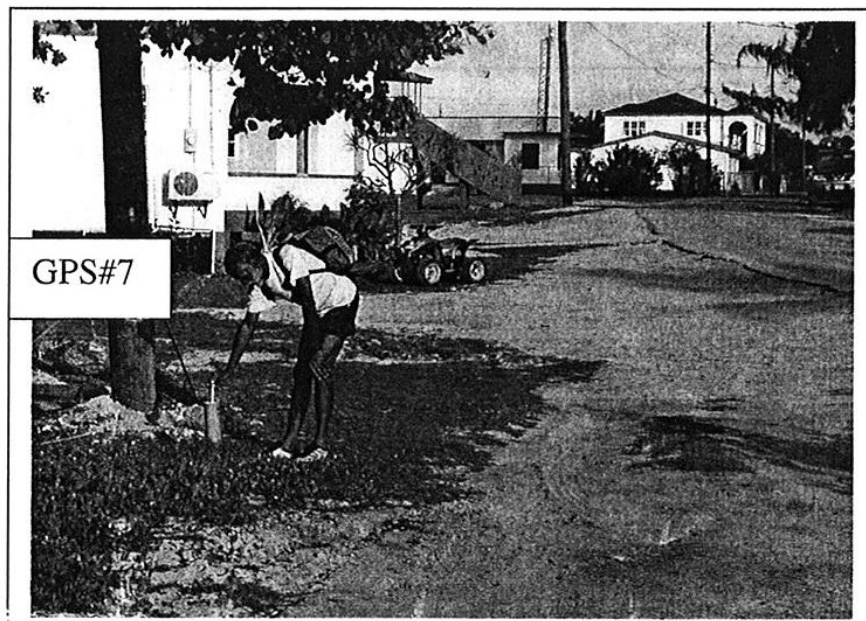
GPS #7 (PVC pipe painted yellow)

E 624,259.96 N 1,950,700.74

Observation of four points from the 2009 survey show that points JI and GPS#7 are at the same distance and angle from same stations as seen in Google Earth. The error in the location of the other two points suggests, however, a misprint (see figure 18). The height given to C1 on the Codrington jetty in the 2009 survey was more convincing at 0,76 m than the height, 1,651, surveyed in using Ba12 as base and the height of Ba12 (38,056) from Ato Kentish.
