Laxá Hydropower Scheme, Iceland

Review of Sediment and Ice Challenges

LV report no: LV-2013-112 **Date:** 02.10.2013

Field Report

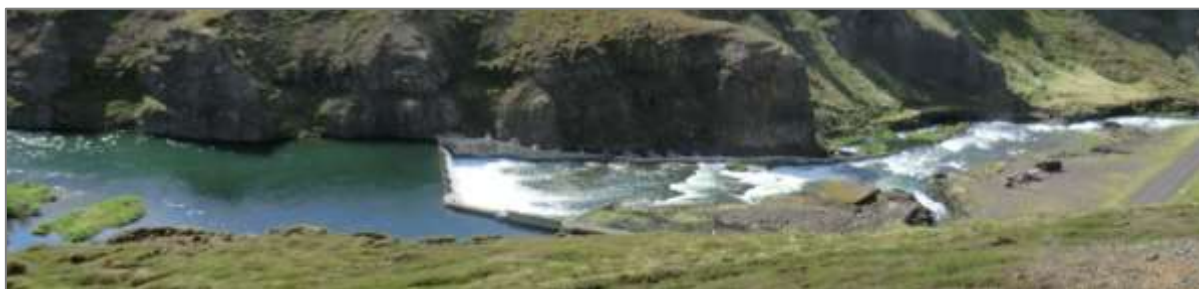
Figure 7: Left side of the dam with free overflow spillway and the existing bay with vertical stop logs, seen from the right bank

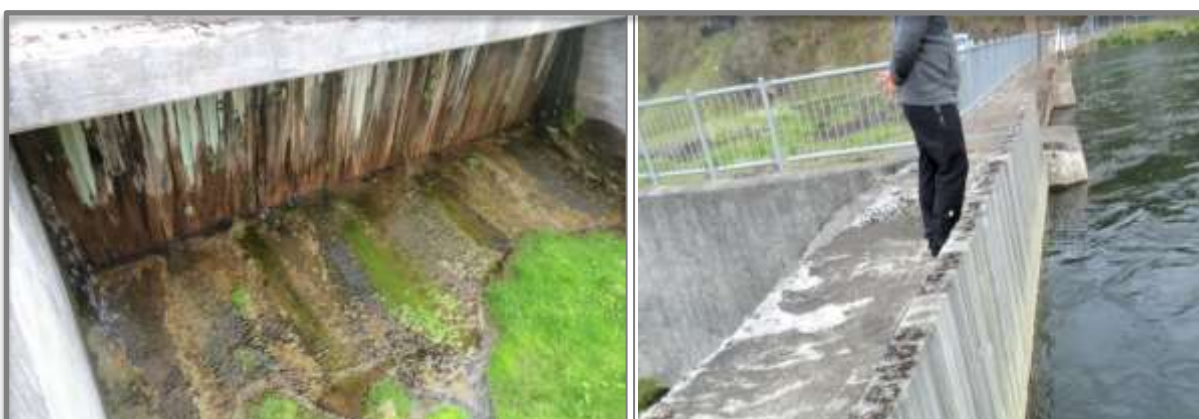
Figure 8: Bay with vertical stop-logs upstream of concreted bays with downstream embankment

There are two existing facilities which could be used for this, i.e. the bottom outlet gate and the bay closed with stop logs shown in Figure 8. The efficiency of using these two low level openings to flush sediment around and not through the intake will be very important information for designing a permanent and robust sediment handling method for Laxá III dam.

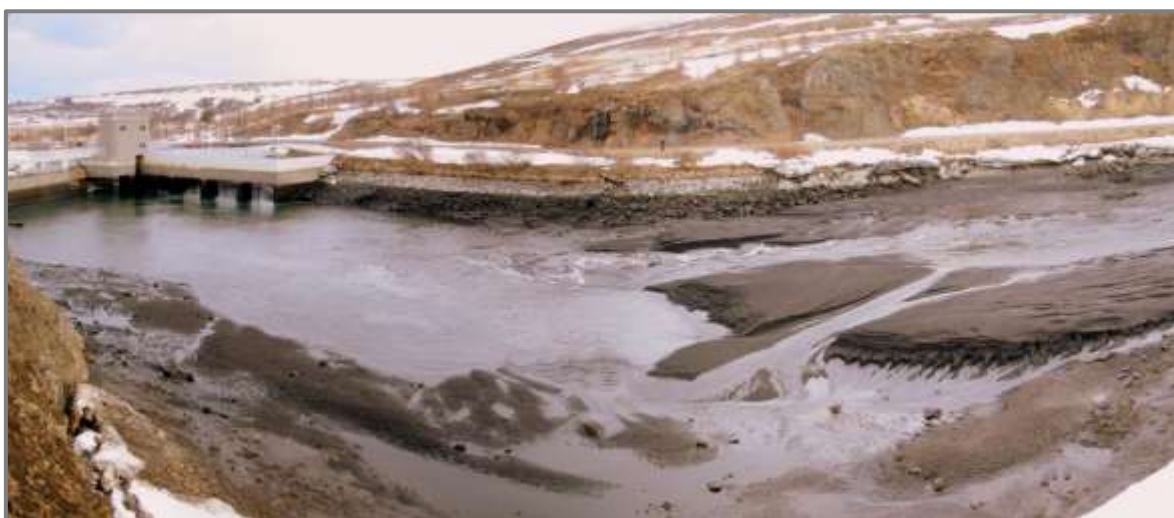
Figure 13: Laxá II head-pond during draw-down and flushing (Ref. 3)

Figure 13 shows the head-pond and the dam during draw down and a reservoir flushing event. The layout of the dam and intake structures (without any terrain information) is shown in Figure 14.

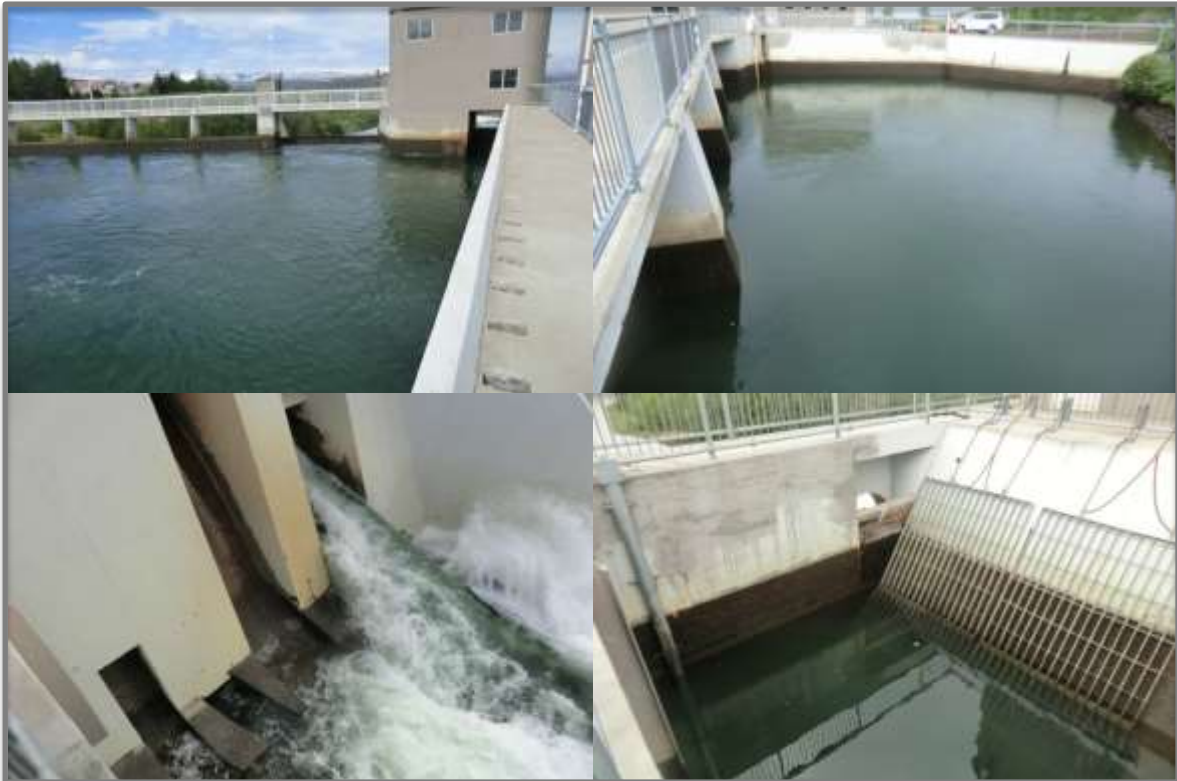
Figure 15: Dam, intake bay with "skirt-wall" and water and ice passage arrangements at Laxá II Dam

There is no facility for letting the entire river flow by-pass the intake in an "as-before-situation" for normal to higher river discharges. Efficient sediment flushing, which requires a low upstream water level and a closed intake, can therefore not be implemented with higher river discharges.

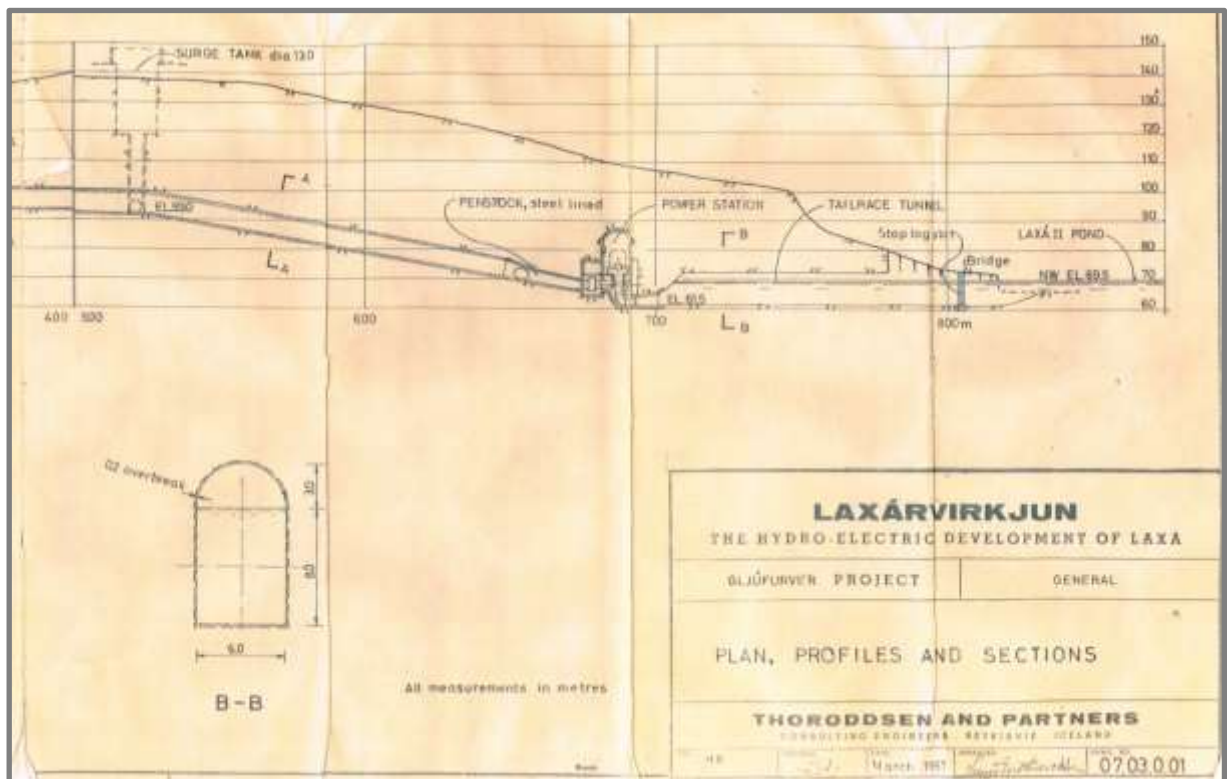
The drawing Figure 4 is extracted from shows also a longitudinal section through the waterway. This is shown in Figure 24. The plan included a “superstructure” on top of the surge shaft which would prevent surface water to enter into the surge chamber. Figure 25 shows the present situation on top of the surge chamber which also is an unfinished structure. There is no structure to prevent material from sliding into the surge chamber during snow melt or heavy rains. Ground water is furthermore drained into the surge chamber through cracks in the rock. The ground water will freeze as it is subjected to the air temperature during winter and ice bodies will form and be hanging from the side walls until they become so heavy that they break off and fall into the surge chamber. Pieces of rock may break off and fall into the surge chamber together with the ice.

Figure 24: Longitudinal section of the waterway as designed for the Laxá III high dam

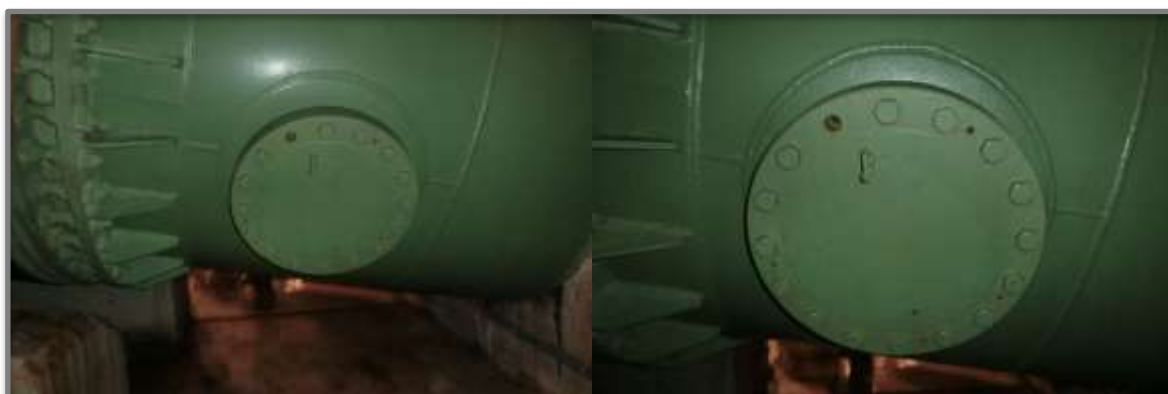
Figure 31: Location for installation of a SMOOTH sediment sampler for manual and automatic sediment measurements

It is not so easy to find a site with good accessibility where representative water samples for sediment analysis can be retrieved with a high frequency, also during the winter. It is therefore recommended to install an arrangement in the manhole between the butterfly valve and the turbine in Laxá 3 hydropower plant. The location is shown in Figure 31. We would recommend that manual samples are taken initially and that a laboratory for analysis of the suspended sediment content by use of the filtration method is established at the site. This will make it possible to take frequent samples for a time to see if the concentration varies rapidly or not. Samples for particle size distribution analysis and mineral content analysis can be taken to Reykjavik or another place for analysis. The sampling pipe arrangement installed in the manhole should however be prepared for continuous indirect measurement by use of the SMOOTH technology in a branch flow. The concentrations observed at Helluvað are too low for the SMOOTH measurement concept. If the manual sampling programme reveals that the concentrations at the Laxá 3 turbine is frequently above 500 mg/l, it would then be interesting to monitor the sediment concentration continuously and get data in real-time.

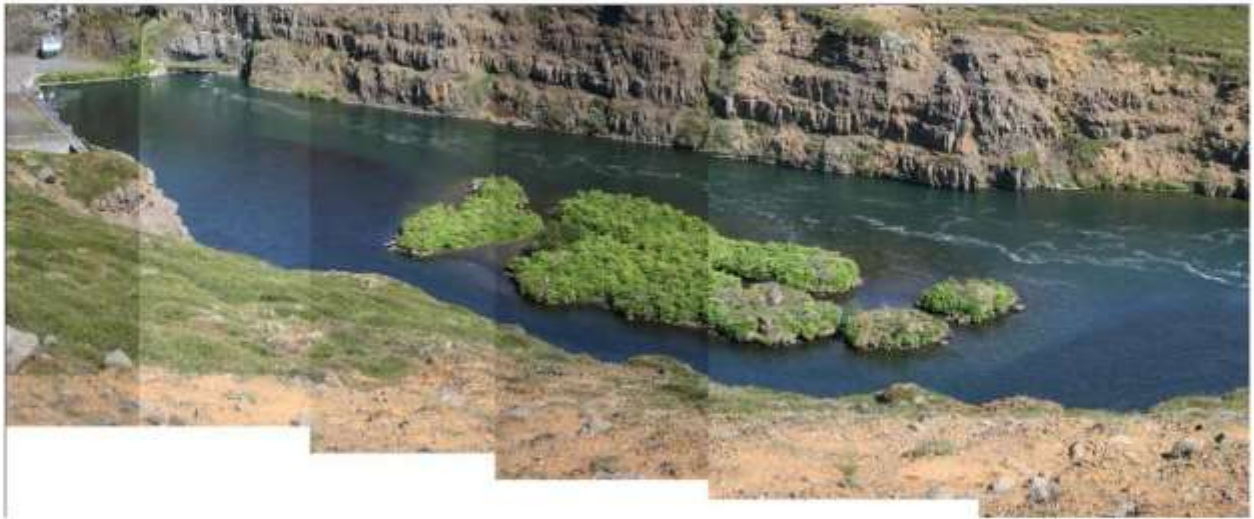
Figure 6 – top view of the Laxá III intake pond. Almost all the discharge flows by the far bank. Accumulation of sand can clearly be seen at stabilized operating conditions.

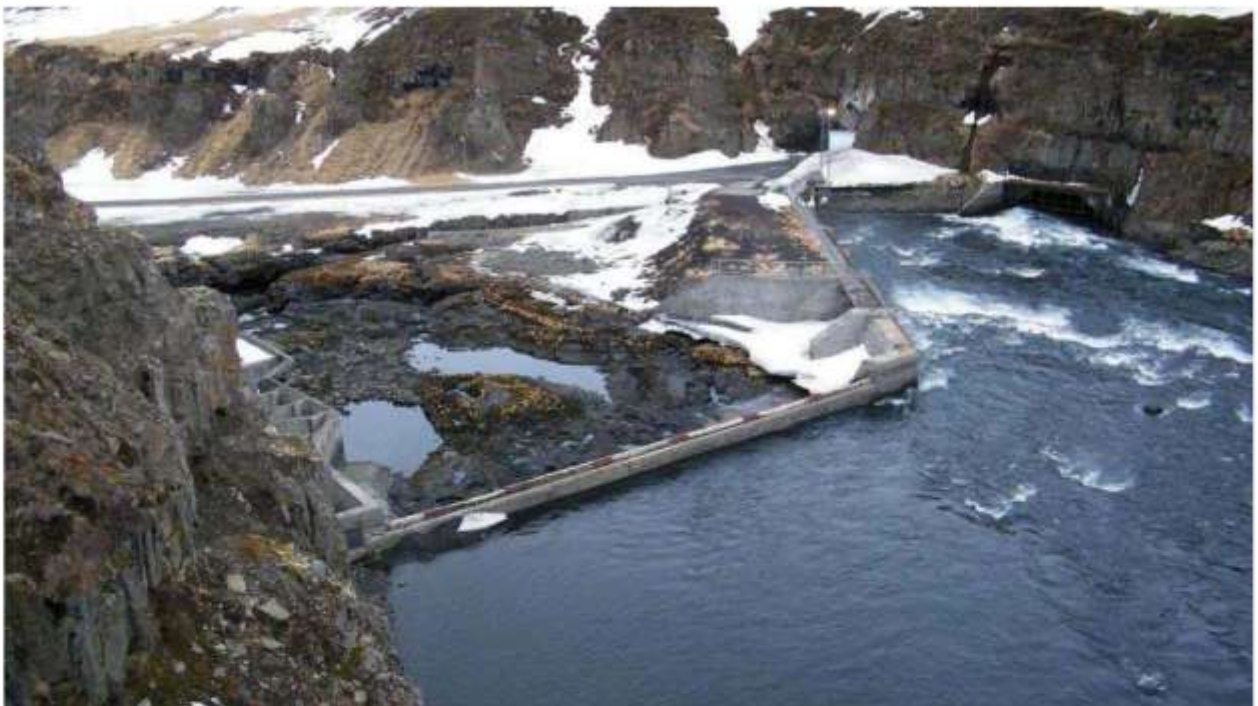
Figure 8 – intake pond at Laxá III during flushing. The intake can be seen on the right.

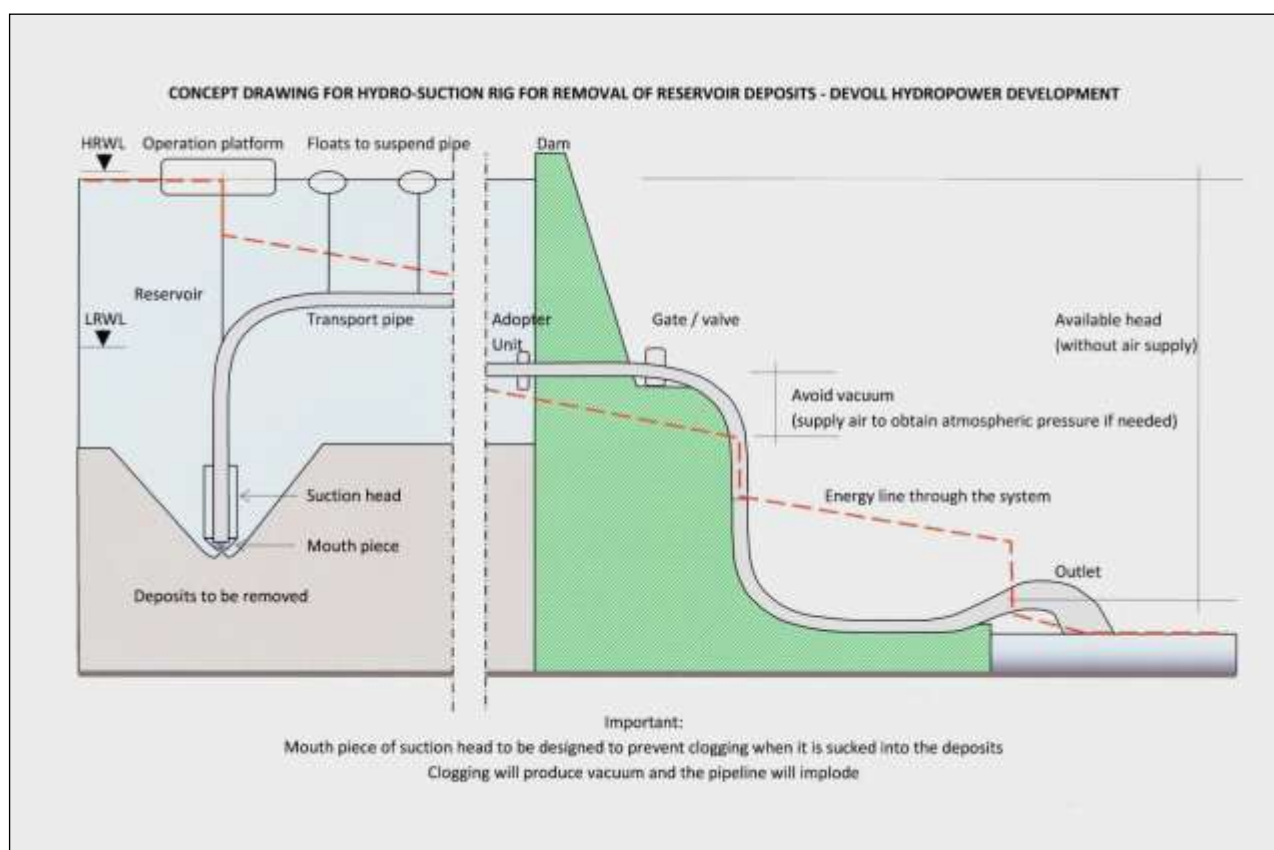
Figure 2: Concept drawing of a hydro-suction rig
