ORKUSTOFNUN
NATIONAL ENERGY AUTHORITY
DEPARTMENT OF WATER POWER

THE III INTERNATIONAL CONGRESS OF
ENGINEERING GEOLOGY

EFFECTIVE SEALING BY SEDIMENT LOAD

DAMAGE TO EARTH DAMS AND OTHER MAN-MADE STRUCTURES CAUSED BY
RIFTING ACTIVITY IN NORTH ICELAND 1975-1977

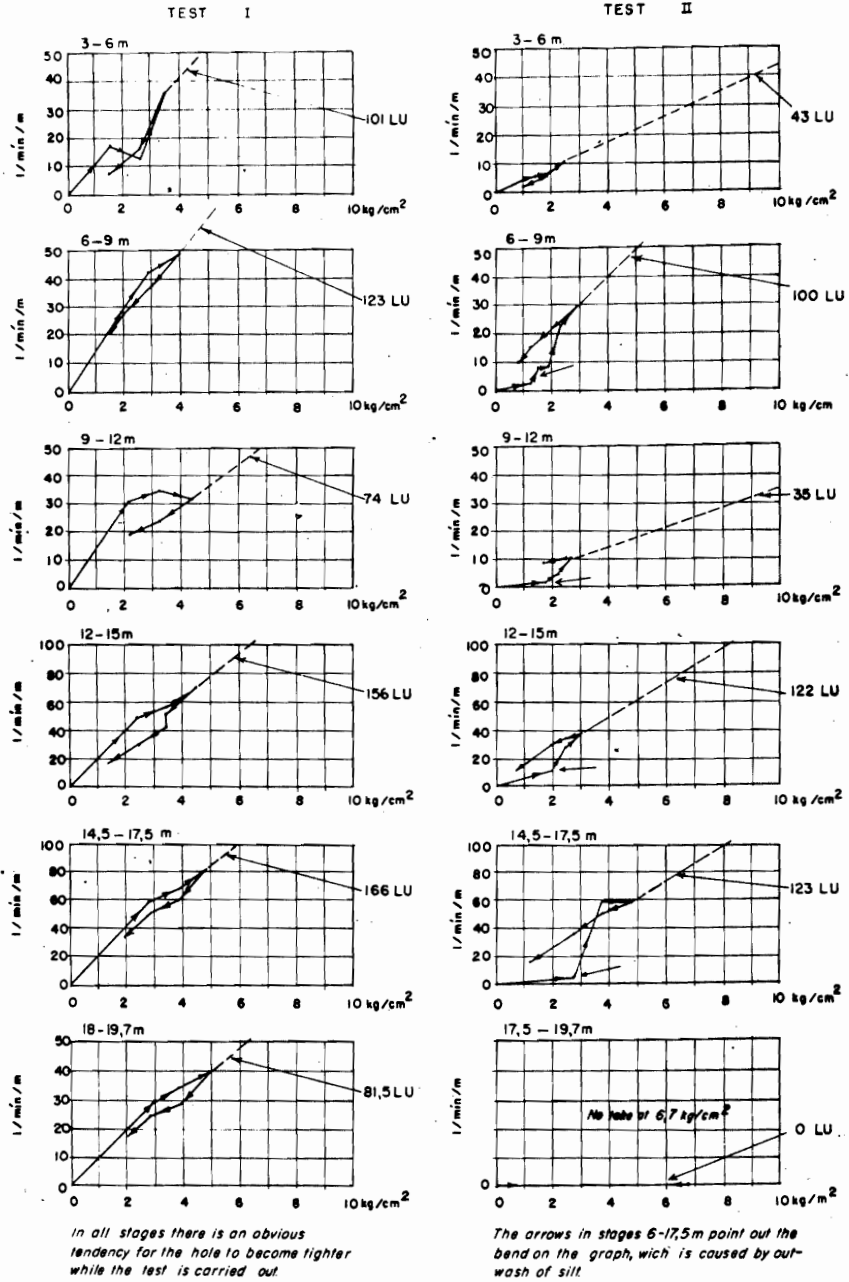
Fig. 1

Fig. 1. Graphs of permeability tests I and II in borhole DI-3.

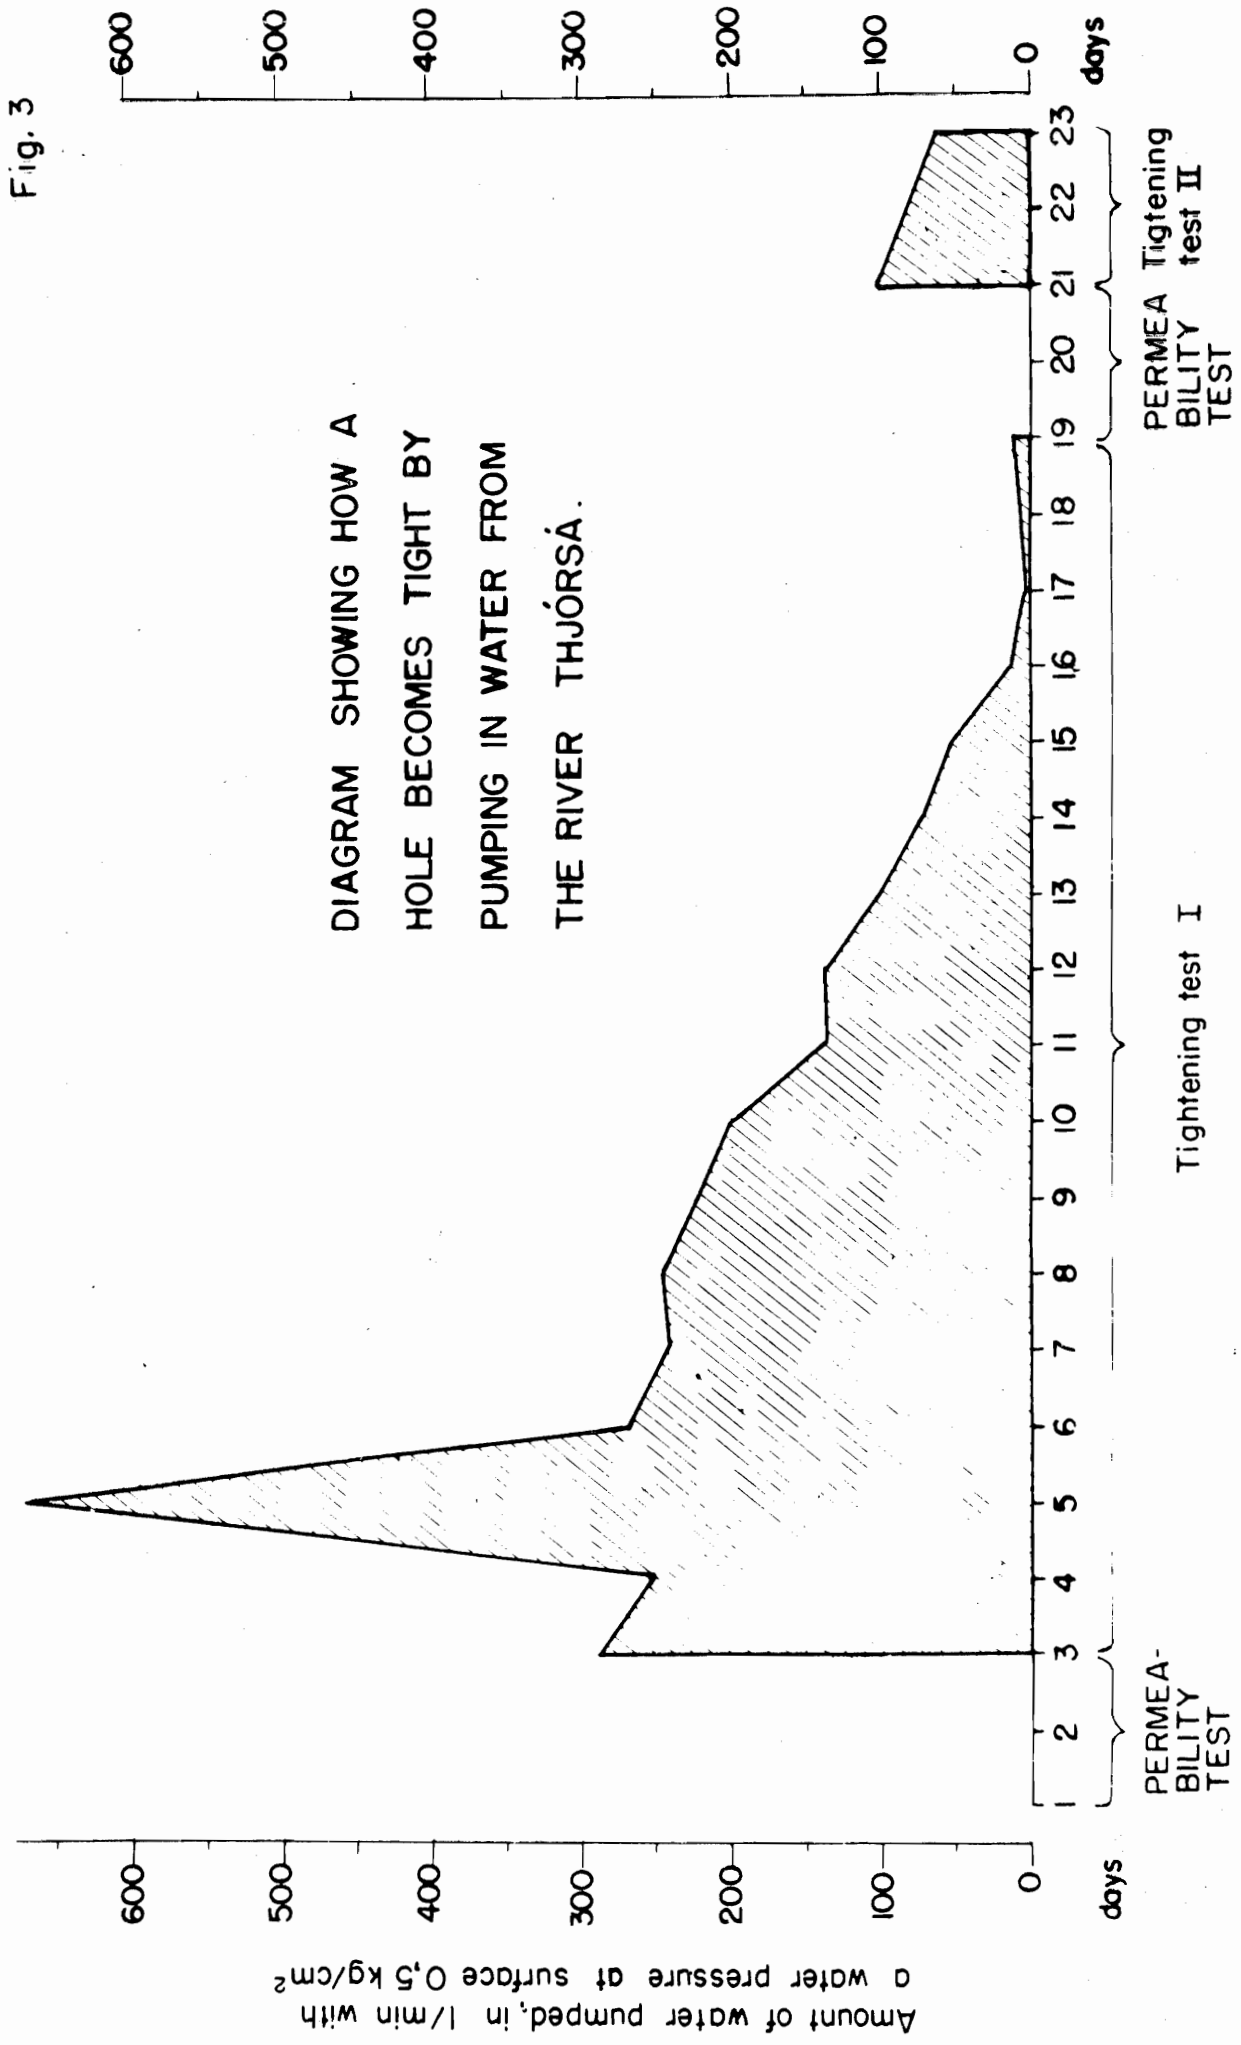
Fig. 3

The results are shown in fig. 3.

Fig. 3. Diagram showing the result of the tightening (sealing) tests in borhole DI-3.

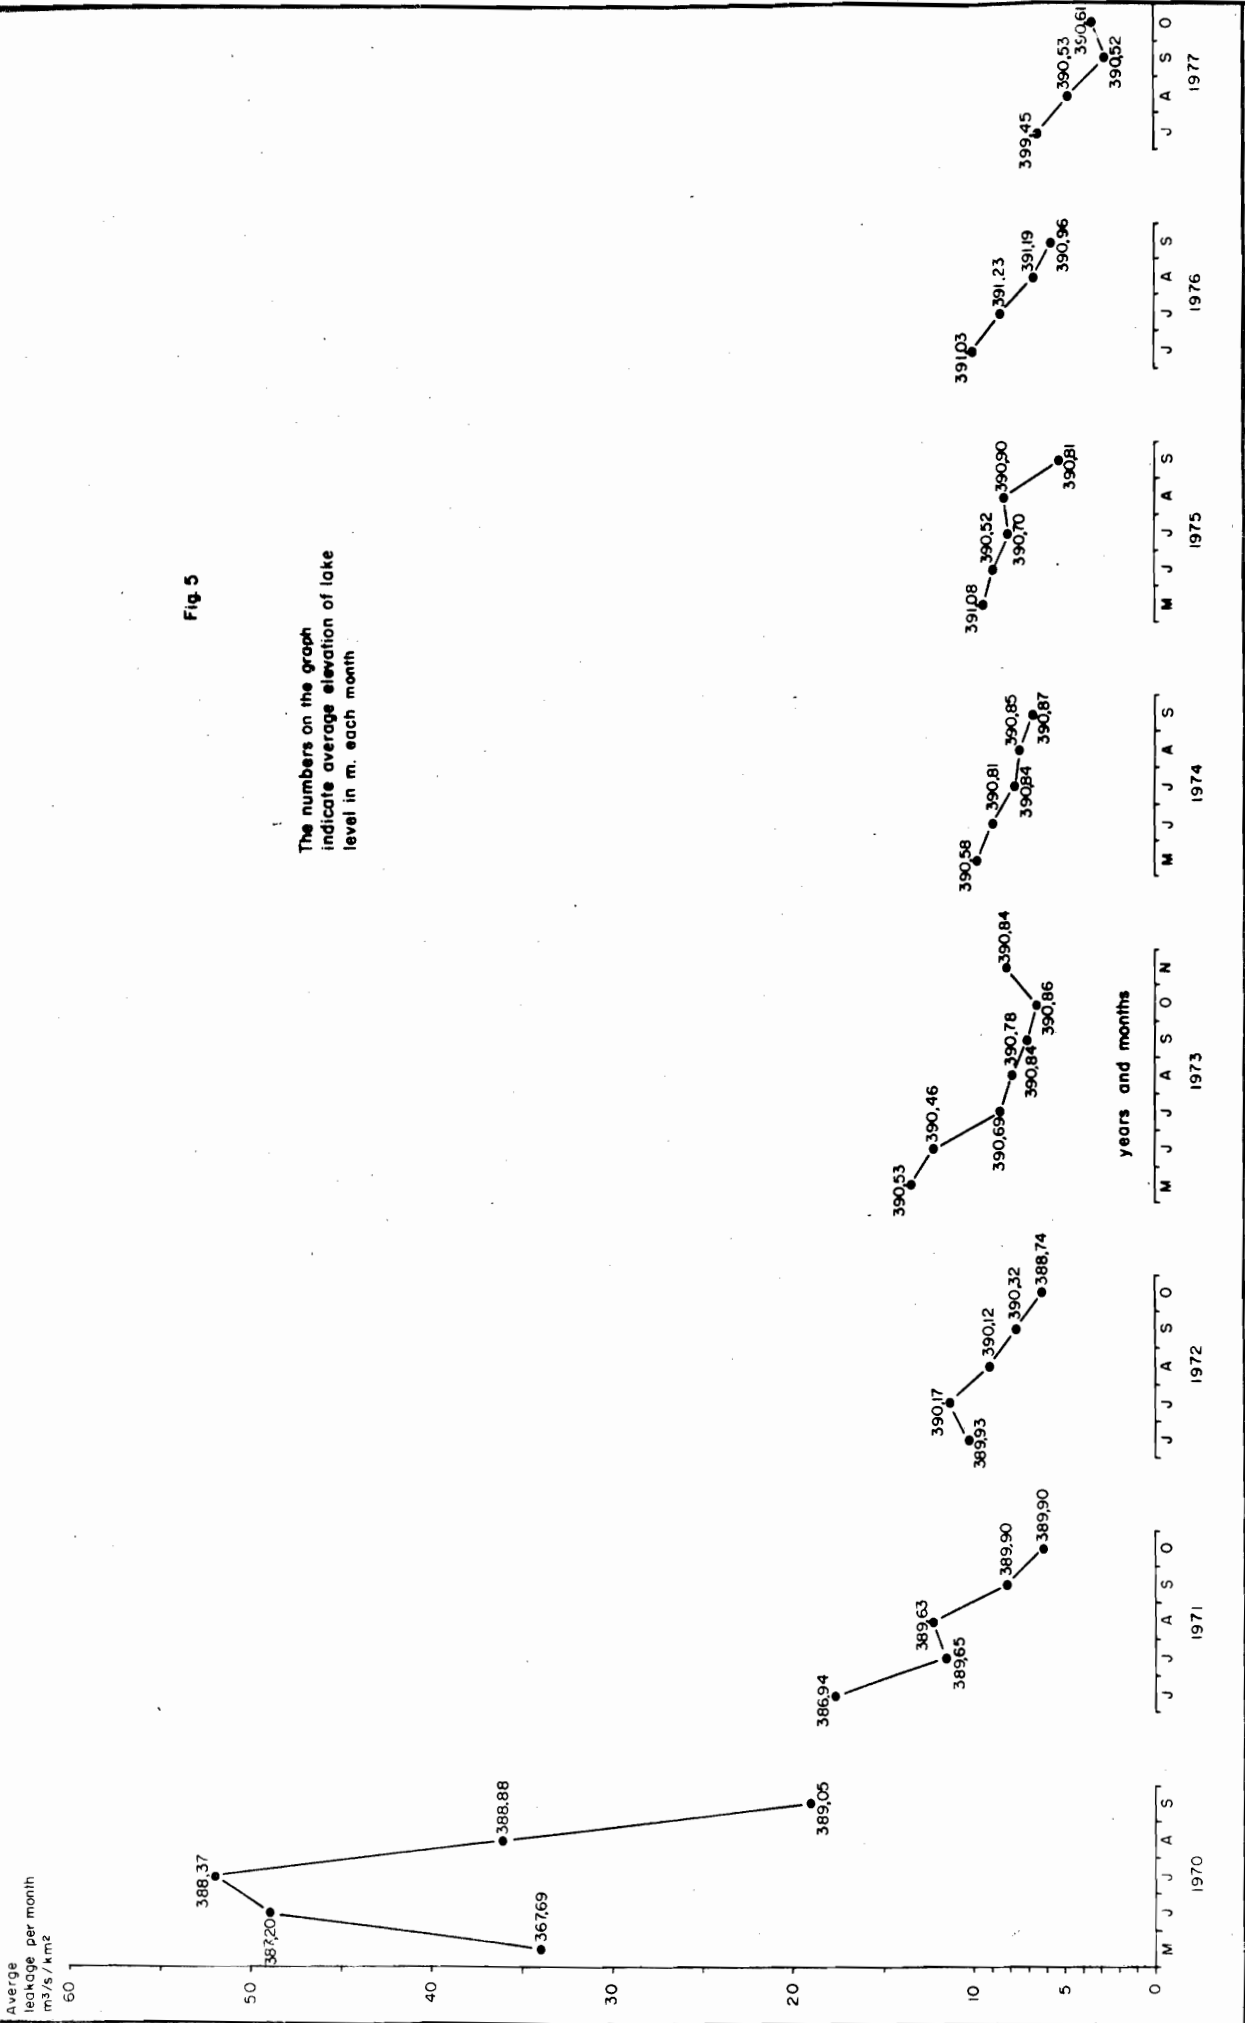
Fig 5

The numbers on the graph indicate average elevation of lake level in m. each month

Fig. 5. Average leakage each month plotted against the corresponding average lake elevation.

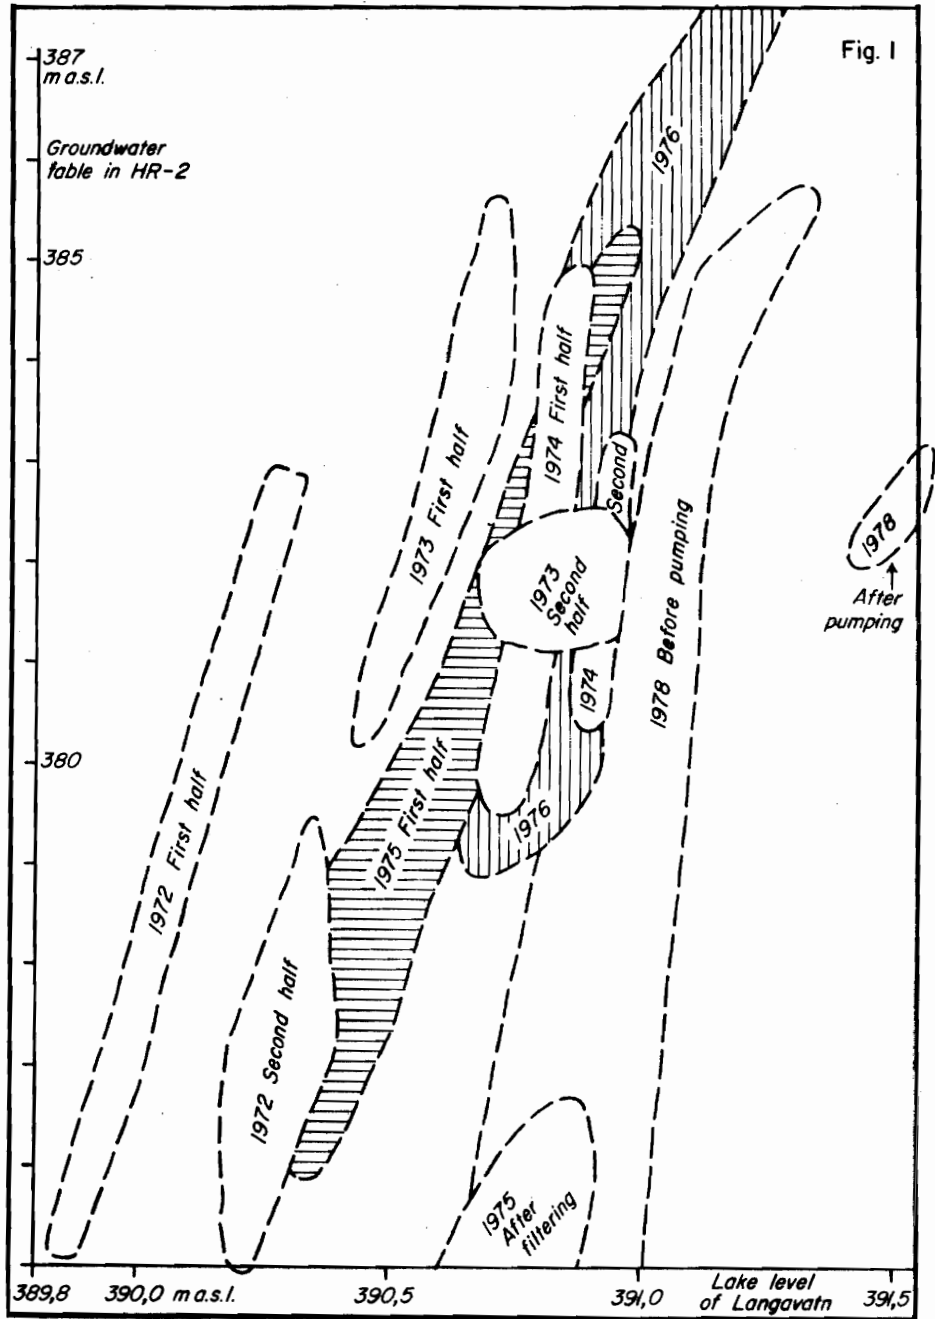
The results of the pumping test are shown in the two graphs following. The first one shows the relation between lake level and ground water level in the near by drillhole HR-2. It shows the gradual tightening of the lake from 1972 to 1974. In 1975 fracture no. 6 opened up and a setback in the tightening process is indicated. After filling of the main swallow hole on fracture 6 with filter material in 1975 at a high lake level there was a very well marked decrease in leakage. Since then a gradual tightening has taken place, but during the pumping test a sudden decrease in leakage occurred.

Fig. 1 Relation between groundwater level and lake level of Langavatn.

This summer (1978) this theory was tested by pumping the sand of an already formed delta into a concentrated area of swallow holes connected mostly to fissure no. 6 but others at lava hillocks assumed to be pseudocraters. The pump used had a pumping capacity of 40 m³ of solid material per hour. Pumping lasted for about 50 hours. The actual concentration of sand was lower than pumping capacity indicated, but activation of sandy material on surface near the swallow holes by the water jet may have compensated for this so that the 40 m³/hour quantity of sealing material may actually have been reached.

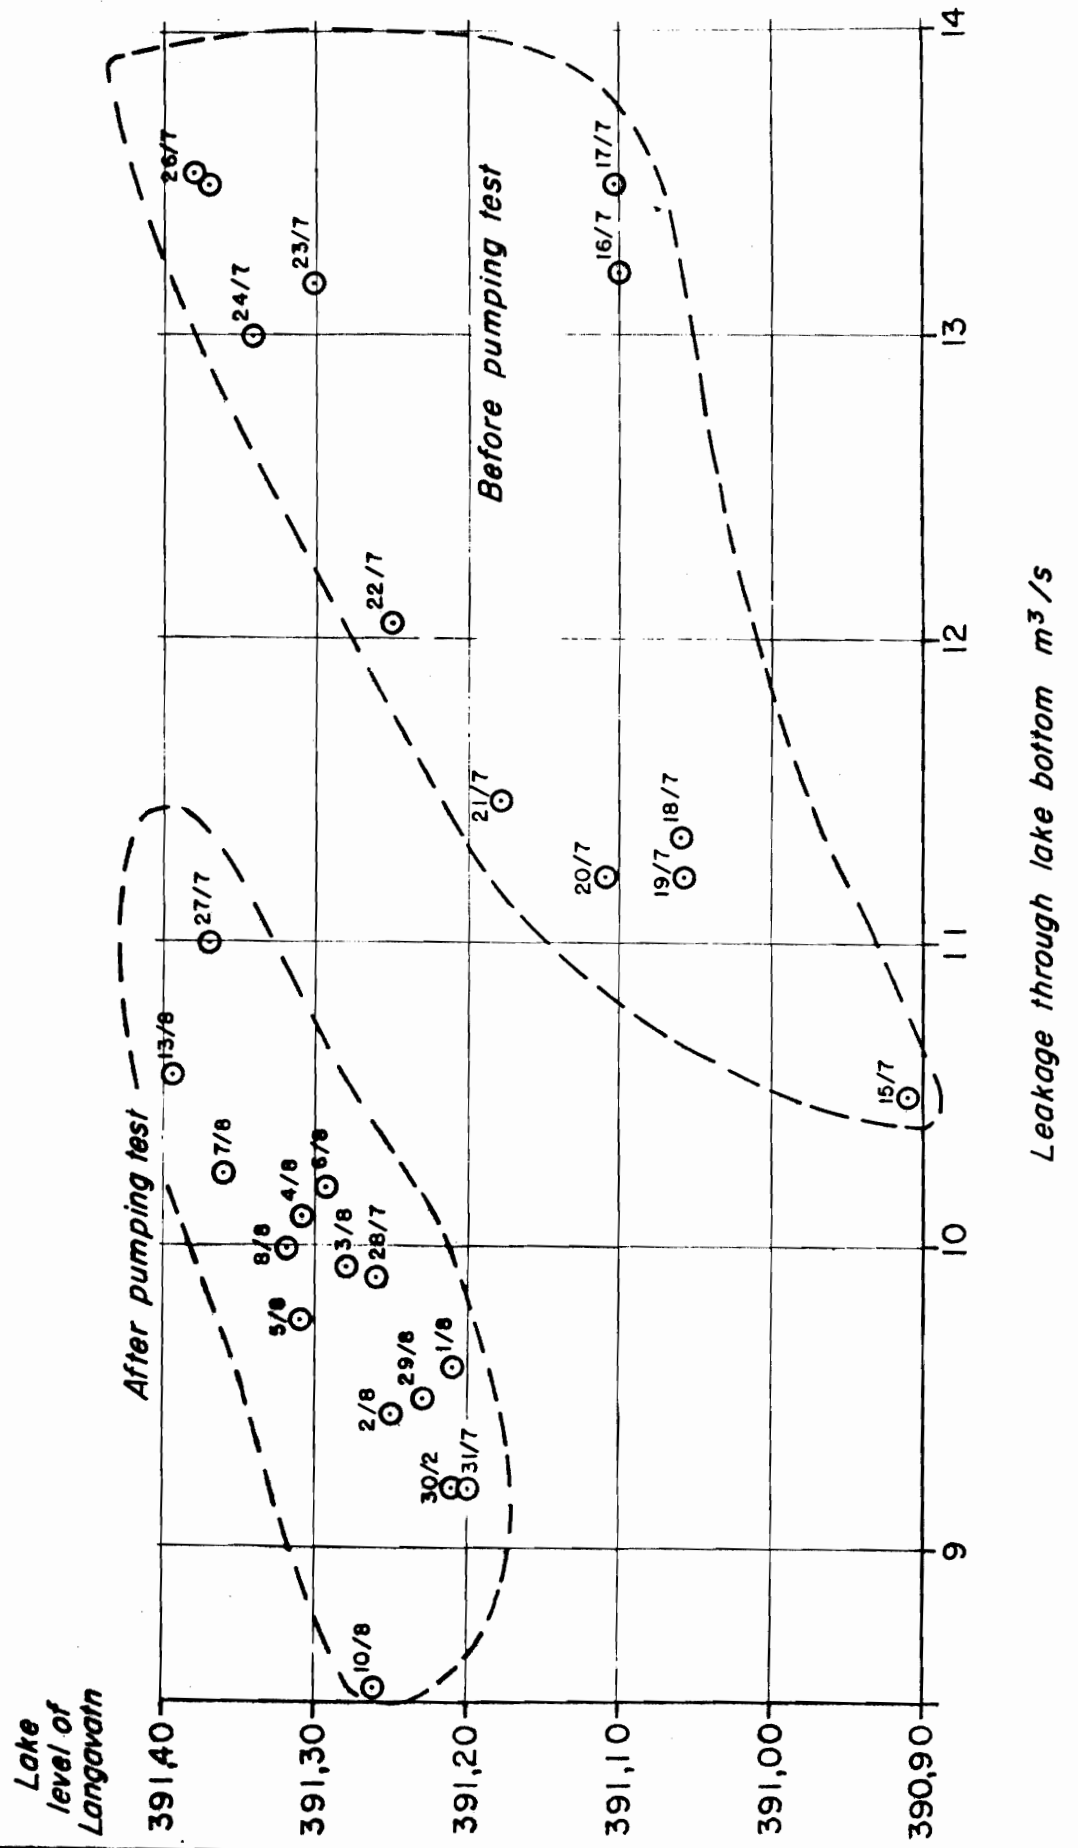
The other graph shows lake level plotted against leakage for each day from shortly before, during and after the pumping. The result is very obvious, a decrease in leakage by 3 to 4 m³/sec. This result is in fact much better than I had expected. The decrease in leakage is similar to what was obtained at Sigalda reservoir last autumn by putting on a sealing blanket at about 200 times higher cost.

Fig. 2 Lake level of Langavatn plotted against leakage through lake bottom.

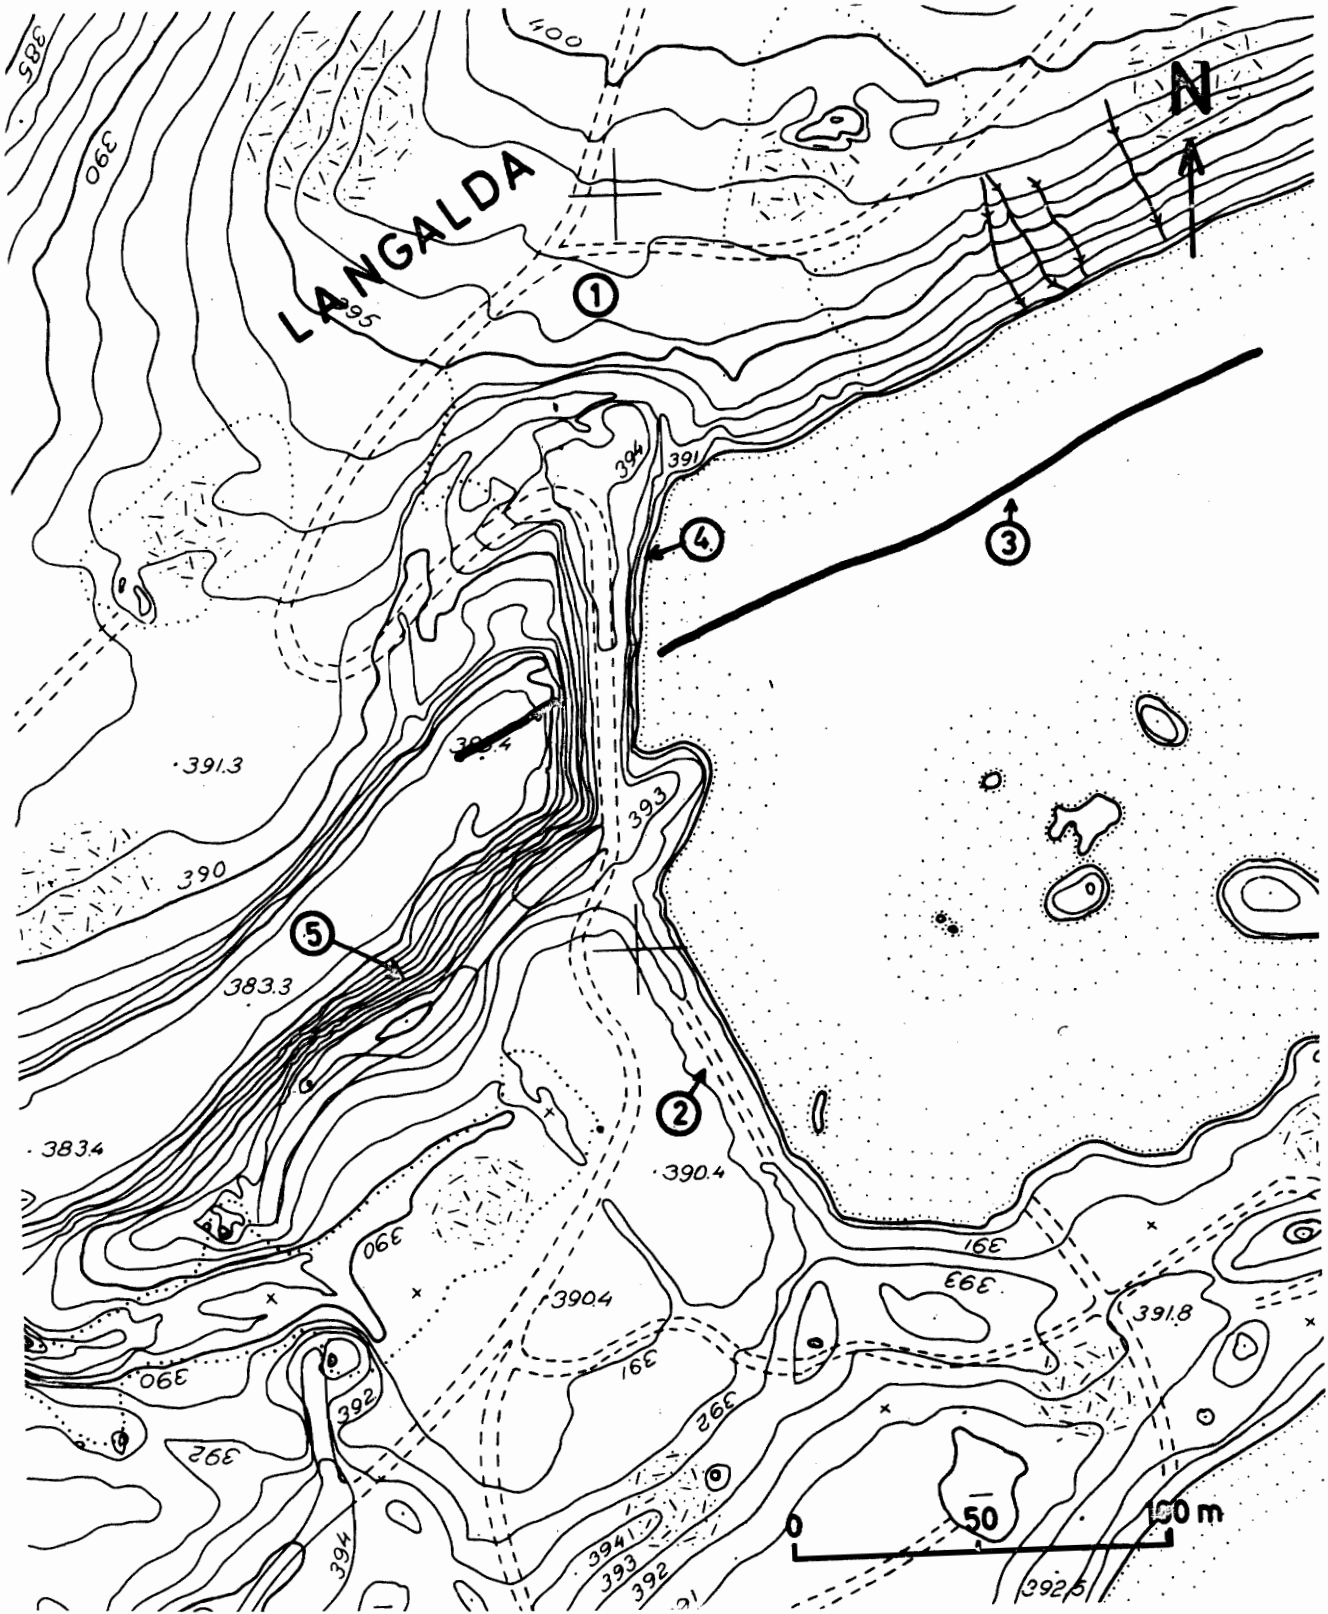
Figure 4

Map with 1 m contour lines showing the dam and the lake approximately 7.5 m deep and fault under the dam. 1 Borrow area in Langalda. 2 Spillway on postglacial lava flows. 3 The fracture. 4 The main dam. 5 Lava front.

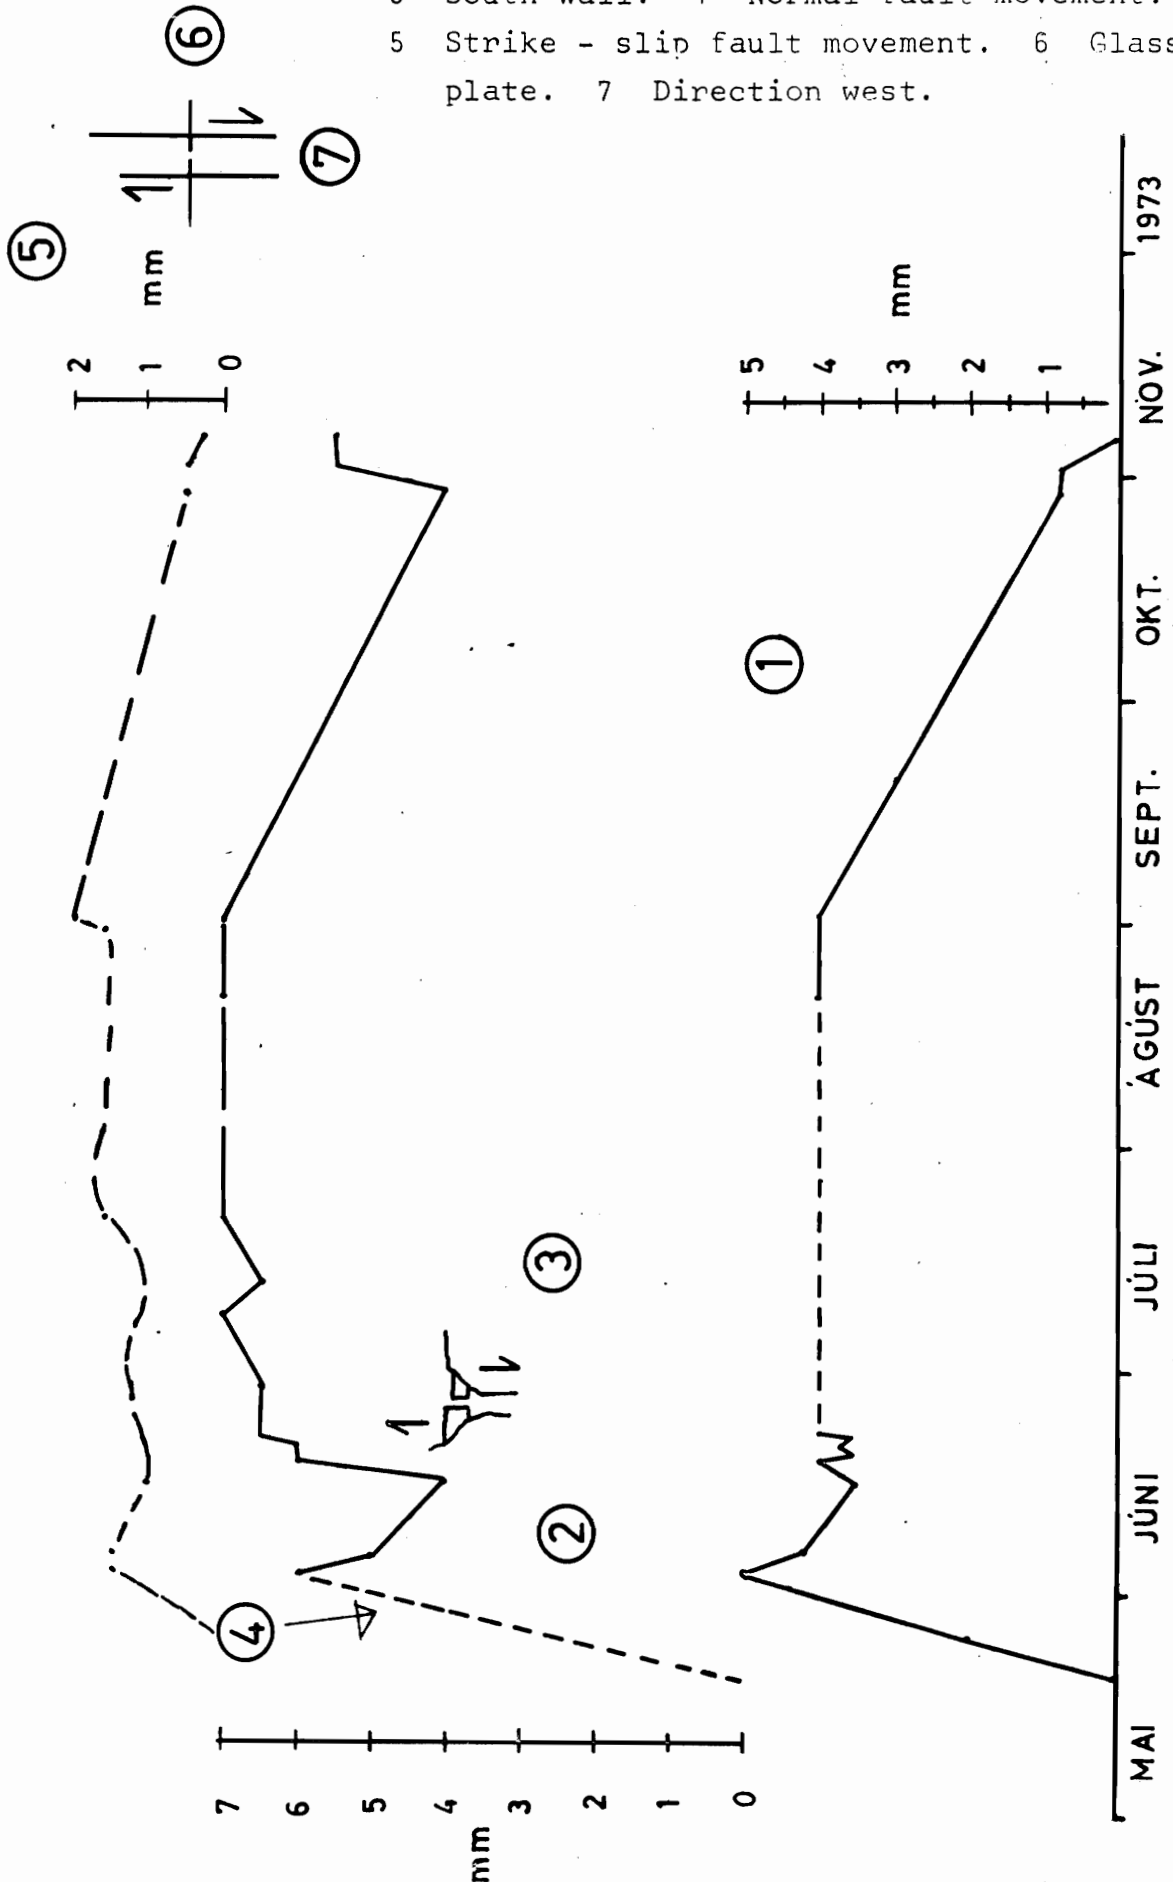
Figure 5

The movement of the fault downstream of the dam and changes in positions of glass plates concreted across it in 1972.

- 1 Widening of fault, 2 North wall.
- 3 South wall. 4 Normal fault movement.
- 5 Strike - slip fault movement. 6 Glass plate.
- 7 Direction west.

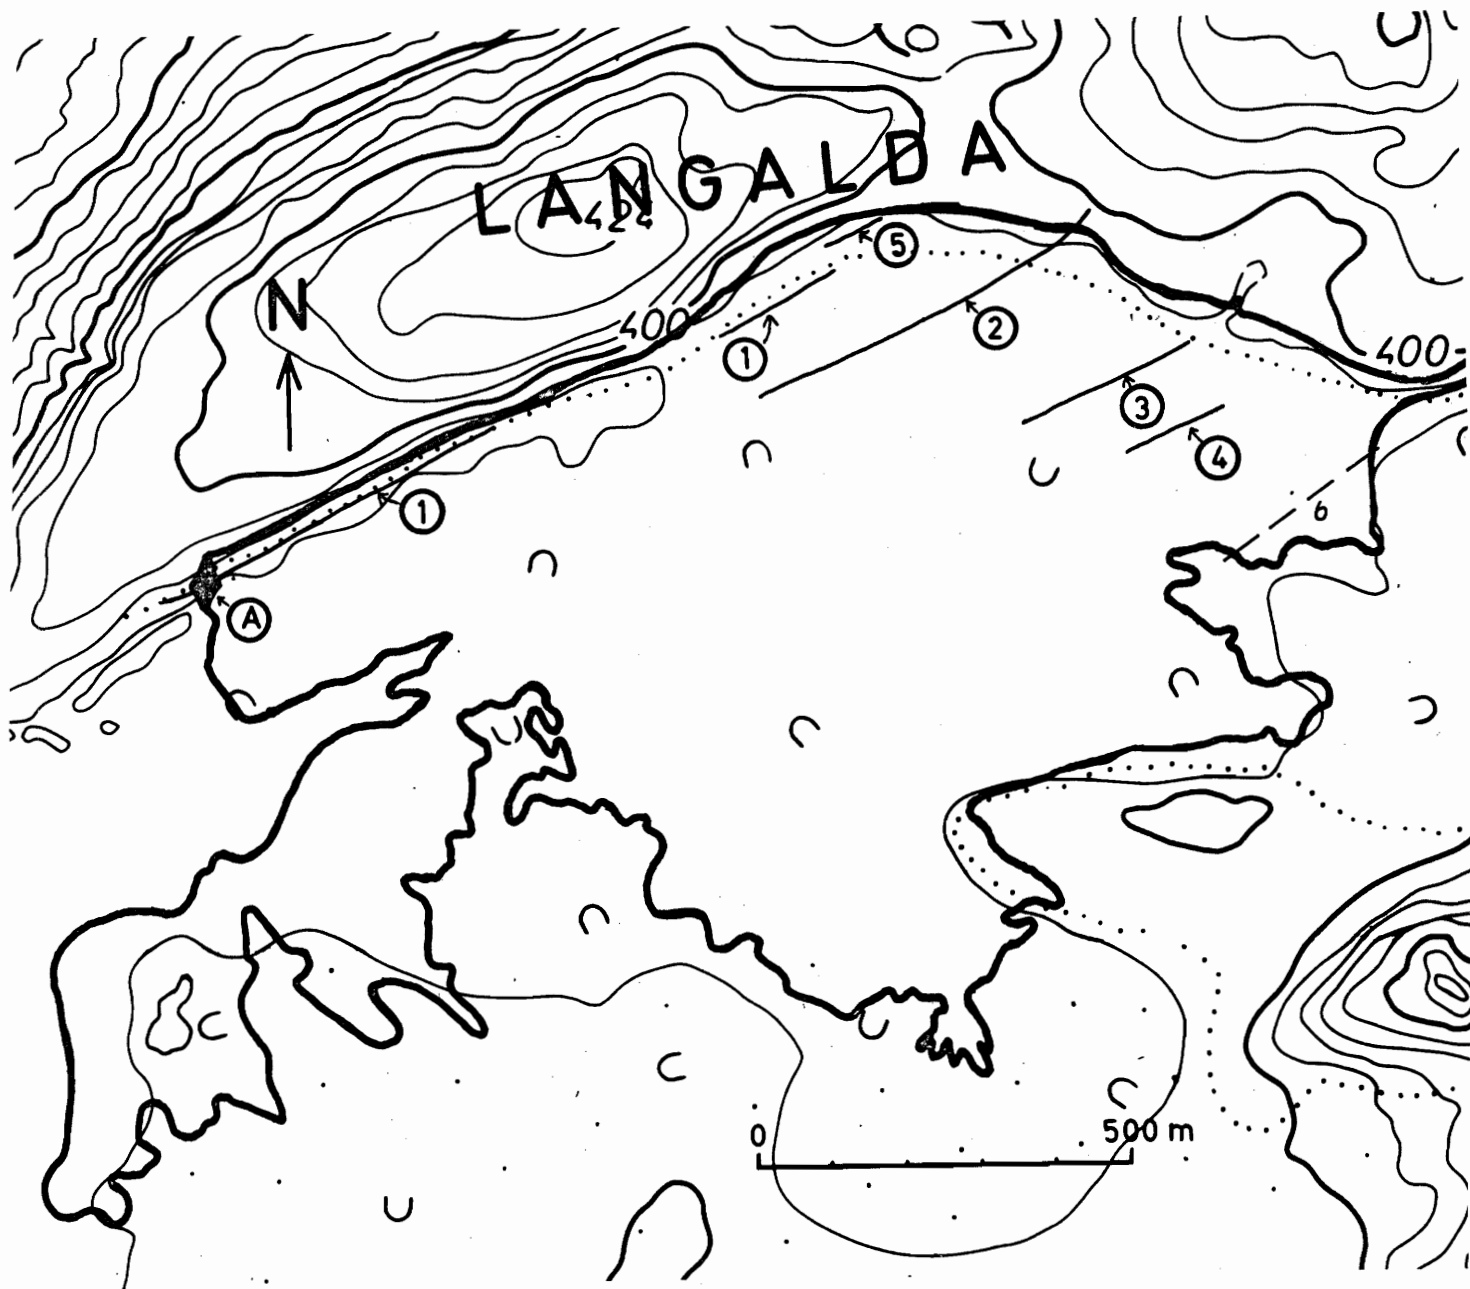
Figure 6

The Langalda test reservoir 7,5 m deep A The dam, 1 The first fracture found in April 1971; 2 The fracture found in September 1972; 3 and 4 were found when lake level was lowered in September 1972; 5 was found at a low lake level in May 1972.

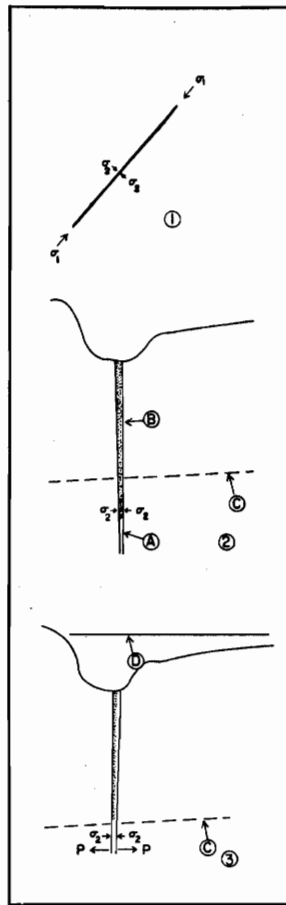
Figure 9

- 1 Plan sketch showing a fault, probably an old normal fault, with stress condition as shown. σ are the principal horizontal stresses.
- 2 Cross section across the fault before water is put on. A is relatively open fault below B, a fault filling which has been washed into the fault when it was an open fracture. C groundwater table.
- 3 Shows the same as above after water is put on. D is lake level. P is hydrostatic pressure in the relatively open fault. This pressure is the same as the head from lake level down to ground water level. It is greater than the minimum horizontal stress. The result is widening of the fault.

Such conditions are of considerable concern as they exist at several potential hydro power sites in Iceland. A possible way to countermeasure movements of this type is by pumping of material into boreholes or directly into fissures and thus gradually increase the horizontal stress in the rock. Experiments have shown that in Iceland the cheapest material for pumping is silty sand, often abundant close by. The cost of pumping should not prohibit the development of an otherwise promising hydro power site in spite of the probability of reopening of fissures.
