TESTING OF EQUIPMENT FOR USE IN CONNECTION WITH
WORKOVERS ON FLOWING GEOTHERMAL WELLS.

SVARTSENGI, 13-18/3. '81

JEA-81/01

Maí 1981

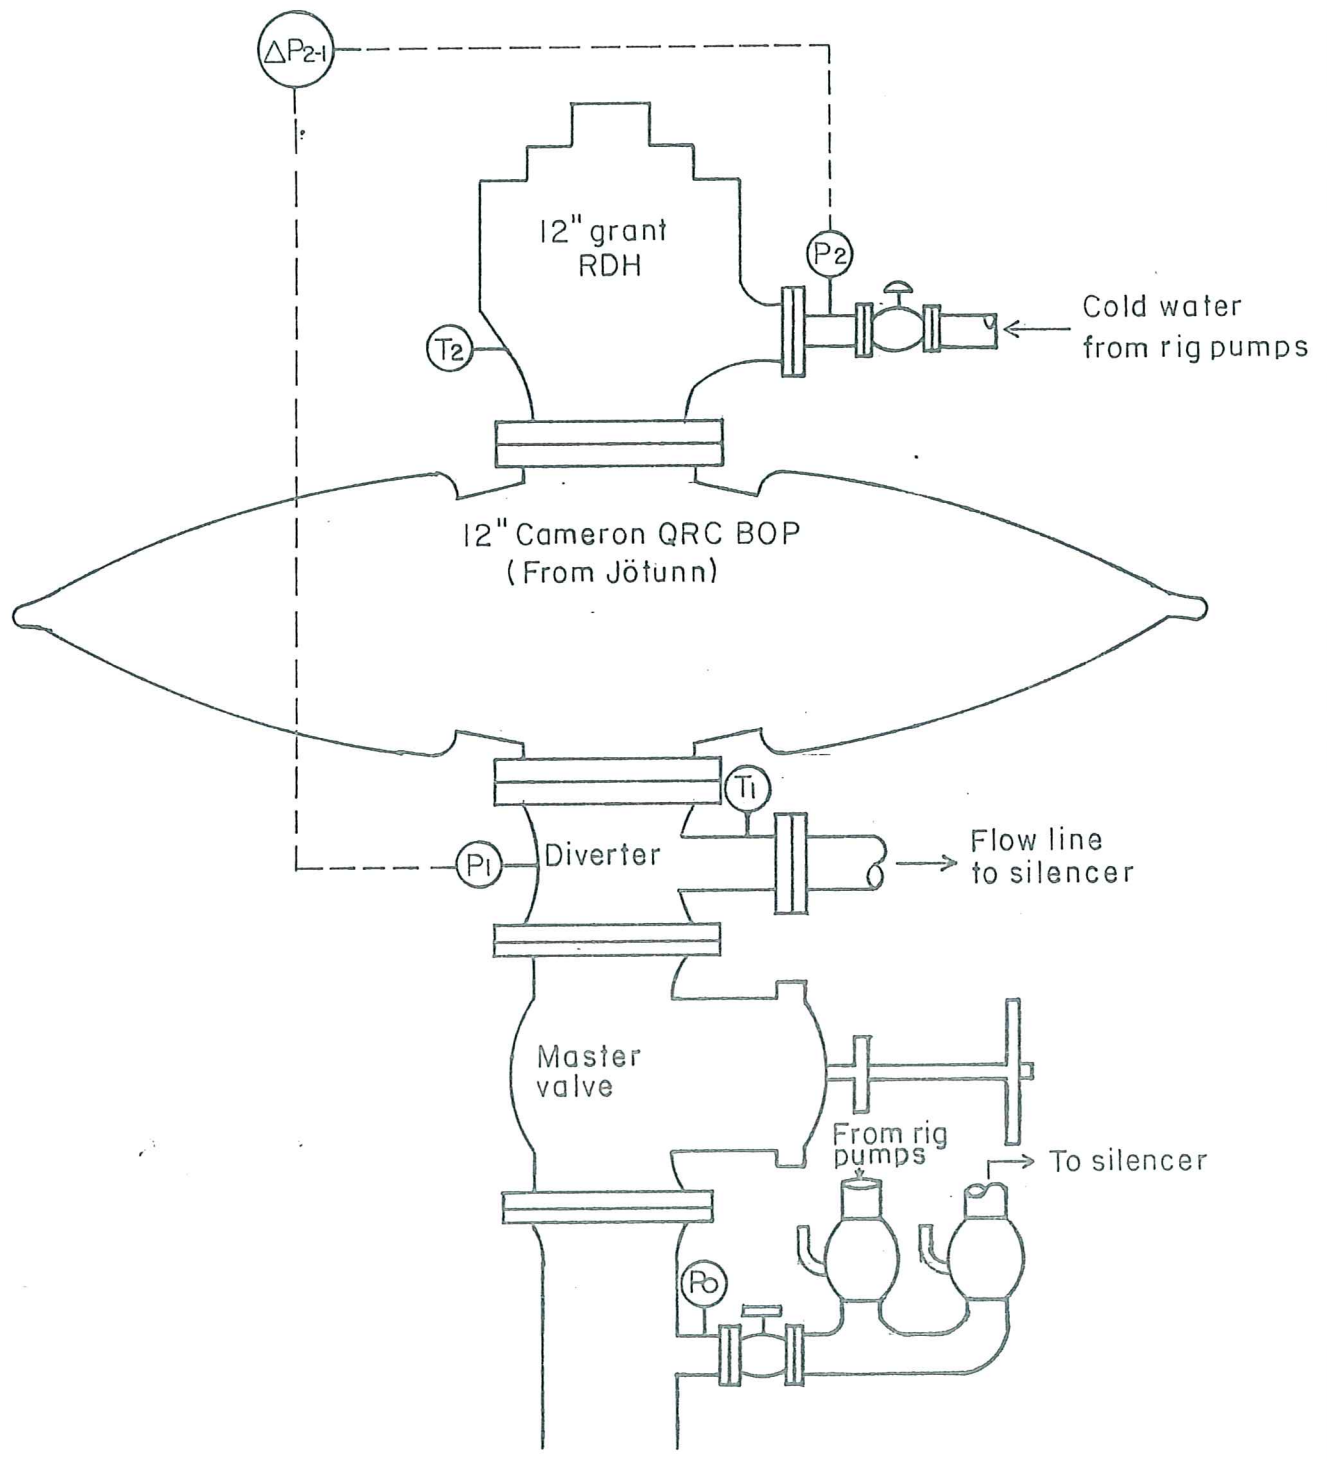
Fig. 4.1

Set up of test equipment at well no. 6 Svartsengi

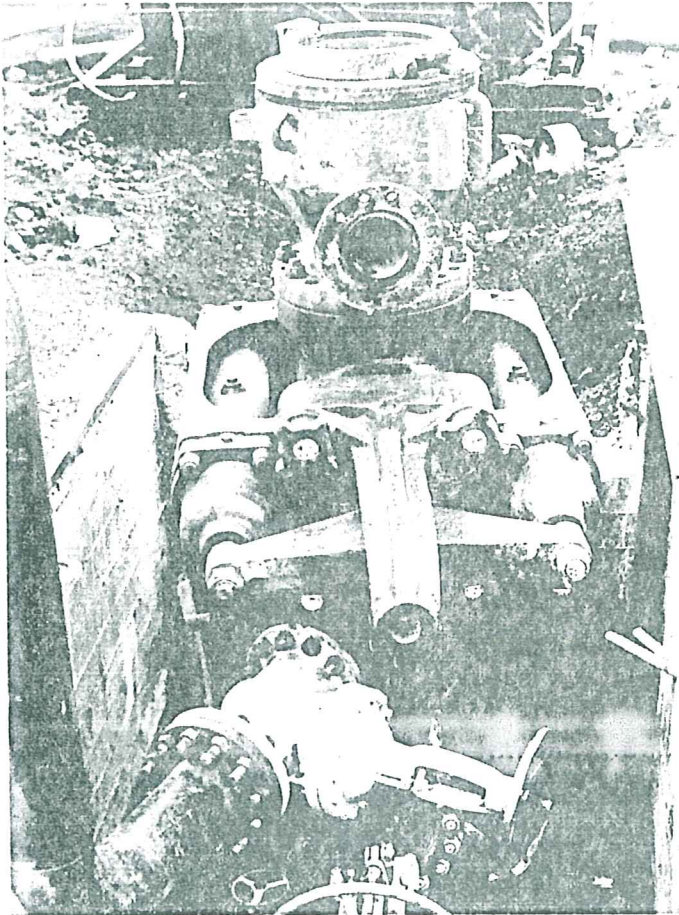
Fig 4.8

The RDH, BOP and flow diverter mounted on top of the master valve (well No. 6. Svartsengi)

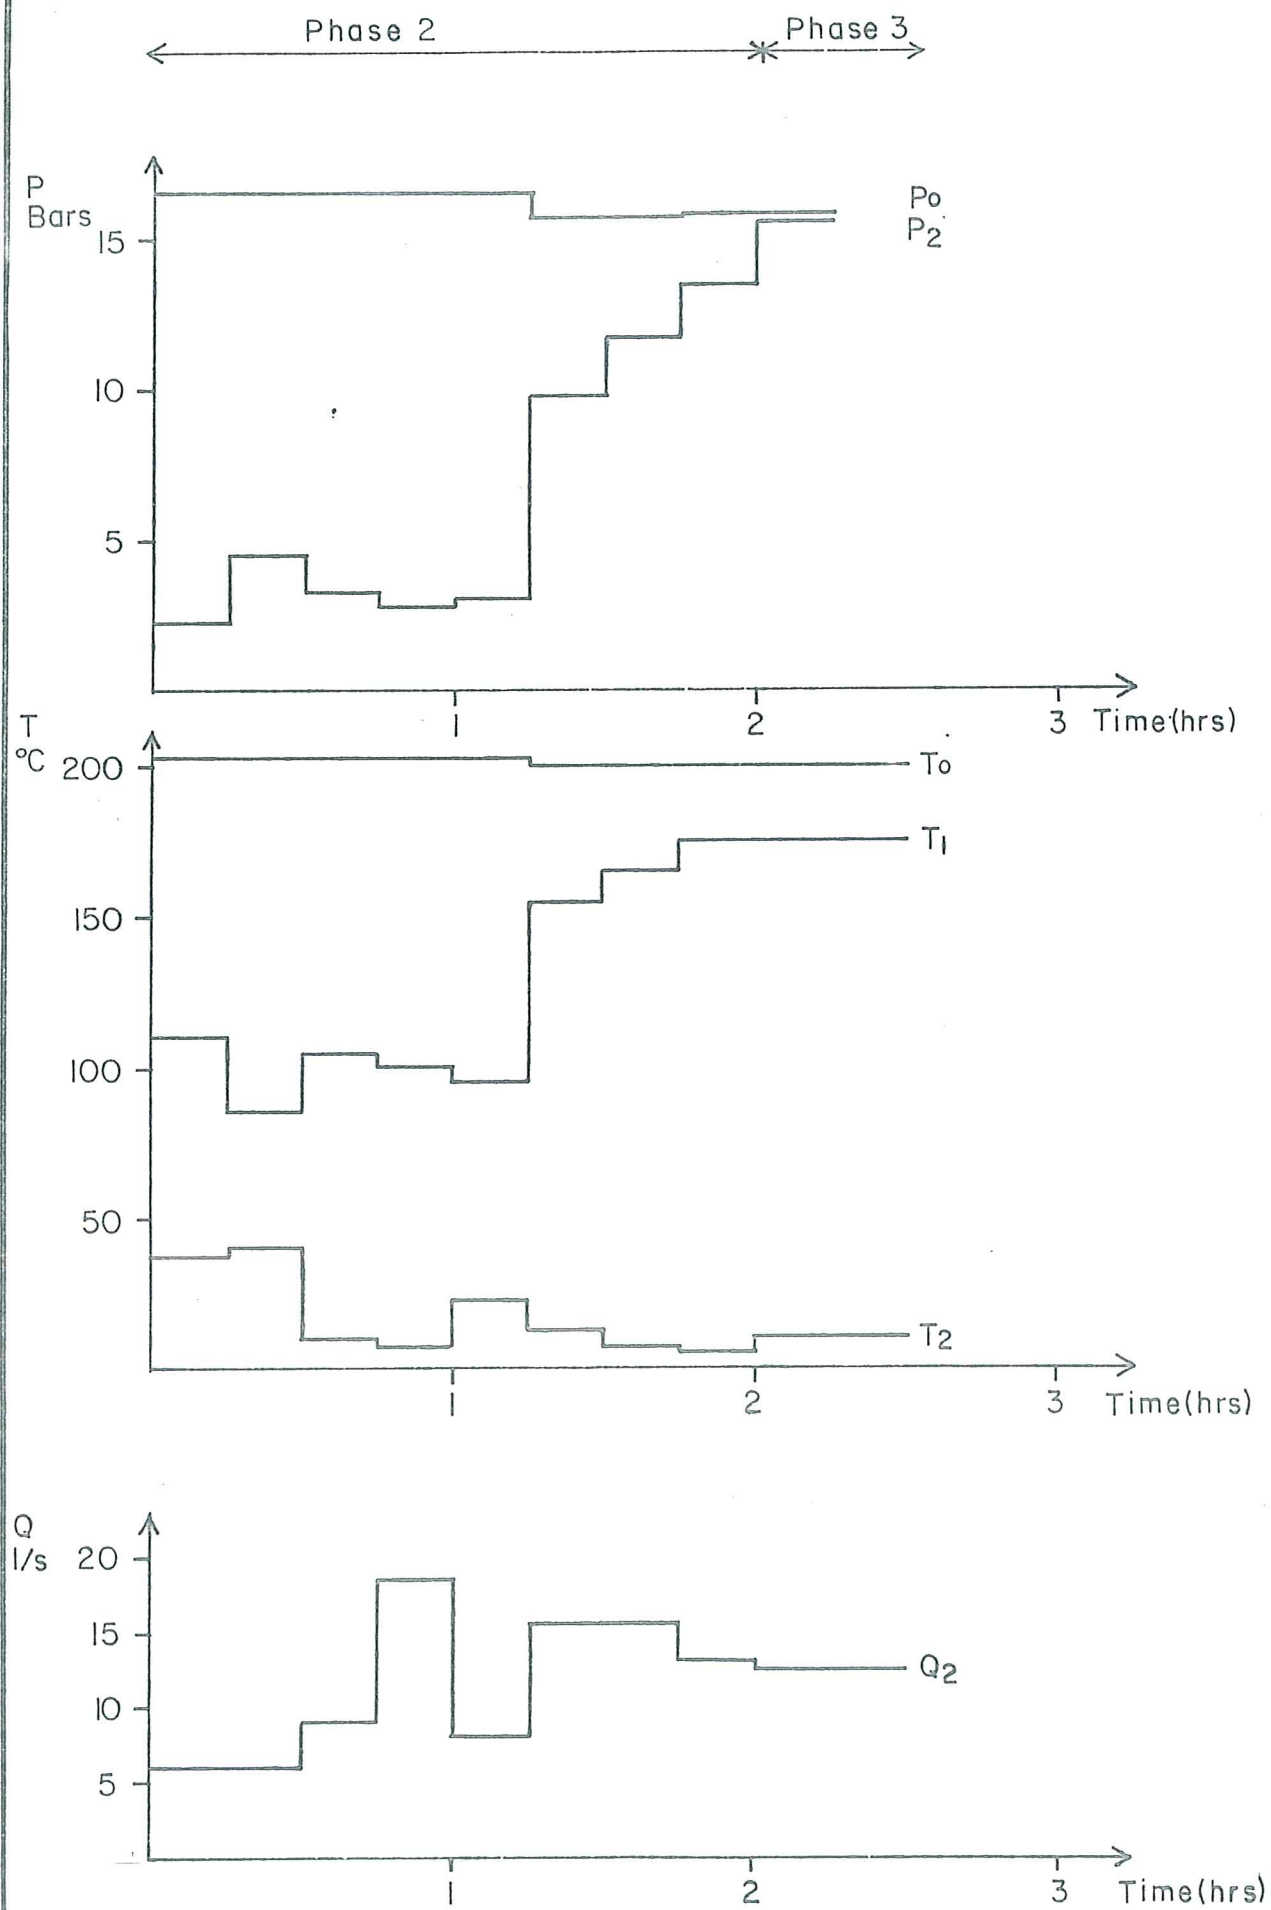
Fig 5.1

Date obtained during testrun I

Test run No. 1 contains mainly phase 2 data. It can be seen from fig 5.1 that the temperature inside the RDH, T_2 , was neither affected by the rising pressure inside the RDH, P_2 , nor the rising temperature below the RDH, T_1 , T_2 was however affected by the rate of cold water, Q_2 .

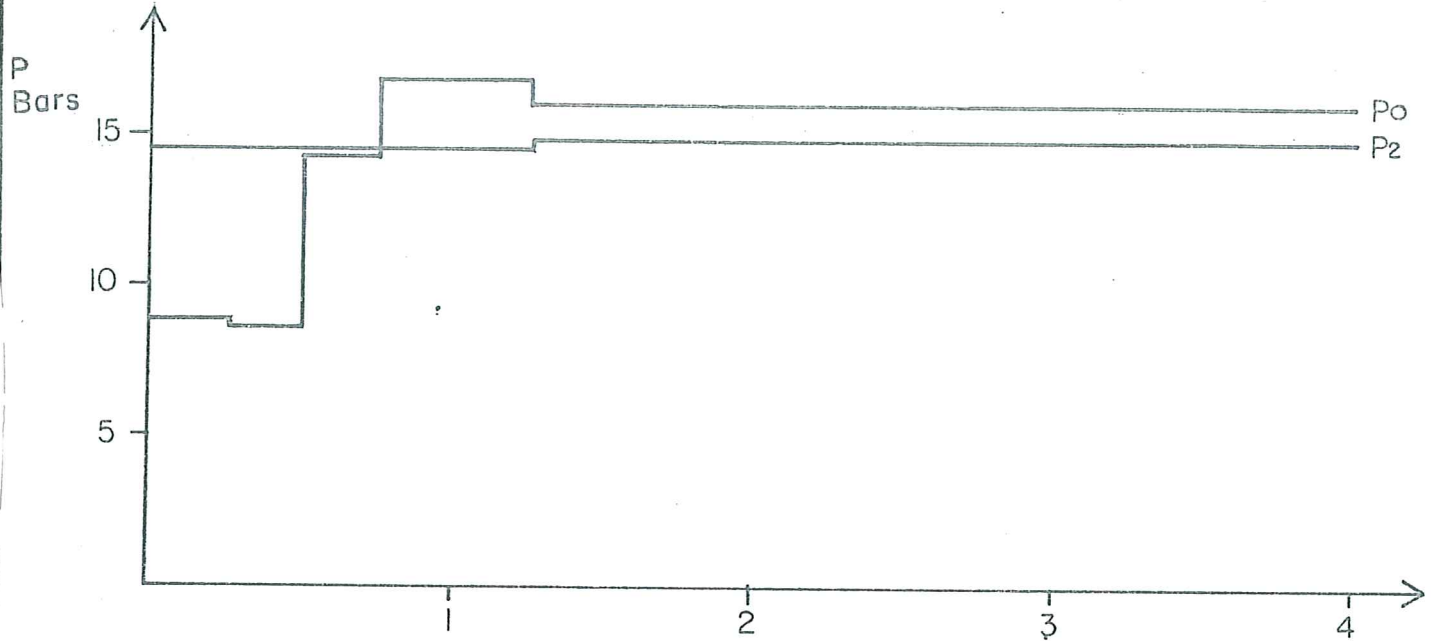
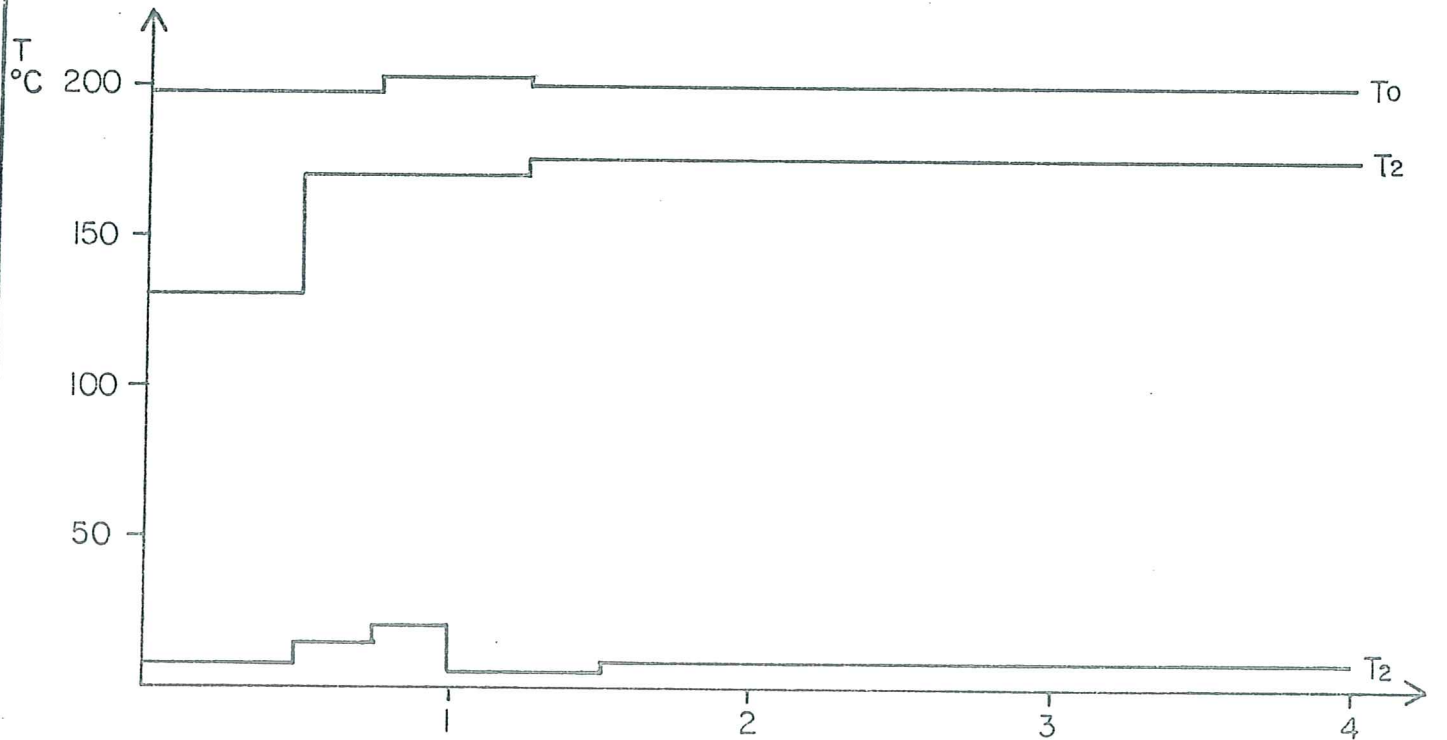
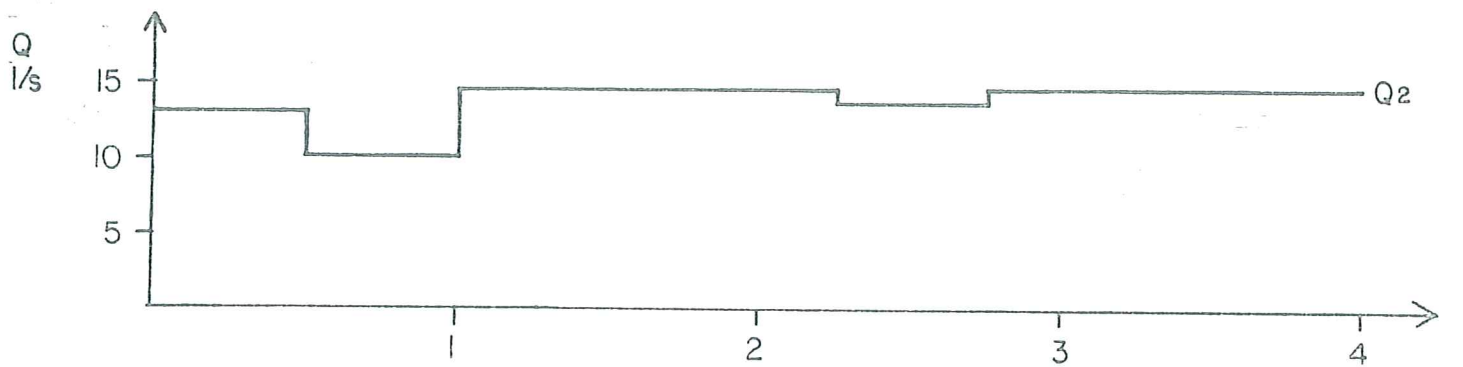
Fig 5.2

Date obtained during test run 2

Test run No. 2 contains mainly phase 3 data, but also some phase 2 and 4 data. The results obtained here were very similar to the ones obtained during test run No. 1. Q_2 seemed to be the only parameter affecting T_2 . Rotation did not seem to have any effect on T_2 .

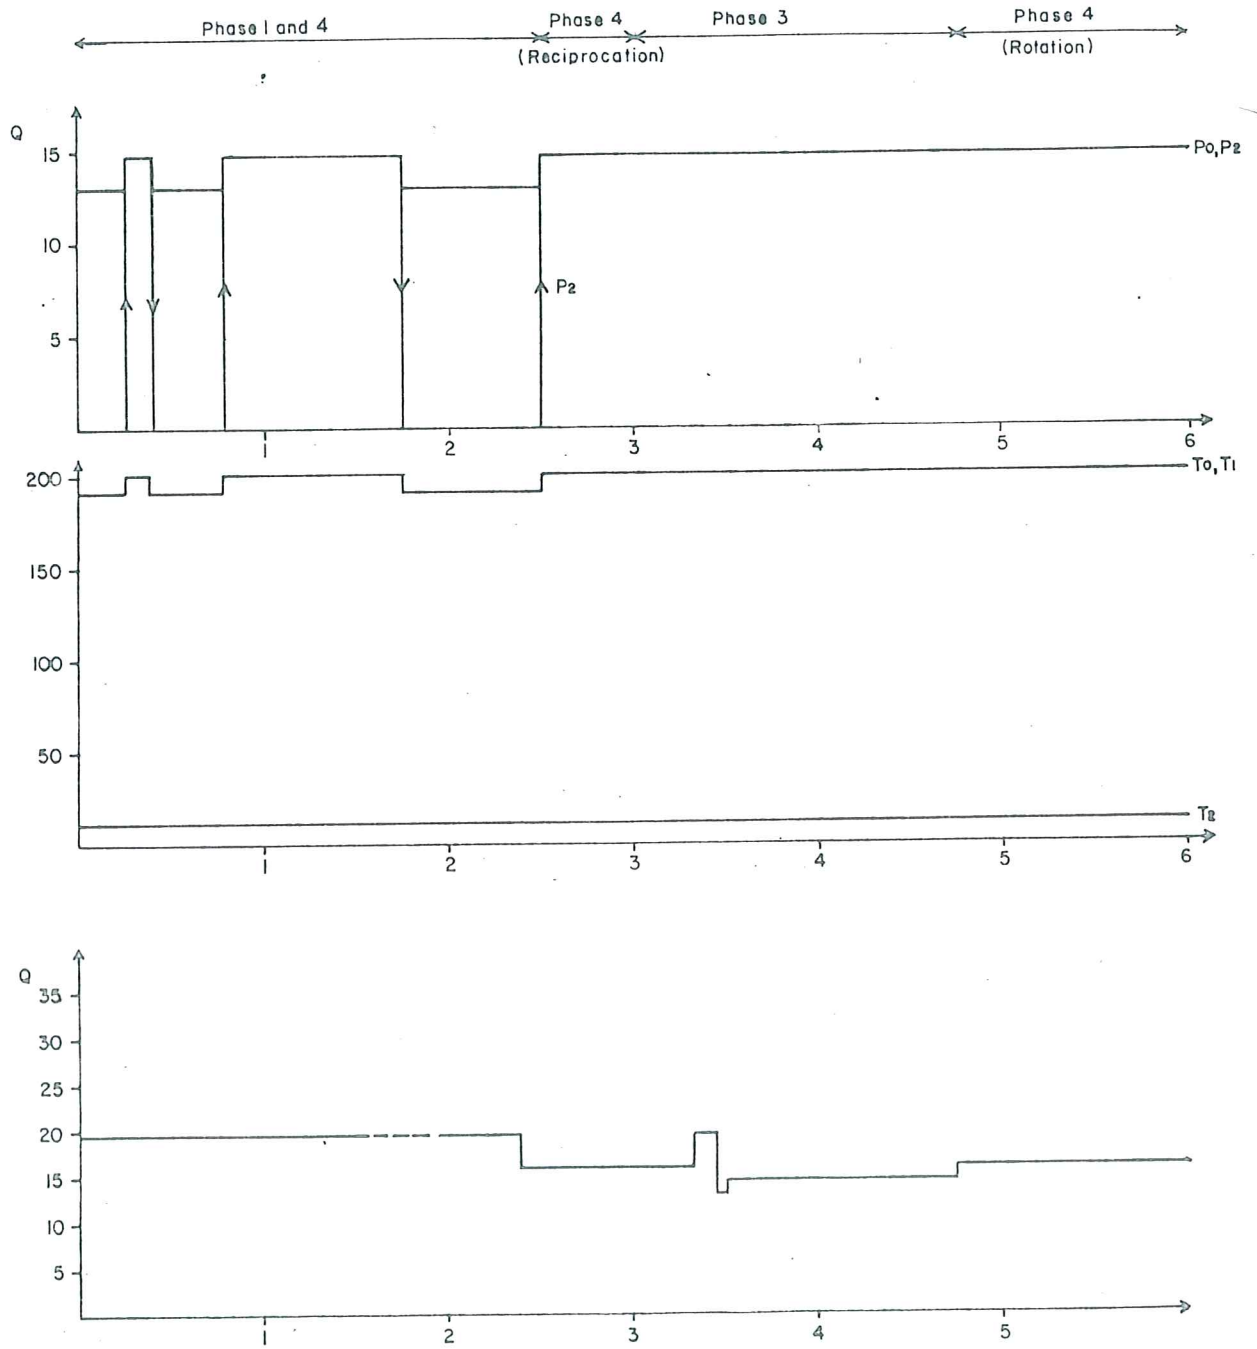
Fig. 5.3

Data obtained during test run 3

Test run No. 3 (fig 5.3) contains mainly phase 3 data and some phase 4 data. The gradual build up of pressure (phase 2) was omitted and the master valve fully opened within a few minutes.

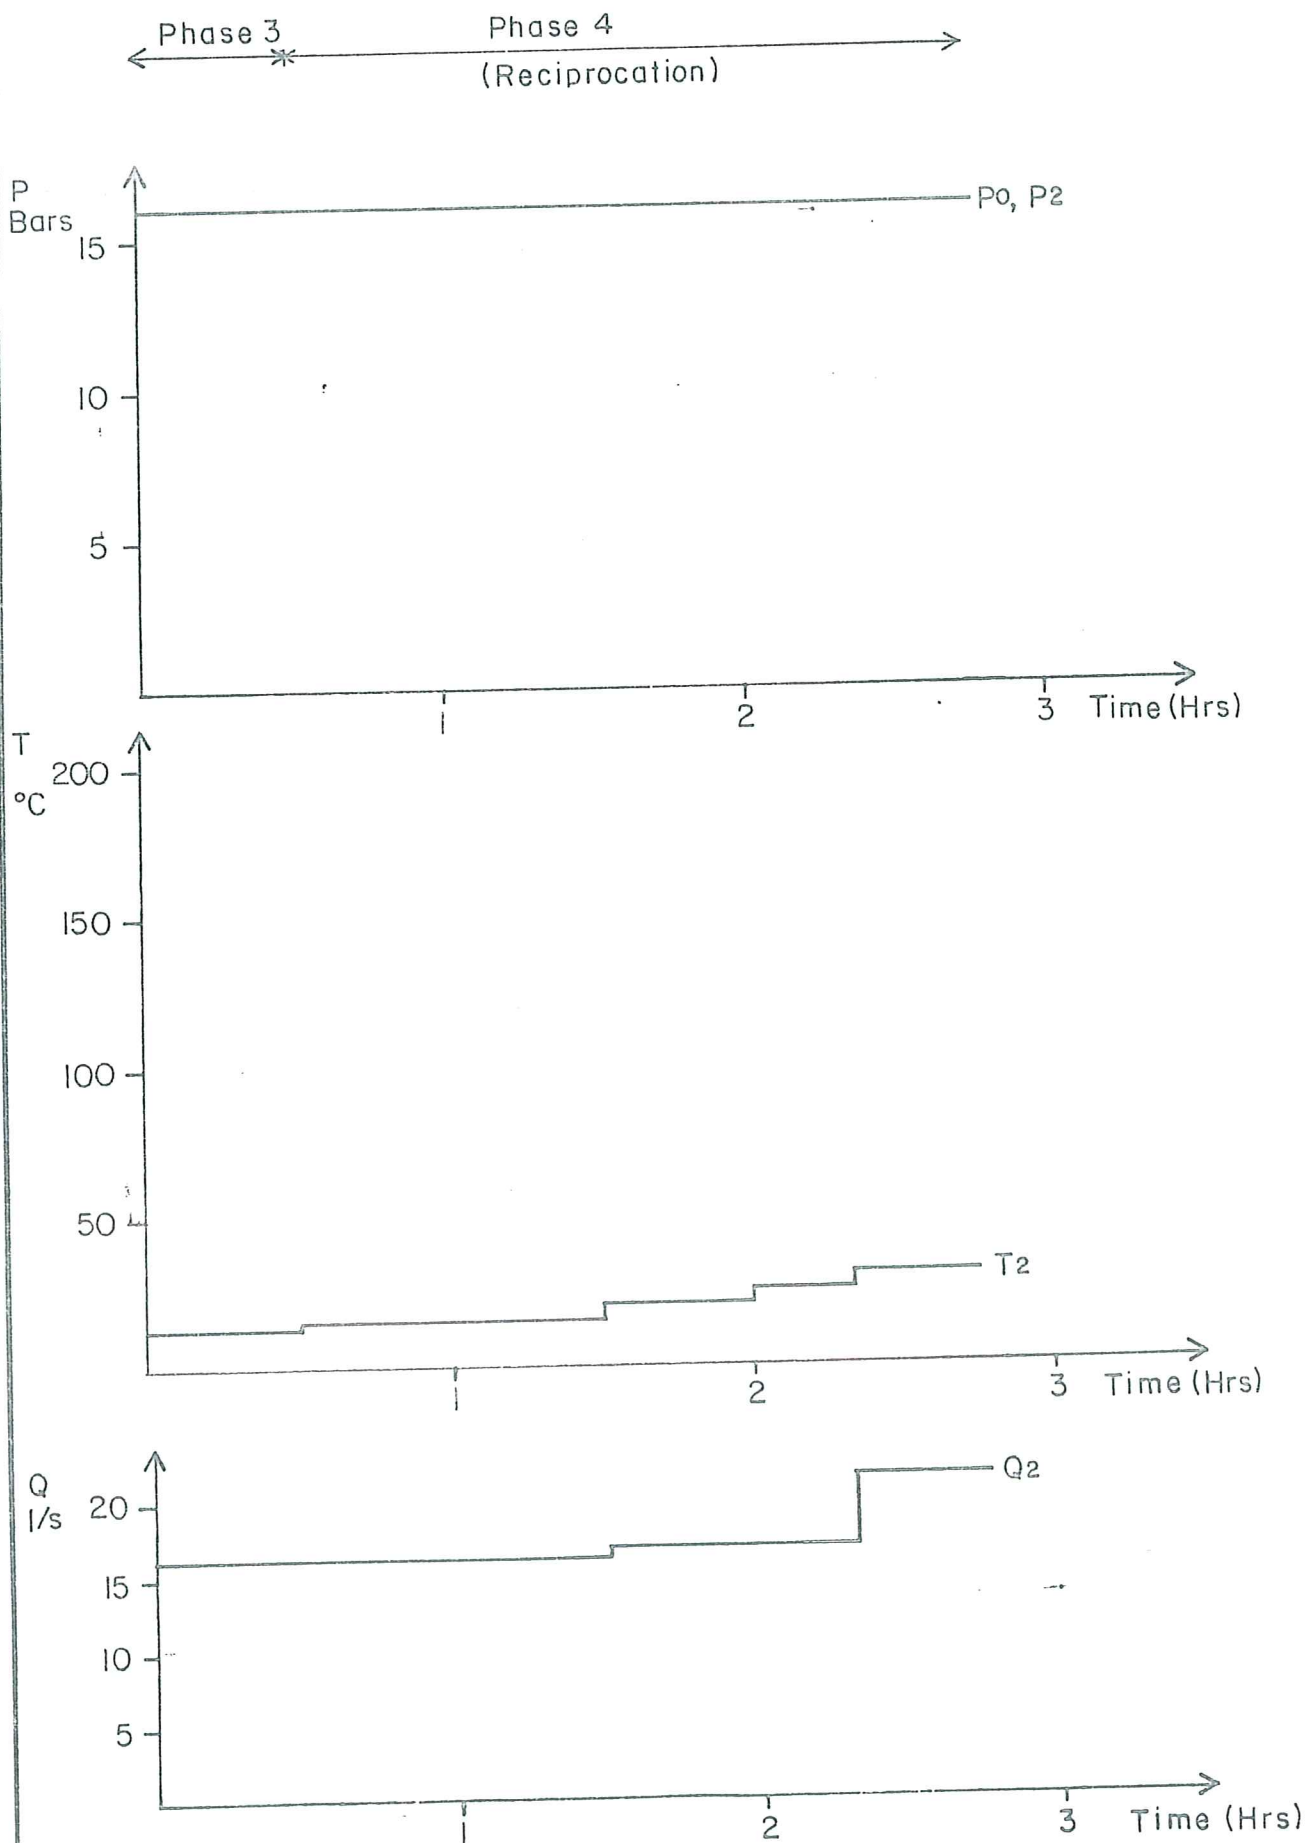
Fig.5.4

Data obtained during test run 4

Test run No. 4 (fig 5.4) contains mainly phase 4 data, and some phase 3.
