SIGALDA

Fissures in the head race canal

Haukur Tómasson, Birgir Jónsson

Client: Landsvirkjun (National Power Co.)

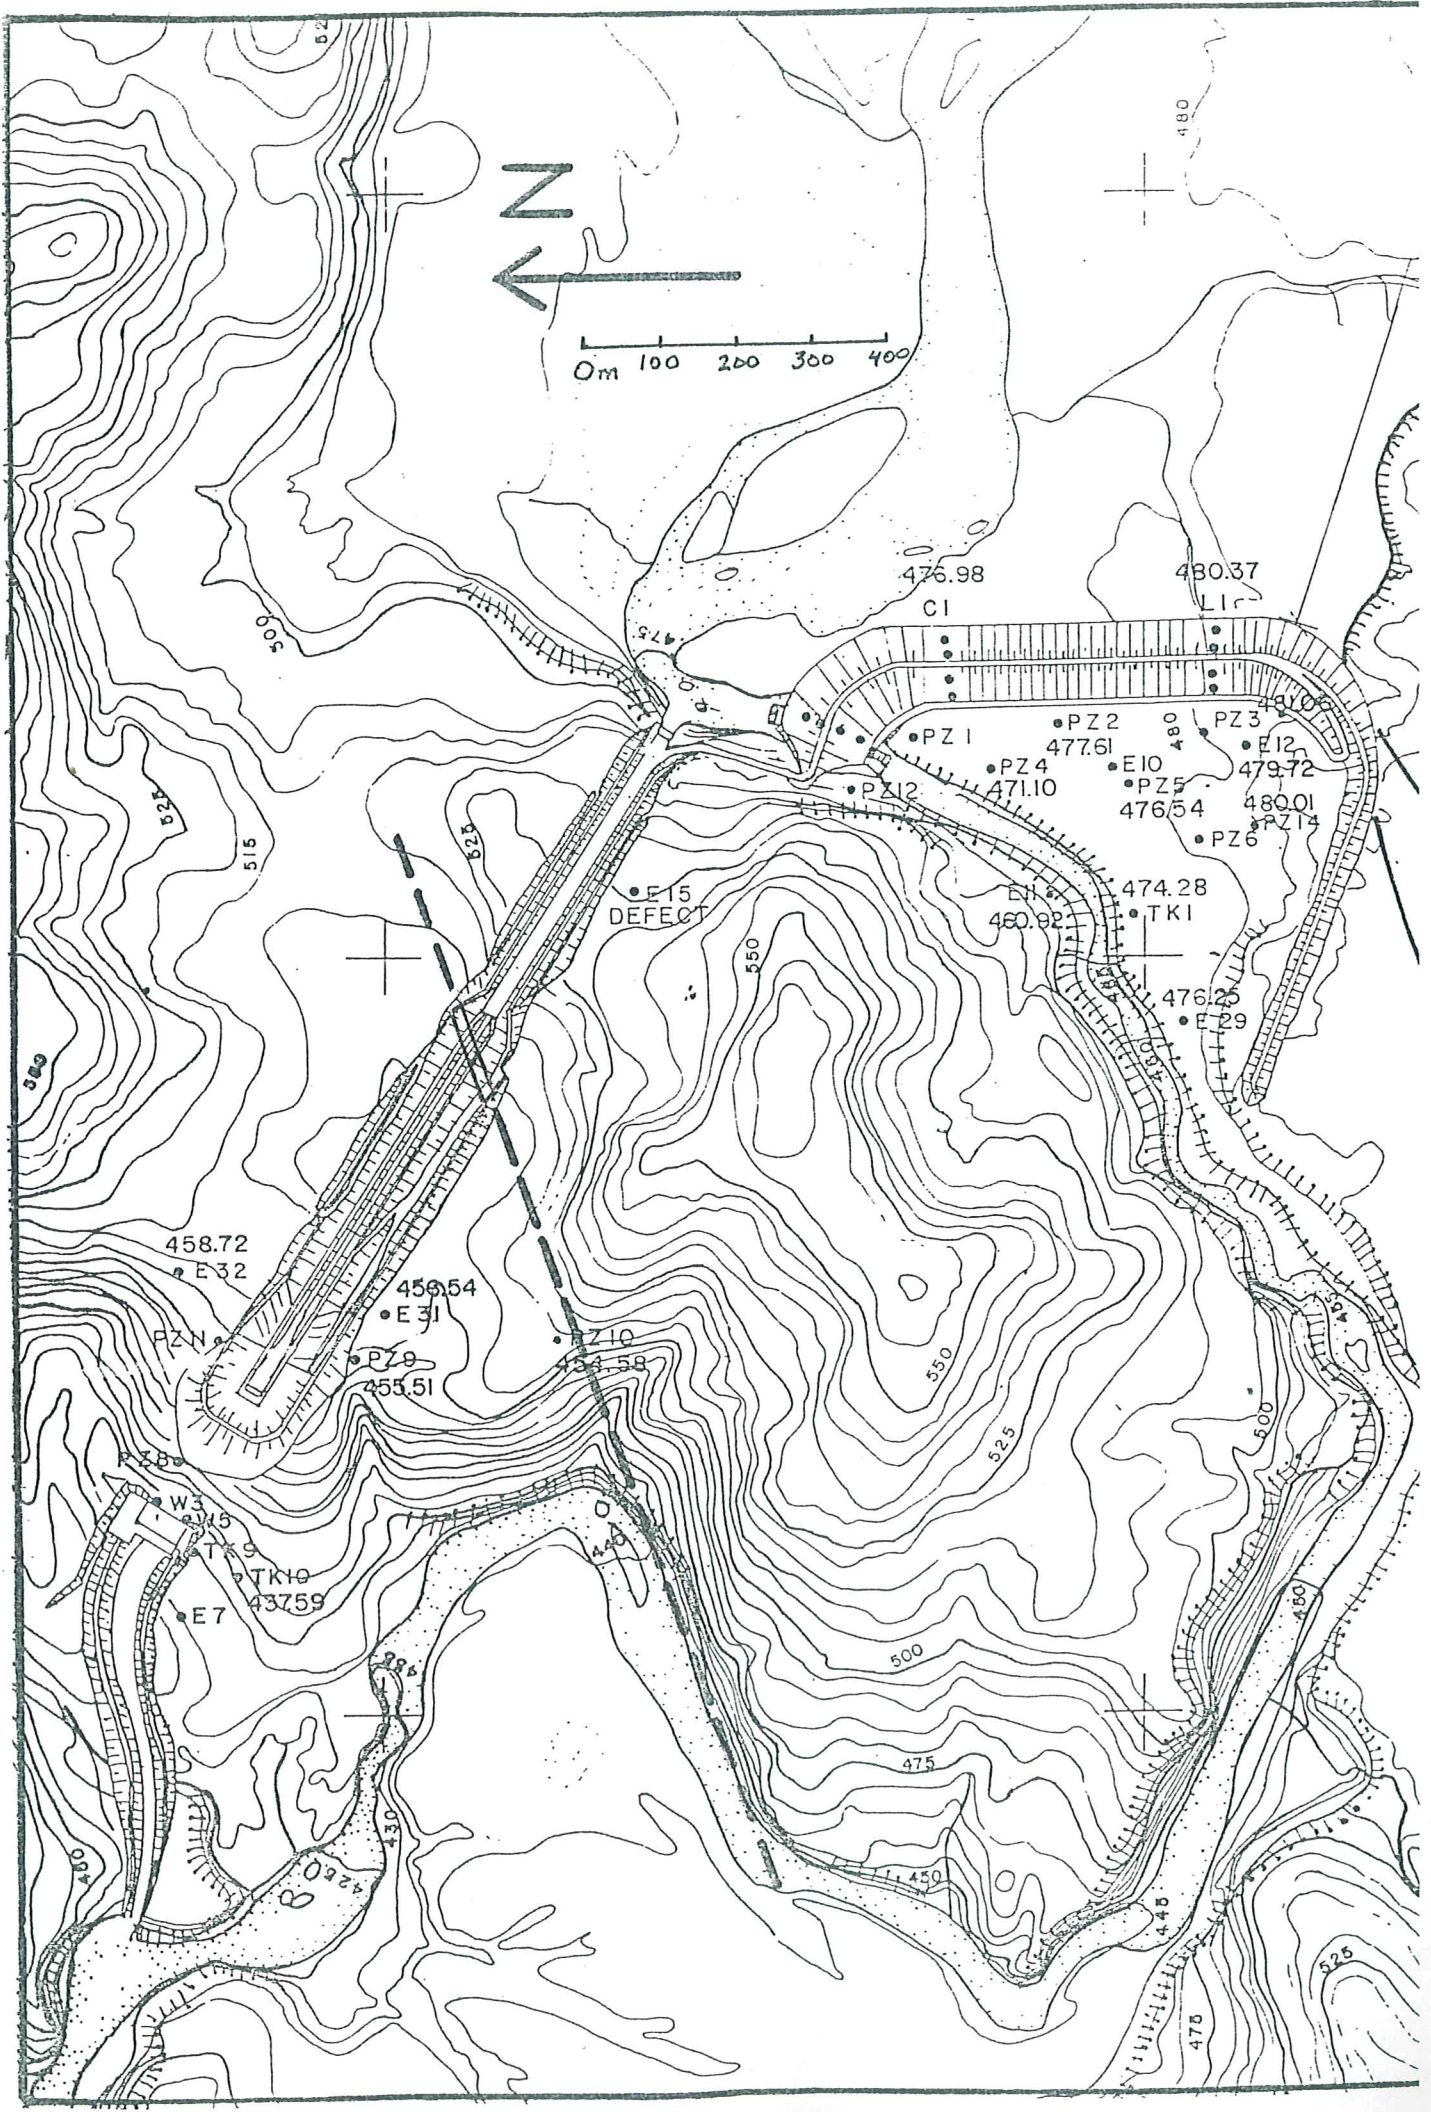
Two almost parallel fractures running ca. ENE can be seen in the canal. They are just downstream of the cut and cover gallery and the distance between them is ca. 30-35m at right angles. On this location the "bedrock" is a very loose volcanic breccia and a clear fracture was not seen when geological mapping of the canal walls was done during construction. However, some irregularities that might indicate the presence of faults or weakness zones were seen there. This ENE tectonic direction appears quite clearly in the Sigalda area landscape and the fracture zone that has now opened up in the canal, seems to control the course of the Tungnaá river just upstream of the Sigalda waterfall (see accompanying map). The distance from the head race canal to the Tungnaá river along the fracture zone is ca. 600 m. Piezometer PZ-10 is very close to the fracture zone and could give indications of when the present fractures opened up.

Of the two fractures the one further SE can be seen in the canal bottom, the right wall and on the right berm. The fracture is located in the shotcrete, near its edge. It has opened up by about 3-4 cm and water from the cut and cover gallery flows into it. The fracture can not be seen in the left wall or the right one above the berm, because of the presence of rip rap. The fracture further NW is easily visible on the bottom (ca. 8-10 cm opening), and on the right berm, but the rip rap covers it elsewhere. Still, there is a slight depression in the rip rap in the left wall, indicating the presence of the fracture.

The fractures look incredibly young and there were sharp edges in the silt/clay layer that now covers the canal bottom on the right berm. Everything suggests that the opening of the fractures are very recent. These fractures seem similar phenomenon to the ones that opened up during the operation of the experimental Langalda reservoir further downstream. This happens when the ground water level is at some depth below the reservoir bottom, a fracture with rather impermeable walls is under the reservoir and the horizontal stress in the crust/bedrock is extremely low. If the fracture connects with the water in the reservoir the water level in the fracture will be much higher than in the surrounding rock. If that difference in water pressure exceeds the horizontal stress in the rock the fracture will open up.

In order to prevent leakage through these fractures we suggest that they should be filled with sand, flushed with water jet down into the fractures. In the last stage of filling it would be beneficial to add bentonite to the sand, for lubrication and expansion after the sand is in place. When impounding of the reservoir and canal starts, one can expect the fractures to open up again, as happened at Langalda, and then the expansion of the bentonite will be of great use. No doubt it will be hard to get the sand into the fractures in the canal walls, so some cement/bentonite grouting might be necessary there. Where rip rap covers the

fracture it must be removed to make the fractures more easily accessible. More than adequate volume of sand is in the delta of the Vatnsfell canal at a distance of ca. 1.5-2 km. It might be economical to pump the sand this distance as possibly a few thousand cubic meters might be needed to fill the fractures.
