## Investigation and repair of a wellhead leak on geothermal well BO-2 at Boullante

**Greinargerð SP-2003-02**

Bouillante 08.05.2003

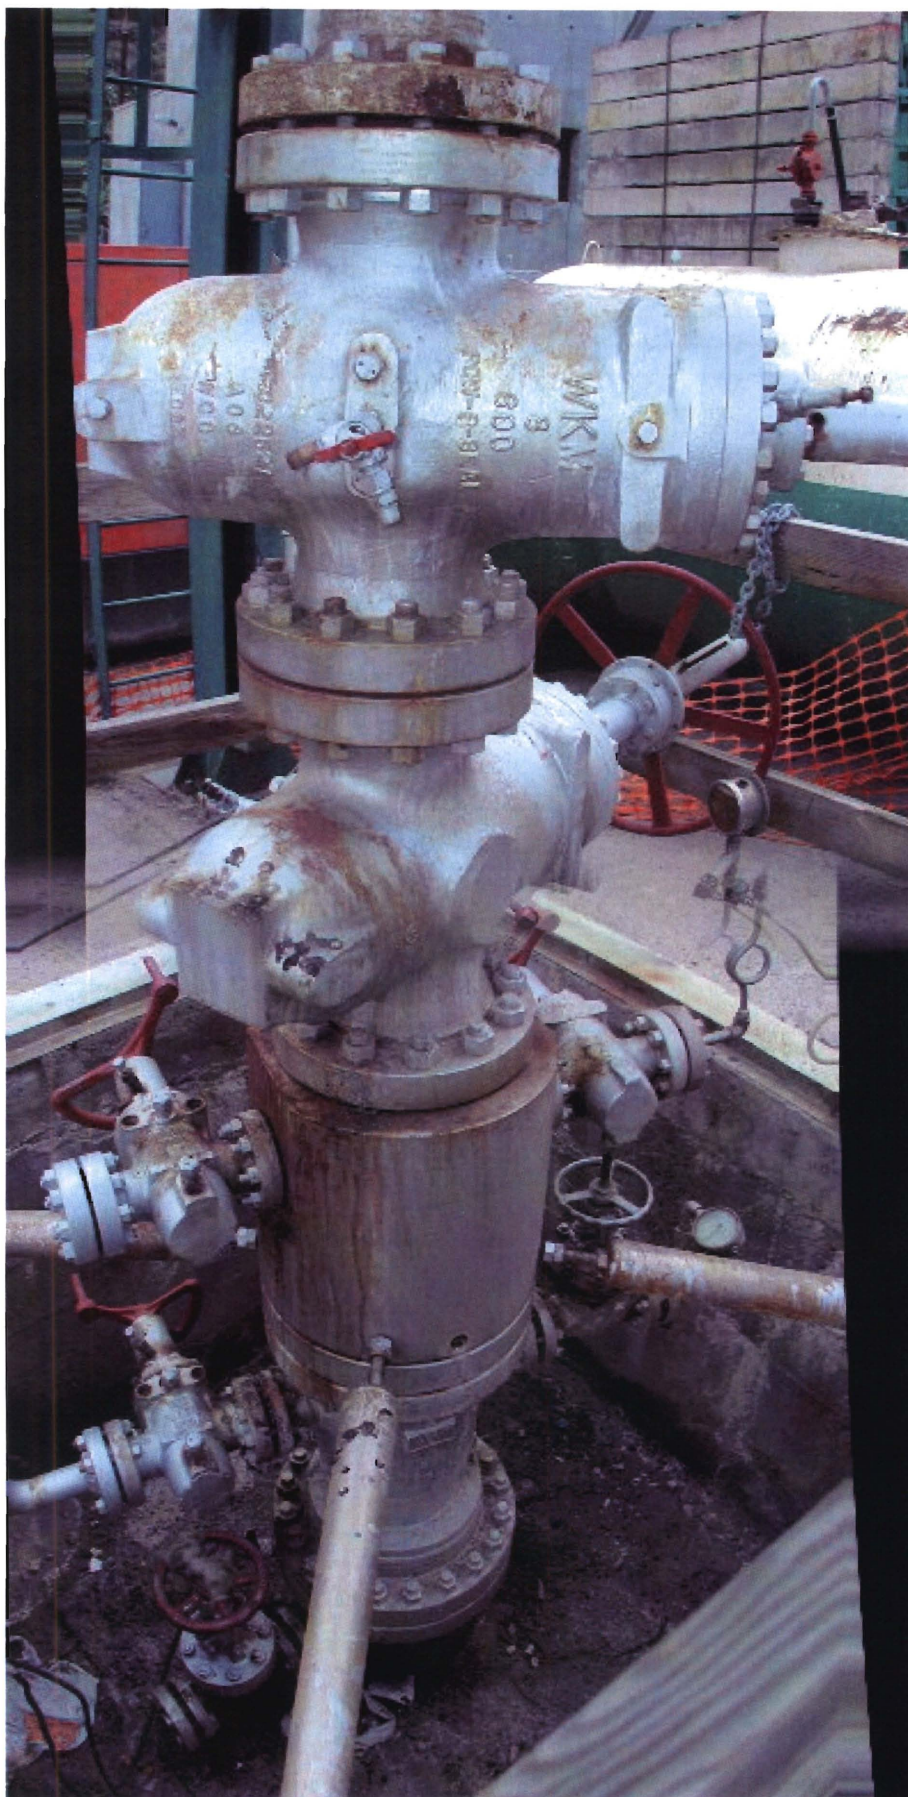
In order to confirm suggestions that the 9-5/8" casing was broken, the pressure in the second annulus (blue colour in fig. 3) would have to be the same as in the first annulus (green colour in fig 3). As the wing valve on the 13-3/8" casing head is the original one, and has been on the well for 32 years (or since 1970?), there were concerns that the pressure could not be measured due to the condition of the valve. Further inspection by Mr. Herbrich revealed that two studbolts on the pressure side of the wing valve were so corroded that only one-third of the stud was still there (fig. 13). Attempts to drive out the remaining bolt failed and it was thus decided to weld the flanges together in four places with four 20x20 mm rods (fig. 14). This job was completed late in the

I informed them that the work outlined in the TOR had all been successfully accomplished. The work was carried out in the order originally laid out and there were now no known external leaks on the wellhead. Pressure measurements on the wellhead of 14.2 bar-g WHP (tan color in fig. 3) and in the first annulus of 2.7-3 bar-g (green on fig.3) moreover confirmed that the 7” production casing was without leaks and also the expansion spool. This was good news and now only pressure in the second annulus (blue on fig 3.) had to be measured to see what the condition of the 9-5/8” casing was. If that casing was also pressure-tight, the well was in the original design condition as far as redundancy is concerned and with a new wellhead and expansion spool. The old part of the wellhead had two stud bolts corroded away and the first 1 m of casing below the 13-3/8” casing head was the most suspect and set for outside corrosion. The well is 32 years old and has been the sole supplier of steam to the existing 4.7 MW plant. By bringing the well on stream very slowly and minimizing thermal cycling on the wellhead by keeping it hot when not in use, will minimize thermal stress. I told them that the items covered in this report, with the positive results in solving the known leakage problems with well BO-2, could influence the decision whether to use the well for a few more years or abandon it immediately. Such a decision will have to take into consideration many factors outside what was covered in the TOR during these three days and would rest with CFG.

Figure 3. Drawing of BO-2 wellhead showing location of possible leaks and pressure zones.
