## CASING FAILURE ANALYSIS AND PROPOSED REPAIR FOR WELL OW-740A IN OLKARIA GEOTHERMAL FIELD

**Nahashon Karanja Nzioka**  
Kenya Electricity Generating Company,  
Olkaria | Off Moi Southlake road  
P.O Box 785-20117, Naivasha  
KENYA  
*Email: nenzioka@kengen.co.ke*

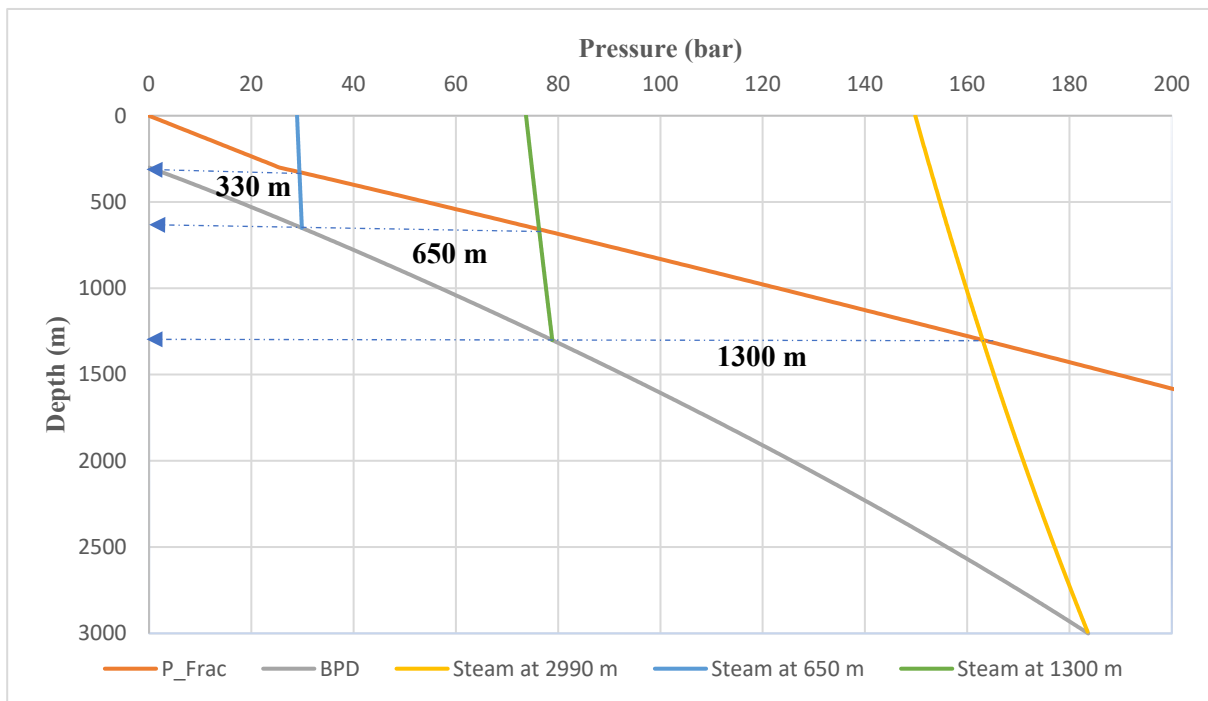
FIGURE 10: Redesigned casing set depth using the African code of practice (the dotted line shows the intersection of pressure and formation pressure curves)

Since the well was drilled to 3000 m RKB, which is about 2990 m measured depth from the surface, the casing sets for the various casings vary from the actual casing depths used in well OW-740A as presented in Table 4. The conclusion is that, assuming the BPD, the casings depths do not comply to the African code. This deviation is though not the cause of the failure in the well.

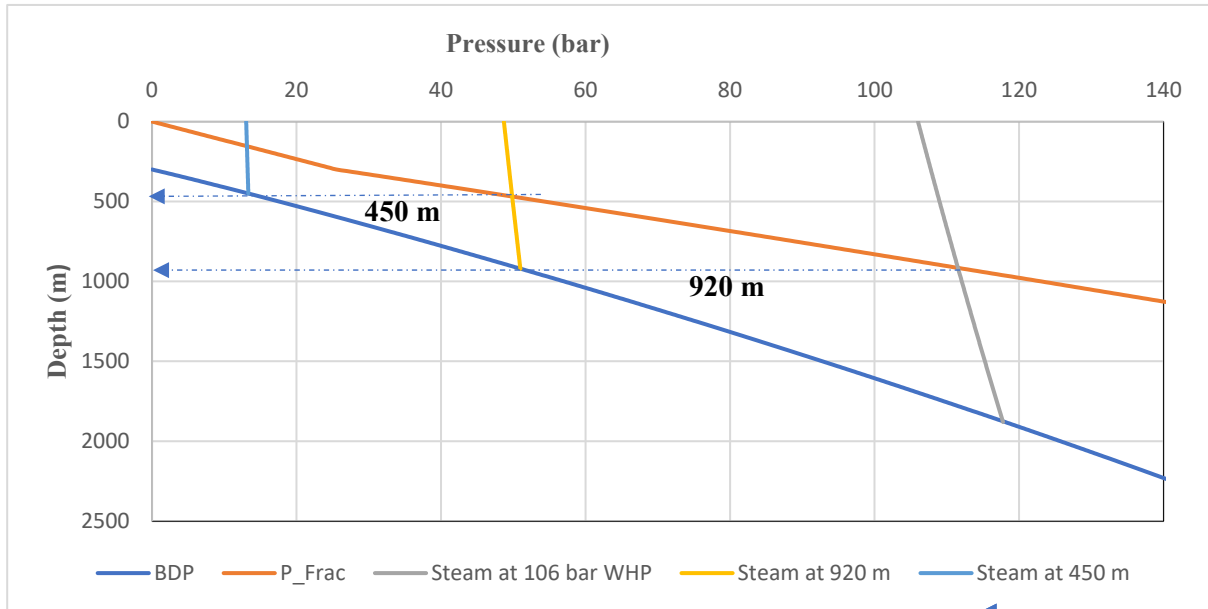
FIGURE 11: Design of the casing depth from the known WHP of 106 bar<sub>g</sub> (the dotted line shows the intersection of pressure and formation pressure curves)

From this plot, we see that the minimum casing depths for the production, anchor, and surface casings are 920 m, 450m, and 100m. The comparison with actual setting depths is shown in Table 5.

From this analysis, we can deduce that the production casing was set at the appropriate design depth. However, the plot also shows that the pressure in the well at 318 m depth, where the casings have failed, is way above the containment pressure of the formation.

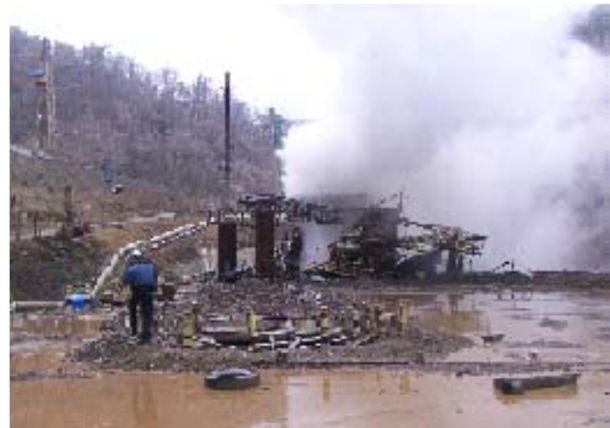
FIGURE 14: View of well 5R-12D that blew out and toppled the rig (Jumawan et al, 2005)

Moreover, this was the first relief well to be directionally drilled using the single-shot directional survey technology. Well 5R-13D was designed and drilled to relieve pressure of the uncompleted well 5R-12D that blew out and even toppled the mast of the drilling rig after encountering a shallow pressurized zone at 450 m with a pressure of 40 bar (Figure 14).

Despite drilling challenges like the non-utilization of the MWD tools and the proximity of the well pad to a main geologic fault prompting a revised well direction, well 5R-13D successfully intersected and quenched 5R-12D. A series of cement plug jobs were conducted at well 5R-12D. Completion tests at well 5R-13D showed that this well can be utilized as a production well. Therefore, the relief well drilling was successful.

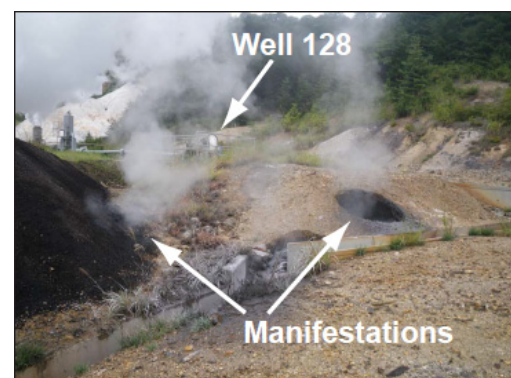
FIGURE 15: Development of fumaroles near well 128 in September 2010 (photo from Akasaka et al., 2011)

In September 2010, near well 128 two small geothermal manifestations started to form as shown in Figure 15. No alarm was raised at this point since fumaroles are a common occurrence in most geothermal fields (Gresse et al., 2018) including this one at Onkobe. The thermal activity started increasing a month after it was first detected, i.e., on 8 October 2010.

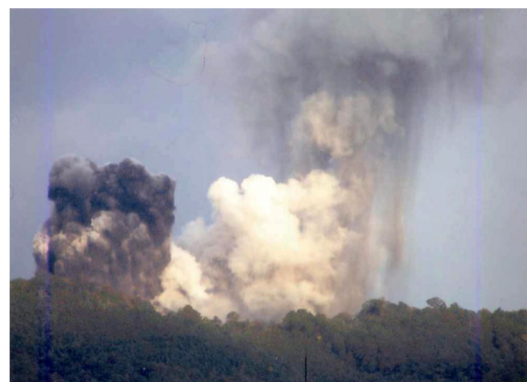
FIGURE 16: Steam explosion captured 5 km west of the field (photo from Akasaka et al, 2011)

October 2010 (Akasaka et al, 2011). The erupting material consisted of rocks, soil, and gravel which were mainly subsurface materials (Figure 16). The materials erupted up to about 250 m high creating a crater of about 45 m diameter. Discontinuous emissions of steam and muddy water continued after the eruption for several days but the discharge reduced in strength and finally ceased on 23 October, six days after the explosion.
