FINAL REPORT

510-000323	Incident		
Aircraft:	Boeing 757-200	A/C registration:	TF-FIR
Engines:	2 Rolls-Royce RB211-535	Type of Flight:	Scheduled, IFR
Crew:	8 – no injuries	Passengers:	144 – no injuries
Place:	Denmark N56°30,7 E010°07,7	Date and time:	11.01.2007 at 1642 hrs. UTC

Synopsis

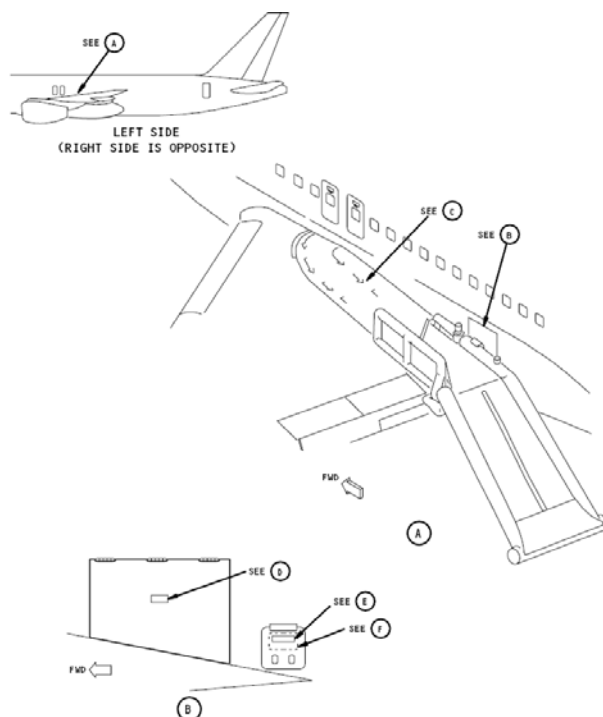
Two over-wing emergency exit hatches are located on each side of the fuselage above the wing. The off-wing escape slide is located in the outboard corner of the main landing gear wheel well. Slide compartment and maintenance access doors are located above the wing flap area. The maintenance access door is located aft of the slide compartment door.

When the over-wing emergency hatch is opened from inside the cabin the off-wing escape slide is activated. The slide system is operated by air from a pressure bottle. The slide actuator is located behind the maintenance access door. Air pressure from the bottle activates the actuator piston. This will cause the slide compartment door to open, the slide carrier to be unlocked from the compartment and rotate to an over-wing position. The slide will then be inflated by air from the pressure bottle.
