Overview of landslide hazard and possible mitigation measures in the settlement southeast of Fjarðará River in Seyðisfjörður

Daniel Illmer, Ingenieurbüro Illmer Daniel e.U.
Jón Kristinn Helgason, Icelandic Met Office
Tómas Jóhannesson, Icelandic Met Office
Eiríkur Gíslason, Icelandic Met Office
Sigurjón Hauksson, Efla Consulting Engineers

Report no.: VÍ 2016-006	Date.: June 2016	ISSN: 1670-8261	Public <input checked="" type="checkbox"/> Restricted <input type="checkbox"/> Provision:
Report title / including subtitle Overview of landslide hazard and possible mitigation measures in the settlement southeast of Fjarðará River in Seyðisfjörður		No. of copies: 18 Pages: 75	Managing director: Jórunn Harðardóttir
Author(s): Daniel Illmer, Jón Kristinn Helgason, Tómas Jóhannesson, Eiríkur Gíslason and Sigurjón Hauksson		Project manager: Tómas Jóhannesson	Project number: 4352-6-0002
Project phase:		Case number: 2015-46	
Report contracted for: Seyðisfjarðarkaupstaður (The community of Seyðisfjörður)			
Prepared in cooperation with:			
Summary: See p. 5.			
Keywords: Seyðisfjörður, landslides, protection measures, hazard zoning		Managing director's signature:

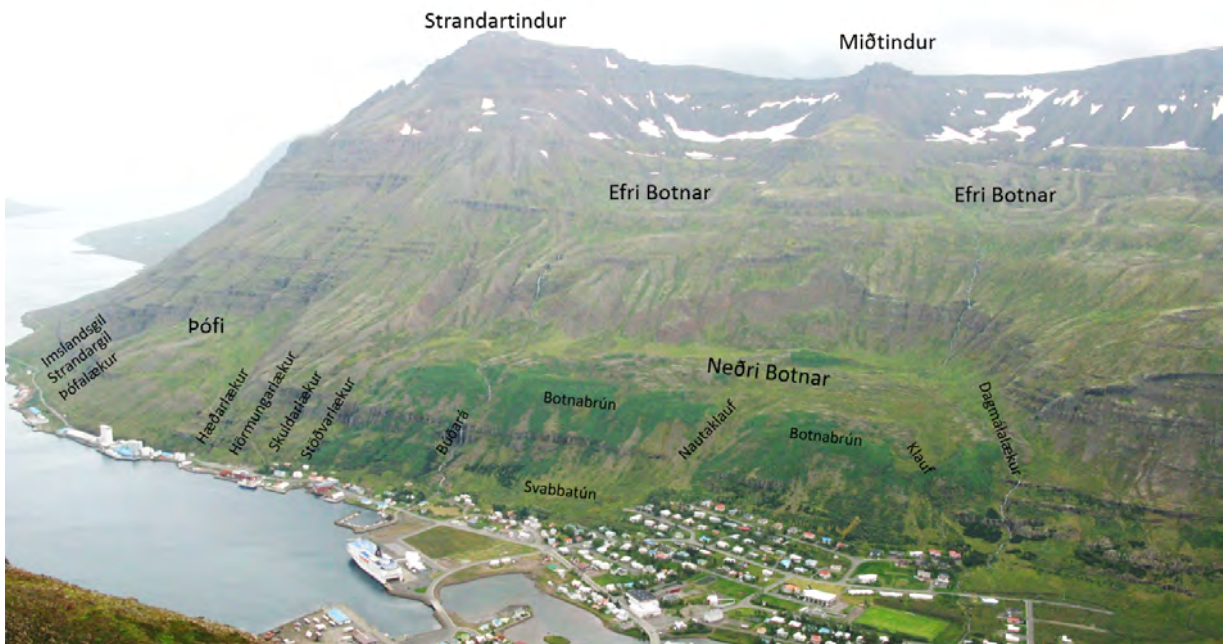
Figure 2. The southern part of the town of Seyðisfjörður and the mountainside to the south and east of the settlement with the names of locations and landscape features discussed in the text.

The village of Seyðisfjörður is located at the head of the fjord Seyðisfjörður, see Map 1 and Figure 2. The general direction of the fjord is mainly ESE–WSW but the innermost part has a NNE–SSW direction. By local convention, the opposite sides of the fjord are referred to as the south and north side irrespective of the actual compass direction. This report adopts this local convention.

Below the Efri-Botnar cirques, directly above the settlement, there is a large flat shelf called Neðri-Botnar (Fig. 2), covered with loose sediments of glacial origin, see Map 5 and Figure 3. The inner part of Neðri-Botnar, west of Búðará, is characterised by many small ridges, cracks, small basins with marsh like vegetation and two large depressions. Transverse ridges on the uppermost part of the shelf are interpreted as glacial moraines formed near the edge of an advancing glacier near the end of the last ice age. Landslides on the slope between Efri- and Neðri-Botnar do not appear to have travelled farther than to the glacial moraines, except in the path of Búðará river. There is no evidence that a landslide, with a source area in the slope above Neðri-Botnar, has traversed the inner Neðri-Botnar shelf.

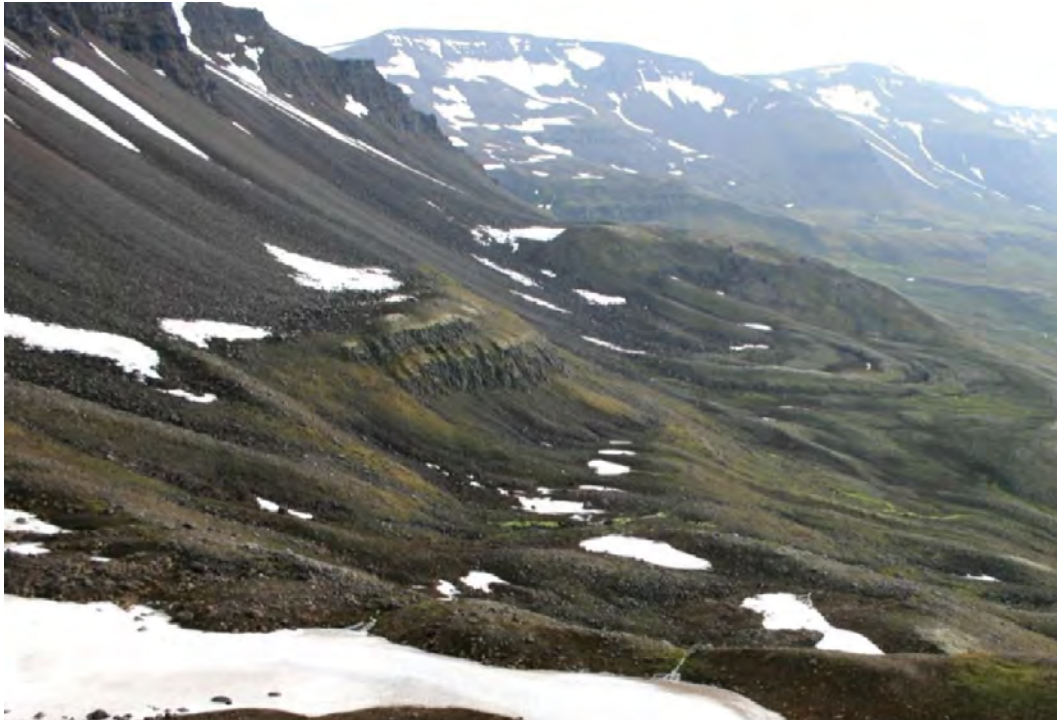
Figure 4. Efri-Botnar seen from northeast. The debris piles in the foreground are at the bottom of the inner cirque. Photograph: Árni Hjartarson.

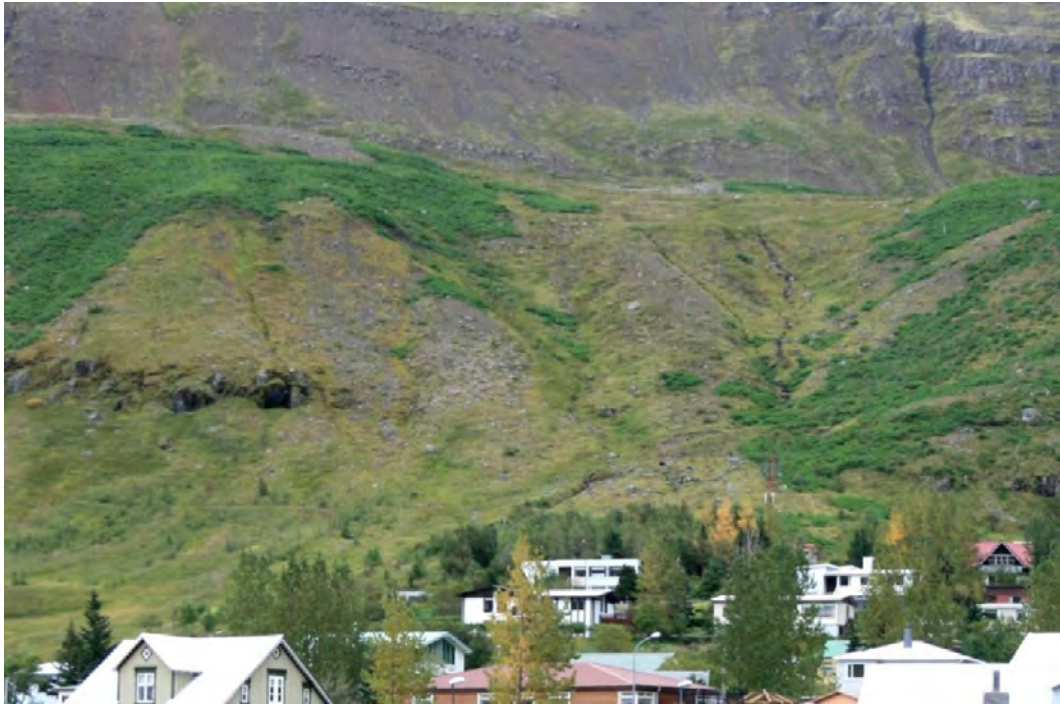
*Figure 5. The Nautaklauf gully in Botnabrún at the lower edge of the shelf Neðri-Botnar.
Photograph: Árni Hjartarson.*

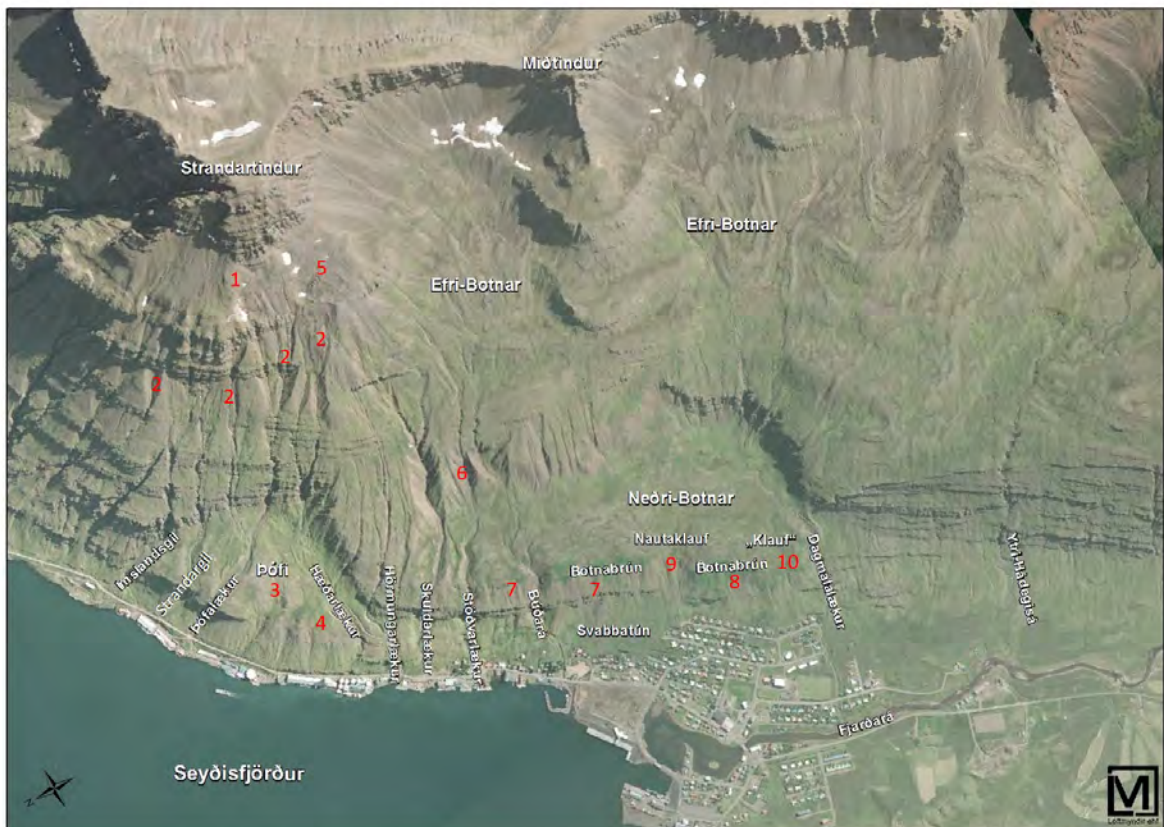
Figure 6. Main potential starting zones for landslides in the mountainside south of Seyðisfjörður between Pófi and Botnahlið. Numbers denote starting areas that are described in separate subsections in the text and shown on Map 2.

Based on this overall assessment of the landslide conditions, ten areas in Strandartindur and Neðri-Botnar have been identified as possible primary starting zones for landslides. Their selection is based on geological, historical and geomorphological evidence for landslides in the area and earlier hazard assessments. The selected areas are displayed with numbers on figure 6 and on Map 2 and the situation in each area is briefly described below.

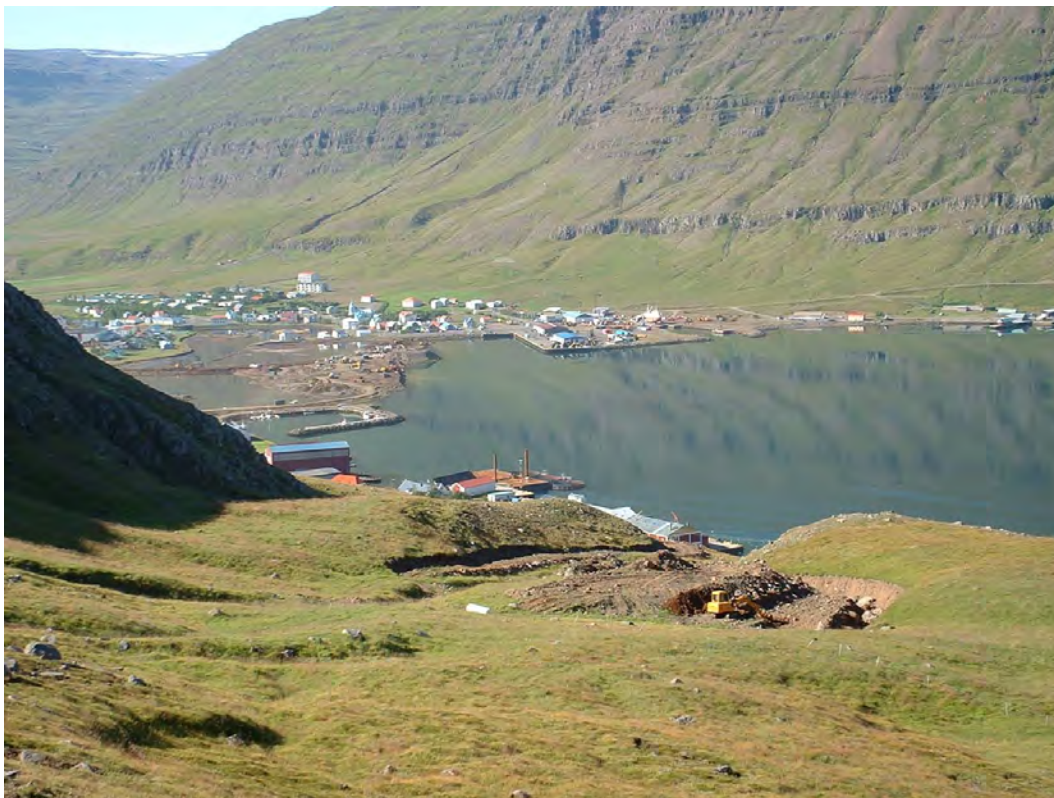
Figure 7. Drainage ditch near the western edge of the Þófi shelf, dug in 2002. Photograph: Sigurjón Hauksson 26.8.2002.

As already mentioned in section 4, a 100-m long and 3–4-m deep drainage ditch was dug in the western part of Þófi above the fish factory in 2002 (Figure 7). It is proposed here to expand the existing drainage measures with additional drainage ditches in the uppermost part of Þófi. Near the drainage ditch from 2002, a debris flow and debris retention basin should be constructed,

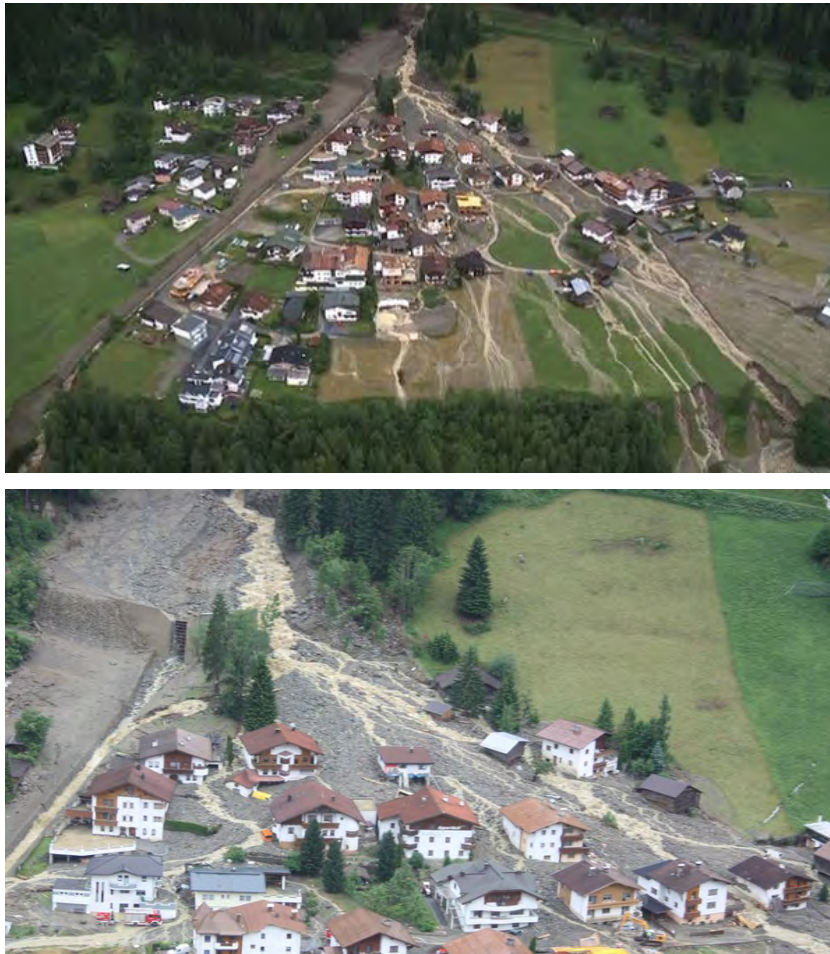
Figure 8. The village of See in the Paznaun Valley in Austria that was hit by a thick debris flow or torrent on 8 June 2015 that left up to several-m thick layer of debris over a large settled area. Photographs FTD, 2015.

This section describes some situations in the Alps where similar conditions as in Seyðisfjörður may have been encountered and mitigation measures that have been studied there. We will start with a few of photographs from recent debris flows or torrents in Austria where a water saturated slurry flowed into settlements and caused extensive damages to buildings, see Figures 8 and 9. Luckily no one was hurt in these debris flows.

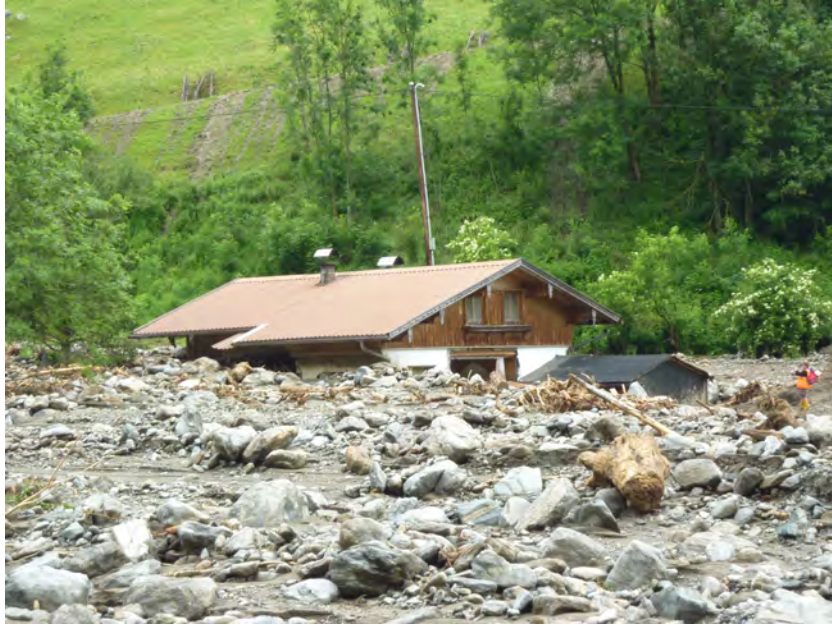
Figure 9. A building hit by a thick debris flow on 8 June 2015 in the village of Sellrain, Tyrol, Austria. Photograph FTD, 2015.

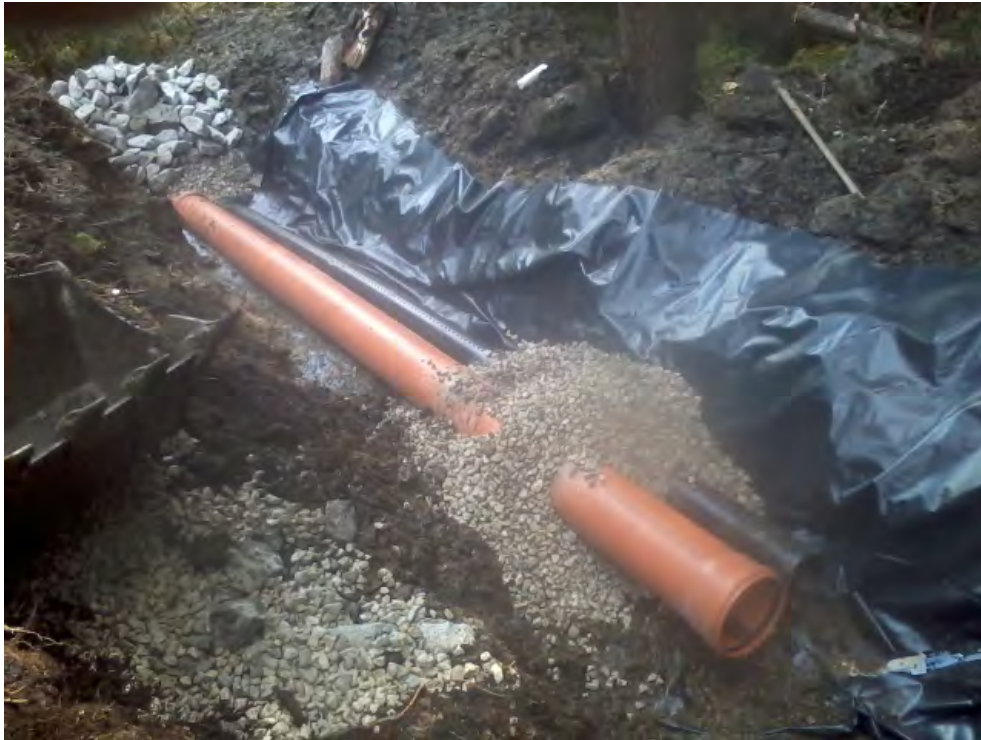
Figure 12. Drainage pipe, discharge pipe, proofing, gravel.

wet areas. For this purpose, a number of drainage ditches, exhaust pipes and shafts (Figs. 12 and 13) were installed above the settlement. Unfortunately, these measures were not sufficient to stop the movement.

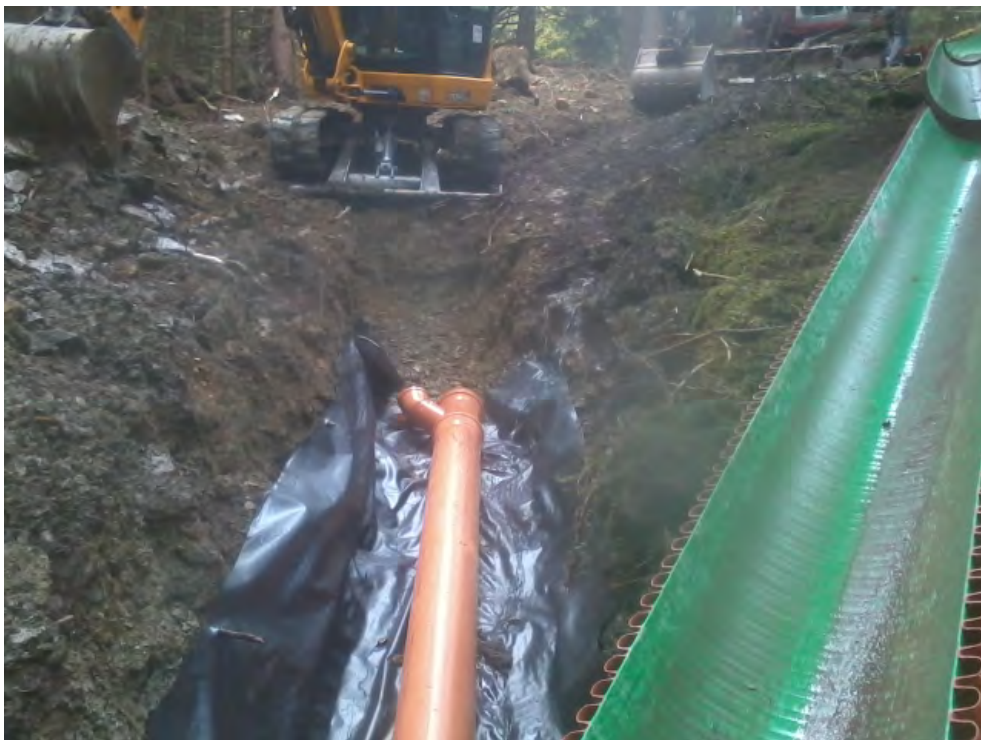
Figure 13. Half-shell parts of drainage pipes.

- Several hundred meters of discharge pipes.
- Numerous shafts.
- Half-shell parts of pipes within the existing ditches to prevent the infiltration of water from the ditch into the ground,
- About 50 wells were drilled to pump water from deep layers to the surface,
- All the drained water is conveyed via two pressure pipes into a power station to produce the electricity for the pumping of water from the wells.

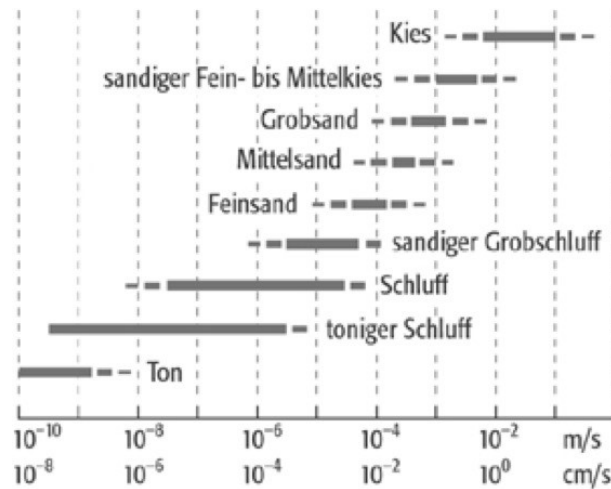
Figure 15. Table with values of the permeability of several types of loose materials (from Parriaux and others, 2010).

Some typical values of the permeability for different types of fill materials are given in the table in Figure 15.

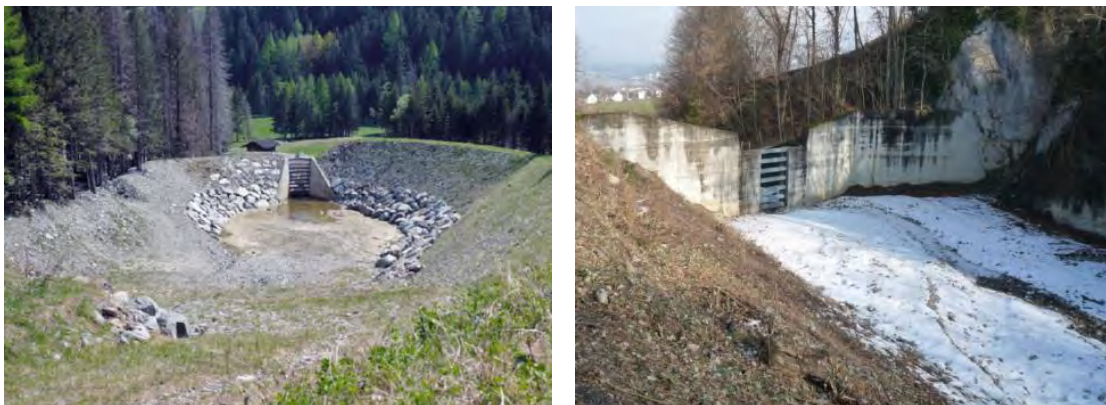
Figure 18. Bed-load samplers in Switzerland made of fill material (left) and concrete (right) with a by-pass structure made of concrete and steel bars (Margreth, 2015). The steel bars separate water from the bed-load. Such structures are often built in Alpine countries. Photographs: Stefan Margreth.

The debris flow retention basins should be constructed with by-pass openings with concrete or steel beams, see Figure 18, as is customary in Alpine countries. Erosion prevention measures may, furthermore, be needed where water flows into and out of the retention basins as indicated on Map 9. The lateral dam sides of the debris retention basins can be built with the angle of repose of the loose materials, but not less than 1:1.5, if this is suitable, but this will depend on

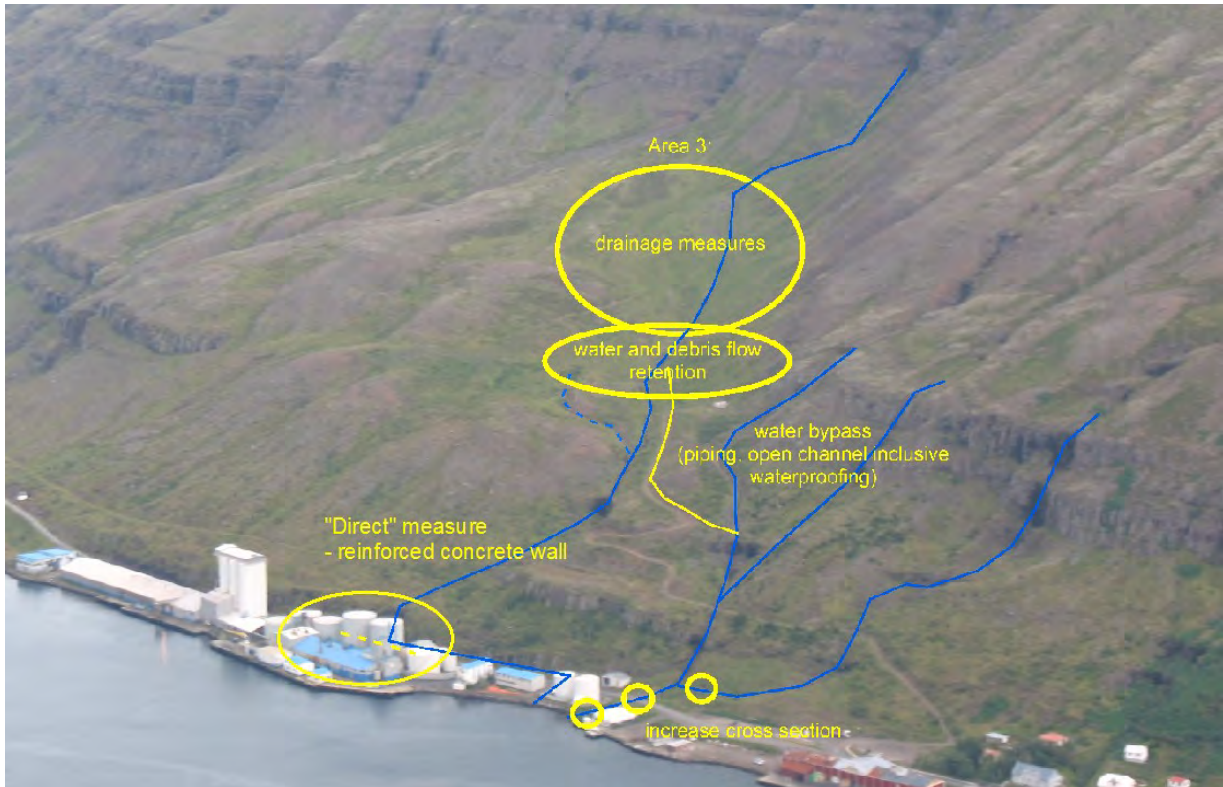
Figure 20. Overview of Þófi area and possible mitigation measures.

Point protection measures for individual buildings are an additional option for protecting the most sensitive buildings of the SR Mjöl fish factory, where people are most often located during working hours. An example is reinforced concrete walls against debris flows along the main tanks (see Figures 20 and 24). The wall must probably be situated nearby the towers, because there is too little space on the other side of the road for the deposition of debris flow material. The dimensioning of the reinforced concrete wall has to take a dynamical debris flow pressure and the pressure caused by the deposition into account. The main office building of SR Mjöl is not as endangered as the area where the tanks are located. As it is continuously occupied by people, it is, nevertheless, advisable to improve the safety of this building, possibly by a ca. 2-m high steel wall above the road, similar as employed by the Icelandic Public Road and Coastal Administration by roads below Súðavíkurlíð and Ólafsfjarðarmúli (Figure 25).

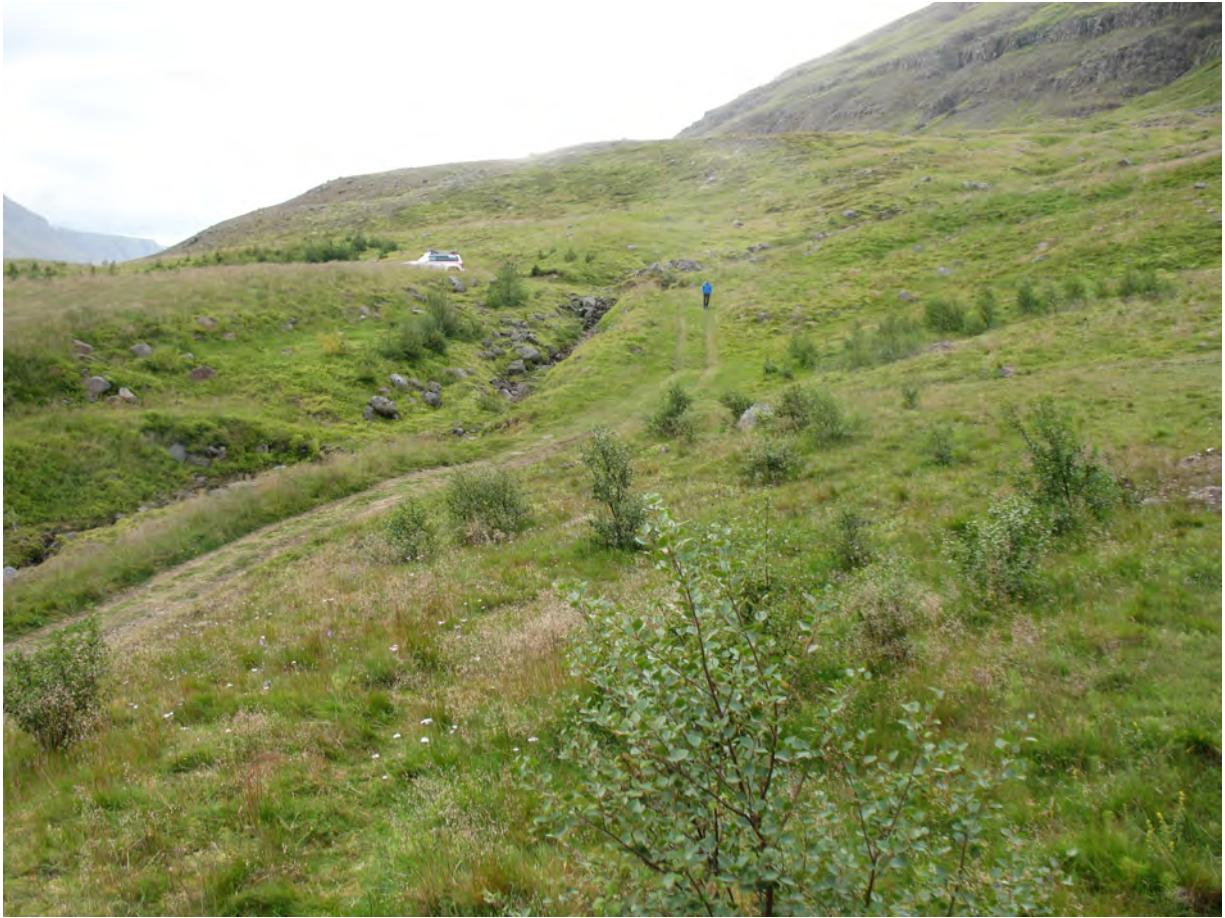
Figure 21. Inner part of Þófi where a debris flow and water retention basin is proposed.

see Figure 21 and Map 10, as well as a low guiding dam, see Map 10, in order to prevent debris flows from Hæðarlækur from hitting the fish factory. The volume of fill material in the proposed guiding dam and retention basin is ca. 13 thousand m³ and the storage capacity of the retention basin at Hæðarlækur is ca. 7800 m³.

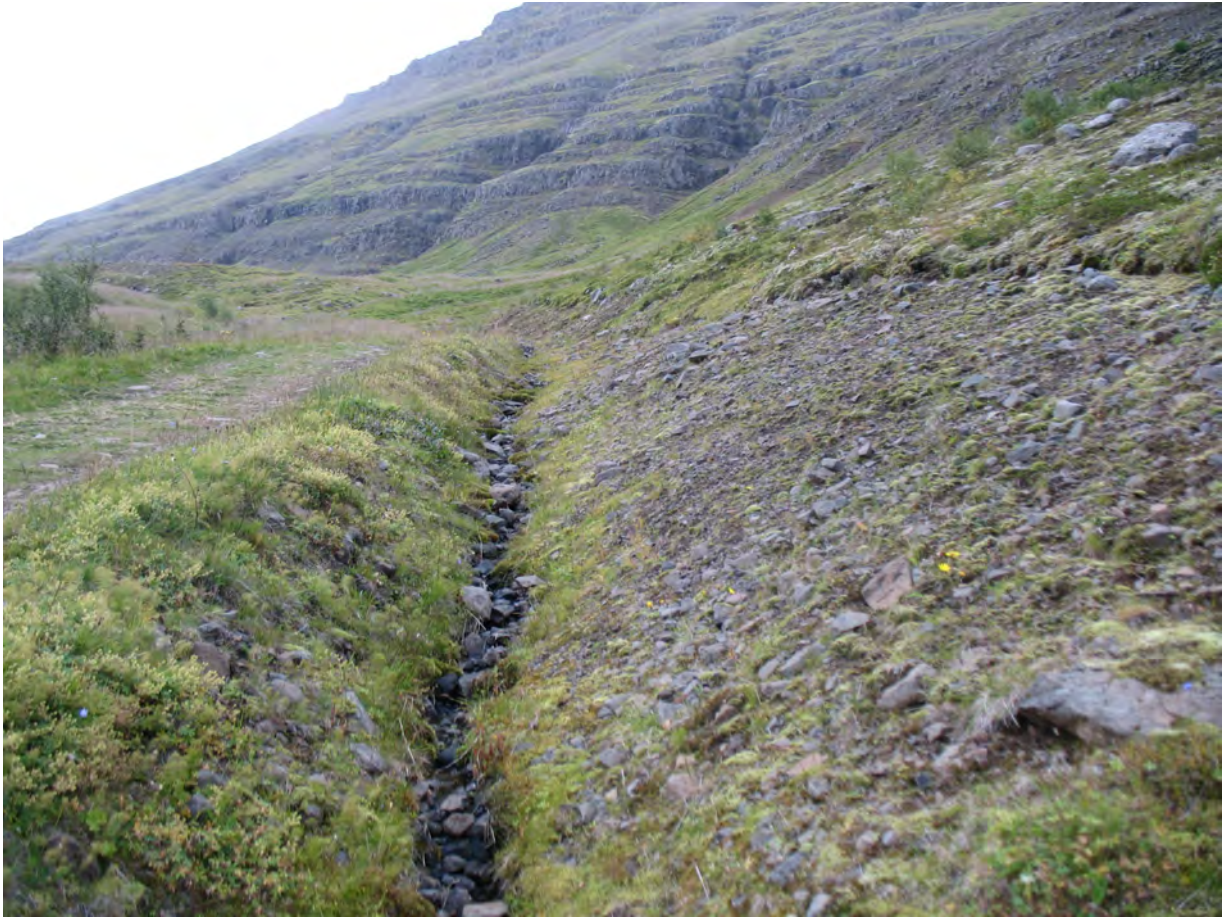
Figure 22. Inner part of Þófi; where a water by-pass is suggested above the existing road.

Furthermore, it is recommended to construct a by-pass for water from Hæðarlækur to the brook Hörmungarlækur, see Figures 22 and 23. This water by-pass can be constructed with a pipe or an open channel above the existing road. Waterproofing of the channel may have to be considered.

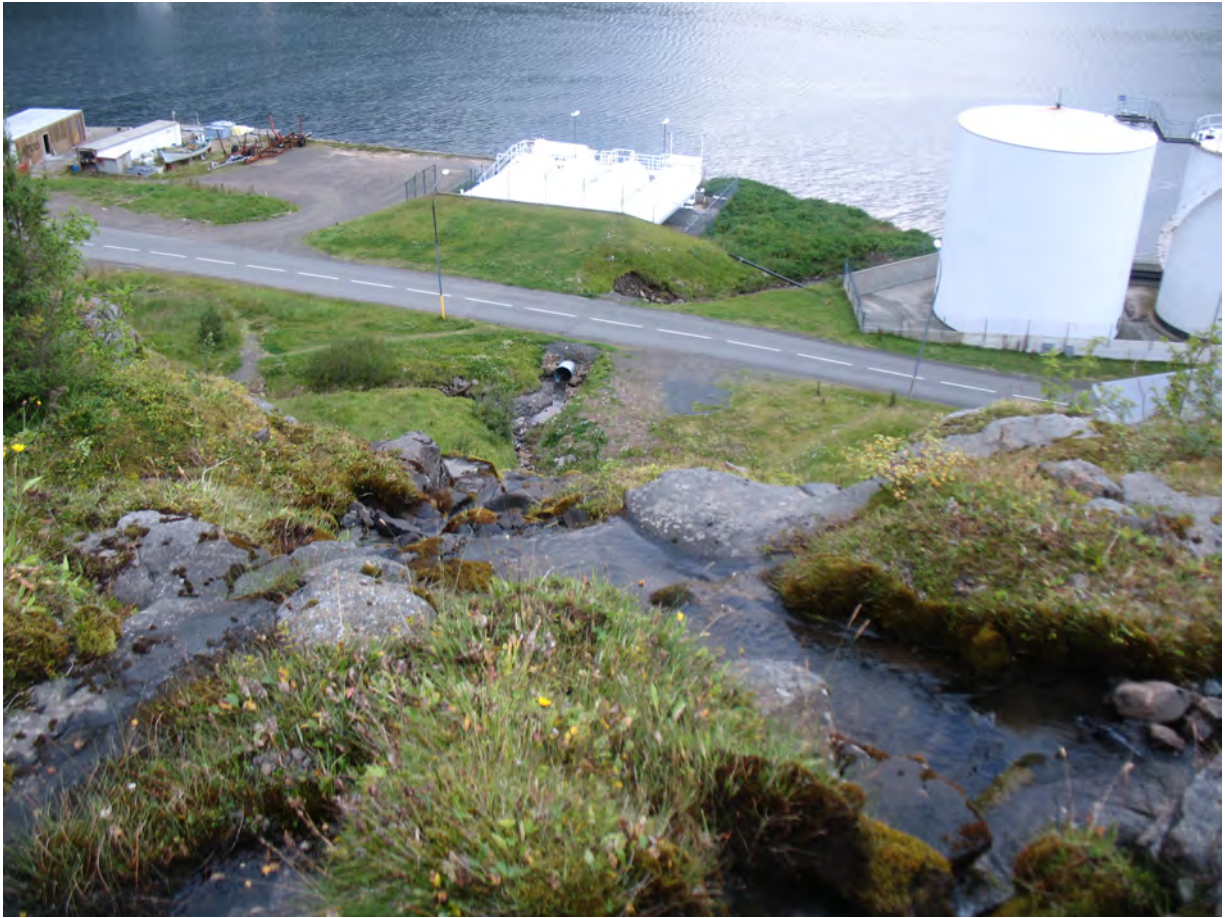
Figure 23. The SR fish factory seen from Pófi; the brook Hörmungarlækur and existing pipe through the road.

If these measures are carried out, it is necessary to carefully consider discharge conditions in the catchment area of the brook Hörmungarlækur, which would subsequently carry substantially greater discharge than under the current conditions. Therefore, the existing pipes under the road would have to be adapted and the cross-section of the waterway would have to be increased.

Some of the cross-sections of the existing pipes under the road, as well as the size of the ditch above the road by Þófi, are clearly too small.

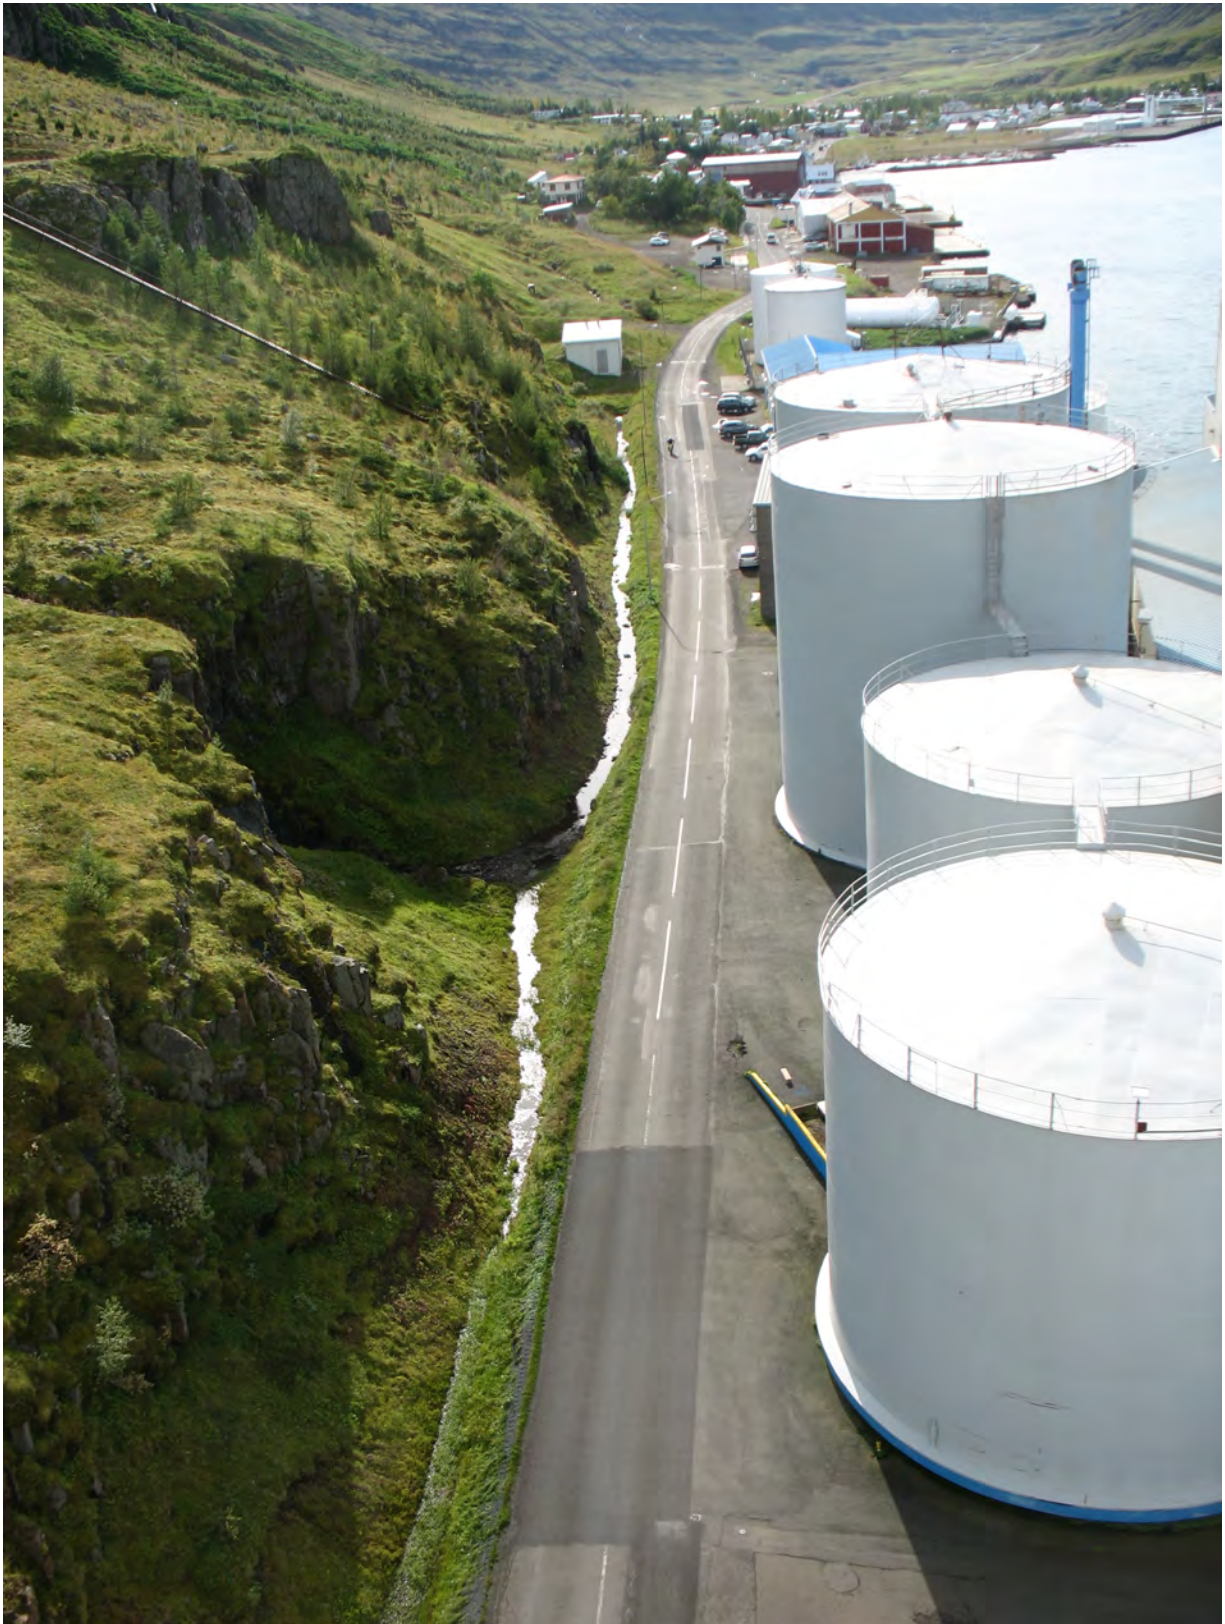
Figure 24. The main tanks of the SR fish factory below Pófi where point protection by a concrete wall might improve the safety.

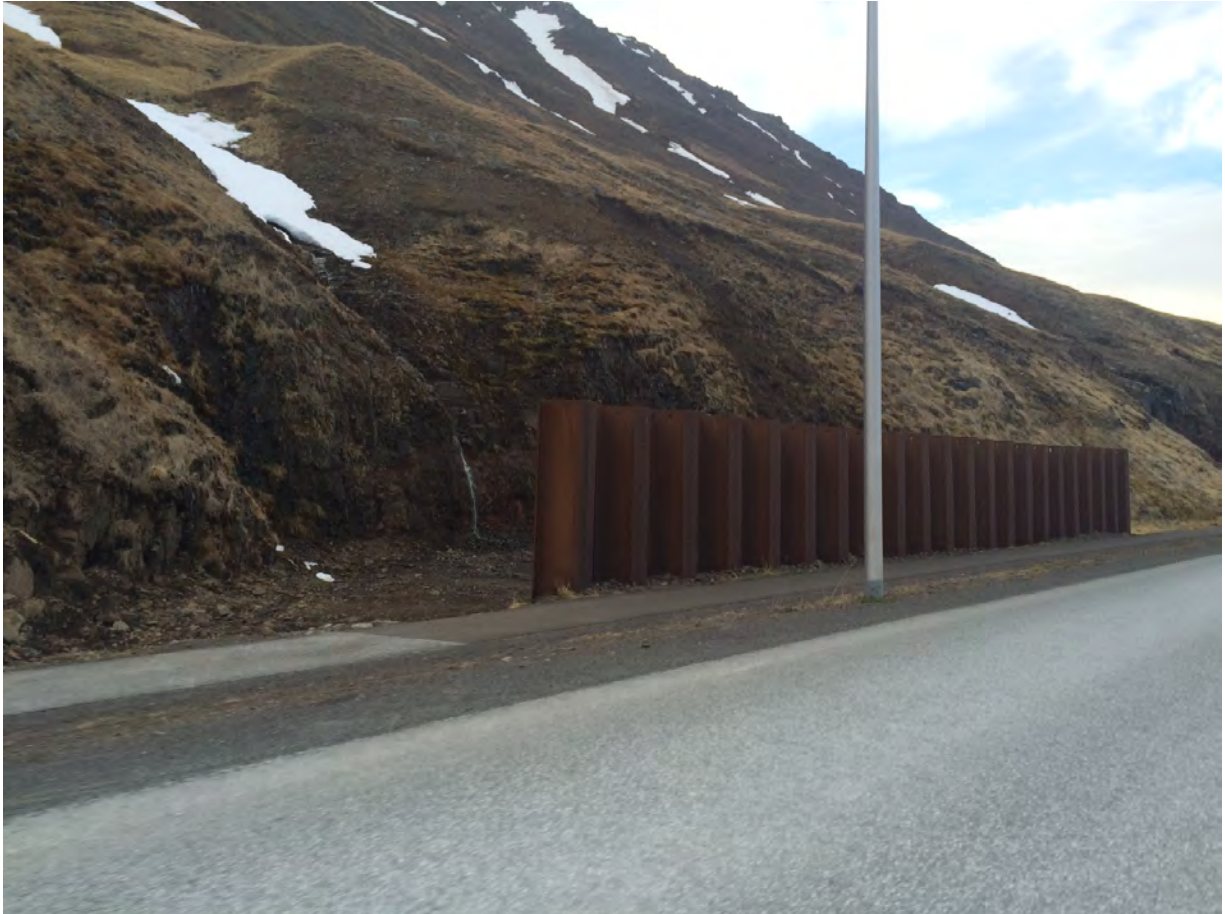
Figure 25. A steel wall above the road below Eyrarhlíð in NW-Iceland for reducing the frequency of snow avalanches reaching the road. Photograph: Jón Kristinn Helgason.

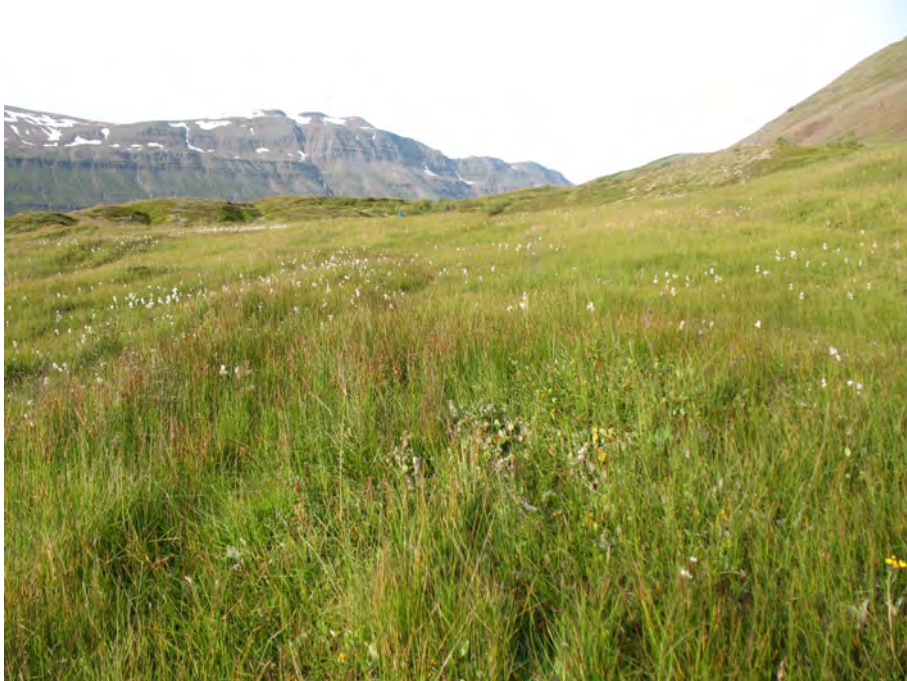
Figure 26. Neðri-Botnar, view towards east.

An important measure for reducing the landslide hazard below Neðri-Botnar is a network of drainage ditches in the two depression above Nautaklauf and Klauf, see Map 9. Figures 26–31 in the Appendix illustrate the local conditions in the areas where the ditches are proposed.

This appendix contains several photographs that illustrate the conditions in Neðri-Botnar where a number of drainage ditches are proposed in section 7.

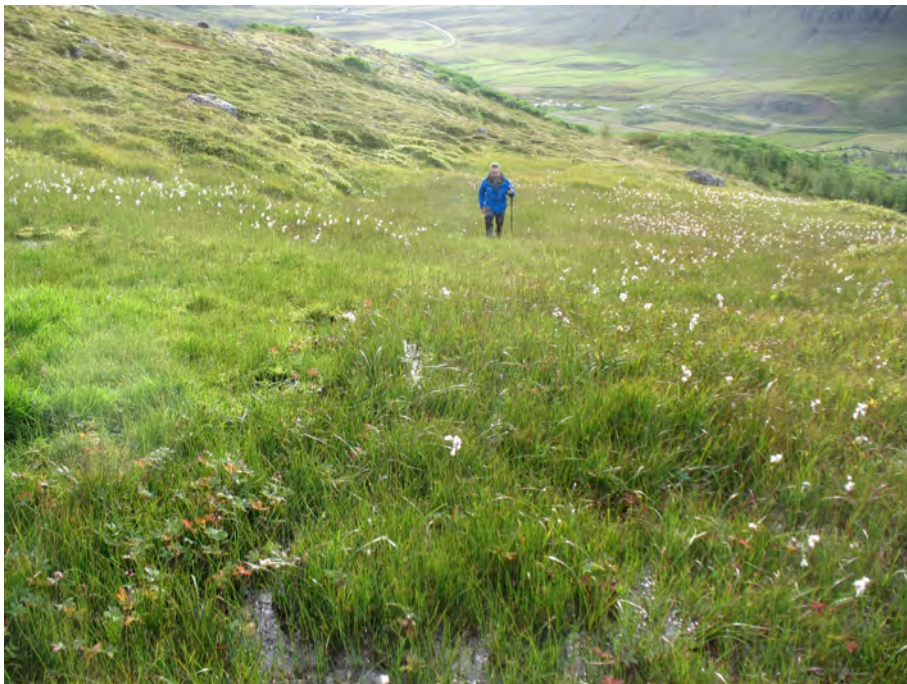
Figure 27. Neðri-Botnar, view towards west.

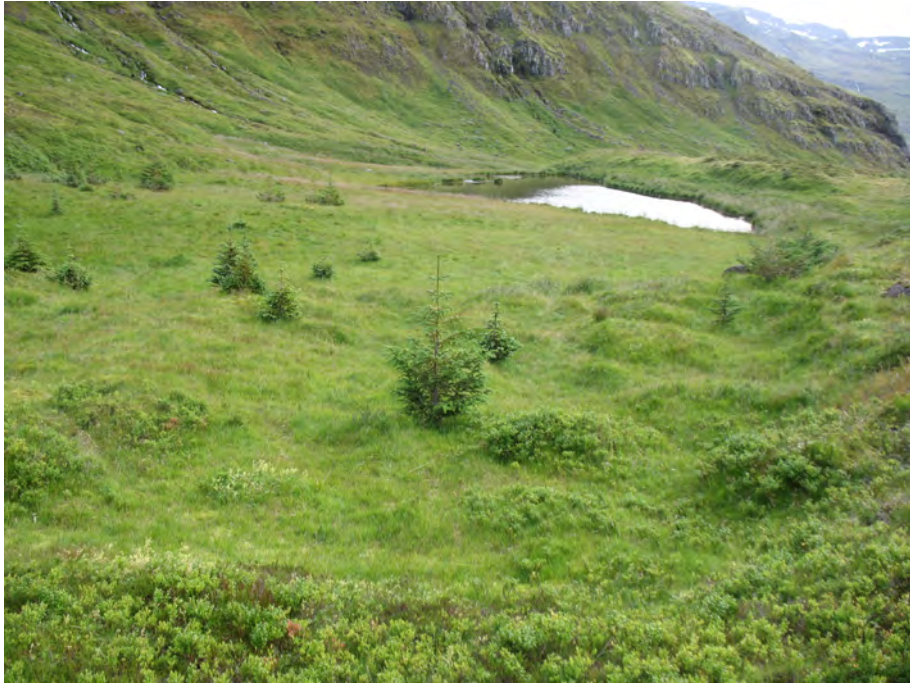
Figure 28. Neðri-Botnar, lake at the upper margin.

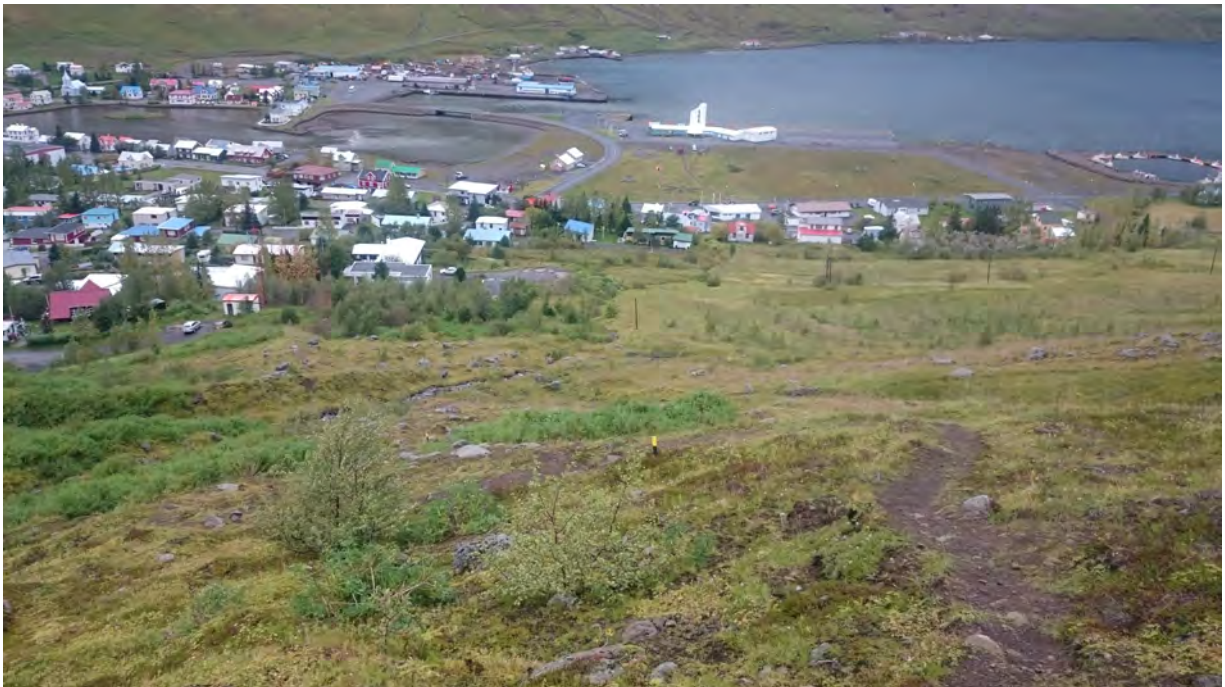
Figure 29. The lower part of Nautaklauf depression in the eastern part of Botnabrún.

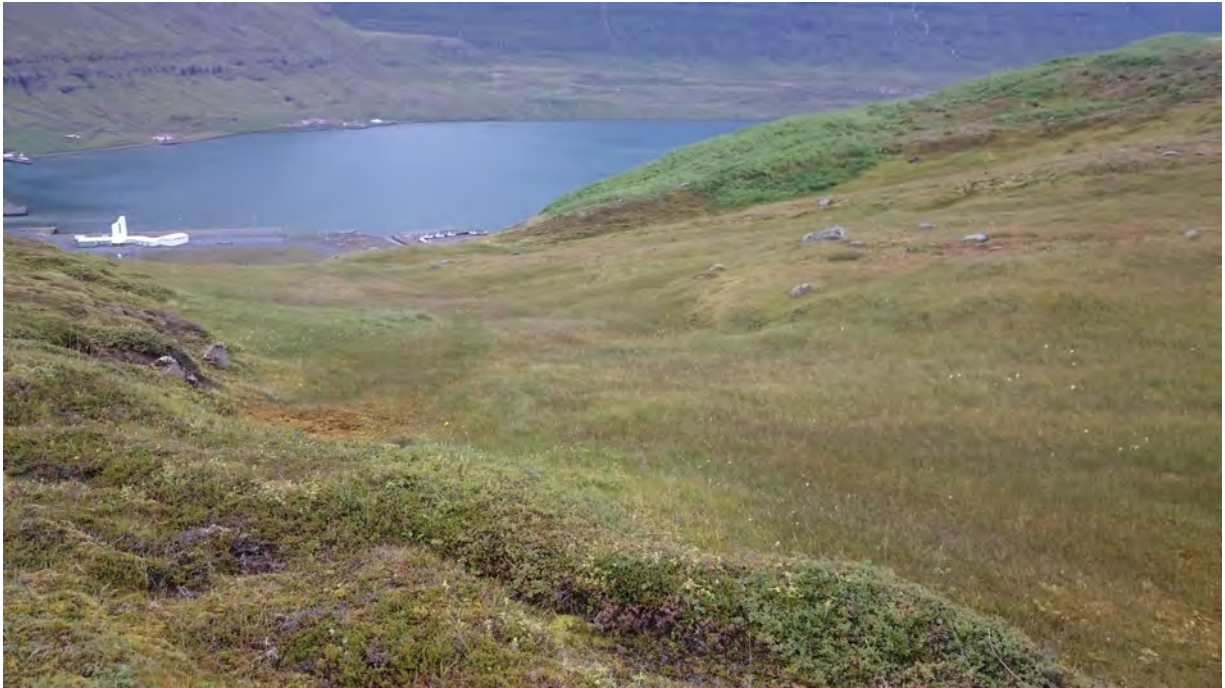
Figure 30. The upper part of Nautaklauf depression in the eastern part of Botnabrún.

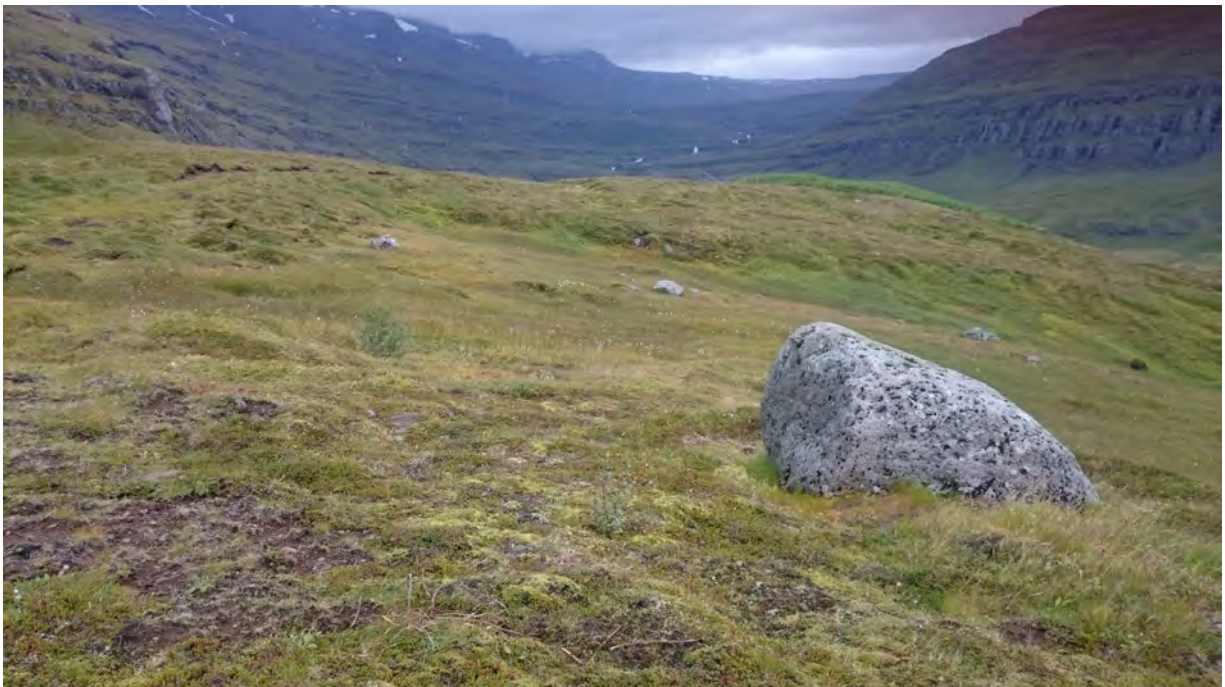
Figure 31. The upper part of Nautaklauf depression, view towards west.
