ARCHAEOLOGICAL  
INVESTIGATIONS AT  
NESSTOFA

ANGELOS PARIGORIS

2005 : 9

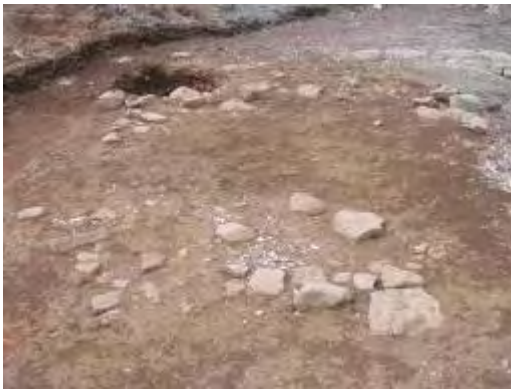
Plate 2: Rectangular Structure

and a number of associated deposits were identified. More specifically, stone inclusions within a reddish brown deposit [282]=[328] appeared to be forming a structure consisted of two walls NW-SE oriented, in quadrant 1. The structure appeared to be enclosing a rather small space (3x3m) and could have been either an outhouse or part of a larger structure. To

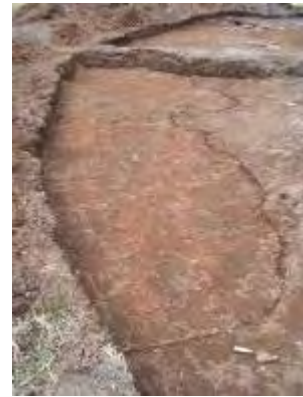
Plate 3: Midden [229]

Associated with [282]=[328] was a brownish orange midden deposit [229]=[253]. This was one of the most extensive deposits in the excavated area. The presence of animal bone along with a whetstone may be indicative of an agricultural aspect of the immediate area.

Situated outside the confines of the above proposed structure at the NW, this deposit is most possibly closely associated with it. A test trench opened within [229]=[253] indicated that the deposit exceeds 0.80 m in depth, and therefore spans much further back in time than the building of Nesstofa.

| Context | Type | Area | Description | Length | Width | Depth |
|---|---|---|---|---|---|---|
| 229 | Midden Deposit | Q. 1 | Description: A loose mid brown-orange peat ash deposit, NE-SW oriented. Located at the SE of 282. Finds recovered included unidentified iron objects, nails, pottery, glass, moderate animal bone (possibly of sheep & cow) poorly sorted, a piece of clay pipe, brick fragments and a whetstone. Some remains of topsoil within the deposit suggest that the specific area might have been disturbed at recent times. | 6.02m (NE-SW) | 2.40m (NW-SE) | N/A |

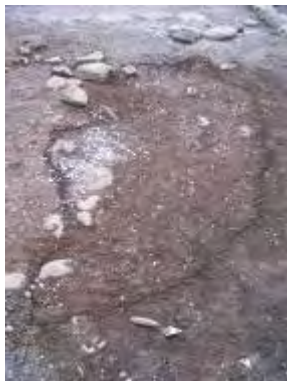
Plate 4: Midden [359]

[359] was a very similar deposit to occupational layer [282]=[328]. However, the high concentration of sea-shells and the fact that this appeared to be situated outside the confinements of the proposed structure consisted of two above mentioned walls within [282]=[328], suggested its different depositional character. Nevertheless, it is most likely that [359] is closely

associated with the structure. Its overall character suggests that [359] is most possibly a midden deposit abutting a possible NW wall of the structure. This specific area could have been used for processing sea-shells for the purposes of fishing. Nonetheless, at the time of sample collecting, some stone inclusions quite well sorted became visible. Such an occurrence could strongly dispute the above interpretation. However, investigation did not proceed further.

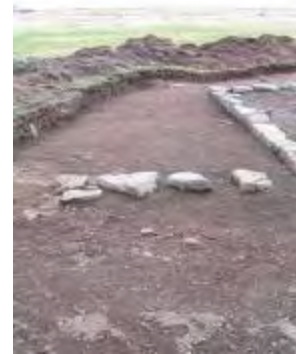
Plate 5: Deposit

While the outline of the pavement in quadrants 2 and 3 was located straight underneath modern deposit [400]=[458], the inside of it was contained within deposit [533]=[17125]=[510] at approximately 0.20-0.30m in depth. This occurrence did not appear at the SW of quadrant 1, where the inside of the pavement was at the same level as the outline and stratigraphically underneath [400]=[458]. The suggestion that two different pavements elapsing in time could be present cannot be sustained with the evidence provided in the field.

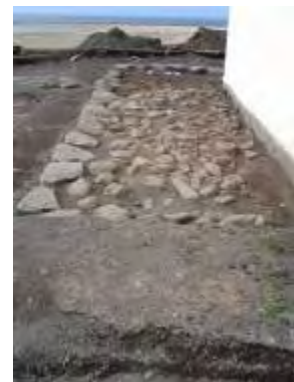
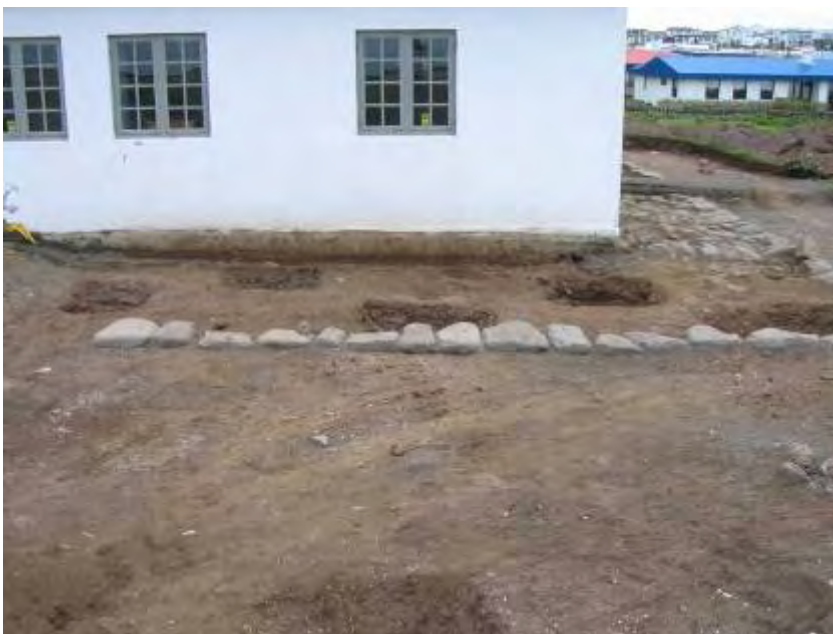
Plate 6: Pavement in Q.1

Contemporary to the Nesstofa building is a pavement. This was comprised of small (>0.15m), medium (0.15-0.30m), and large (0.30-0.80m) angular, sub-angular, rounded, sub-rounded and rectangular stones. All stones placed at the edges of the pavement appear to have been selected carefully and worked into a generally square shape (specially noted on the outside of the stones), while the stones on the inside of the pavement seem to have been randomly chosen, yet carefully placed to form a generally

smooth, even surface. The dimensions of the pavement are as follows: In length, this is 18.06m (NE-SW) at the S end of the building, 20.26m (NW-SE) at the W part, and 23.29m (NW-SE) at the E part, while at the N end of the building the pavement does not survive. The width varies. Measurements were taken from the walls of the building and out to the edge of the pavement. As such, this is approximately 2.40m (NW-SE) at the S end, 3.70 at the W, and 3.10m at the E part of the house. The type of stone used for the construction of the pavement was basalt.

Generally speaking, the inside of the pavement in quadrants 2 and 3 was in good condition. Some truncation by modern intrusions, [5438] (Pipe) in quadrant 2, [7305] (Electricity Cable, Pipe) in quadrant 3 occurred, and appear to have disturbed the S part of the pavement adjacent to the building in quadrant 3, and the W corner in Quadrant 2. The inside of the pavement in quadrants 1 and 4 rarely survives. Its good condition at the N corner in quadrant 1 does not correspond with the rest of the quadrant. Five test trenches opened during excavation (1.50x1.30m) have proven that the pavement had been removed at a later period. Modern intrusion [15640] was identified at the W of the excavation area, however, it is not clear whether this was the reason for the pavement's removal/disturbance.

| 900 | Pavement | --- | Description: Pavement contemporary with Nesstofa building. Comprised of small (>0.15m), medium (0.15-0.30m), and large (0.30-0.80) angular, sub-angular, rounded, sub-rounded and rectangular stones, well sorted. All stones placed at the edges of the pavement appear to have been worked into a generally square shape (specially noted on the outside of the stones), while the stones on the inside of the pavement do not seem to bear the same occurrence. | 23.29m (NW-SE) at E side of building<br>20.26m (NW-SE) at W side of building | 18.06m (NE-SW) at S end of building | N/A |

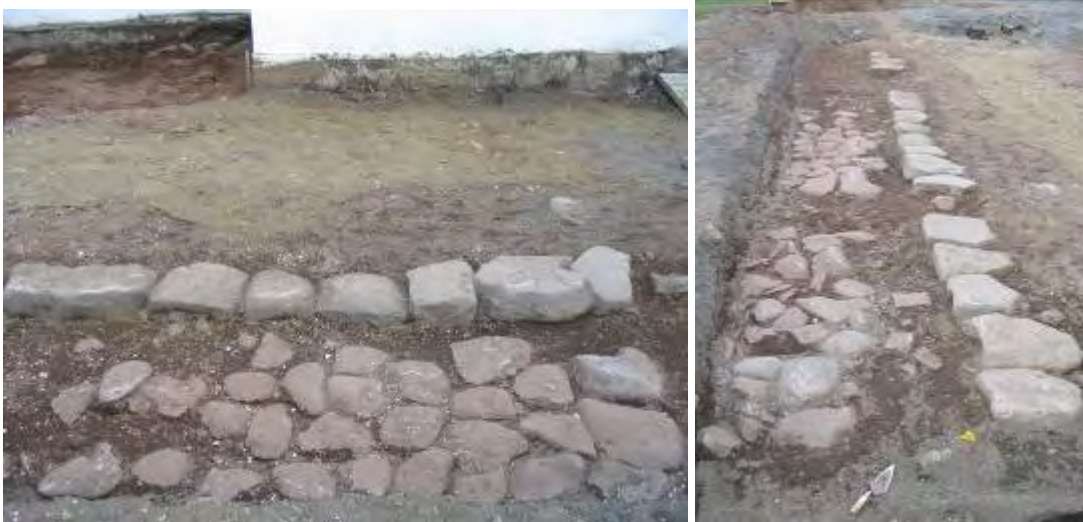
Plate 8: Paved Area in Q. 4

This was also possibly truncated by [16989] and [16934] that appear to belong to a later phase of occupation. Part of the pavement's outline in quadrant 4 survives and has been recorded, while another paved area of appr. 5m in length (NW-SE) was identified on the outside and adjacent to the pavement's outline. Due to time limitations this occurrence was not investigated further. However, this paved area appears to be in line with a pathway (water-way road) NW-SE oriented that leads into the immediate to the house area.

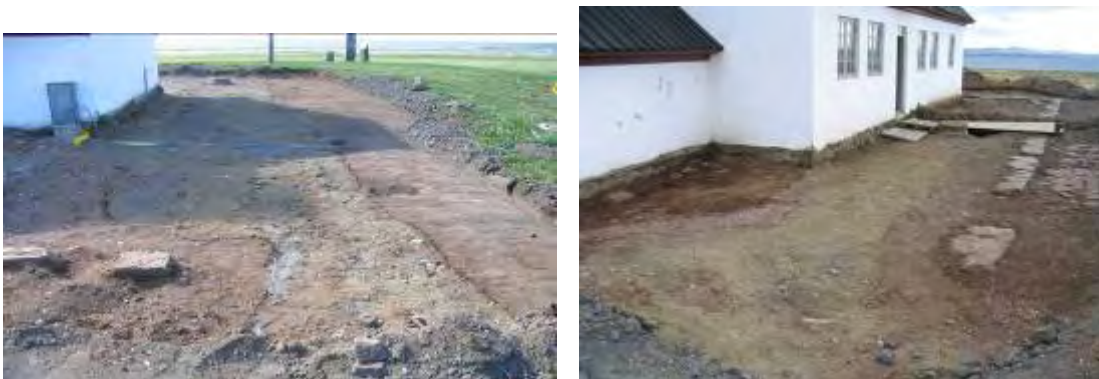
Plate 9 & 10: View of Quadrant 4 at NE & NW

At the N part of Quadrant 4, the pavement had been removed entirely due to modern construction [16853] (Sewage Pipe, Electricity Cable). Upcast material from these works in the face of [17710] at the NW and [17743] at the SE is evident.

| 16853 | Modern Intrusion | Q. 3 & 4 | Description: A linear, loose dark grey-black sand, NW-SE oriented in Quadrant 3, and NE-SW oriented in Quadrant 4. Located at the NE of 16793, SE of 17710 and is adjacent to the Nesstofa building. | Pipe: 12.05m (NW-SE) (Q. 3)<br>Cable: 18.40m to baulk (NE-SW) (Q. 4) | Pipe: 2.10m (NE-SW)<br>Cable: 2.25m (NW-SE) | N/A |

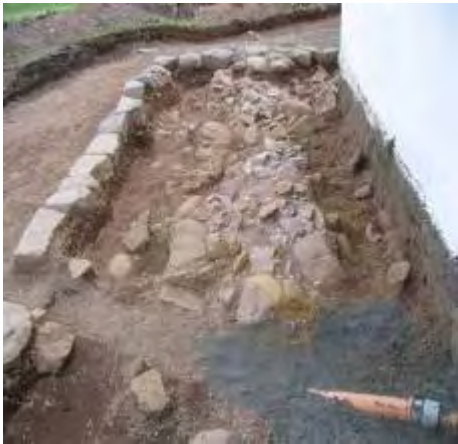
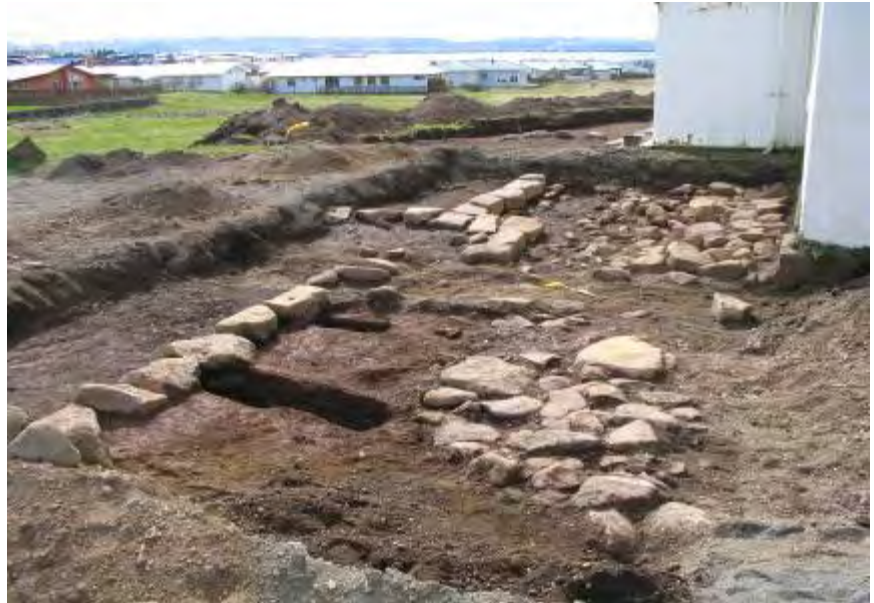
Plate 12 & 13: Pavement in Q. 2 & Q. 3

A fairly different peculiarity occurs in quadrant 2 and 3, where a gap of 0.75-1.05m is noticed between the outline and the inside, core pavement. Taking into account the possibility of sinking material, the specific location was excavated meticulously and in depth of approximately 0.40m in order to locate the pavement. Some stone inclusions were notified, yet these appeared to belong to an earlier occupation phase, and were not investigated further. Interpretations concerning the above vary. As such, it was first considered that the gap represented an effort in expanding the pavement towards the E. Encouraging this scenario was the fact that at the location where the core of the pavement was standing, it appeared to be forming a straight line NW-SE oriented, and thus a possible earlier edge. This was noticed in both quadrants. However, the complete absence

of the core pavement in the corresponding area on other side of the building at the W, prevented the generalisation of this interpretation. Following a similar pattern of thinking as above, a later interpretation involved the deliberate removal of stones and their possible re-use.

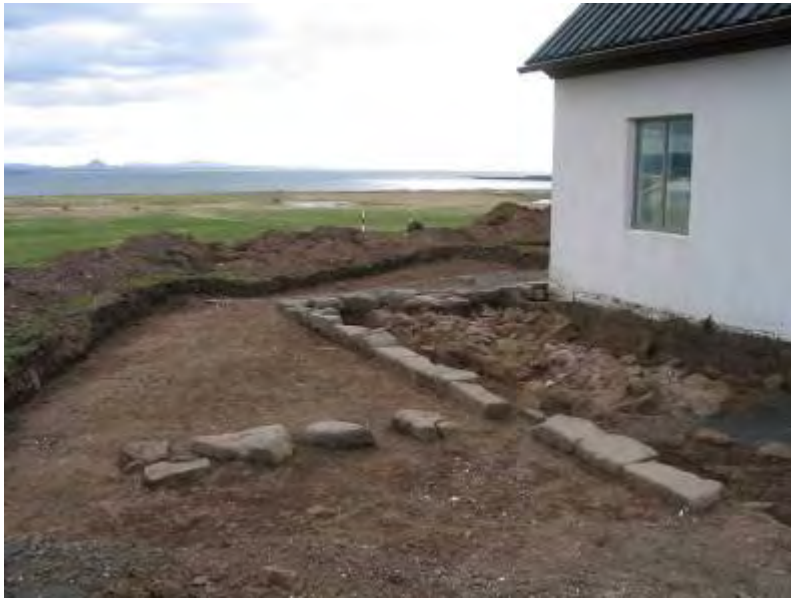
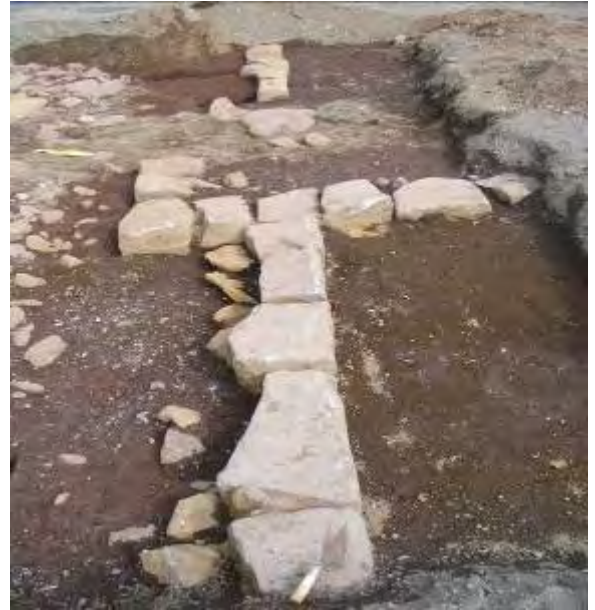
Plate 14 & 15: Stone Rows at Q. 2 & Q. 3

Lastly, two rows of large ( $>0.50\text{m}$ ) sub-angular stones, NE-SW oriented and nearly parallel to each other are located in quadrants 2 and 3 respectively. (Fig: ). It has been stated that these might be forming the enclosure of an earlier farm. However, the overall character of the stones, type and size, and the fact that they both come off from the edge of the pavement reveal that they are not only contemporary, but also possibly an integral part of the structure. As discussed above, these two rows might be representing an extension of the pavement to the E, or the remains of a structure closely associated with Nesstofa.

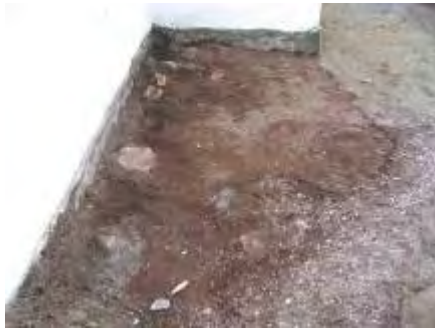
Plate 16: Deposit [16934]

[16934] was a mixed friable orange turf deposit, adjacent to the building. Due to truncation by modern intrusion [16853] (sewage pipe) at the NW, the deposit did not

appear to be defining any particular structure and it is possible that this was a midden deposit instead. The fact that the pavement [900] is not existent within or above the deposit may raise the hypothesis that [16934] post-dates the pavement. This in turn could indicate that [16934] might have truncated [900] and

is of modern origins. Therefore, [16934] would belong to a later phase of Nesstofa's habitation.

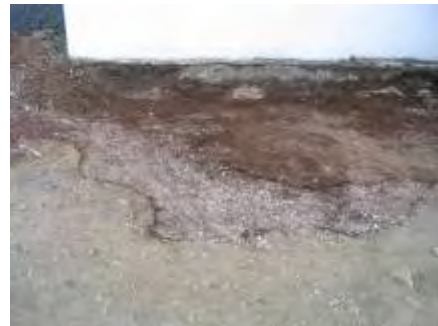
Plate 17: Midden [16989]

Very possibly associated with [16934] was a reddish brown, midden deposit [16989]. Located W of [16934], this was also truncated by modern intrusion [16853] (sewage pipe) at its NW. Very similar to midden deposit [359] in quadrant 1, [16934] had frequent inclusions of sea-shell that could have been dumped at the specific location after extracting the bait. Finds retrieved from both deposits indicate that they belong to a post-1763 phase, the date when Nesstofa was built.

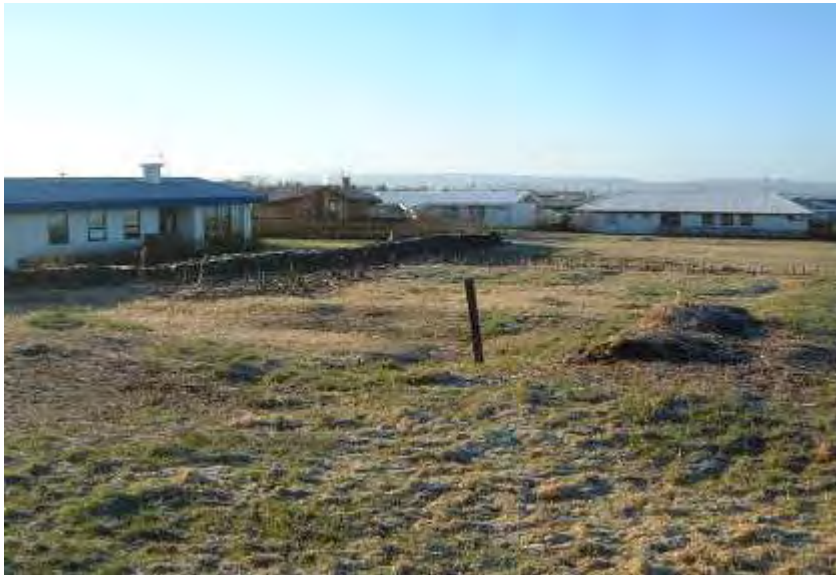
Plate 18: Building Remains at the SE

pavement's edge, in quadrant 4 at the NW of Nesstofa. Investigation with the opening of a new area in order to fully expose the paved area to either verify or disprove any relations with the road [2994] is required. The second feature [6569] was located at the SE of Nesstofa. This has been a rectangular structure, 33.13m (NW-SE) in length, 19.40m (NE-SW) in width. It was truncated in its long axis (NW-SE) by a later stone wall. Both features were planned, yet further investigation is required in order to place these in a chronological framework and into a wider landscape context.

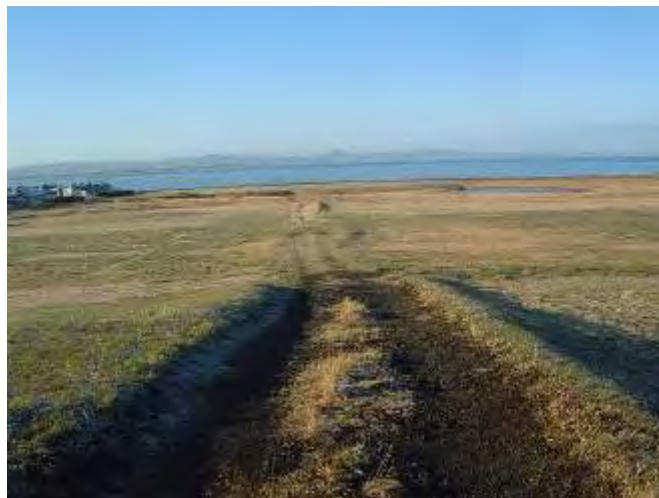
Plate 19: Old 'Waterway' Road

Two landscape features were identified in the immediate to the excavation area. Located at the SW side of the building was a road [2994], NE-SW oriented. Its dimensions were, 167.17m (NW-SE) in length, and approximately 2.50m (NE-SW) in width. It has been stated that this road was used for fetching water. The interesting aspect of this feature is that it appears to be in line with a paved area situated outside yet adjacent to the
