S I G A L D A
H Y D R O E L E C T R I C P R O J E C T

PROGRESS REPORT ON 3RD AND 4th IMPOUNDING

GROUNDWATER AND LEAKAGE STUDIES ON BASIS OF
CHEMICAL ANALYSES

PREPARED FOR
LANDSVIRKJUN
THE NATIONAL POWER COMPANY
JUNE 1978

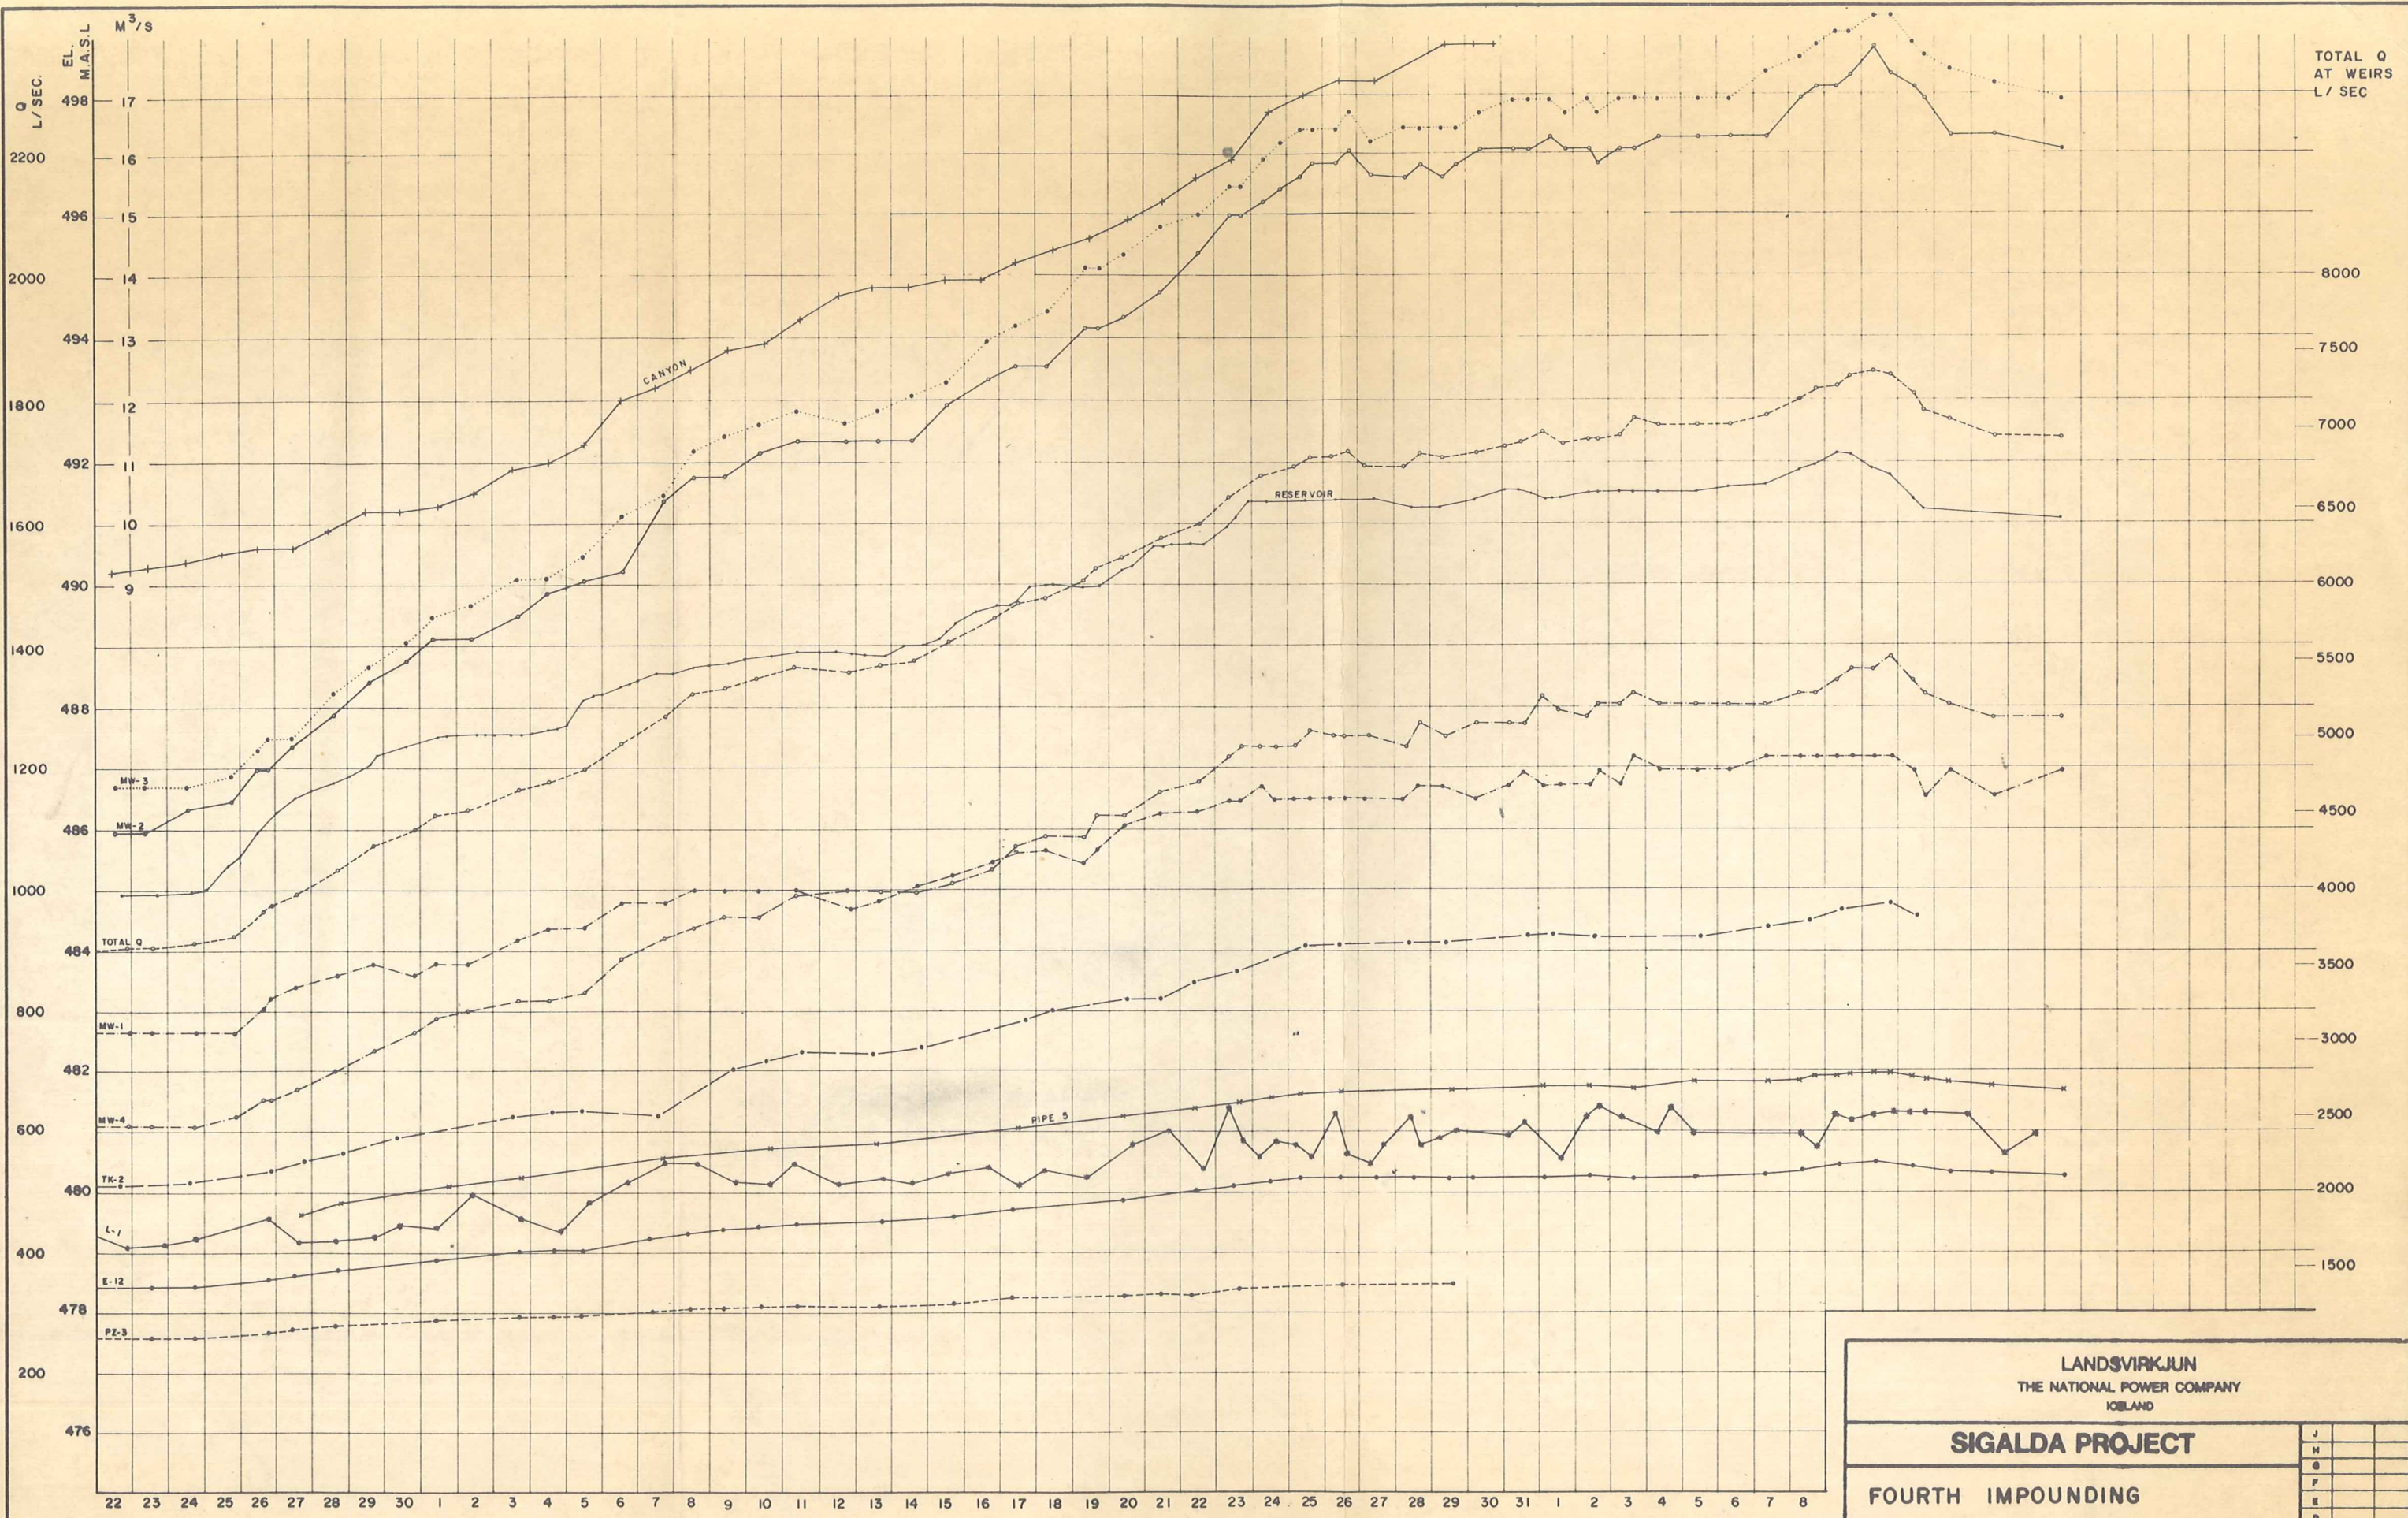
SEPTEMBER 1977

OCTOBER 1977

On the damsite samples were only taken at four locations, i.e. at MW-1 (S04) and in the springs (S06, S25 and S32). The results of the chemical analyses and Mole-ratios are listed in Tables 5 and 10. The rising (behavior) of the reservoir and ground-water levels and the observed discharge of spring water is shown on Exhs. 4 and 5.
