HRAUNEYJAF OSS 1974

Additional drilling
and geological work

OS-ROD 7515

Prepared for
LANDSVIRKJUN
THE NATIONAL POWER COMPANY
Mai 1975

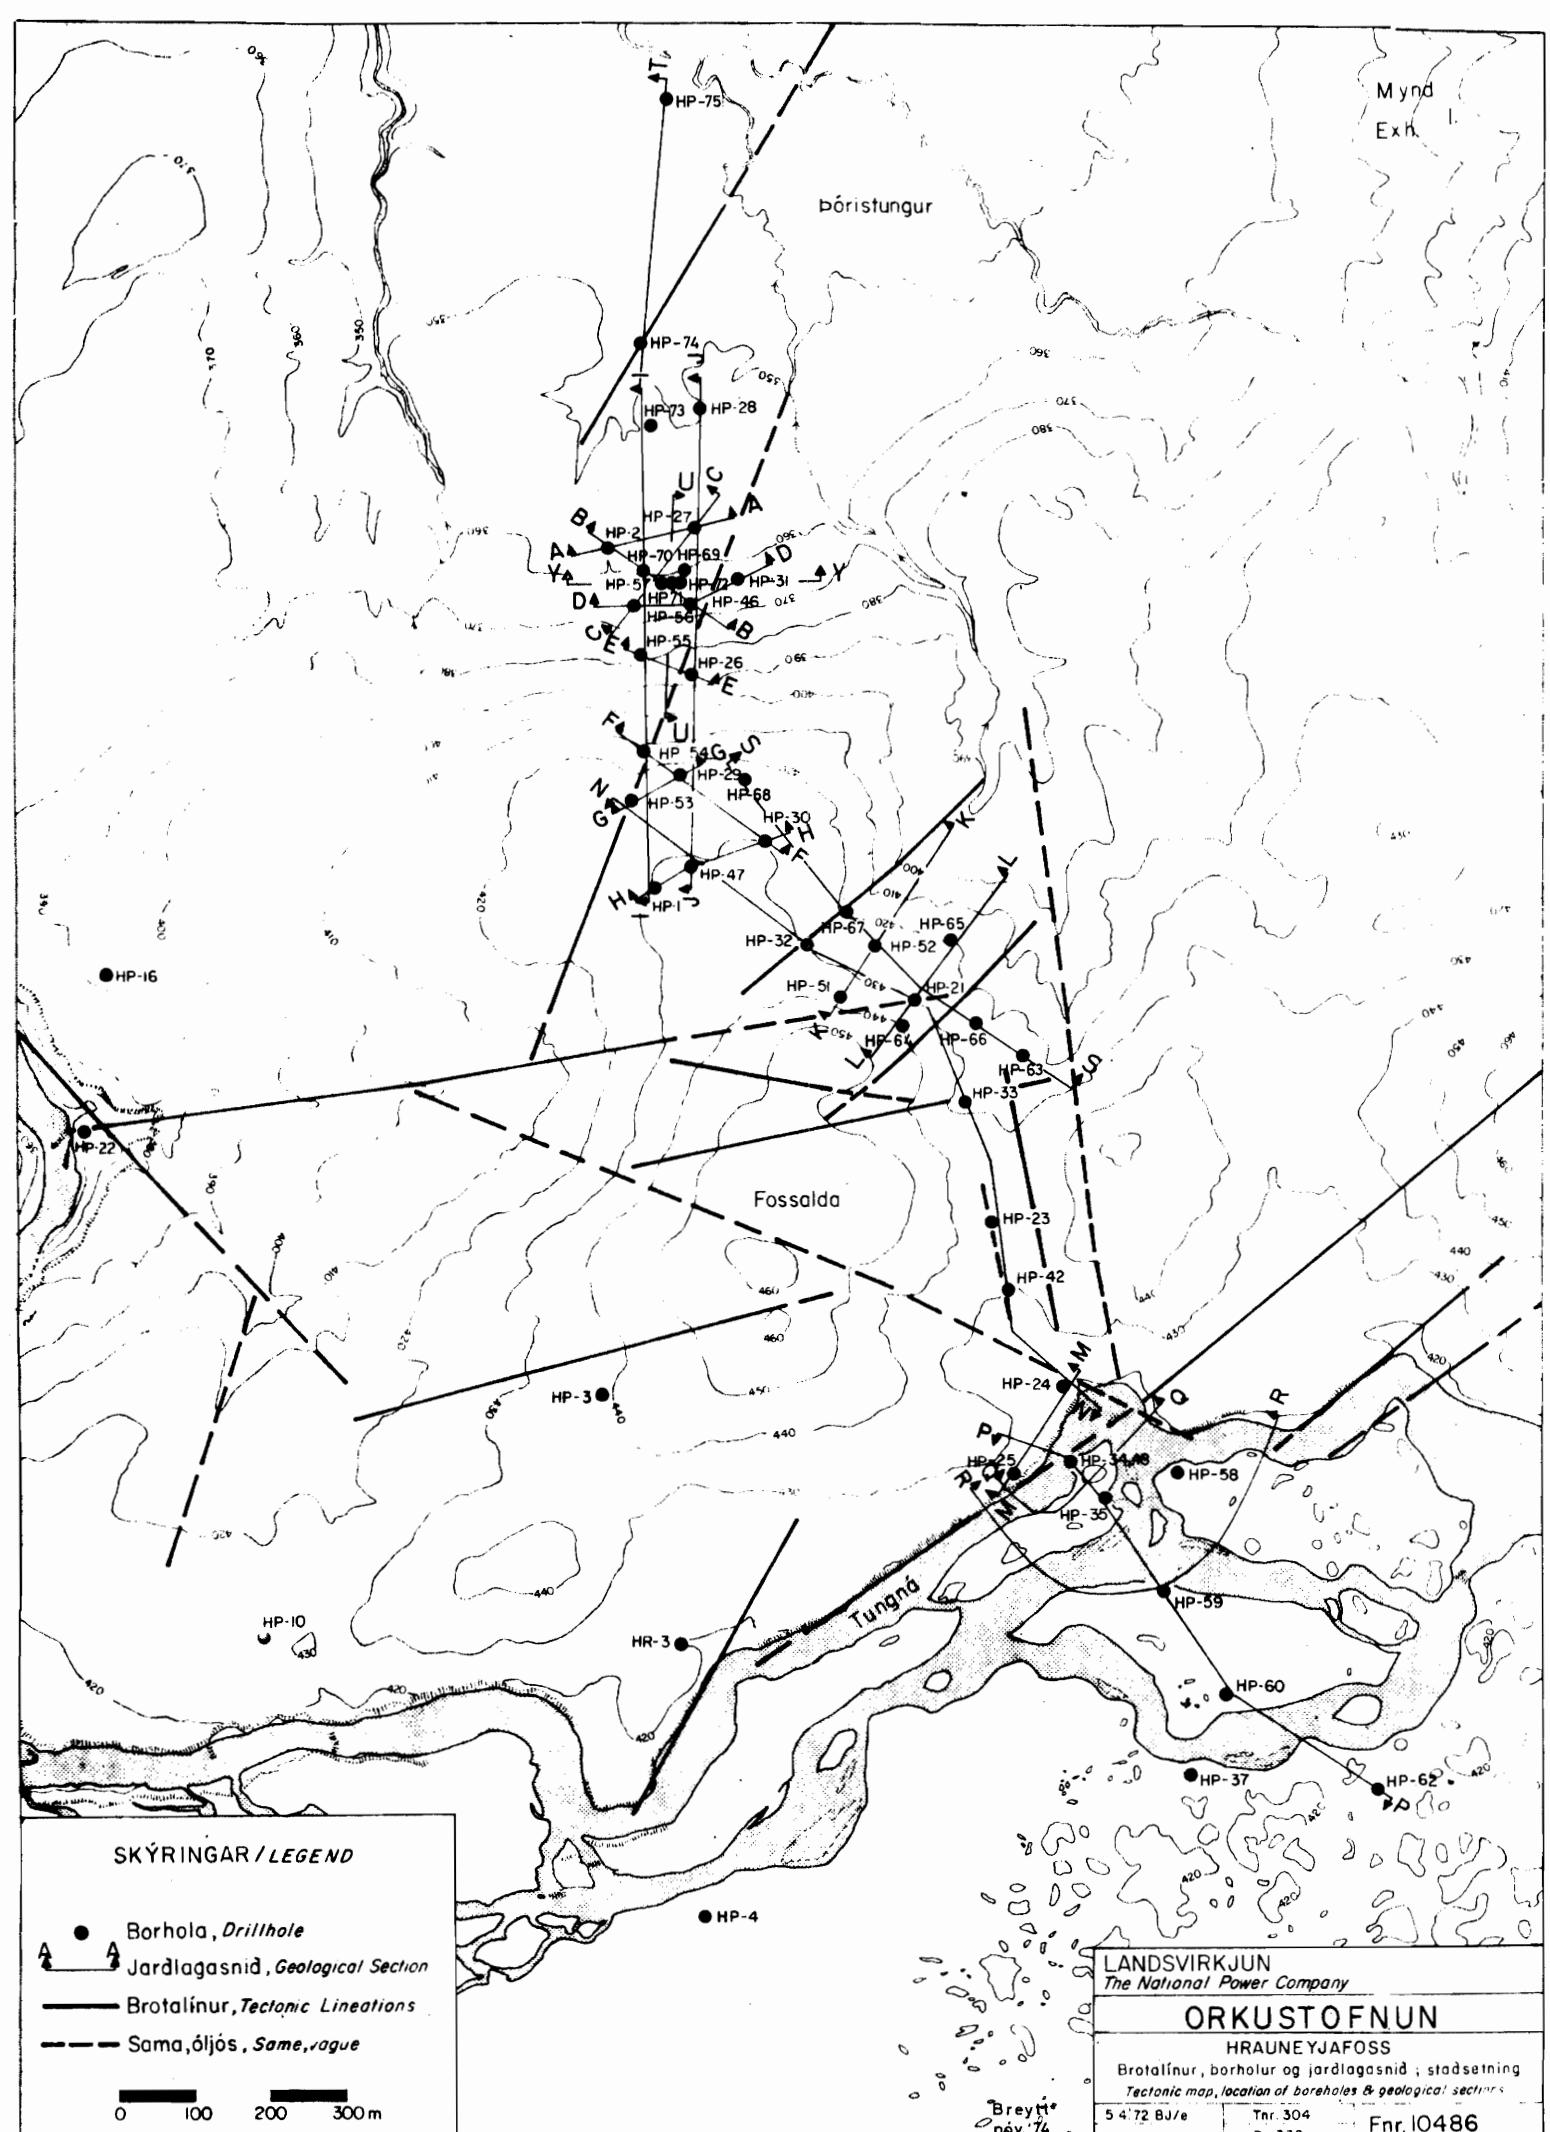
Mynd
Exh.

LEKTAR-OG JARDVATNSÚTSKÝRING
NOTE ON PERMEABILITY AND GROUND WATER

*Ground water levels are shown by arrows.
Base of the arrows and the horizontal bars indicate the hole depth when the water level was measured. If no change in level was observed during drilling, the arrow reaches the bottom of the hole.*

1 LU = Lugeon Unit = 1 l/min/m in 76mm Ø hole at pressure 10 kg/cm²

Figures for ground water levels are shown with smaller lettering on graphic core logs.

Core: Numbers indicate % core recovery
÷ core sampling not attempted.

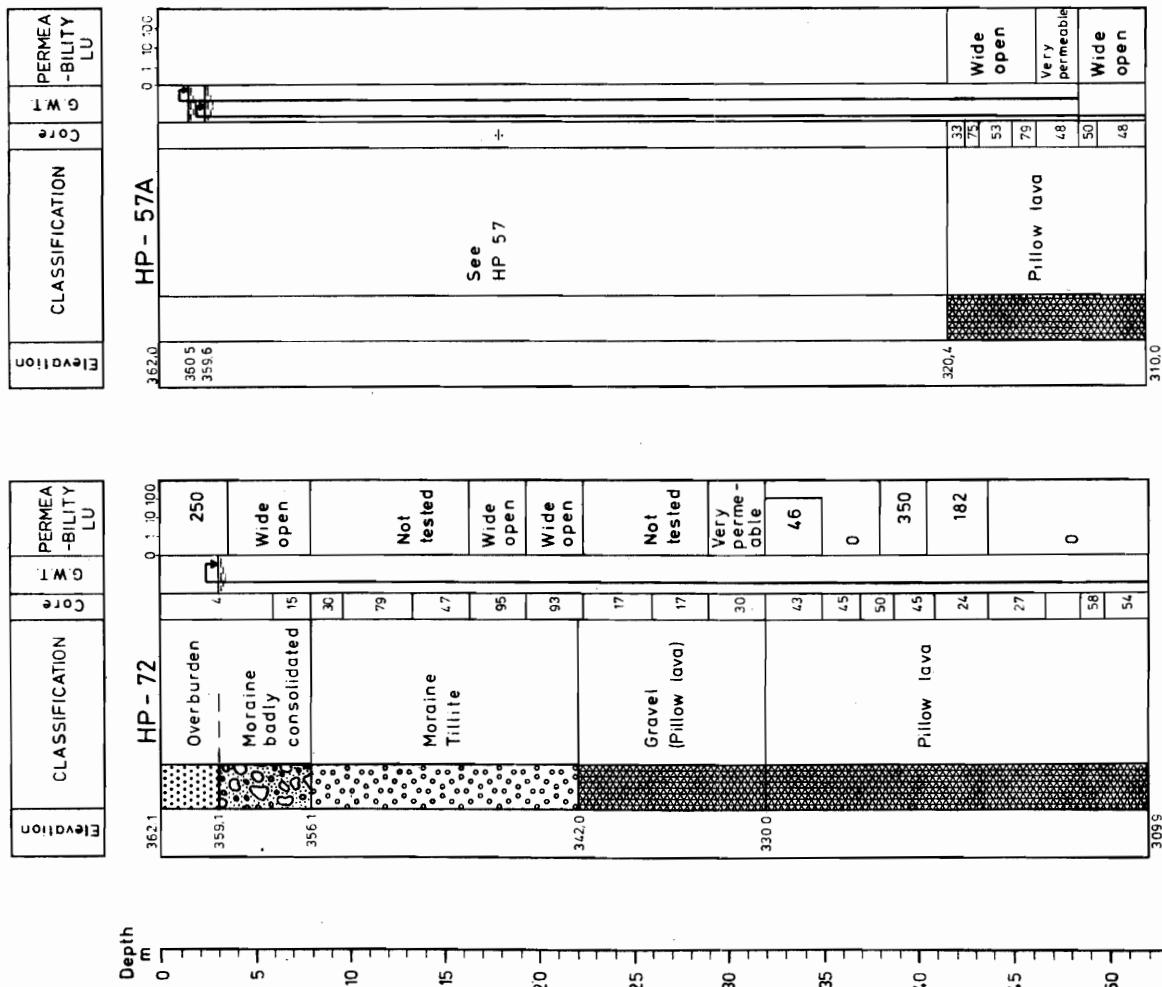
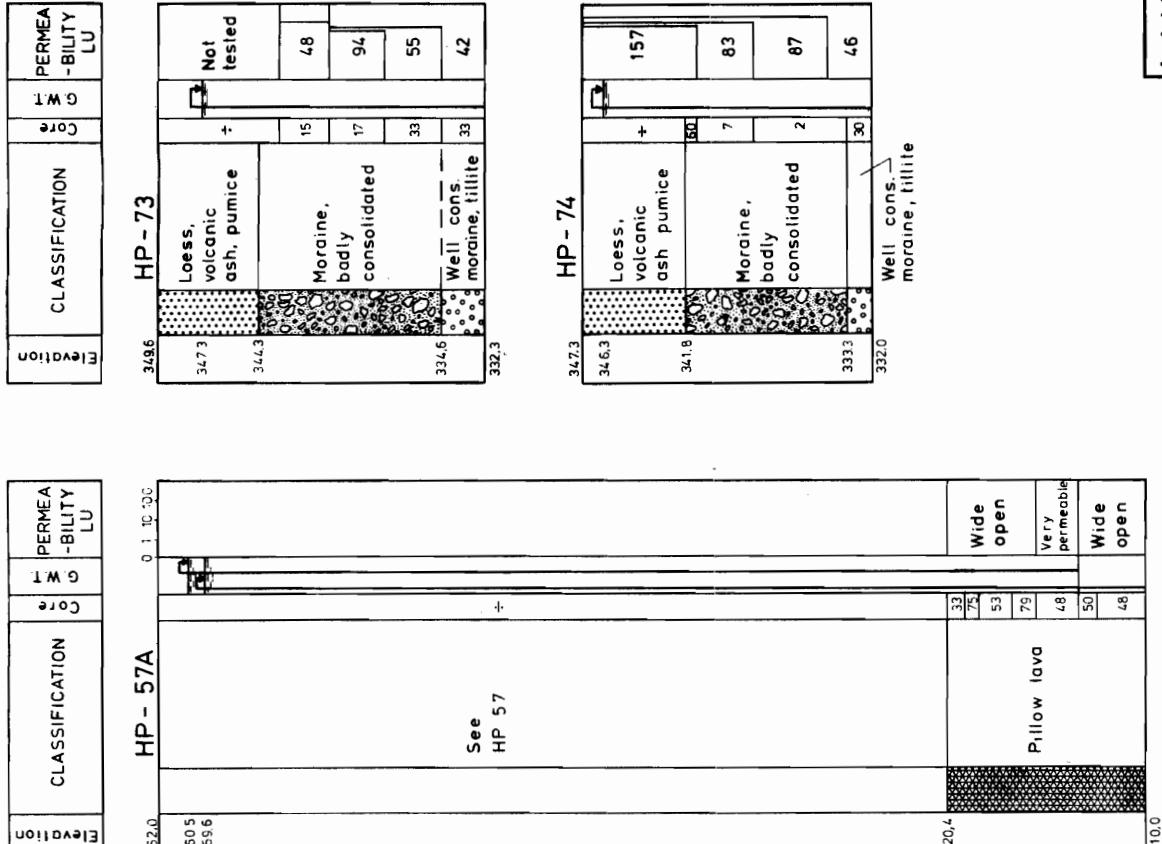
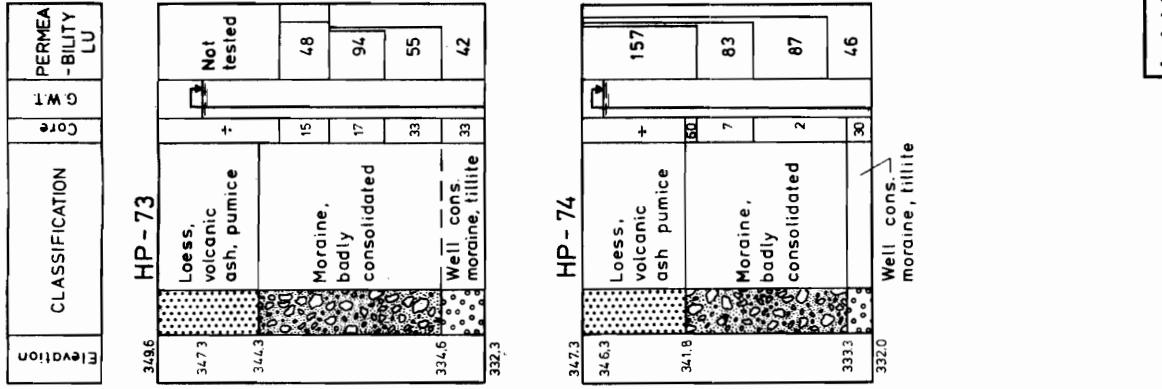
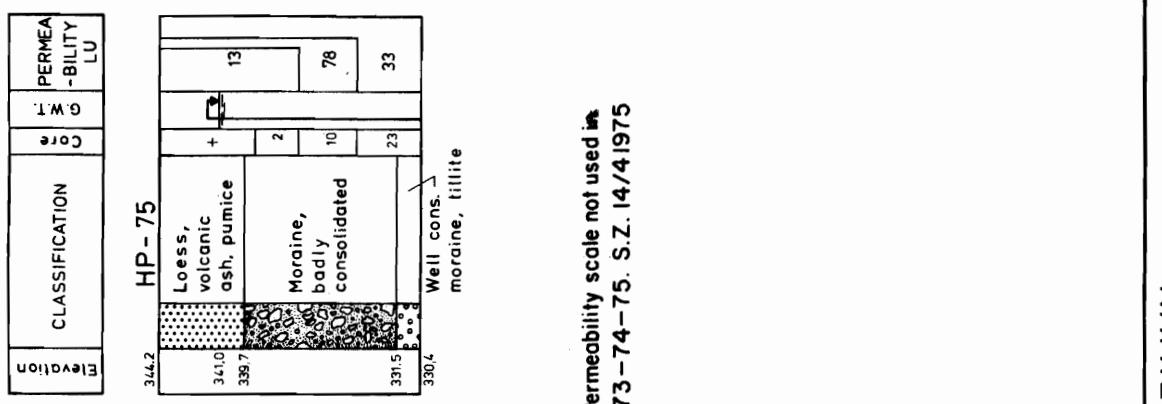
HRAUNEYJAFOSS PROJECT
GRAPHIC CORE LOGS

Note. Permeability scale not used.
HP - 73 - 74 - 75. S.Z. 14/4 1975

The graphic core logs of the new boreholes are exhibited on Figs 2, 3, 4 where the results of the permeability tests, core recovery, groundwater table and core description are presented. A more detailed description of the core is to be found in the field logs. Photographs of the cores are No. H-11 to H-38 in our drillhole register.

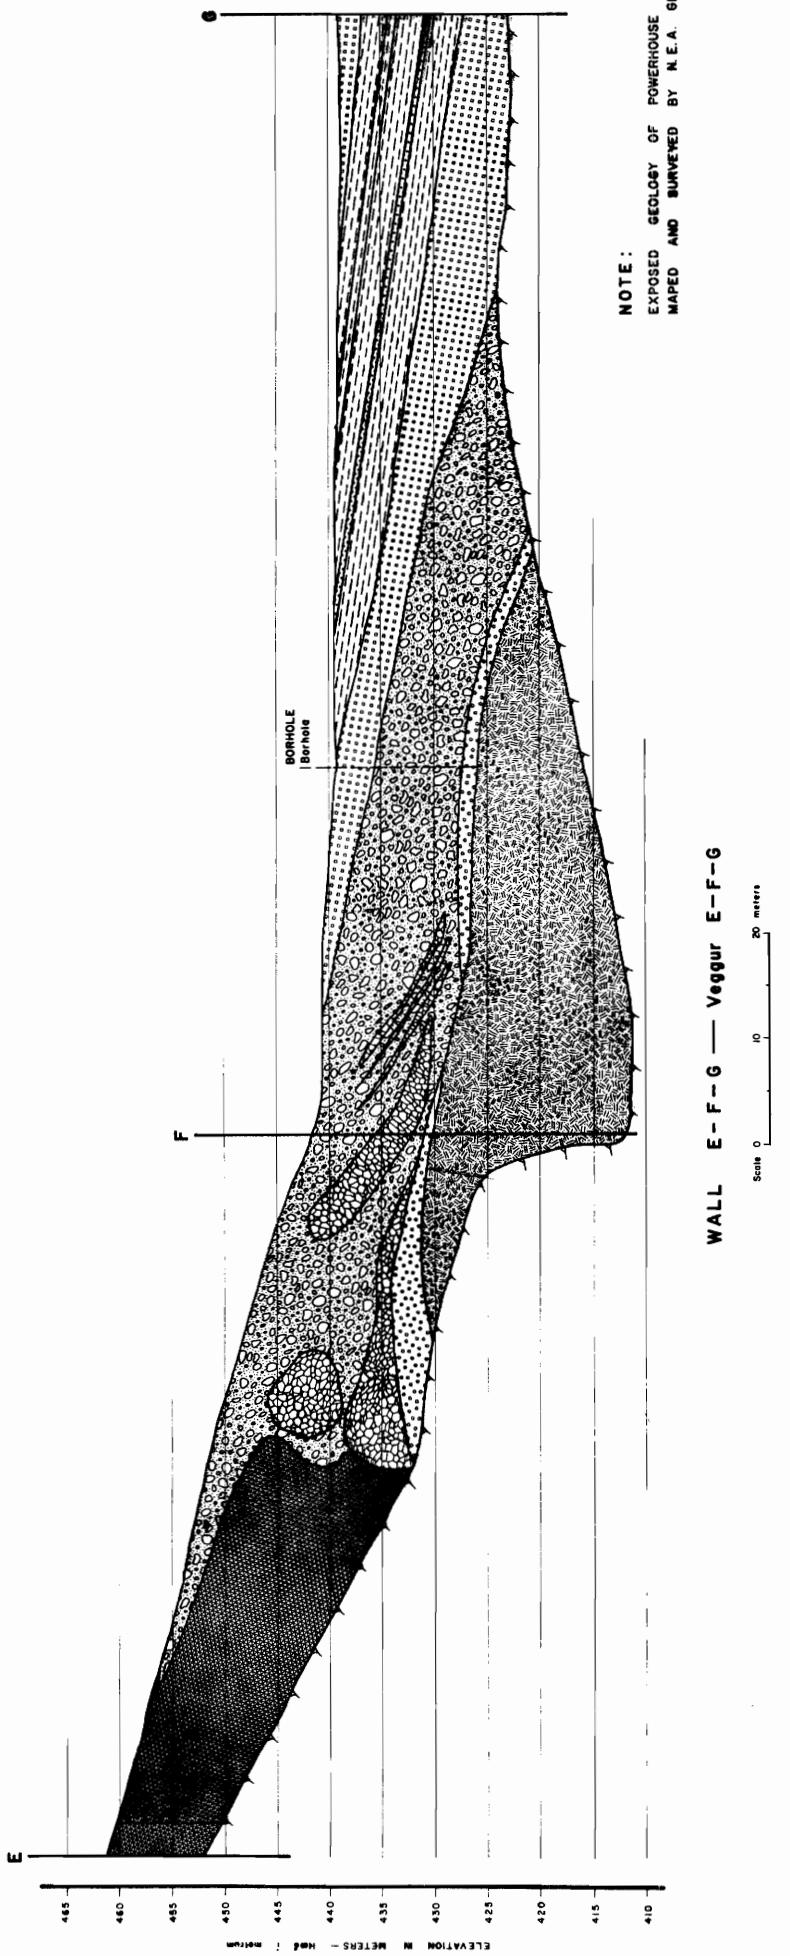
WALL E-F-G — Veggur E-F-G

NOTE:
EXPOSED GEOLOGY OF POWERHOUSE EXCAVATION
MAPIED AND SURVEYED BY N.E.A. GEOLOGIST.

At Sigalda the leakage is partly through a fracture upstream of the power-house excavation but a substantial part also takes place through the pillow lava. The fracture acts as a ground-water barrier creating considerable head in ground-water level there. At Hrauneyjafoss on the other hand leakage probably takes place almost solely through fractures.
