# *The church in Gásir*

*Interim report on excavations in 2004 and  
2006*

**Orri Vésteinsson**

**Reykjavík 2008**

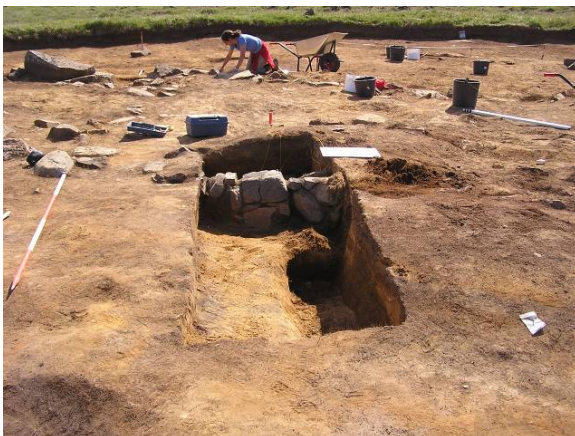
**The 1986 trench [5034], looking south.**

*Modern excavations.* The first objective of the excavation was to establish the extent of previous incursions into the site. The 1986 trench, reopened in 2001 [5034], was clearly

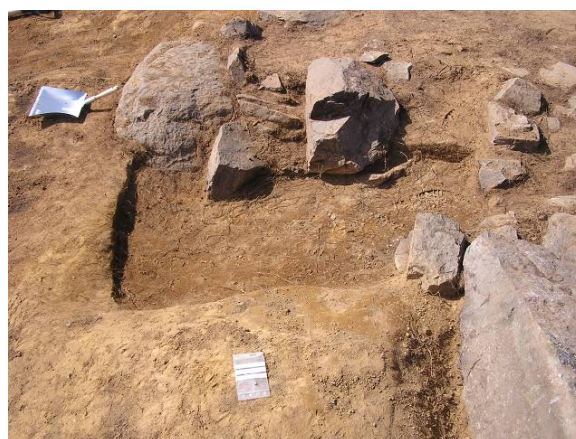
**Bruun's trench [5037] on the south side of the chancel, looking west.**

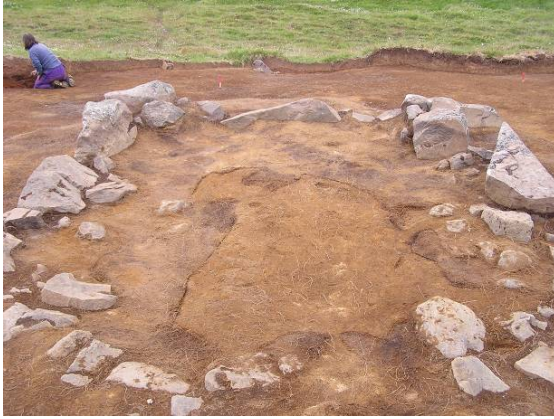
**Fill [5071] covering modern trenches [5072] in the chancel, looking east.**

very irregular cut [5071/72]. It is a discontinuous trench which follows the insides of the walls of the chancel, including the partition between the chancel and nave. There are separate sondages adjacent to the insides of the stones in the eastern gable, but the trench parallel to the north-side is set some 0,3 m inside the foundations. The trenches are dug to the base of the foundation stones or to where progress was blocked by smaller stones and it is not apparent that any structural remains were removed by these excavations. In the easternmost part of the chancel there are additional irregular spade marks and the main trench is decidedly more uneven there than further west. It is possible that these trenches, all or in part, are from the yet earlier excavations in the chancel reported by Brynjúlfur Jónsson and Froda in 1900 and 1902 respectively. While more irregular than the trenches outside the chancel these trenches are however very much in Bruun's style.<sup>22</sup> His main concern was to establish wall-lines and he would dig around stones rather than remove them. The possibility that these trenches are a mix of both earlier and the 1907 excavation cannot be ruled out.

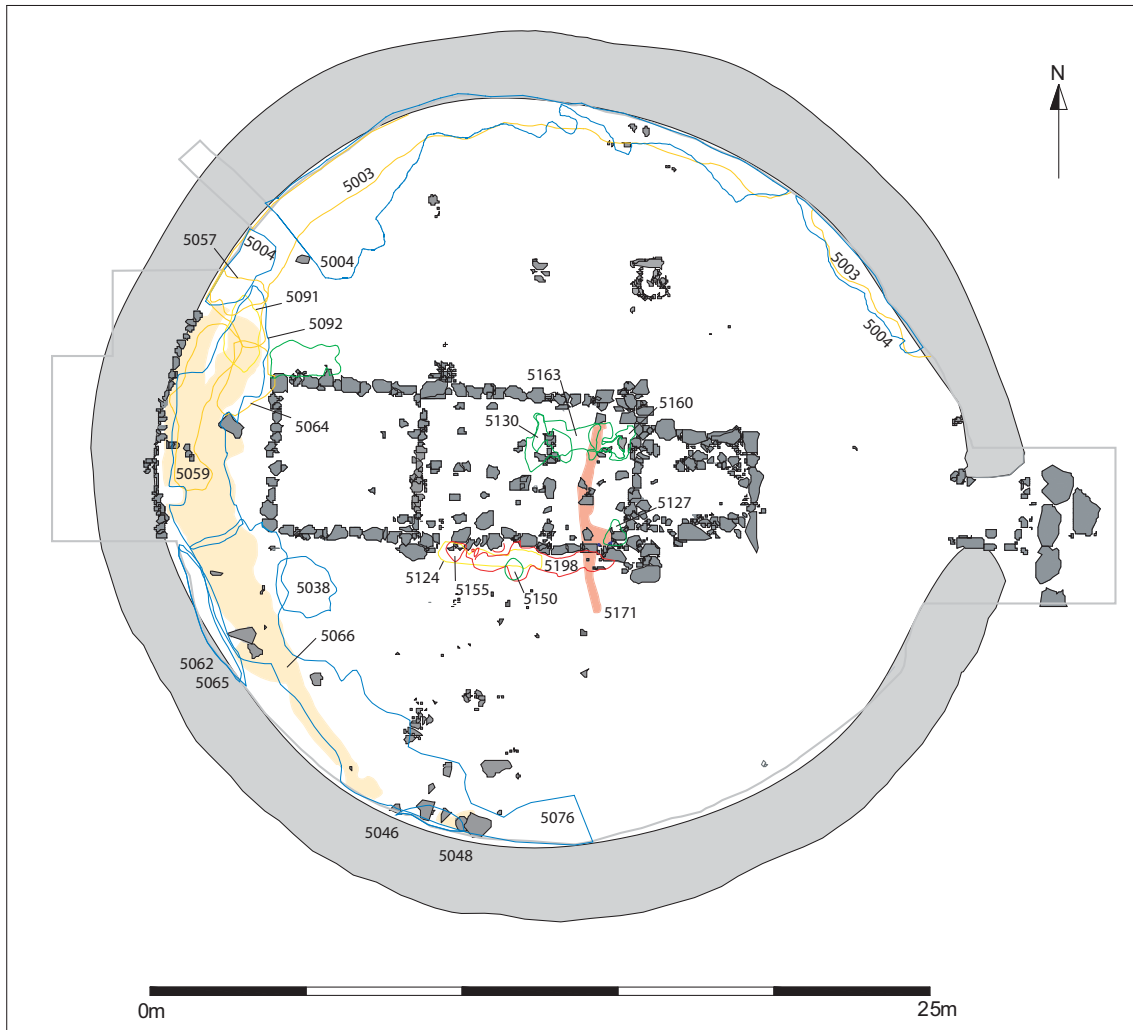
**Deposits post-dating the H-1300 tephra.**

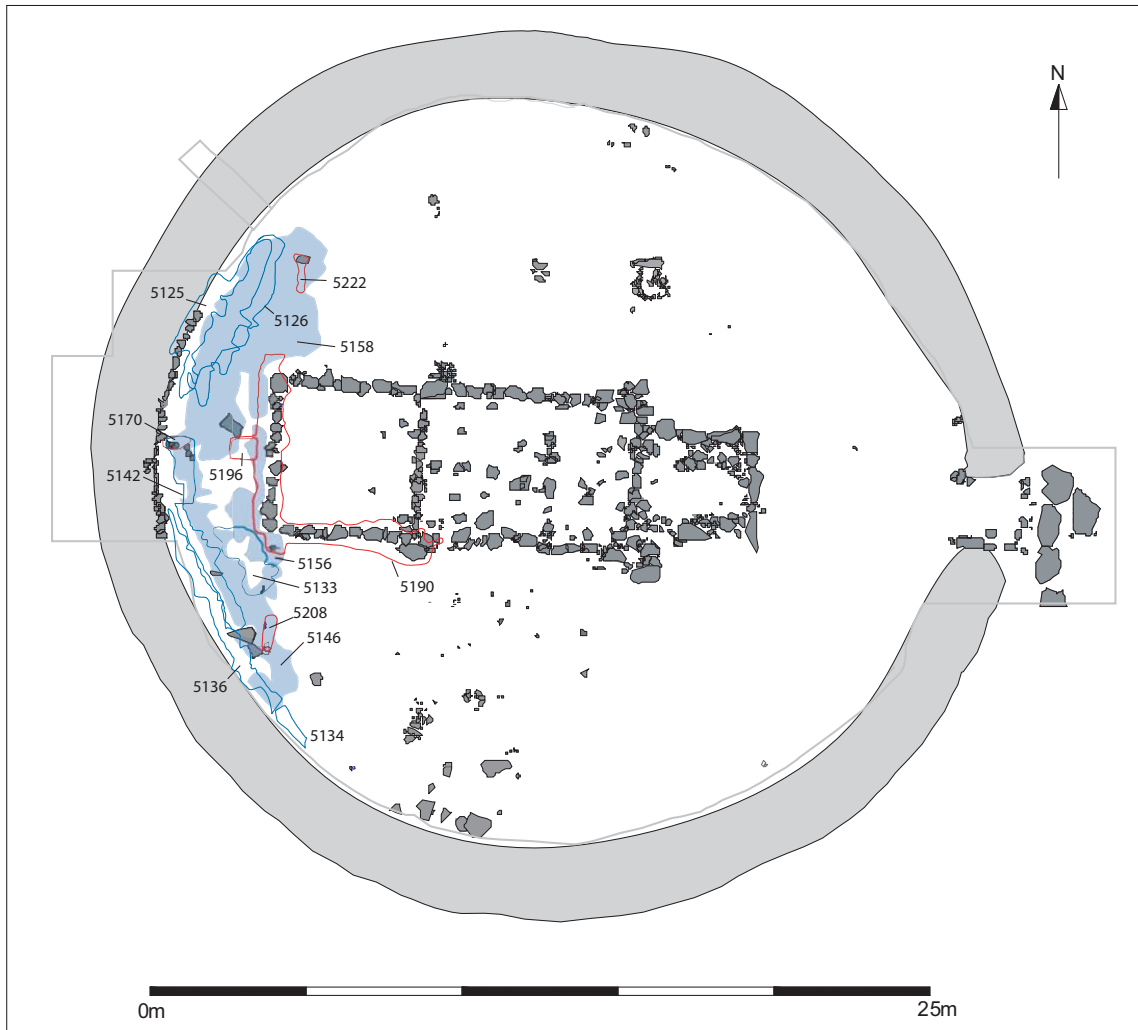
**Deposits pre-dating the H-1300 tephra.**

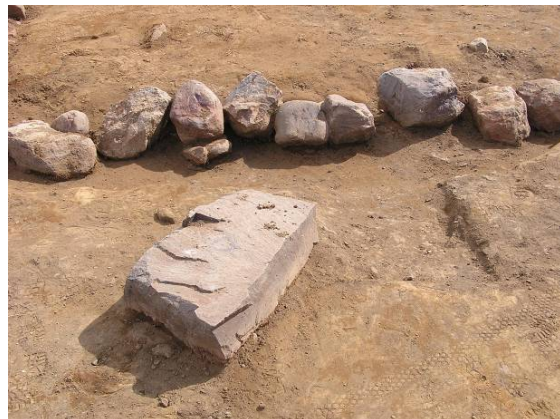
**The large stone besides the cut [5196], looking east.**

[5169/5170] dug up against the churchyard enclosure due west of the church, and shallow near-rectangular cut [5196] with fill [5195] similar to the mixed layer above. Cut [5196] is suspiciously similar in size to a large stone with a flat top which sits askew just north of the cut. It seems likely that this stone originally sat in the cut (which can be regarded as an extension of the foundation trench of the third phase church), but its function is not immediately apparent. It could have been a step to enter the church, a necessity if there was a horizontal beam on top of the foundation stones, but a 0,4 m gap

between the cut and the western extension's foundation may cast doubt on that explanation. Another, only marginally more plausible, is that the stone was a weight for a tether, possibly a chain, to keep the church in place, the removal of which would have entailed shifting the stone from its original location. Whatever its function it is clear that the stone was moved at an early stage and that all the subsequent deposits west of the church accumulated against it in its dislocated position. That in itself speaks against the main entrance into the church being on its western gable.

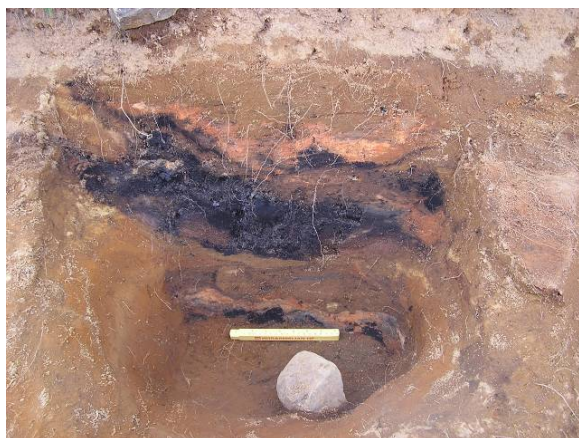
**Series of fills of charcoal and peatash in pit hearth 5200/5201. Looking south.**

A small blob of turf collapse [5151] separates [5076] from yet another, similar turf collapse layer [5167] which is spread along the inside of the enclosure wall in the southeast quadrant, stretching all the way to the entrance on the east side. It included a stone manuport (5126), a possible iron buckle (5130), a ceramic sherd (5133), a whetstone (5134), some charred wood (5132) and animal bone (5128). There were two deposits of burnt turf collapse on top of this layer, layers [5143] and [5161], the former unusually rich in finds, with an iron nail (5113), a piece of worked wood (5114), an iron rivet (5117) and animal bone (5115, 5116). [5167] seals a pit hearth [5200/5201] (with animal bone 5139)) dug up against the

enclosure wall, and is above sandy silt layer [5194] which is at the bottom of the sequence of deposits associated with the entrance to the churchyard (see below). Most of the finds in [5167] were found in a relatively small area which included the pit-hearth [5200/5201] and the upper deposit [5143], suggesting that some relate to the hearth (including the ceramic sherd) and other to a later midden deposit.

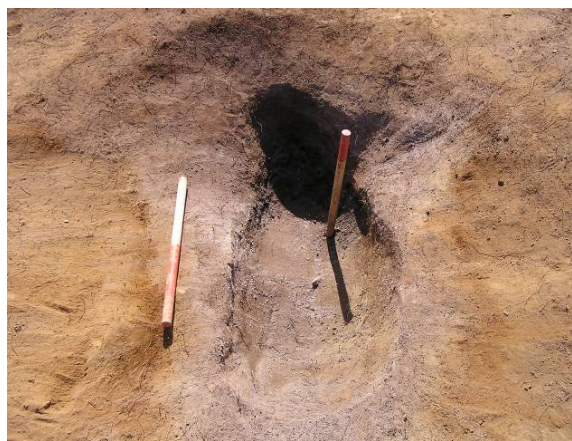
**Complex pit group [5041] looking south.**

Complex pit (group [5041]) north of the church with mixed fill [5035] of sand and ash with textile (5038), charred wood (5011) and animal bone (5012), re-cut [5040] into earlier fill [5220], also a mix of sand and ash with frequent charcoal with textile (5147). The sandy matrix of the fills in this pit is similar to the pit [5068/5069] described above.

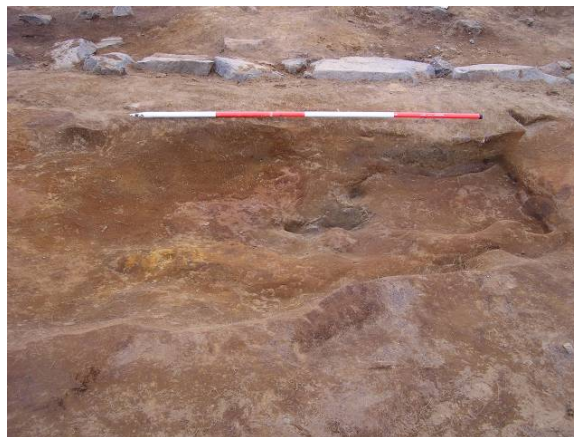
**Pit [5070], looking south. Note the yellowish stains to the left. Possibly sulphur.**

*Contexts on the northern and southern sides of the church.* On the northern side of the church, below the sequence of deposits post-dating the church and described above, there are three separate but similar layers of sandy silt with some turf debris, gravel and occasional charcoal [5080], [5082] and [5094]. The first two are on top of a fill [5070] of a large sub-rectangular pit [5095], measuring 3x1,5 m. This fill was very heterogeneous and seems partly to have accumulated in situ, and partly to have been dumped into the pit and mixed with pre-existing material. It is a blend of turf chunks, sandy silt, gravel, ash (both from peat and wood), fire cracked stones and charcoal and had some animal bone (5024), a wooden object (5030) and some textile remains (5031). In addition there was yellowish staining reminiscent of sulphur deposits seen in area A. Confirmation of this identification is

awaited. This pit was cut mainly into natural but it post-dates a layer of sandy silt with some turf debris [5115] which has accumulated against the foundation stones, stretching from the north-western corner of the church to the middle of the nave where its eastern end was cut by the 1986 trench. This layer respects the stones in the foundations except immediately east of the northwest corner. There it seals another layer [5173] of more definite turf debris which fills a gap in the wall-line, 1,5

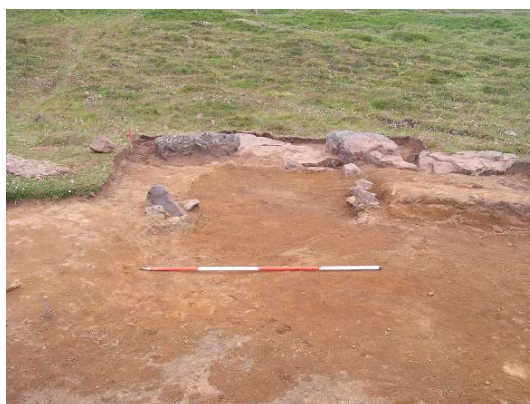
**The churchyard entrance after excavation, looking east.**

*Contexts in the entrance to the churchyard.* The entrance to the churchyard is on the eastern side and there the area of excavation was extended outside the enclosure to include the large boulders which have been arranged as steps up into the churchyard. In the entrance itself, an area some 2,5x2,25 m in size, there were a number of deposits, apparently relating mainly to the final and abandonment phases of the site.

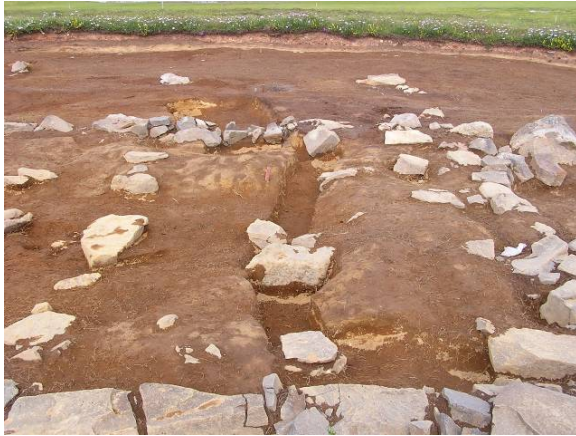
**Ditch [5171] inside the church, looking north.**

the southern foundation and ends 2 m south of the church. It is 1,5 m west of the partition between chancel and nave and describes a wide arc. In all it is 6,2 m long, mostly some 0,4 m wide and has a 0.7 m long eastwards extension under the easternmost section of the foundation in the south side of the nave. It is carefully dug, some 0,2 m deep, with vertical sides and a flat base. The fill [5152] is up-cast and the ditch seems to have been backfilled in one

The purpose of the ditch [5171] is far from clear. It does not have any obvious structural function and can hardly have been a drain – its sides are too freshly cut and the backfill clearly a single event deposit. It should probably be seen as evidence for repairs, possibly related to the same problem as is evident with the southern foundation of the nave. It is clear that the stones in the foundation of the south side must have been reset after the ditch was backfilled. The ditch therefore belongs to the last phase of the church but was clearly dug and backfilled and the foundation reset some time before its demolition.

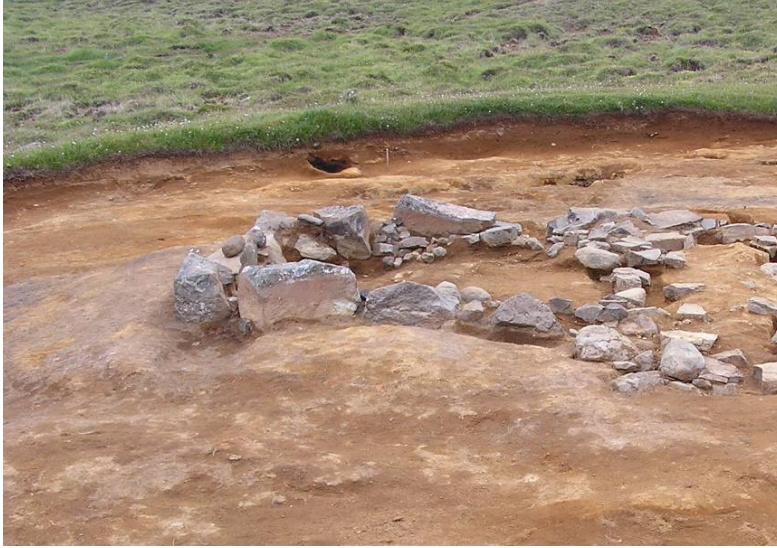
**The foundations of the chancel, looking south.**

Unlike the nave and western extension the stone foundations for the chancel do not sit in trenches. The stones in the chancel foundations are also much larger, substantial angular blocks set on edge, standing 0,5-0,8 m high. They rest on the H3 tephra – suggesting that some truncation was made to get them in place, but the edges of this do not remain. On the outside turf-debris and up-cast has been piled up against the foundation stones, creating a U-shaped collar of earth around the chancel. This pile post-dates the fill (not excavated) in the foundation trench/pit around the large boulder that is suggested to have been the southeast corner post pad of the second phase (see below). That suggests that the chancel in its preserved state belongs only to the final, third phase, of the church.

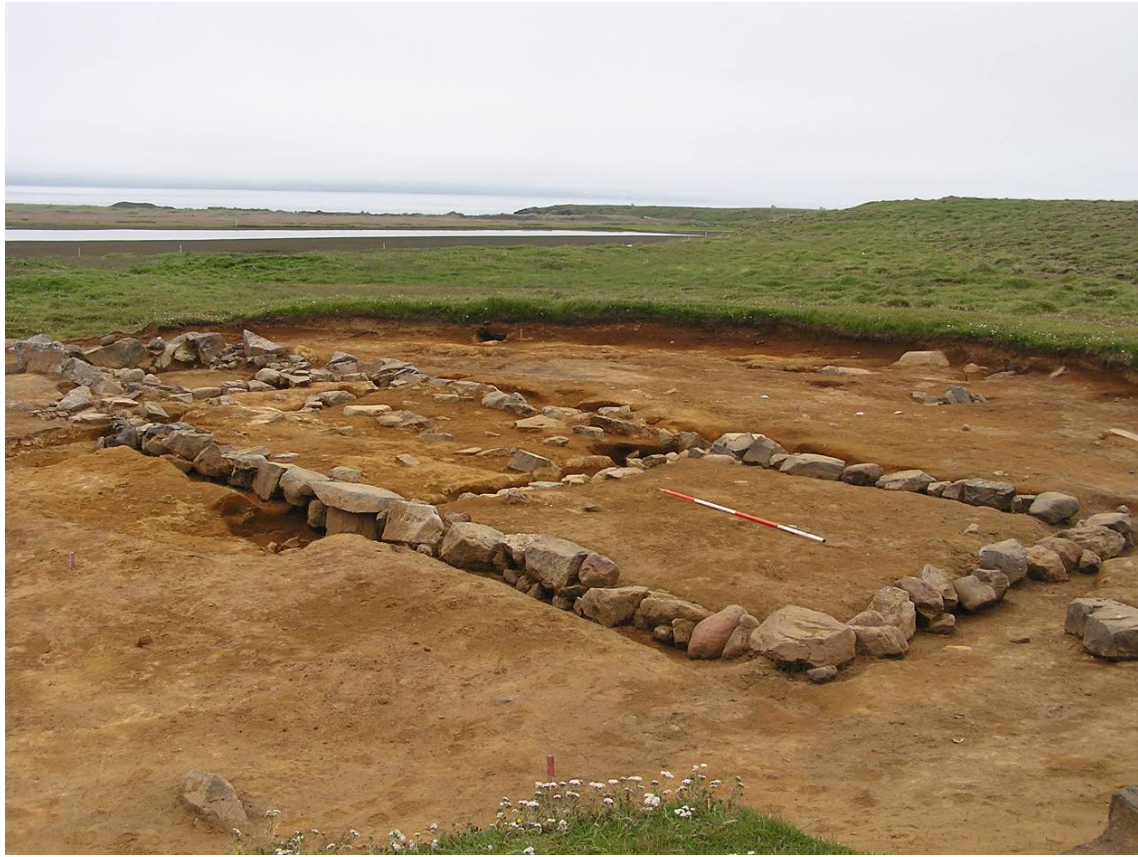
**The church at the end of excavation in 2006, looking southeast.**

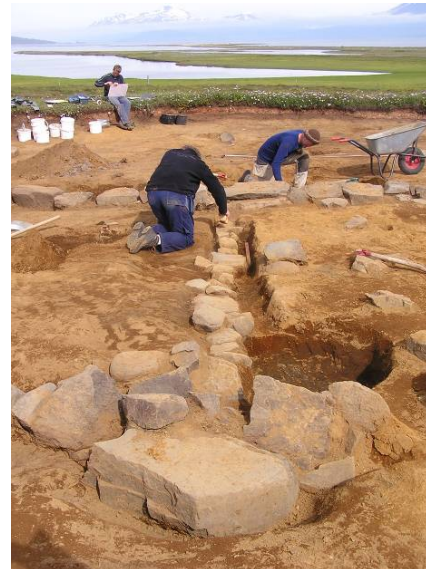
**Foundation for the western gable of phase 2, looking north. [5209] in the foreground, pit [5217] to the right.**

northern wall of the nave, suggesting that an earlier row of foundation stones was also removed there before the final construction event. The original cut [5216] for the foundation trench under the west side of the nave seems to be contemporary with the cut [5209] in which the large boulder outside the southwest corner of the nave is set. If that is true then both can be regarded as belonging the second phase of the church. Both of these second phase cuts postdate a large pit [5212/5217] inside the southwestern corner of the nave. It is semi-circular, 0,5 m deep, 1,1 m in diameter and has signs of robbing and backfilling before the construction of the second phase foundations. It is probably contemporary with another similar pit [5229/5230/5231], more oval in shape (1,4x0,85 m),

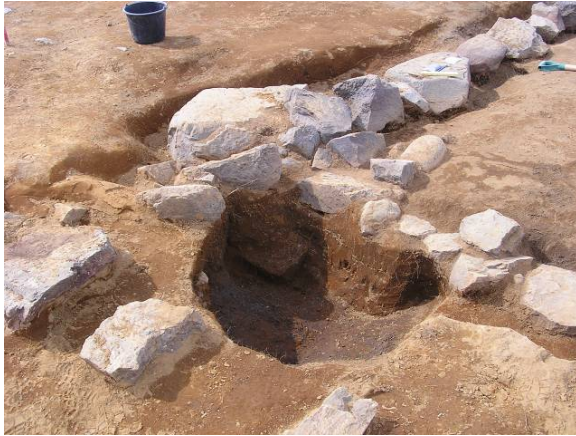
**Pit [5217], looking southwest. Southwest corner- of the phase 1 church, partly filled by the foundation for the western gable of the phase 2 church.**

outside the north western corner of the nave. It is also 0,5 m deep. This pit had also been robbed and backfilled but a pile of stones has been left in its base. It is suggested that these two pits, possibly along with the post-hole [5150], represent the first phase of the church. A cut observed under the stones in the southwest corner of the chancel, predating foundation trench [5210] could also belong to this earliest phase, representing the southeast corner post of the nave.

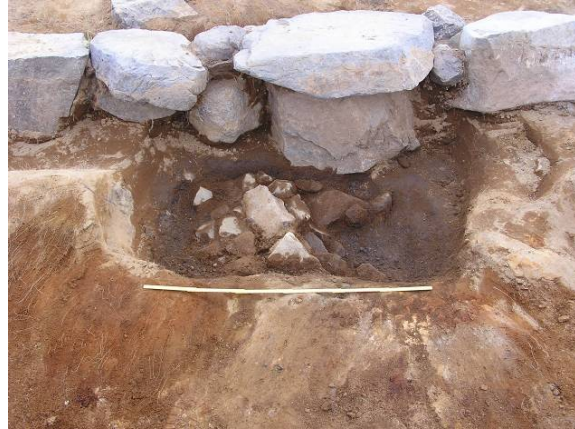
**Pit [5231], looking south. Northwest corner of the phase 1 church, partly filled by the phase 3 foundations.**

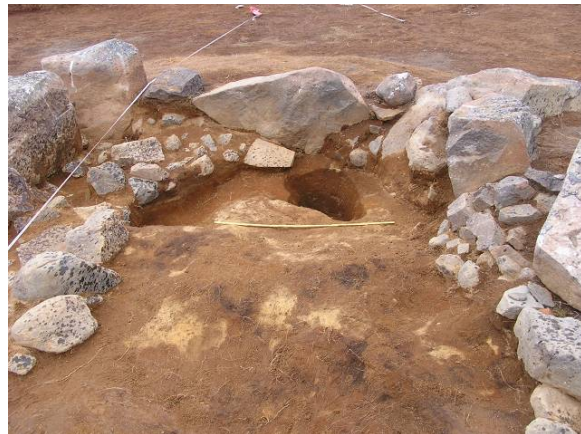
**Post-hole [5150], right, and cut [5147] in the chancel, looking east.**

In the chancel modern excavations (esp. [5072]) had taken a relatively heavy toll but the recovered sequence is nevertheless comparable to that of the nave. A layer of turf debris [5117] is identical to the small patch [5217] in the south-eastern corner of the nave and most likely represents also a dilapidation or post-abandonment phase of the church. It included a stone manuport (5104). [5117] has accumulated in the southern two thirds of the nave and is probably contemporary with [5121] in the northern one third. The latter deposit is similar except that it has a high frequency of small stones and some sand lenses. [5121] extends over the wall-line at the junction of chancel and nave, supporting the interpretation that it belongs to a post-abandonment phase. The two deposits are divided by a row of stones. Below [5117] there is a layer of up-cast [5131] and a surface [5135] (with a stone manuport (5110)) in the south-eastern part of the chancel, formed on a layer of up-cast [5145] identical to [5131]. These latter two represent levelling events, infilling cuts and depressions from earlier phases and can be associated with the construction of the final phase. To this final phase belong also two small but deep post holes side by side in the northern part of the chancel ([5138/5139] and [5137] – the latter was a 0,32 m deep cavity). Up-cast/levelling layer [5145] in-filled an elongated cut [5147], with a steep 0,23 m high north side but a more gradual south side in the northern half of the chancel. It also caps the fill [5149] (with stone manuport (5118)) of a complex posthole [5150]. [5150] is two postholes within the same cut, with a ridge between them. The more easterly hole is more substantial, sub-rectangular, 0,4x0,4 m and 0,36 m deep. The more westerly is also sub-rectangular, 0,18x0,18 m in size and 0,24 m deep. These holes along with cut [5147] most likely belong to an earlier phase of the church.

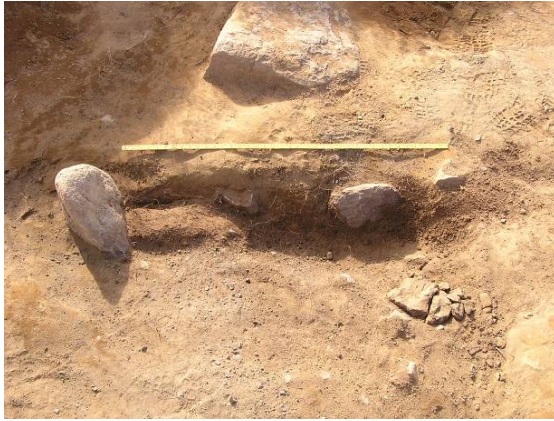
**Southwest buttress foundation [5208] with wooden plank, looking west.**

*Structural remains. Buttresses.* In the churchyard there are three features interpreted as foundations for buttresses. In the western half there are two identical elongated features, aligned roughly with the western gable of the western extension, 2,5 m south and north from the south-western and north-western corners of the church respectively. The more northerly of the two [5221/5222] is 1,1 m long and 0,2 m wide. It is 0,1 m deep in the southern end (closer to the church) but 0,19 m at the northern end where there is a single stone sat on edge, which has functioned as a stopper to wedge down the wooden buttress. The pressure from the weight of the buttress has been greatest by the stone and this presumably explains why the cut is deeper at that end. The corresponding, more southerly buttress foundation [5207/5208], is 1 m long and 0,3 m wide and also has a stone sat on edge at the end facing away from the

church. Here a small wooden plank (5145) was found in the cut, pressed against the stone. 0,2 m of its length remained but it can be surmised that the plank originally filled the length of the cut. The plank is 0,1 m wide and 0,05 m thick. The fill also contained some animal bone (5144). Both buttress fills were covered by layers predating the H-1300 tephra and this might indicate that they had therefore ceased to function and were not a part of the church structure in last the 60+ years of its life. This is not bullet-proof however as the fills could be capped by layers while the buttresses were still functioning. A resetting of the buttresses after 1300 would however have left traces and it must therefore be considered likely that the buttresses had disappeared when the church was blown of its foundations in 1359.

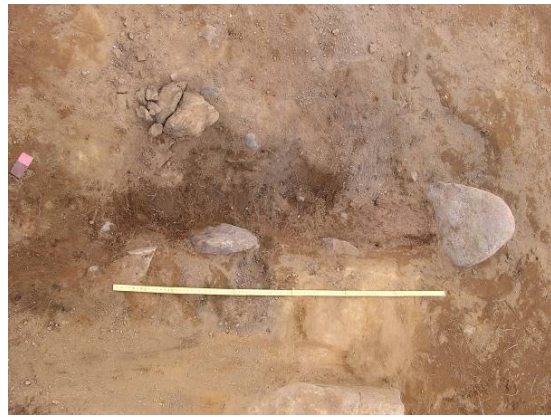
**Northwest buttress foundation [5222], looking west.**

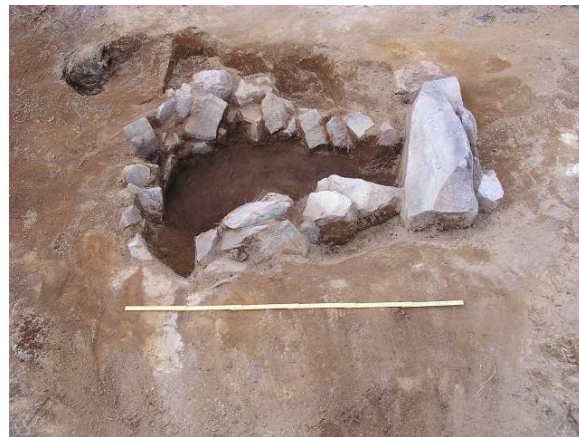
**Northeast buttress foundation [5223], looking west.**

The third buttress foundation is a much more substantial construction. It is 2,5 m north of the north-eastern corner of the nave. The cut [5223] is close to oval, 2,5x1,5 m in size. The fill [5219] is very mixed and contained a concentration of ash in a limited area by the middle of the western edge of the cut. This may represent a secondary event, a fire pit dug into the side of the buttress cut, but as there was no cut associated with the

concentration of ash it seems more likely that the fill represents mostly the backfilling of the pit, with material including this ash, after the buttress end had been removed. The design of this buttress foundation is identical to the others, with a large stone sat on edge at the end of

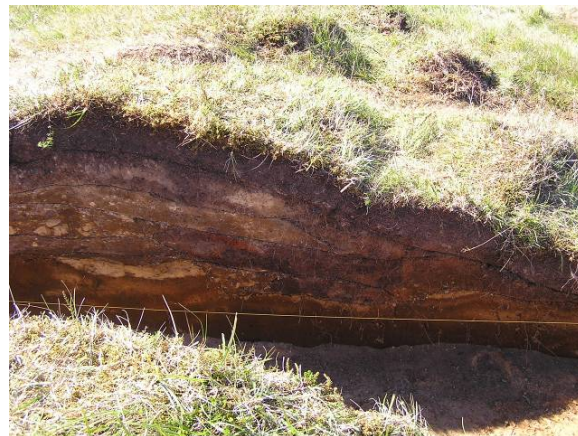
**The section, looking northeast.**

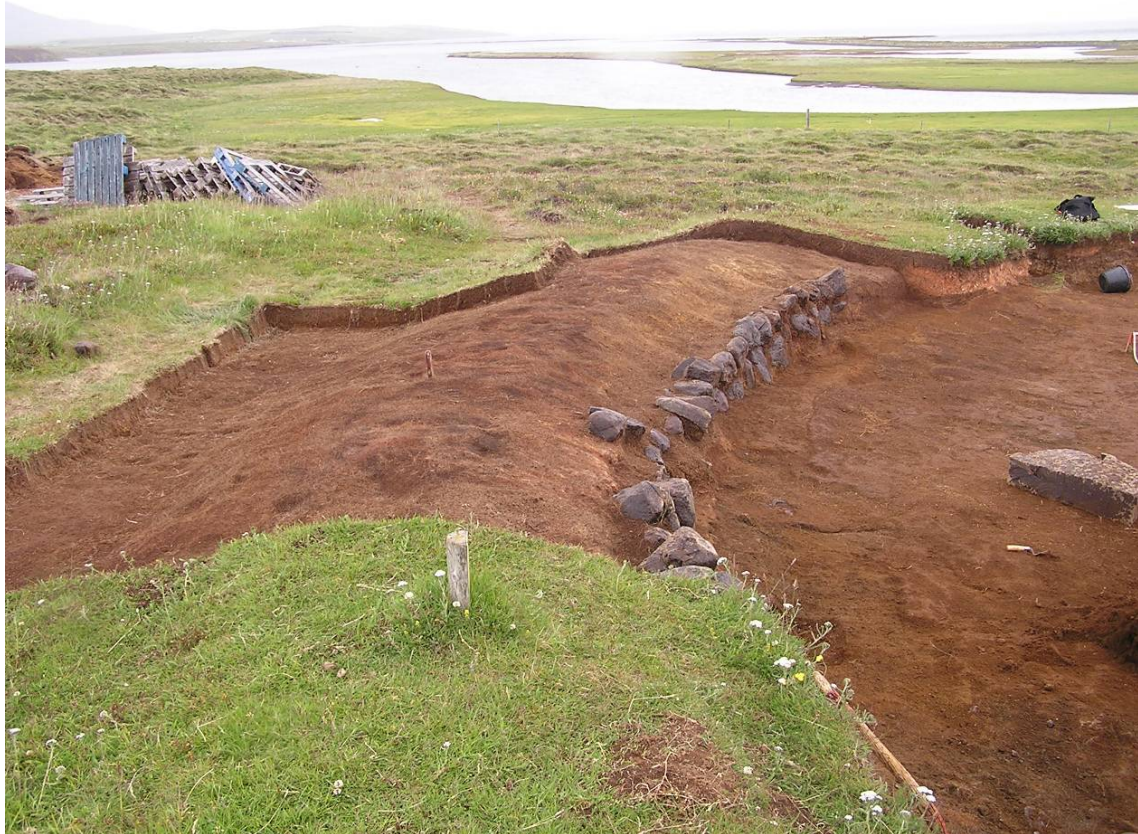
**The extension over the west-section of the churchyard wall with the full length of the stone facing exposed. Note the signs of burning on the turf. Looking north.**

In the extension the width of the turf wall, including turf collapse on the outside, is 2,0 m, comparable to the width observed in the trench. The original width of the wall can be estimated as 1,8 m at the base, judging i.a. by the depth of the entrance on the eastern side. In the western extension the turf wall had visible signs of burning and this was also observed in the eastern extension, where the turf on the south side of the entrance was clearly singed. Some of the turf debris deposits in the entrance area showed signs of burning (see above) and small pockets of burnt turf were also observed here and there in the southern side of the churchyard. It is possible that this burning represents the same event as the charred wood deposits in group [5058] (discussed above), and if so may support the idea that the wreck of the church was burnt after it had collapsed or been torn down. The complete absence of any signs of burning in or around the church's foundations speaks against the possibility that the church structure burned while still standing.

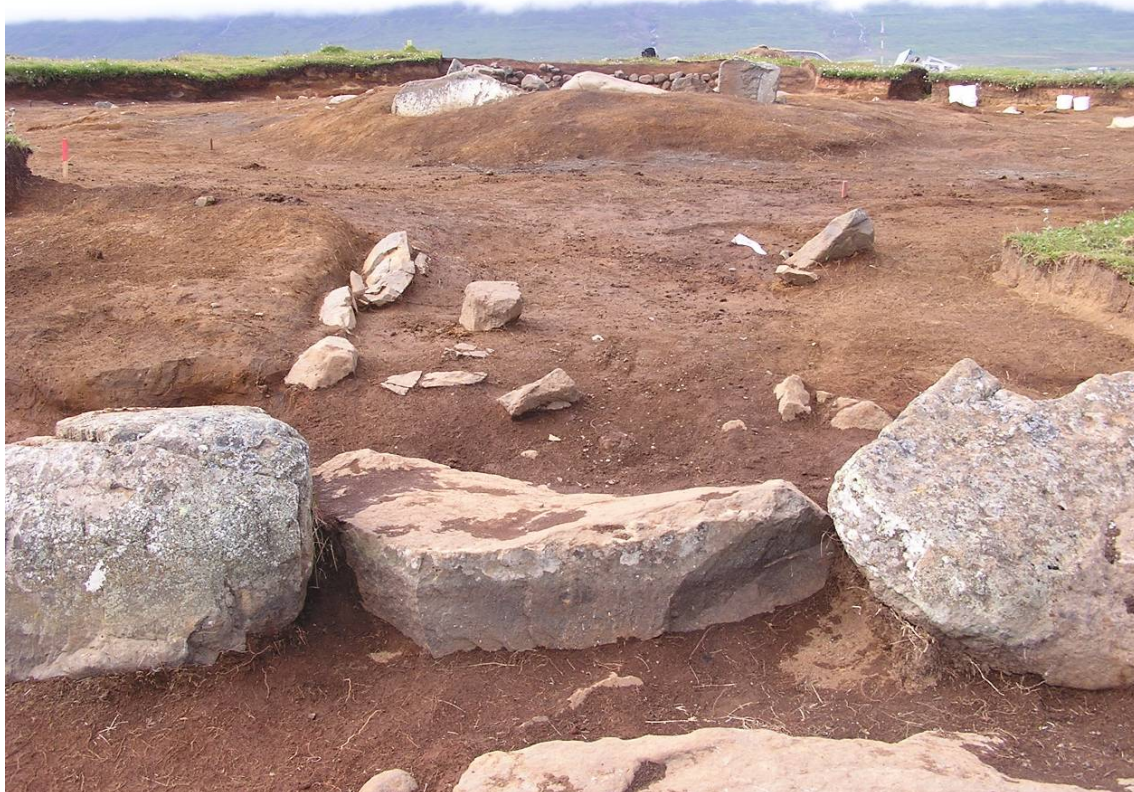
**The entrance under excavation, looking west towards the church. The collar of earth around the chancel can be clearly seen.**

Before excavation the entrance on the east side appeared as a wide gap of almost 8 m, associated with a row of large boulders outside and below the enclosure it self. The excavation revealed that the entrance had originally been much narrower or 2,2 m, clearly defined by a row of stones on the south side and a post-hole and some stones on the north side. The ends of the enclosure wall on both sides of the entrance had eroded to a considerable degree, particularly on the northern side where a nearly 4 m stretch has more or less eroded away. Within the extension a thin layer of turf [5172] was interpreted as the remnants of the wall on the northern side, but this was more due to its extent being consistent with the expected lay-out of the wall than it being possible to characterise it as a turf-wall. On the southern side the turf-wall, although thin, was preserved all the way to the entrance (not excavated).

A line of basalt boulders arranged below the entrance give it a monumental aspect. These are up to 1,5 m in length and 1 m in width, and in the centre two of them have been selected for their flat sides, creating steps leading up to the churchyard entrance. The lower step has apparently slid some 0,4 m down-slope to the northeast. Flanking these at both sides there are two higher boulders, framing the steps. There is a fifth large stone to the south of this construction but its function is not clear. These stones come from the same, or similar,

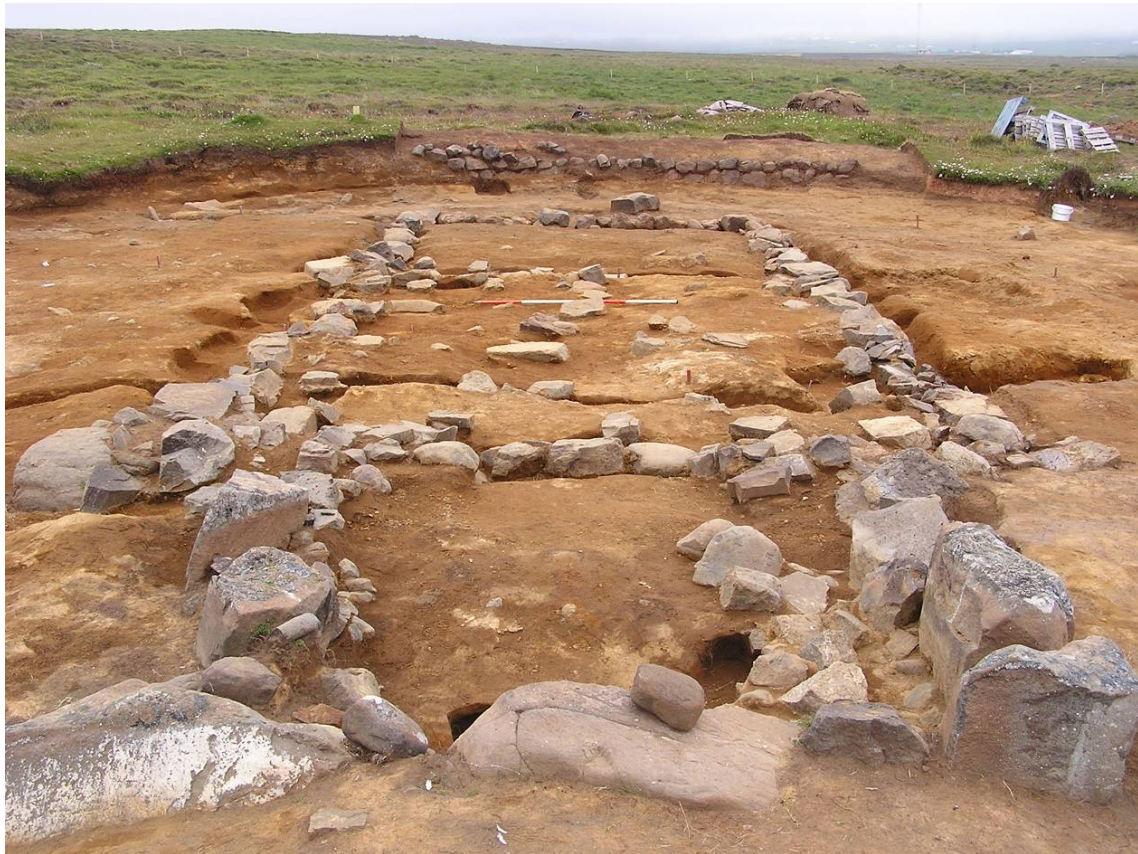
**The church after excavation, looking west.**

The third, and final, phase church is the only one which can be described in some detail. Its nave is 11,6 x 5,0 m and the chancel is 3,8 x 3,1 m. It is 0,5-1 m further north than its predecessor and oriented closer to compass east-west. Unlike its predecessors this church did not have any particular arrangements for the foundations of the corner posts. The walls of the nave rested on stone foundations, mostly a single, but in places two, courses of large (0,5 m+) stones, sitting in a trench, typically some 0,2 m deep and 0,6 m wide. The foundations of the chancel are made of larger stones placed directly on the natural, with loose earth piled up around the stones on the outside. The chancel foundations are some 0,3 m higher than those of the nave, suggesting, along with the eastern wall of the nave which is supported in the

same way as the others, that the chancel was a structurally separate unit, possibly with a higher floor level than the nave. The nave was supported by wooden buttresses at each corner (three of which survive) suggesting that the weight of the roof rested entirely on the walls, which as a result required buttressing so that they did not fall apart. There is no evidence for buttressing of the earlier phases, which were more or less of equal width, but neither is there of internal supports (unless the stones suggested as supports for floor beams in the second phase are interpreted as such). It seems therefore that structurally the main difference between the third phase and the earlier phases was that the latter had very substantial corner posts which supported most of the weight of the roof, whereas in the third phase the weight was distributed more evenly along the length of the, possibly more substantial, walls with added supported given by the buttresses.

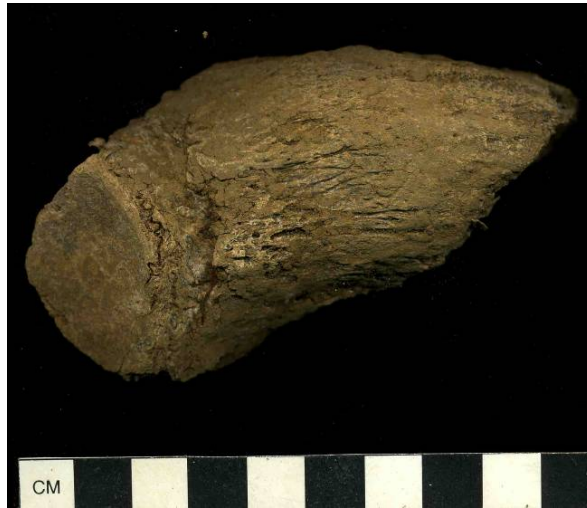
**Figure 2: Cattle Horn Core, posterior view (context 5227)**

*Cattle* bone is present, and the caprine/cattle ratio is about 1.17 caprine bone for every cattle bone. The total number of *Bos taurus* remains is 29, including three cattle horn cores, found in contexts 5078, 5207, 5227 (fig. 2). These horn cores are potential indicators for horn craft working. Four of the long-bone remains showed chop marks and at least half of all the elements exhibited signs of heavy erosion or exfoliation.

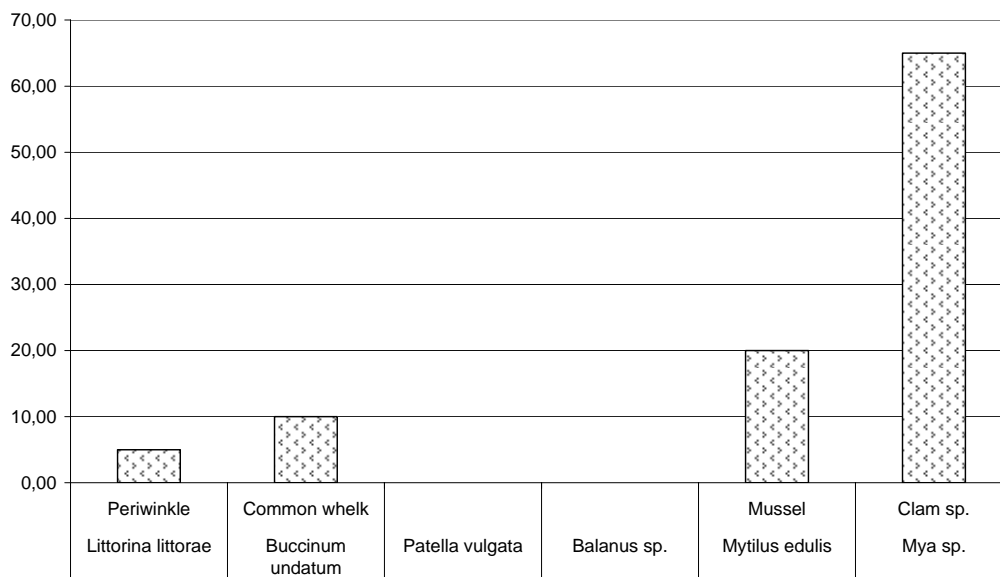
**Figure 3: Gásir Area B  
Mollusca Sp ID %**

*Mollusks.* Mollusk remains made up roughly 12% of the total bone assemblage, and 17% of the [5019] assemblage. Clam fragments were the most abundant, and mussels the second highest in number. Midden [5019] contained 28 of the 30 elements of mollusks and two of them were speciated to *Buccinum undatum* or common whelk that lives in the waters of the North Atlantic. Figure 3 presents the various identified Mollusk species.

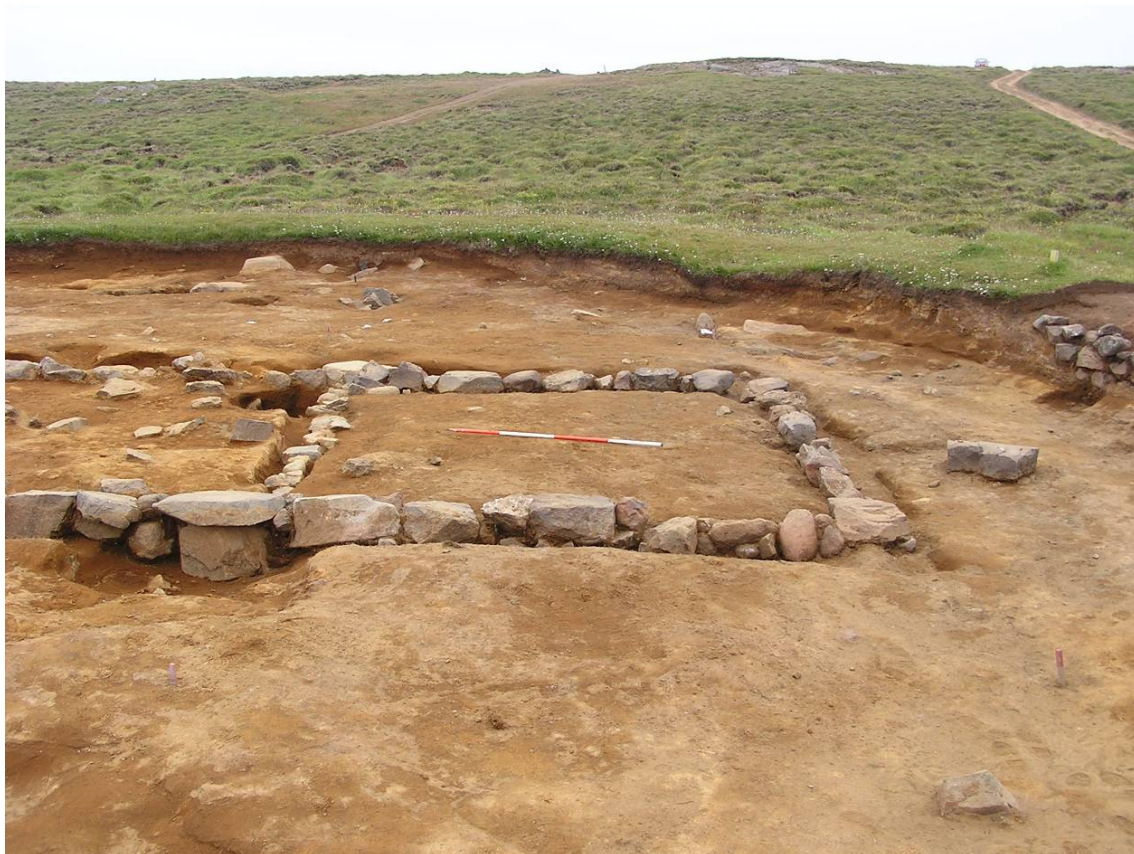
**Vesturendi yngsta byggingarstigsins, horft í suður. Undirstaða undir vesturgafli miðstigsins sést til vinstri sem og gryfjurnar undir hornstafi elsta stigsins.**

Yngstu kirkjuundirstöðurnar eru gerðar úr samfelldri röð steina í grunnnum skurðum. Aurstokkar kirkjunnar hafa hvílt á þessum undirstöðum og þyngd þaksins hefur alfarið hvílt á

útveggjunum. Til að hindra að kirkjan gliðnaði undan þunganum hafa verið skástífur við horn kirkjuskipsins og fundust þrjár af fjórum undirstöðum undir þær. Skipið er 11,6 x 5,0 m en kórinn er undir minna formi, 3,8 x 3,1 m að stærð. Alls hefur þessi yngsta kirkja því verið 15,4 m að lengd. Timburgólf hefur verið í henni allri og virðist gólfíð í kórnum hafa verið um feti hærra en í kirkjuskipinu, en undirstöður kórsins eru gerðar úr mun stærri steinum sem hafa staðið hærra upp úr jörðinni en steinarnir í undirstöðum skipsins. Dyr hafa verið á vesturenda norðurveggjar og hugsanlega einnig á suðurvegg kórsins.
